SPECIAL REPORT FCDD-AMR-23-01

# COMPOSITE REPAIR ENGINEERING CASE STUDIES FOR U.S. ARMY AEROSTRUCTURES

August 2023

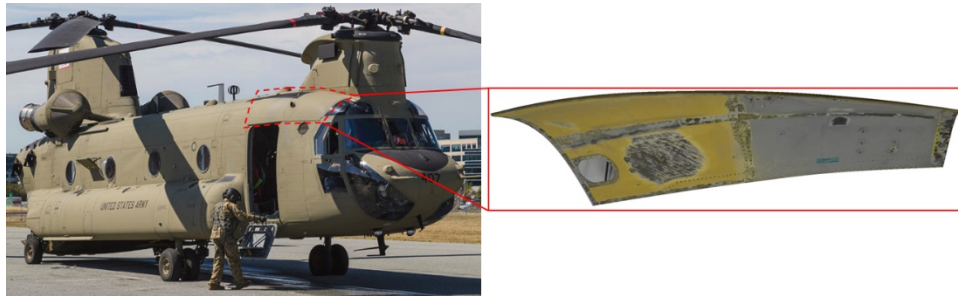
Figure 11. H-47 Crown Skin Specimen.

The H-47 Chinook has an advanced composite structural panel called the crown skin which is located on the right hand side of the aircraft, near the cabin cockpit and above the crew access door, which is shown in Figure 11.

The subject crown skin is a carbon fiber epoxy composite laminate sandwiched over Nomex honeycomb core structure. Each face of the sandwich panel is made from several layers of carbon fiber plain weave prepreg and one external layer of style E-glass prepreg. The E-glass composite is an external ply used for damage protection, galvanic isolation, and an interface for attaching electrical discharge material. This ply was excluded from evaluation as it does not impose significant strength to the part. There were no structural repair instructions available for this carbon fiber component, meaning that significant damage beyond the limits often leads to replacement of the assembly. However, due to cost, availability, and maintenance burdens, the U.S. Army recognized that repairs to these components are prudent. As a result, SRD developed repair instructions for the purposes of implementing into DMWR 1-1520-271. This DMWR is for the repair and overhaul of the H-47 Chinook airframe structure.

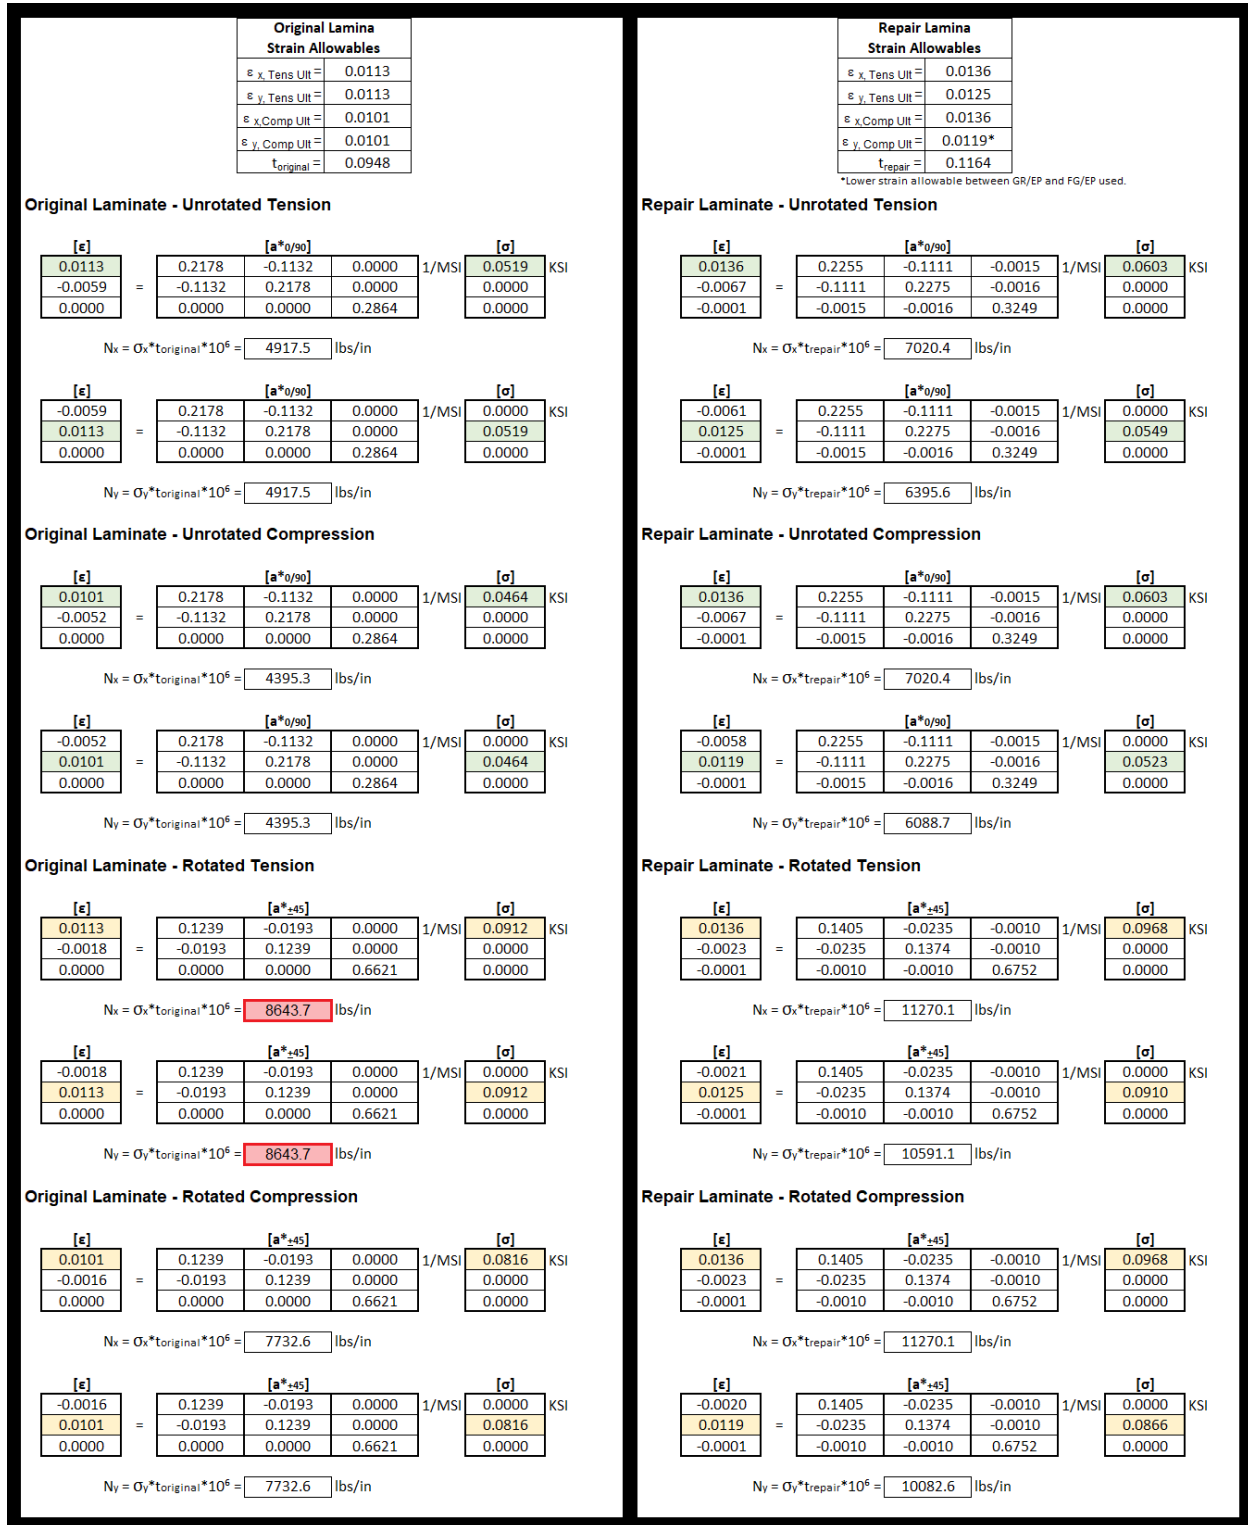
Figure 17. Running Load Calculations.

Note that the running load is in units of lbf/inch. Figure 17 provides the corresponding calculation necessary to achieve the running loads through the original and repair laminates. The corresponding structural capability ratios (equation 15) are then taken as the ratio of the repair load capability to the original base laminate capability. Table 7 provides the resulting calculations.

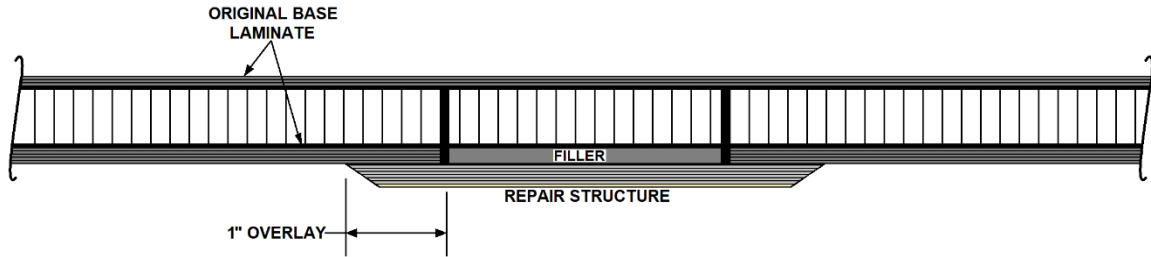
Figure 19. Scab Patch Repair Configuration.

While the repair performed on the subject Chinook crown skin employed a scarf type configuration as shown in Figure 18, this analysis will also consider a typical external bonded scab patch as shown in Figure 19 for comparison. Although the image is representative and not to scale, an additional carbon repair ply and external fiberglass ply were included in this repair and case study. This scarf repair uses a filler ply (included in analysis), and a 1/2-inch overlay per ply for a total scarf length of 6 inches per side. Alternatively, Figure 19 demonstrates the typical one-sided bonded scab patch repair. This configuration is assumed to include the same ply stacking and orientation sequence as the scarf repair but practically truncates the edges of the plies and uses a one inch overlay beyond edge of damage. In both repair cases, the opposite face of the skin panel is considered undamaged, there are no out-of-plane loading effects, and the repair laminate has been stabilized as is it bonded to the core and filler material.

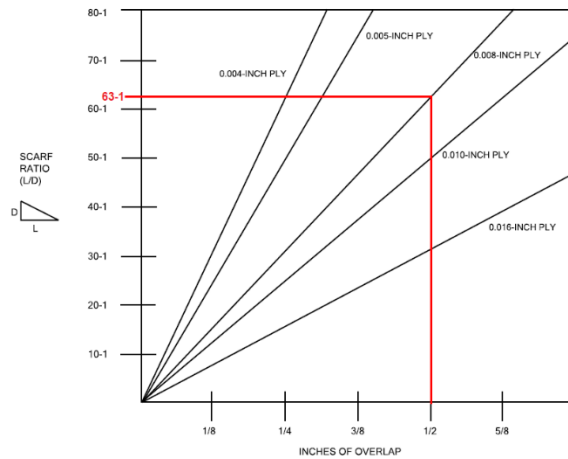
Figure 21. Ply Overlap Chart.

Confirmation of the necessary scarf ratio is performed by using the scarf ply criteria provided in TM 1-1500-204-23-11 (reference 17). Using the corresponding ply thicknesses (i.e., 0.0079 & 0.0083 inch) and ½ inch overlap criteria, an approximate scarf ratio of 63-1 was obtained; as shown in Figure 21.

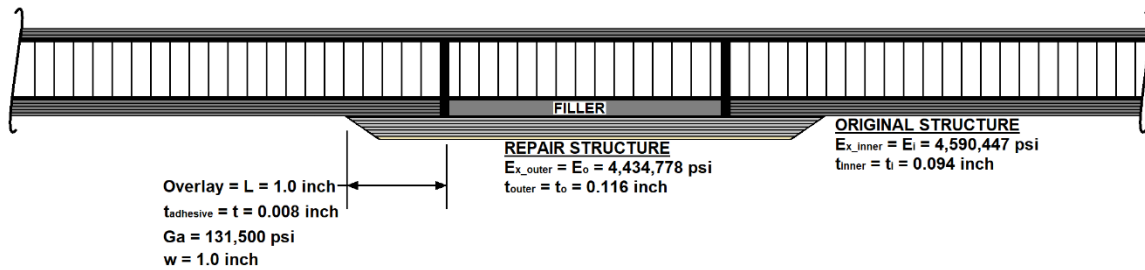
**Figure 22. Scab Patch Repair Configuration and Properties.**

Figure 22 provides the repair configuration of the scab patch, along with the respective material properties of the structure. It is important to point out that since both laminates are adhesively bonded to the honeycomb core, it is presumed that this precludes any out-of-plane deformations (i.e., rotation) as the structure is loaded. Additionally, the Volkersen method assumes idealized laminate and adhesive termination on the overply. However, legacy scab patch repairs and adhesive flows during curing result in material build-up at edges of the repair. This fillet feature is usually allowed to remain in place as it helps to transition the repair into the original structure, provides for environmental protection, and may be subsequently sanded to achieve aerodynamic profiles. For this analysis, the ply taper and presence of additional adhesive material at repair edges are neglected.

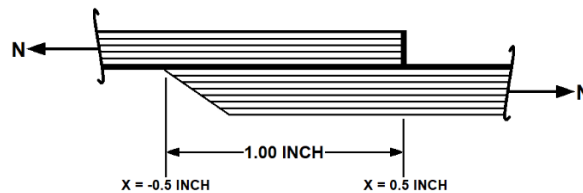
**Figure 23. Scab Patch Repair Overlap Length Detail.**

As this method is for a single bonded overlay, and both sides of the repair patch are symmetrical, analysis of one side of the repair is considered sufficient for the bonded scab patch. This overlay is shown in Figure 23, where the honeycomb core and filler material have been removed for clarity. The shear stresses in the adhesive are a result of its position within the length of the overlap, which is provided by equations 28 and 29 (reference 10).

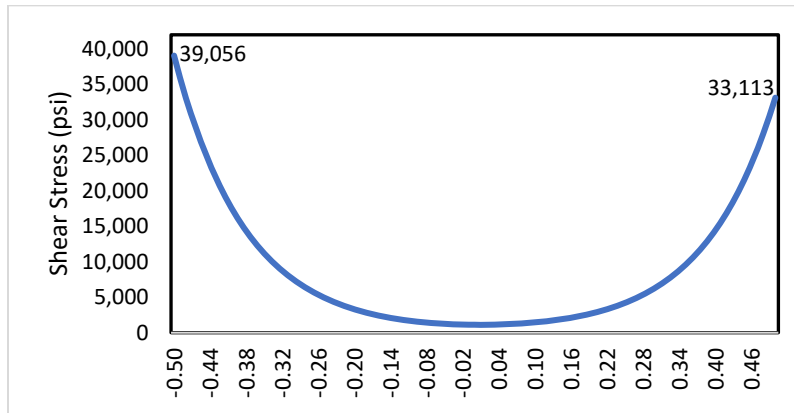
Chart 1. Bondline Elastic Shear Stress.

Using equation 30 and the overlap length (Figure 23), the shear stress profile is plotted and peak stresses at both ends of bondline can be calculated. As shown in Chart 1, the peak shear stress ( $\tau_{\max} = 39,056$  psi) is located common to the original base laminate structure and edge of the repair patch. This is expected as the original base laminate structure will deform faster than the repair structure, effectively increasing the strain near the edge.

While the peak shear stresses calculated in Chart 1 exceed the elastic-plastic transition for this adhesive, this load case was derived from maximum ultimate fiber strain values. The subject structure is not expected to see true adhesive plastic deformation while in operation and shear stresses in the adhesive are expected to be much lower during normal flight operations. In addition, increasing the overlap length of the scab patch repair does not significantly reduce the peak stresses that build up in the adhesive. To verify this, the overlap length, used in equation 29, was subsequently increased to two inches; the resulting peak shear stresses in the adhesive were reduced by less than one percent. Also, while increasing the thickness of the adhesive bondline layer did reduce the shear stresses, it did not reduce the peak stresses enough to be below the elastic-plastic threshold.
