NRL REPORT F-3417

FULL SCALE SHOCK TESTS - USS NIAGARA APA87

PART 2 - FAILURES IN ELECTRONIC EQUIPMENT

February 15, 1949

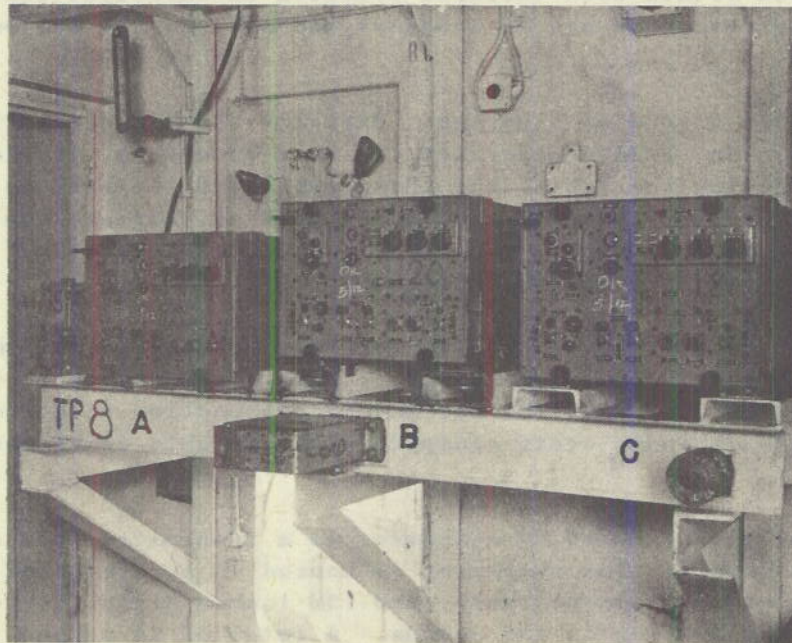
Figure 1- Mounting of BN Equipments

locations were designated as Test Positions 1-10 and they are fully described in Part 1 - Techniques and Instrumentation, NRL Report No. F-3404. Each of the three units located at each test position was supported by a different mounting arrangement. One unit was bolted securely to the mounting bracket without resilient mounts, and was designated as Mounting A. The second unit was supported on mounts providing about one inch of rubber, and was designated Mounting B. The third unit was supported on mounts providing approximately 3/8 inch of rubber, and was designated Mounting C. This third mounting plan is used extensively for supporting electronic equipment on naval vessels. The lowest natural frequency of vibration in any direction was above 20 cps for both mounting plans B and C. A mounting bracket for the three units was constructed according to Figure 2. For deck mounting, the two channels of the bracket were welded to the deck. For bulkhead mounting, the rear channel was welded to the bulkhead, and the front channel was supported by triangular gussets. Figure 1 shows three units on the bulkhead-supported mounting bracket.
