## Finite Element, Petrographic, and Mechanical Analyses of Field-Cored Concrete Fairlead Beam Anchor Rods from Luke Air Force Base

May 2024

Final Technical Report (TR)

Prepared for US Air Force Civil Engineer Center  
139 Barnes Drive Suite 1  
Tyndall AFB, FL 32403

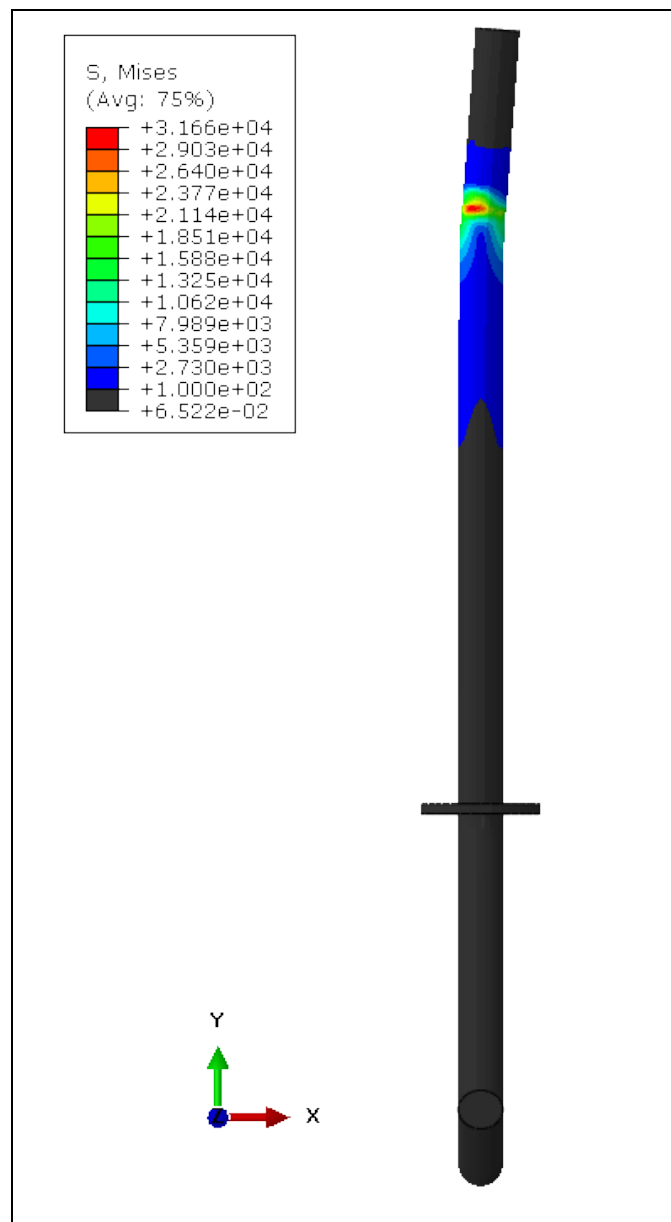
Figure 9. Von Mises equivalent stress (pounds per square inch) in the Y-bolt (deformations scaled 50×).

Under an 11-kip load, the maximum von Mises stress in the bolt was approximately 31.7 ksi, occurring at 0.1 in. above the top of the grout pad (or 4.5 in. below the top of the bolt). The maximum von Mises stress occurred on the side of the bolt (approximately  $\pm 90$  degrees from the direction of applied loading). This indicates that the bolt was primarily stressed in shear. The corresponding displacement at the top of the bolt head was 0.009 in. Figure 9 shows the von Mises equivalent stress,  $\sigma_{vm}$ , distribution in the Y-bolt. For purposes of visualization, deformations are scaled by a factor of 50. All areas with  $\sigma_{vm} < 100$  psi are colored dark gray. The lowest point where  $\sigma_{vm} > 100$  psi is 10.5 in. below the top of the bolt (4.9 in. below the surface of the concrete).

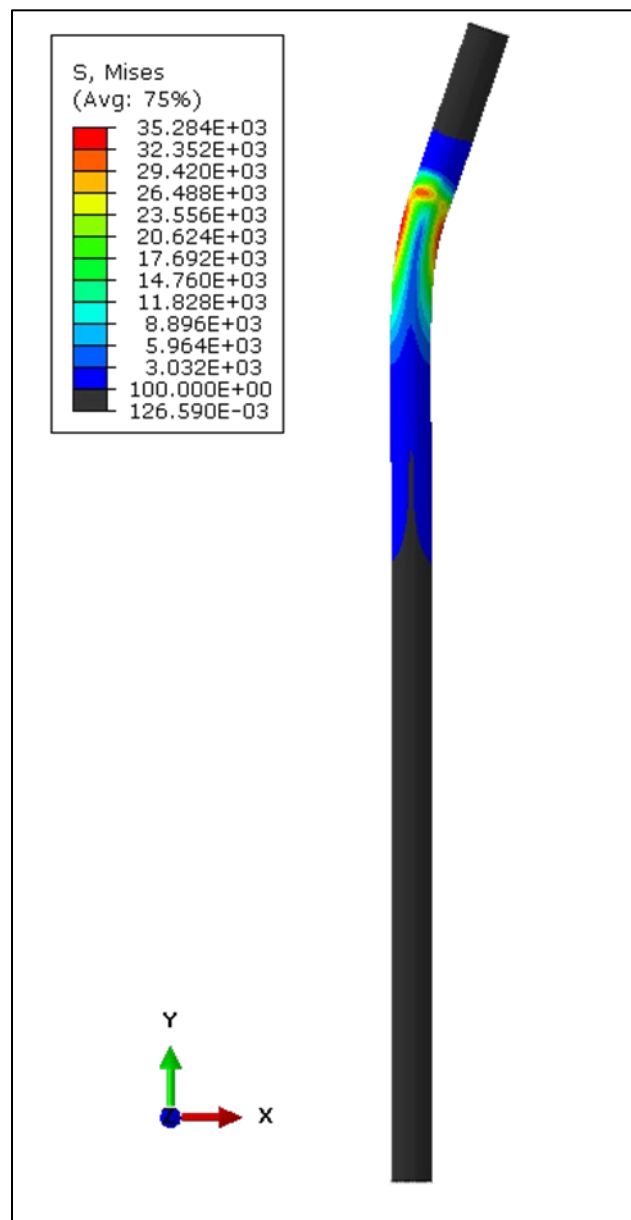
Figure 16. Von Mises equivalent stress (pounds per square inch) in the repaired Y-bolt anchor (deformations scaled 50×).

Under an 11-kip load, the maximum von Mises stress in the repaired Y-bolt was approximately 35.3 ksi, occurring at roughly the same elevation as the top of the concrete slab (6.6 in. below the top of the bolt). The maximum von Mises stress occurred on the front and back of the bolt (approximately 0 and 180 deg from the direction of loading). This indicates that the bolt was stressed in flexure. There was also a stress hot spot near the top of the grout pad. The corresponding displacement at the top of the bolt head was 0.043 in. Figure 16 shows the von Mises equivalent stress,  $\sigma_{vm}$ ,

in the repaired anchor bolt. For purposes of visualization, deformations are scaled by a factor of 50. All areas with  $\sigma_{vm} < 100$  psi are colored dark gray. The lowest point where  $\sigma_{vm} > 100$  psi is 14.8 in. below the top of the bolt (8.2 in. below the surface of the concrete).

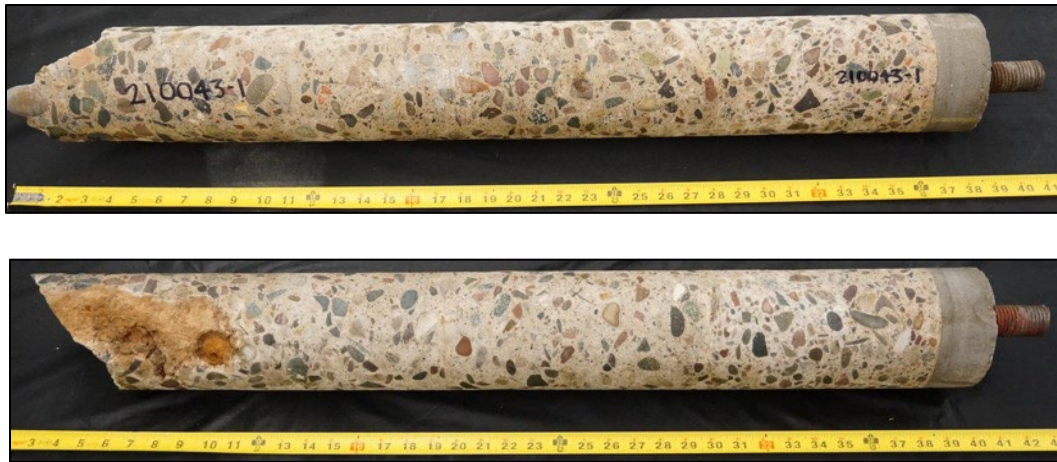
Figure 19. Core 210043-1.

The as-received core 210043-1 is shown in Figure 19, and the bisected core 210043-1 is shown in Figure 20. The length of the core was 37 in., and the diameter was approximately 5 in. Based on total core length and diameter of the threaded anchor rod, this core contained a Z-bolt anchor.

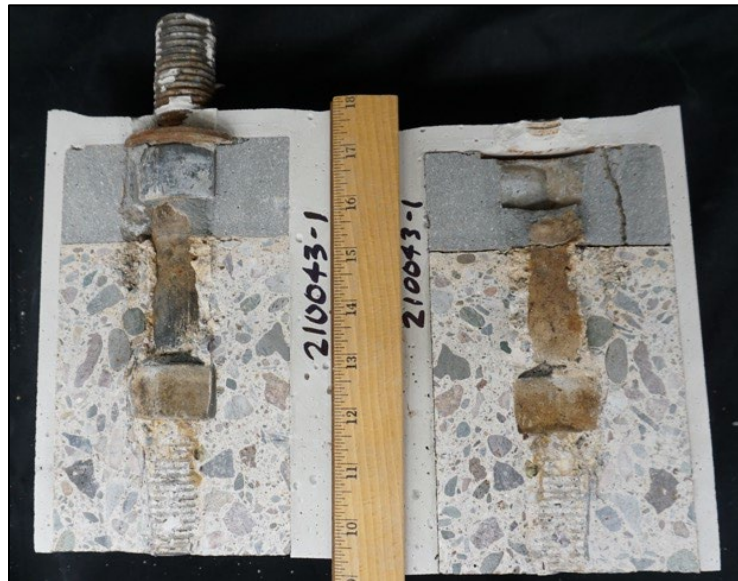
Figure 20. Bisected core 210043-1.

Upon bisection of the upper portion of the four received PCC cores with the fairlead beam anchor rods, the team observed that the galvanized pipe sleeves did not extend to flush with the surface of the concrete placed for the fairlead beam foundation pad (see Figure 20, Figure 26, Figure 32, and Figure 37), which deviates from the design intention of Drawing Number 67F2013A. Additionally, voids in the concrete mixture were observed around the galvanized pipe sleeve, indicating inadequate or inconsistent consolidation of the concrete mixture around the anchor assemblies. Furthermore, the removal of the grout layer and PCC above the top of the galvanized pipe sleeve revealed that concrete mixture—and not grout—had been placed inside the pipe sleeve. Figure 48 shows an end-on view of the top of the galvanized pipe sleeve of core 210043-1 with the grout layer and PCC removed. It appears that the same concrete mixture used to place the fairlead beam foundation pad was crudely placed into the pipe sleeves. Similar observations were made across the other three field-cored anchor rods. The presence of voids and coarse aggregate within the pipe sleeves would be expected to negatively affect the mechanical performance of the

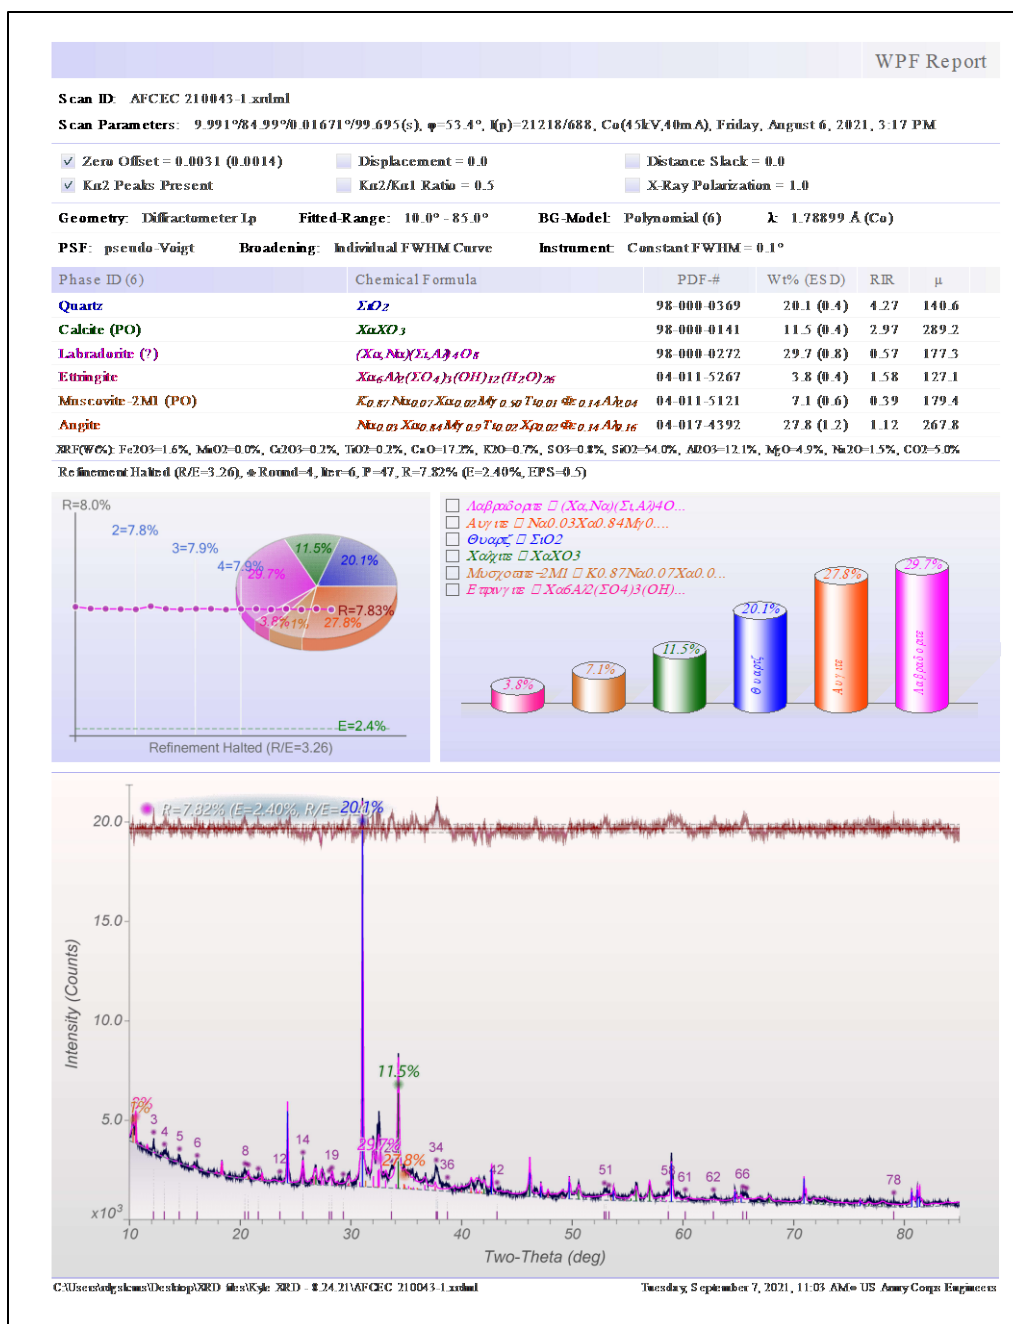
Figure 24. Diffraction pattern for 210043-1 with phase identifications, whole pattern fit, and calculated weight percentages.

Figure 24 provides mineralogy of the aggregate fraction of 210043-1 as determined by XRD. The aggregate composition indicates silicate-dominated lithologies, including granites and sandstones with minor calcite (11.5%). Muscovite, a clay phase, was identified, as well as ettringite, a common alteration phase associated with cementitious materials.

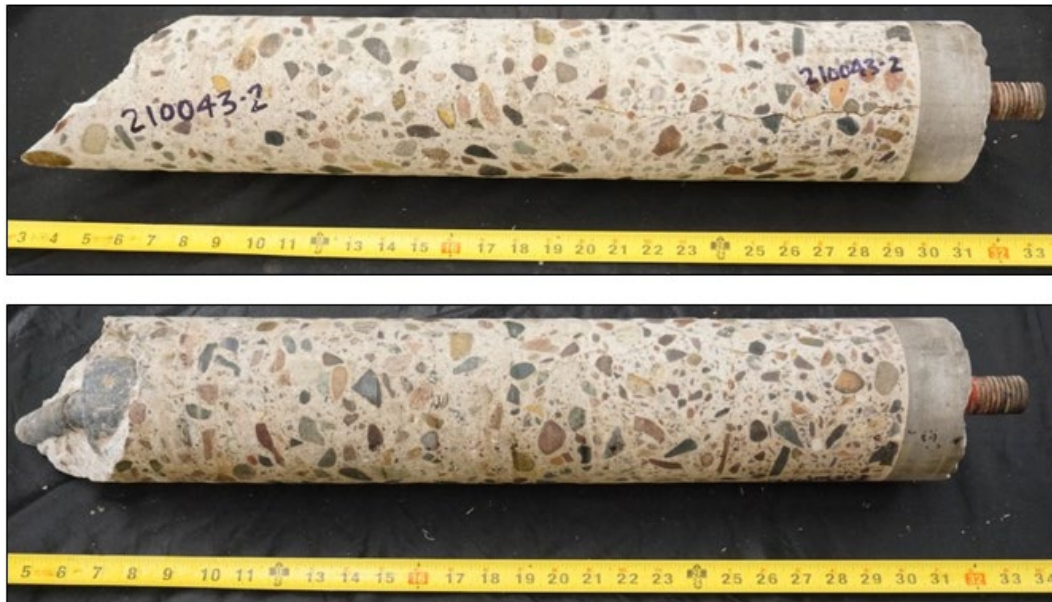
Figure 25. Core 210043-2.

The as-received core 210043-2 is shown in Figure 25, and the bisected core 210043-2 is shown in Figure 26. The core had a length of 27.5 in. a diameter of approximately 5 in.

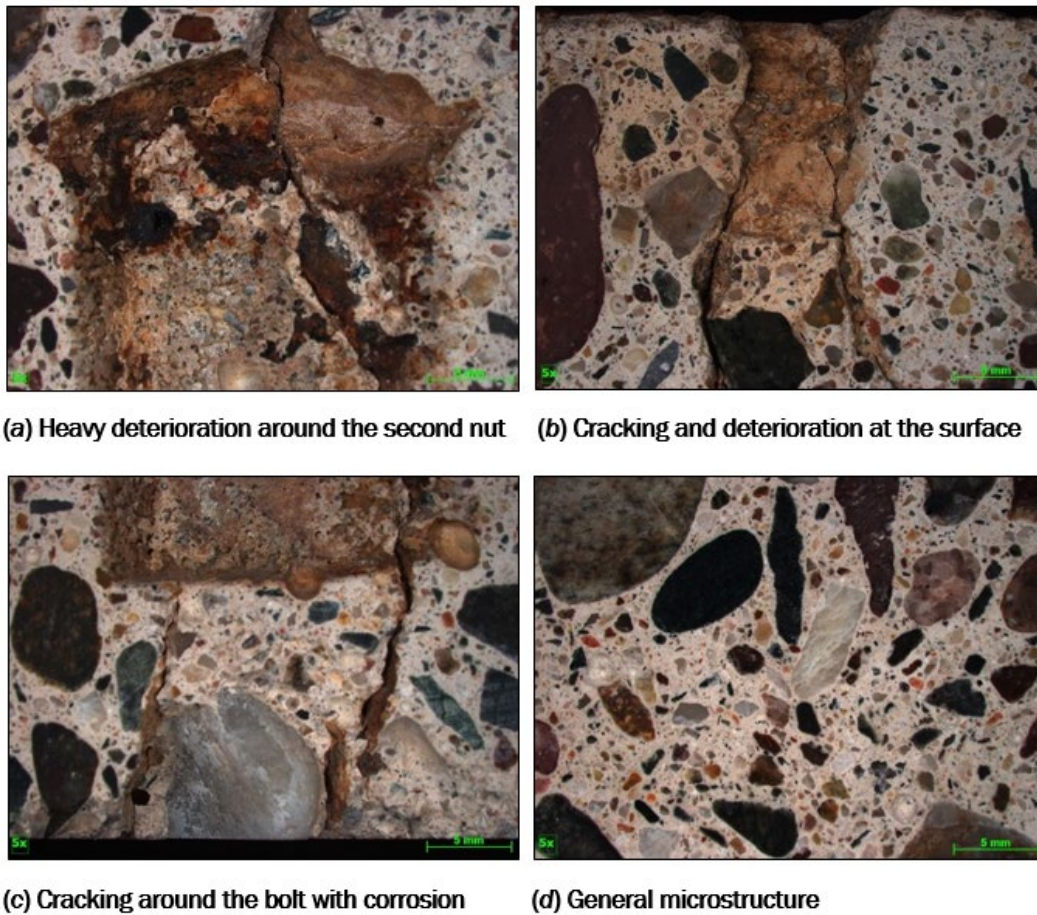
Figure 28. Photomicrographs of 210043-2 at  $5\times$  magnification.

Visual inspection images for core 210043-2 are provided in Figure 27, and detailed photomicrographs of the core's microstructure are shown in Figure 28. Under the 2 in. mortar cap, cracking was seen in the concrete, running a depth of about 9 in. and terminating in the mortar cap. Corrosion

Core 210043-2 showed cracking in the upper 9 in. of the concrete, terminating in the mortar cap, with no cracking observed through the mortar cap. Carbonation was observed up to a depth of 17 mm. Corrosion was observed after the core was bisected and was limited to the area around the bolt.

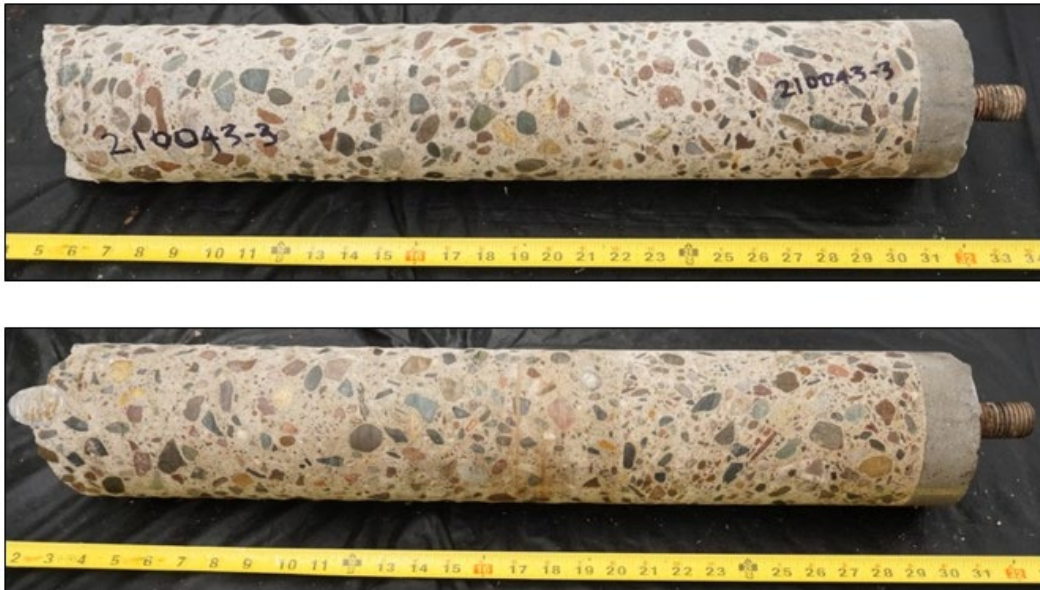
Figure 31. Core 210043-3.

The as-received core 210043-3 is shown in Figure 31. Images of the visual inspection and bisection of core 210043-3 are shown in Figure 32. The core had a length of 27.5 in. and diameter of approximately 5 in.

Core 210043-3 showed cracking in the upper 8 in. of the concrete, terminating in the mortar cap, with no cracking observed through the mortar cap. Corrosion was observed after the core was bisected and was limited to

the area around the bolt. Possible linear stress cracking was present in the middle of the core, not extending to the surface and measuring 1 to 1.5 in. long.

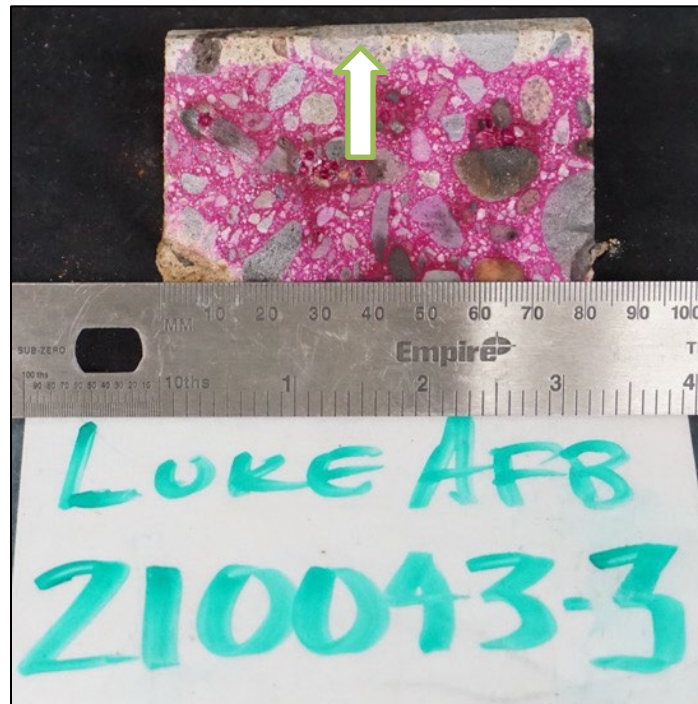
Figure 34. Phenolphthalein applied to sample 210043-3.

Figure 34 provides a photo of a freshly broken sample from section A1 with phenolphthalein applied to ascertain the degree of carbonation that occurred. Purple coloring indicates a pH of 10 and above. If the cement is

uncolored, the sample tests for carbonation and the pH is below 10. The sample shows carbonation up to 10 mm (depth indicated by arrows). Note that the top of the core was destroyed in preparation, and phenolphthalein testing was not performed on the top of the core.

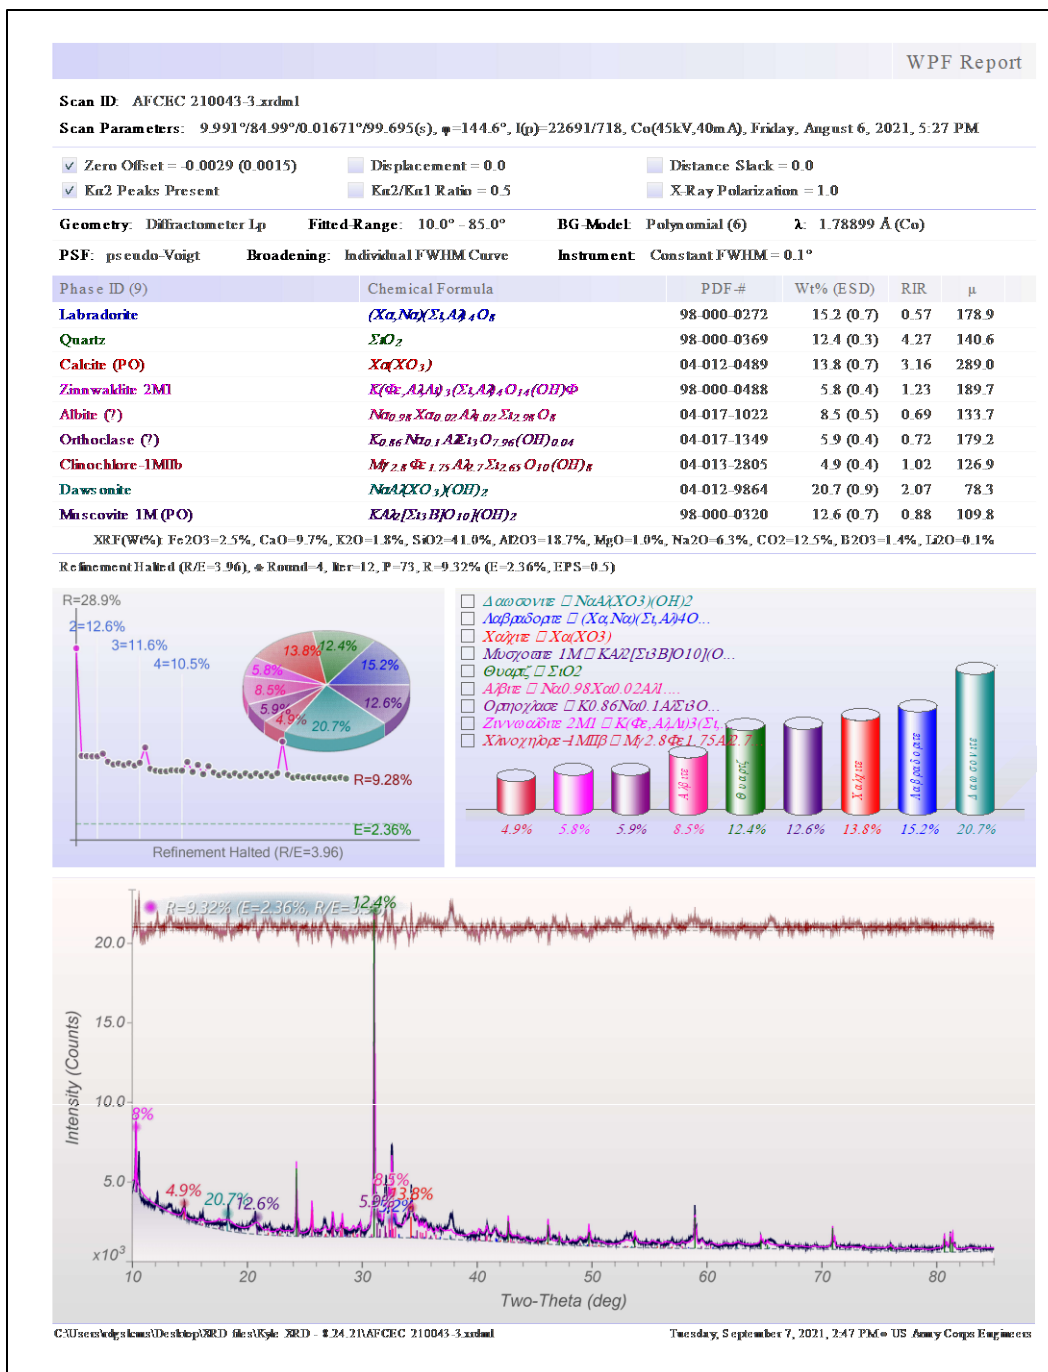
Figure 35. Diffraction pattern for 210043-3 with phase identifications, whole pattern fit, and calculated weight percentages.

Figure 35 provides the mineralogy of the aggregate fraction determined by XRD. The aggregate composition indicates silicate dominated lithologies, including granites and sandstones with minor calcite (13.8%). Clay phases zinnwaldite, muscovite, and clinocllore were detected, amounting to 23.3% of total minerals.

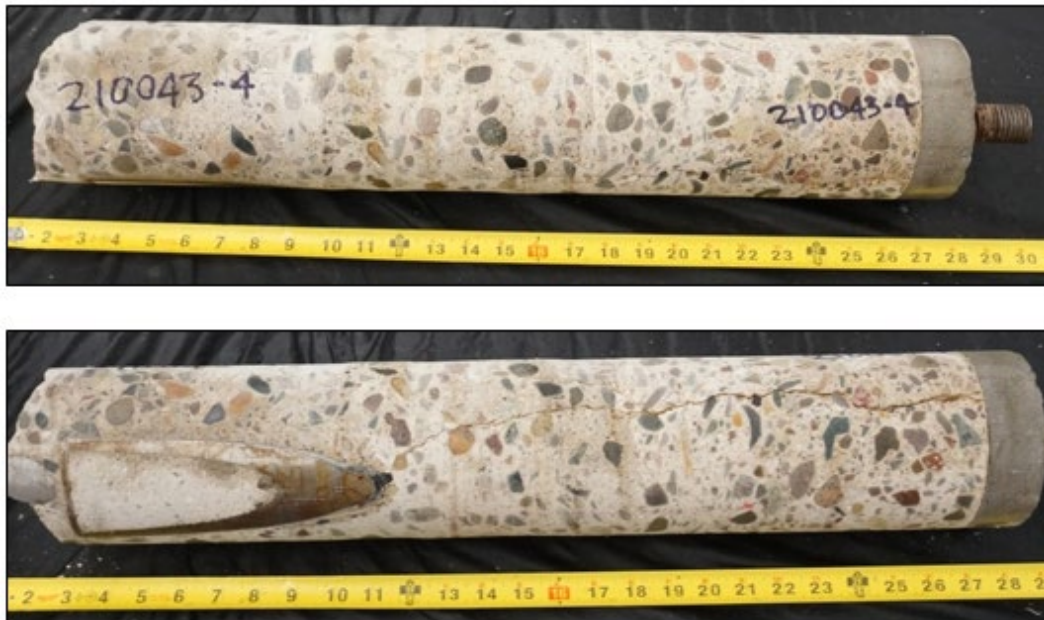
Figure 36. Core 210043-4.

The as-received core 210043-4 is shown in Figure 36, and the bisected core 210043-4 is shown in Figure 37. The core had a length of 26 in. and a depth of approximately 5 in.

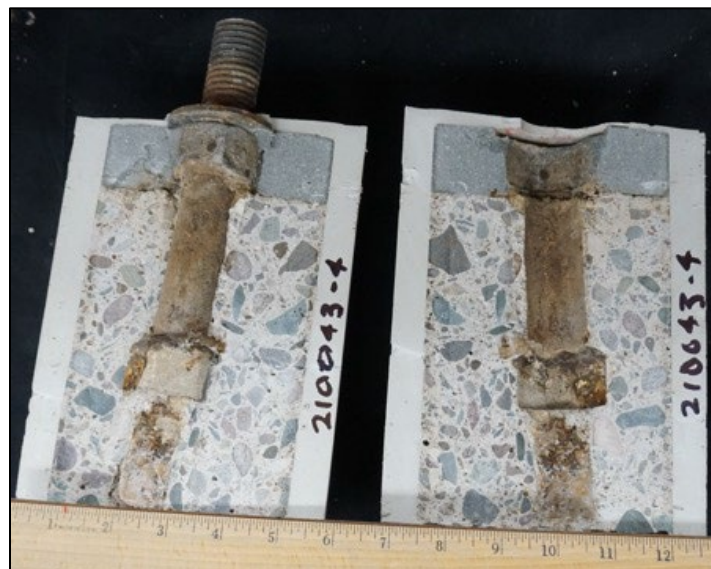
Figure 37. Bisected core 210043-4.

anchor assembly while also affording sites for accelerated oxidation and corrosion of the anchor rods. These voids and corresponding corrosion would have an unknown impact on nondestructive inspections of the fair-lead beam anchor bolts.

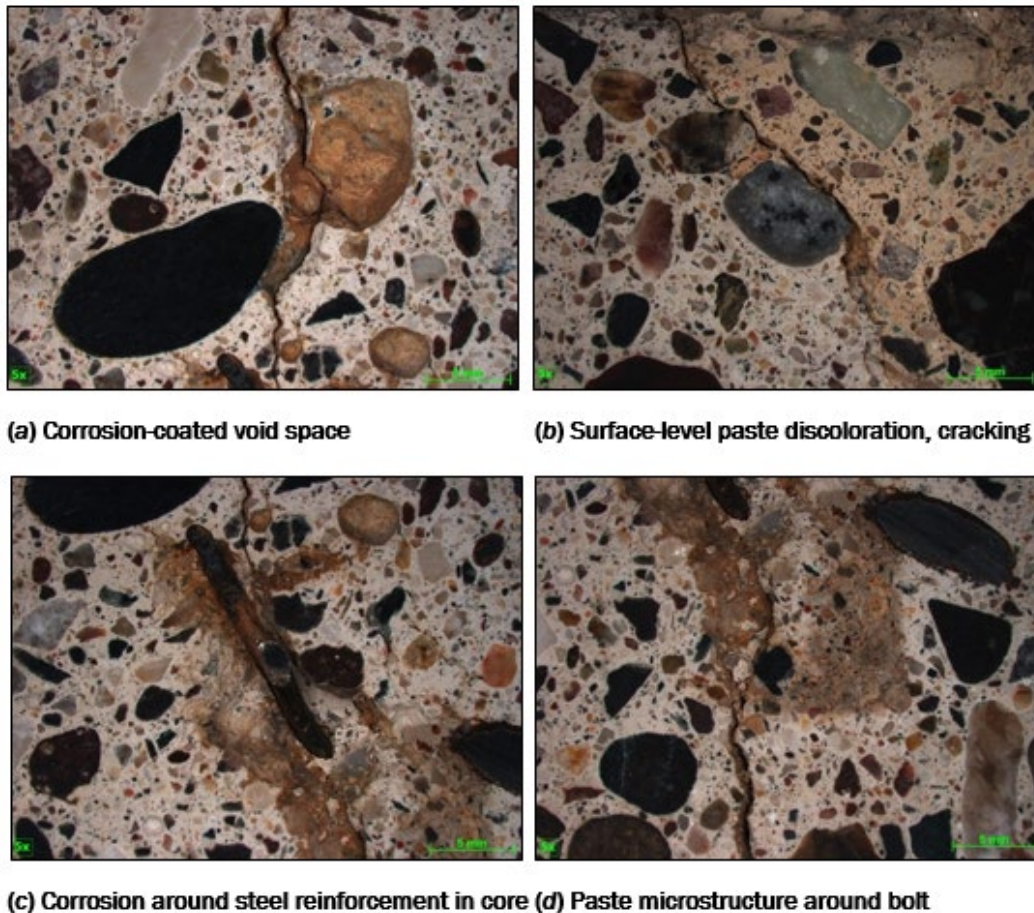
Figure 39. Photomicrographs of 210043-4 at 5× magnification.

Visual inspection images for core 210043-4 are provided in Figure 38, and detailed photomicrographs of the core's microstructure are shown in Figure 39. Cracking had developed in the concrete, extending throughout the

core as well as through the 2 in. mortar cap. Corrosion was seen only in the observable cracks, but after bisection, the top 6 in. had corrosion close to the bolt and extended into voids and paste proximate to the cracking. The coarse aggregate had a nominal size of 0.75 in. and a maximum entrapped air size of 0.5 in. Silicate phases dominated the coarse aggregate fraction and were sub-round to round, indicative of a natural stone.

Core 210043-4 showed cracking extending throughout the entire concrete core and through the mortar cap. Carbonation was observed up to a depth of 20 mm. Corrosion was observed within the heavy cracks and throughout the top 10 in. of the Y-bolt.

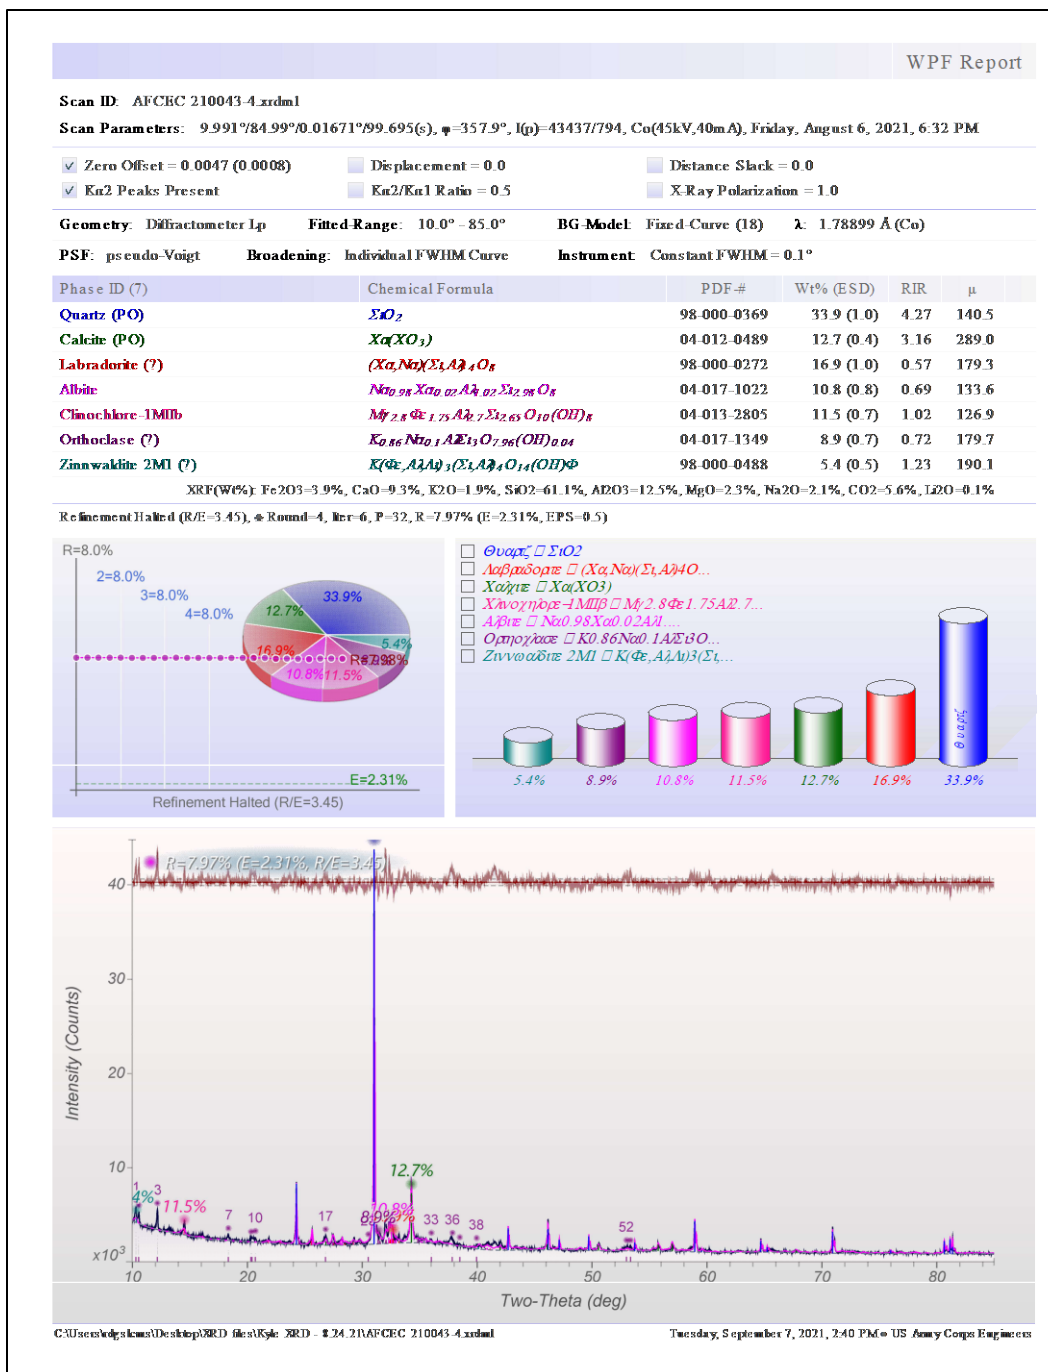
Figure 41. Diffraction pattern for 210043-4 with phase identifications, whole pattern fit, and calculated weight percentages.

The mineralogy of the aggregate fraction as determined by XRD of the concrete is provided in Figure 41. The aggregate composition indicates silicate dominated lithologies, including granites and sandstones with minor calcite (12.7%). Clay phases clinocllore and zinnwaldite were detected, amounting to 16.9% of total minerals.

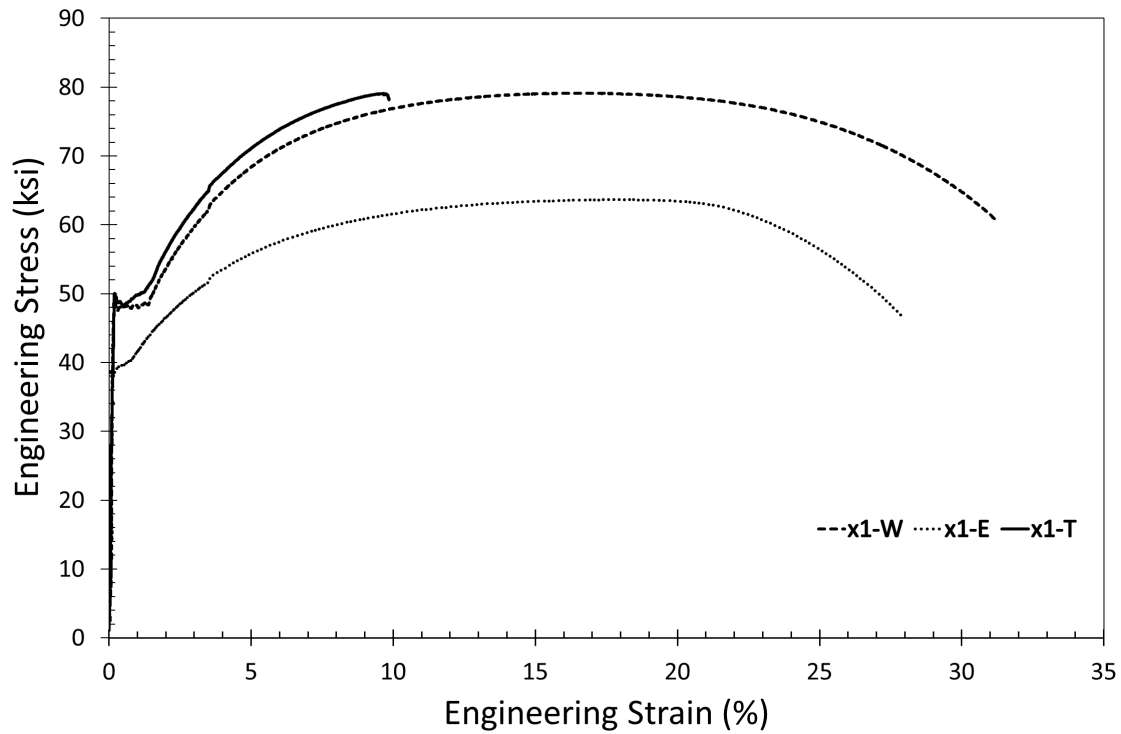
Figure 42. Stress versus strain plot for core 210043-1.

Twelve tensile tests in total were performed on the specimens extracted from the field-cored fairlead beam anchor rods: three tests per core with one for each of the W, E, and T specimen positions described in Section 4.1. Stress versus strain plots for cores 210043-1, 210043-2, 210043-3, and 210043-4 are provided in Figure 42, Figure 43, Figure 44, and Figure 45, respectively. Tabulated test results for the tensile testing are presented in Table 5. Issues with the test fixture prevented the completion of testing for

specimen 210043-1 T, so percent elongation at failure could not be determined.

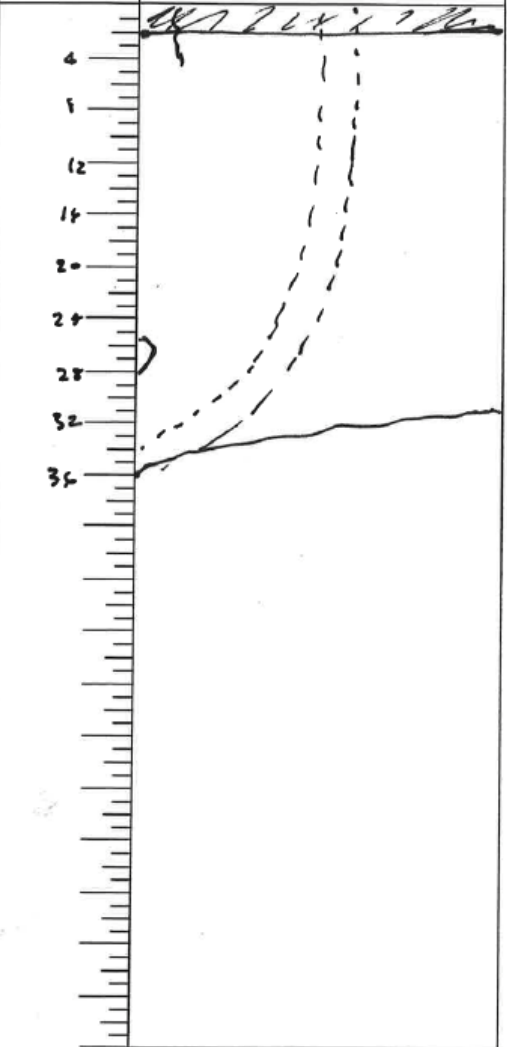
| 4<br>8<br>12<br>16<br>20<br>24<br>28<br>32<br>36 | | Max. aggregate size - 1.5"<br>Aggregate type -<br>Max. entrapped air size - 1.5"<br>Cracks visible? yes<br>Top 2" mortar |

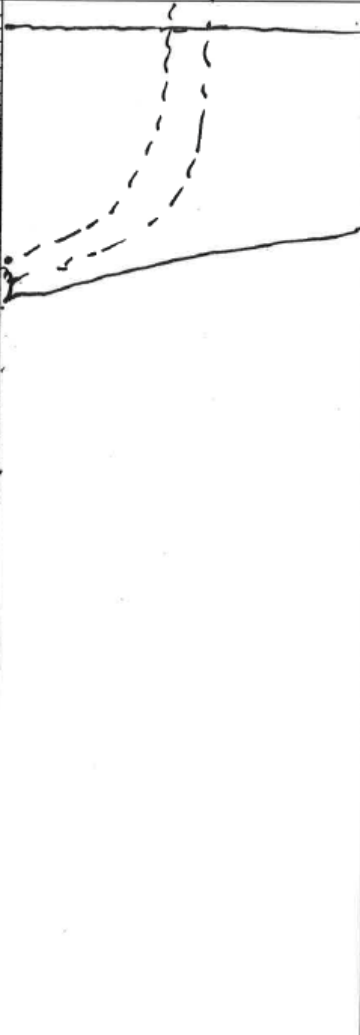
Figure A-2. Core log for 210043-2.

| | | Max. aggregate size – <b>1.75"</b><br><br>Aggregate type –<br><br>Max. entrapped air size – <b>1"</b><br><br>Cracks visible? <b>yes</b><br><br><b>Top 2" mortar</b> |

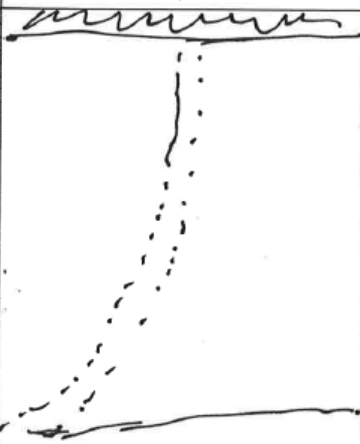
Figure A-3. Core log for 210043-3.

| Core Length: <b>27 3/4"</b><br>Bit Diameter: <b>5"</b> | | <div style="border: 1px solid black; padding: 5px;">REMARKS/COMMENTS</div> <p>Max. aggregate size – <b>1"</b></p> <p>Aggregate type –</p> <p>Max. entrapped air size – <b>1/2"</b></p> <p>Cracks visible? <b>Y</b></p> |

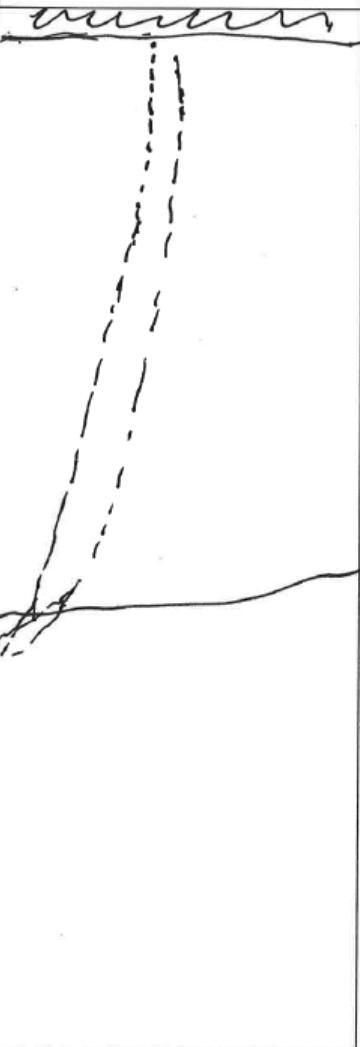
Figure A-4. Core log for 210043-4.

| | | Max. aggregate size - .75"<br>Aggregate type - <del>AS</del><br>Max. entrapped air size - .5"<br>Cracks visible? Y |
