SHRIKE AND SPARROW MISSILE BASELINE  
COOKOFF TESTS

Naval Weapons Center

October 1974

NWC Technical Publication 5672  
NMC Technical Publication 74-36

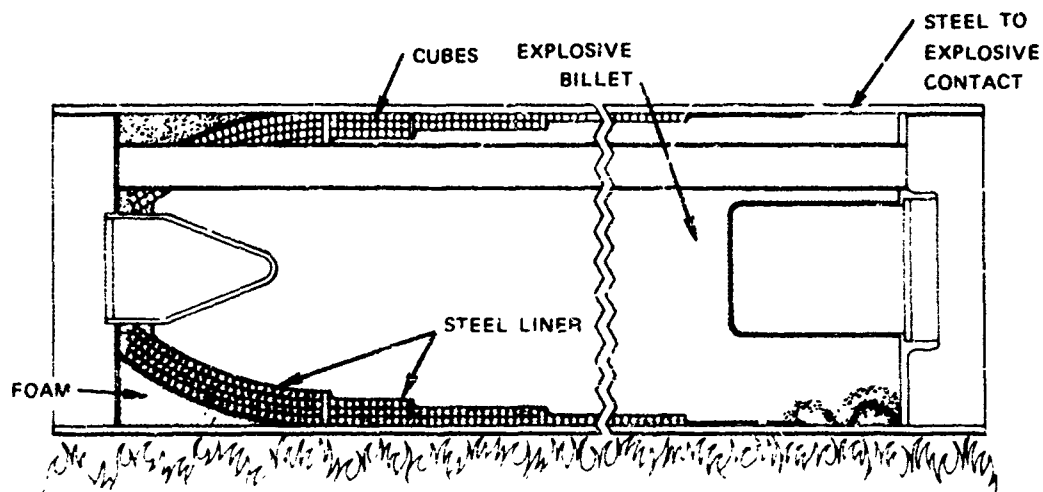
The exothermic heating produced from the potting material and/or cavity paint ignites the explosive sooner than if only heating by conduction from the fire existed without chemical reactions. The explosive is shown burning at the aft end in Figure 4a.

FIGURE 4a. SHRIKE Warhead Explosive Igniting at Lower Aft End.

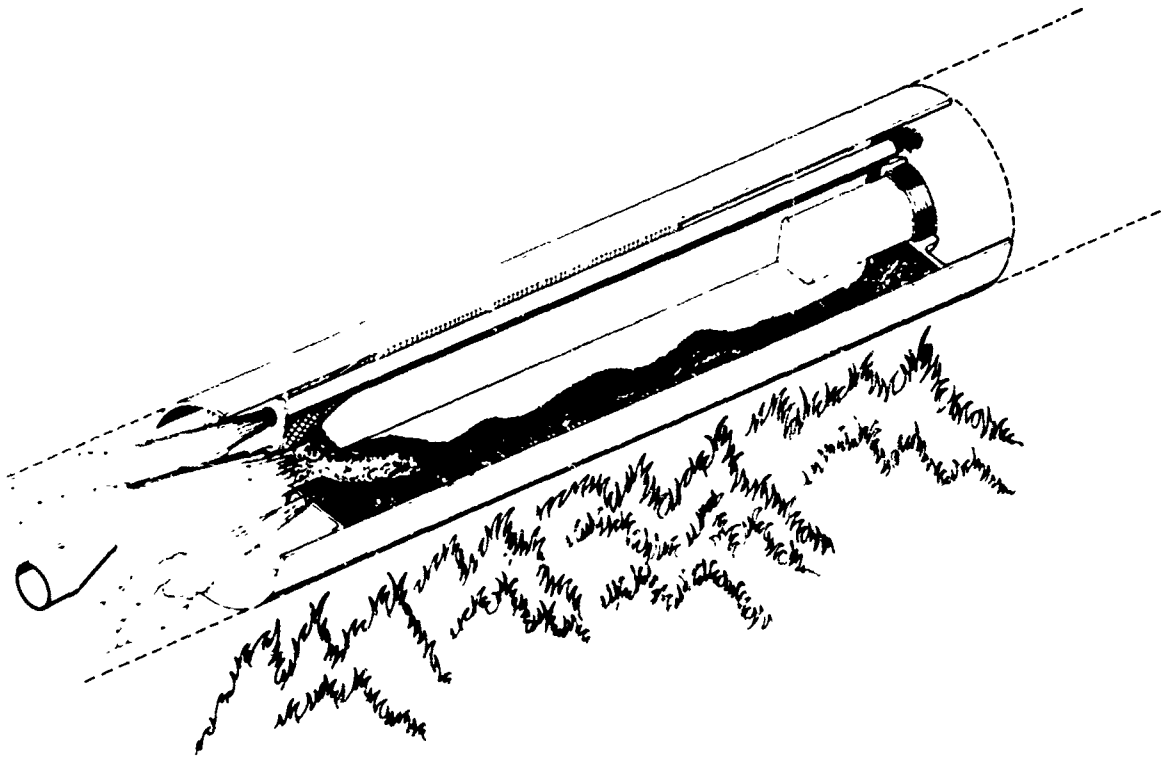
The failure of the SHRIKE warhead is hypothesized to be due to over-pressurization within the steel casing, which causes the crack as shown in Figure 4b. Inadequate venting exists for the SHRIKE warhead, and it explodes before 169 sec, e.g., SH-13A, 128 sec; SH-14A, 109 sec; SH-16A, 169 sec. If the excess explosive-gas can be vented, then there may be deflagrations instead of explosions. Both types of reaction are illustrated in Figures 4c and 4d.

FIGURE 4c. Possible SHRIKE Warhead Venting.

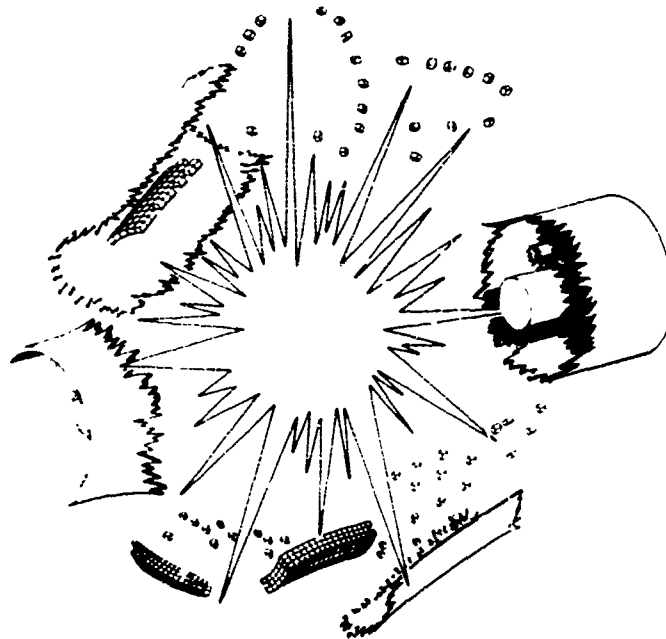
FIGURE 4d. Possible SHRIKE Warhead Explosion Due to Overpressurization.

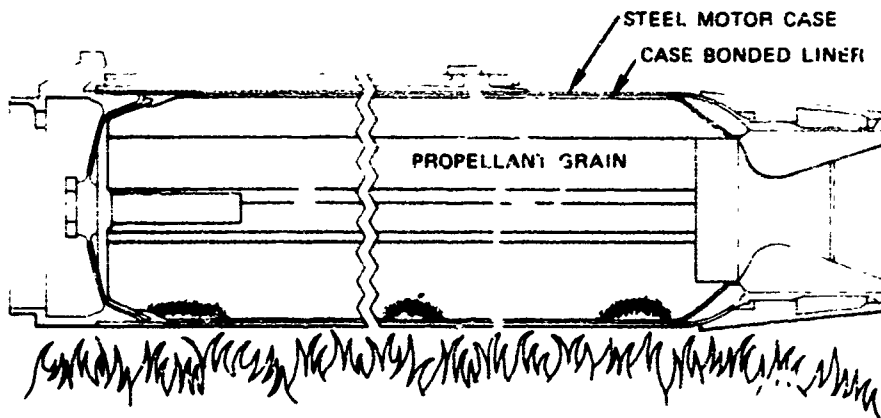
The SHRIKE rocket motors tested were the Mk 53 Mod 1, Mk 78 Mod 0 and the Mk 39 Mod 7. Descriptions of these motors are included in Appendix A. They exhibited internal exothermic reactions in the steel/liner region before 104 sec (e.g., SH-1A, 80 sec; SH-7A, 54 sec; SH-8A, 25 sec; SH-12A, 28 sec; SH-16A, 104 sec). The region where apparent exothermic reactions occur prior to burning of the propellant is between the lower steel case and liner. The exothermic heating produced from the liner and/or other material used to prepare the inside of the steel case for grain ignites the propellant sooner than if only heating by conduction from the fire existed without chemical reactions. The solid propellant is shown burning at the lower surface in Figure 5a.

FIGURE 5a. SHRIKE Motor Propellant Igniting at Lower Surface.

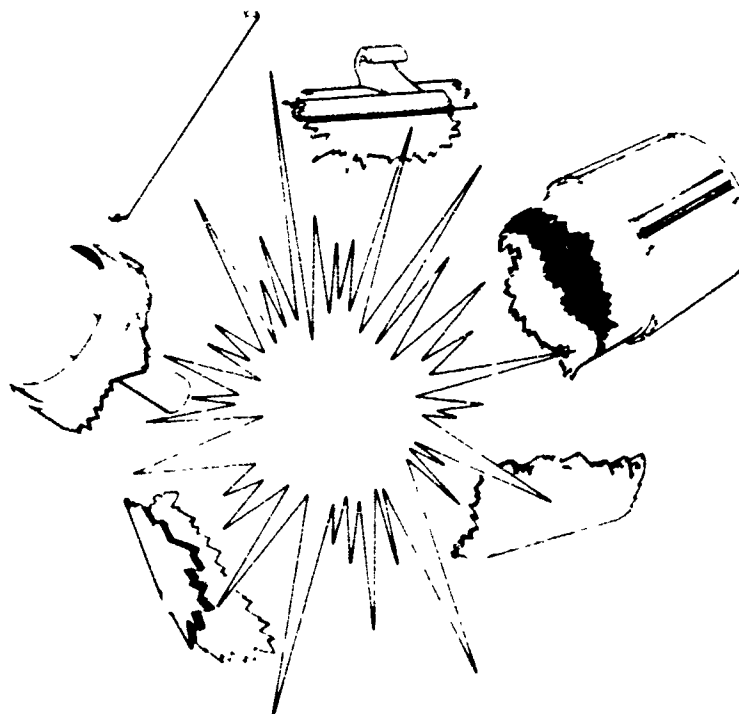
The failure of the SHRIKE rocket motor is hypothesized to be due to over-pressurization within the steel casing, which causes solid propellant cracks (Figure 5b). If the excess propellant gas can be vented (e.g., SH-7A, SH-8A, SH-12A) then the reaction will be one of deflagration; otherwise an explosion may result (e.g., SH-16A). Both types of reactions are illustrated in Figures 5c and 5d.

FIGURE 5d. Possible SHRIKE Motor Propellant Explosion Due to Overpressurization.

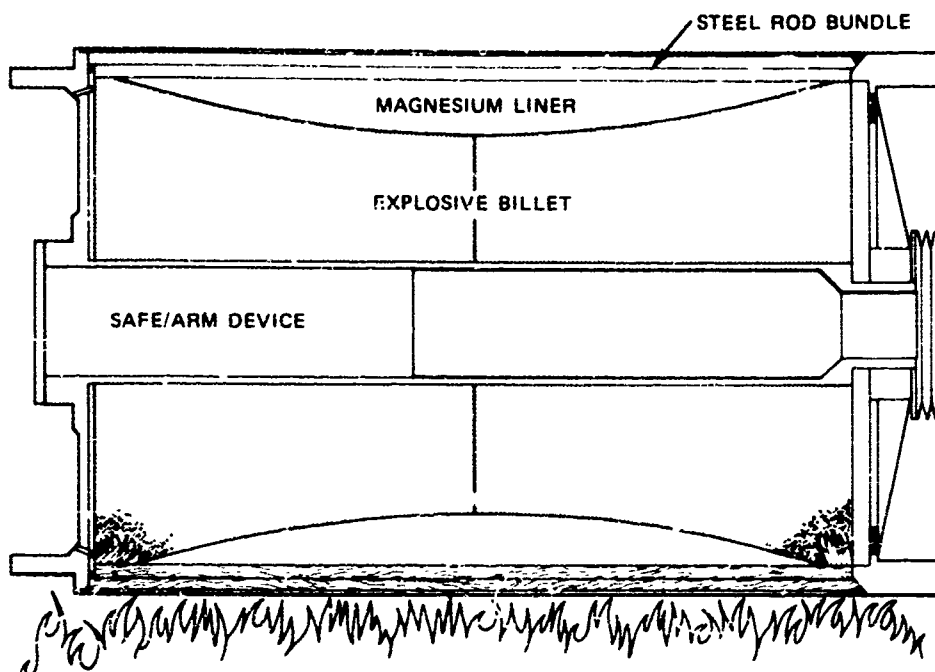
The exothermic heating produced from the potting material and/or cavity paint ignites the explosive sooner than if heating only by conduction from the fire existed without chemical reactions. The explosive is shown burning at its ends in Figure 6a.

FIGURE 6a. SPARROW Warhead Explosive Igniting on Lower Surface.

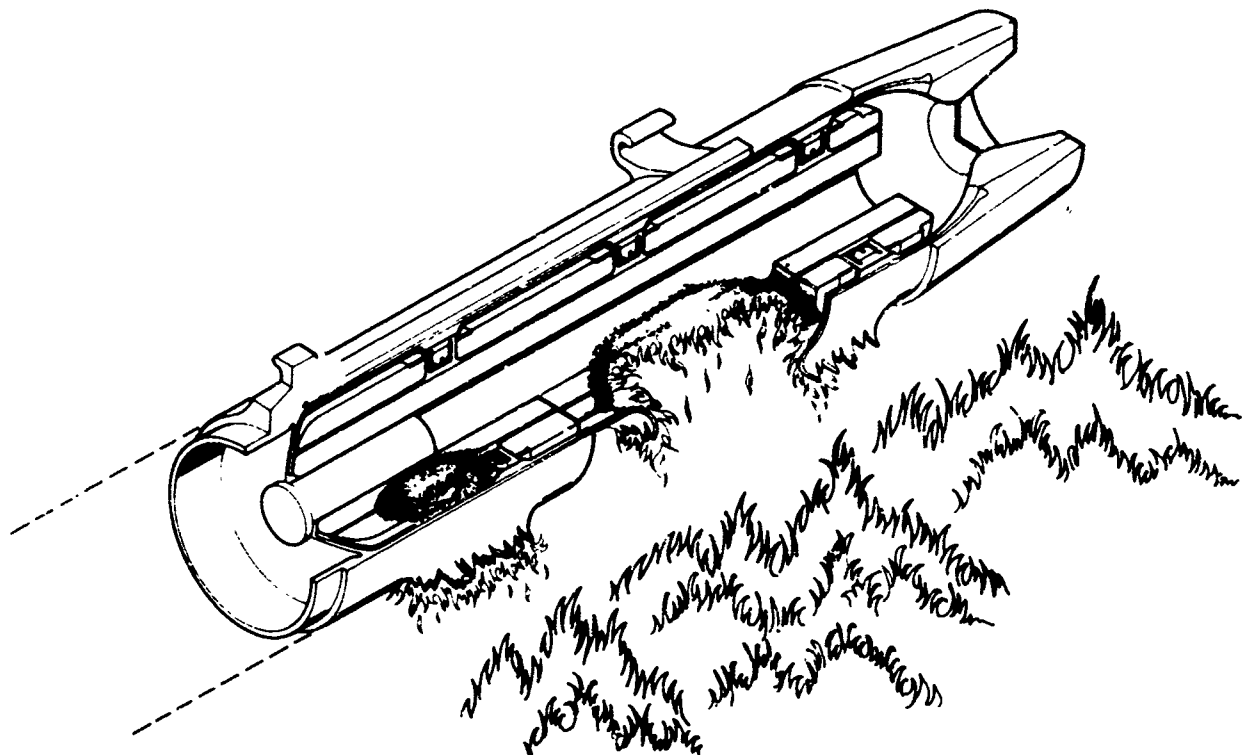
The failure of the Mk 38 Mod 0 SPARROW rocket motor is hypothesized to be due to over-pressurization within the steel casing, which causes the solid propellant to crack, as shown in Figure 7b. If the propellant gas can vent, then the reaction may be one of deflagration, as shown in Figure 7c. Otherwise an explosion may result, as shown in Figure 7d.

FIGURE 7c. Possible SPARROW Motor Venting.

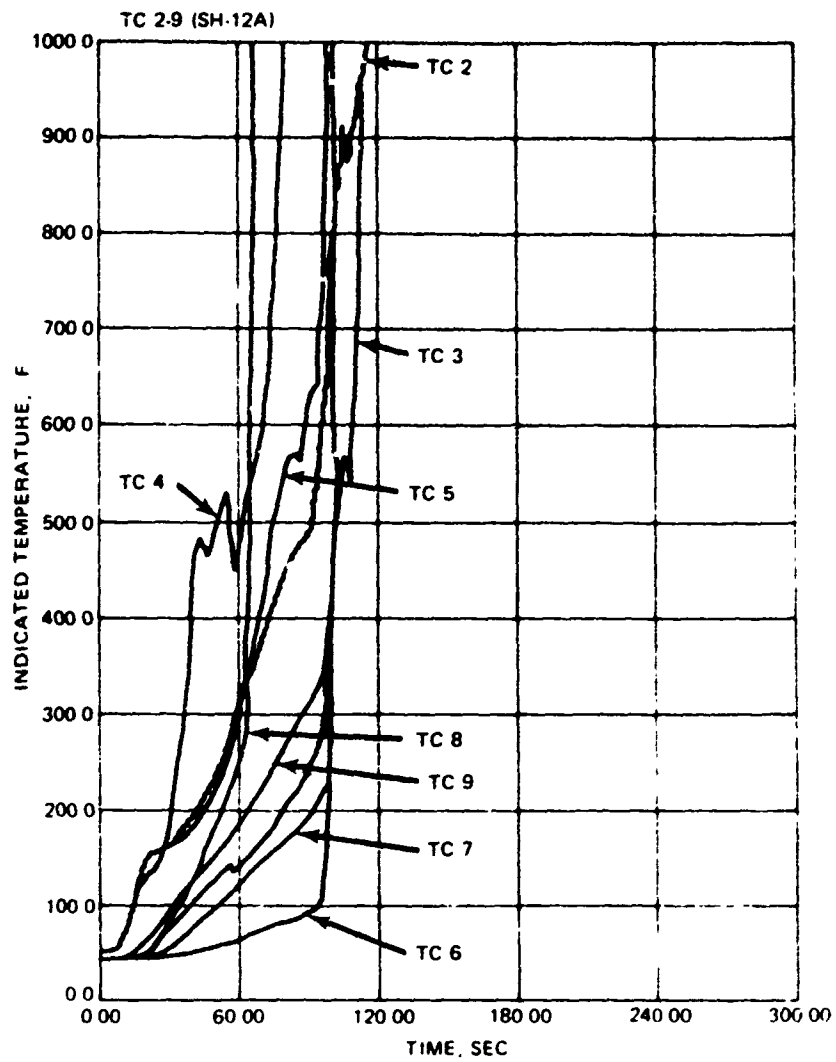
FIGURE C-36. TC 2-9 Response, SH-12A

The responses of the thermocouples in the motor are given in Figures C-36 and C-37. Apparent exothermic reaction is indicated by TC 2 and 4 which were welded to the motor case adjacent to the liner. Failure of TC 2-9 occurred before 104 sec, and was probably due to lead-wire burn-through. TC 8 was the first to fail, and did so at 66 sec.

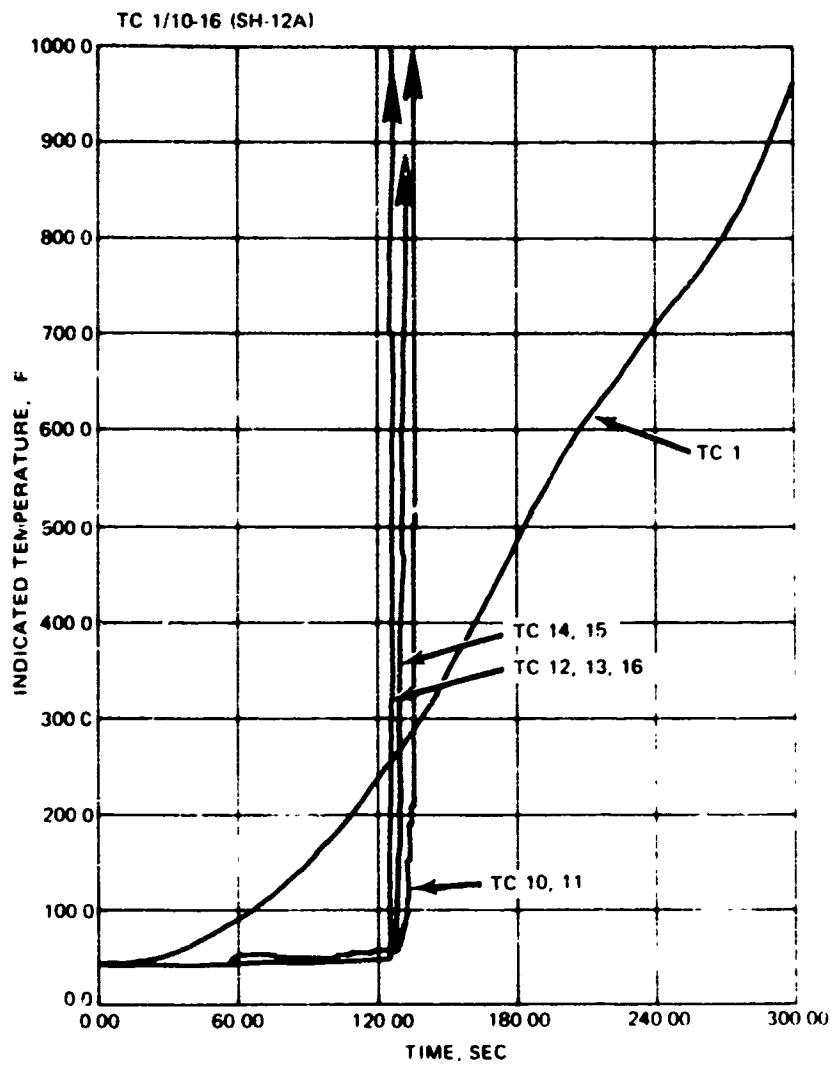
FIGURE C-37 TC 1/10-16 Response, SH-12A

Thermocouples 10-16 (Figure C-37) located in the motor port region showed a small response at 56 sec, but after 128 sec began to fail.

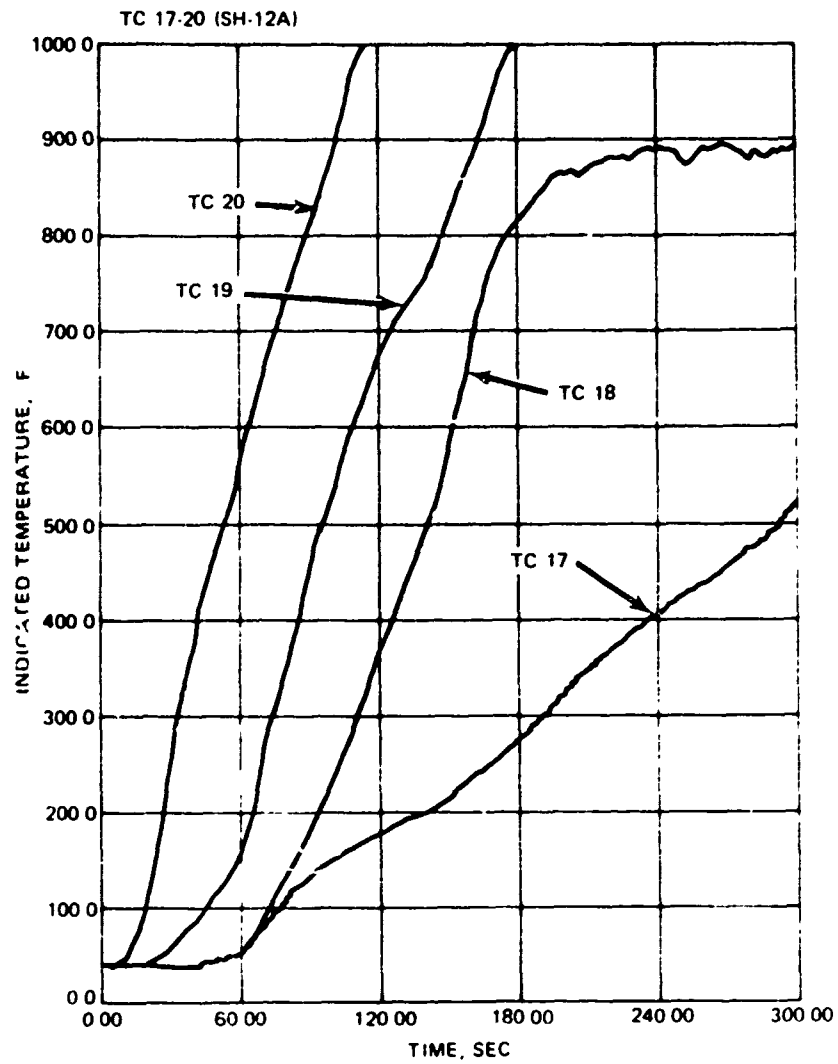
FIGURE C-38 TC 17-20 Response, SH-12A.

Outputs from TC 17-20, located at the forward bulkhead of the warhead, are shown in Figure C-38. The response of TC 18 is unusual, and is not understood, unless the warhead cup had caused a mechanical interference. The responses of TC 21-27 (Figure C-39) are similar to those in Figure C-30 in test SH-8A. Outputs from warheads TC 28-31 are given in Figure C-40.

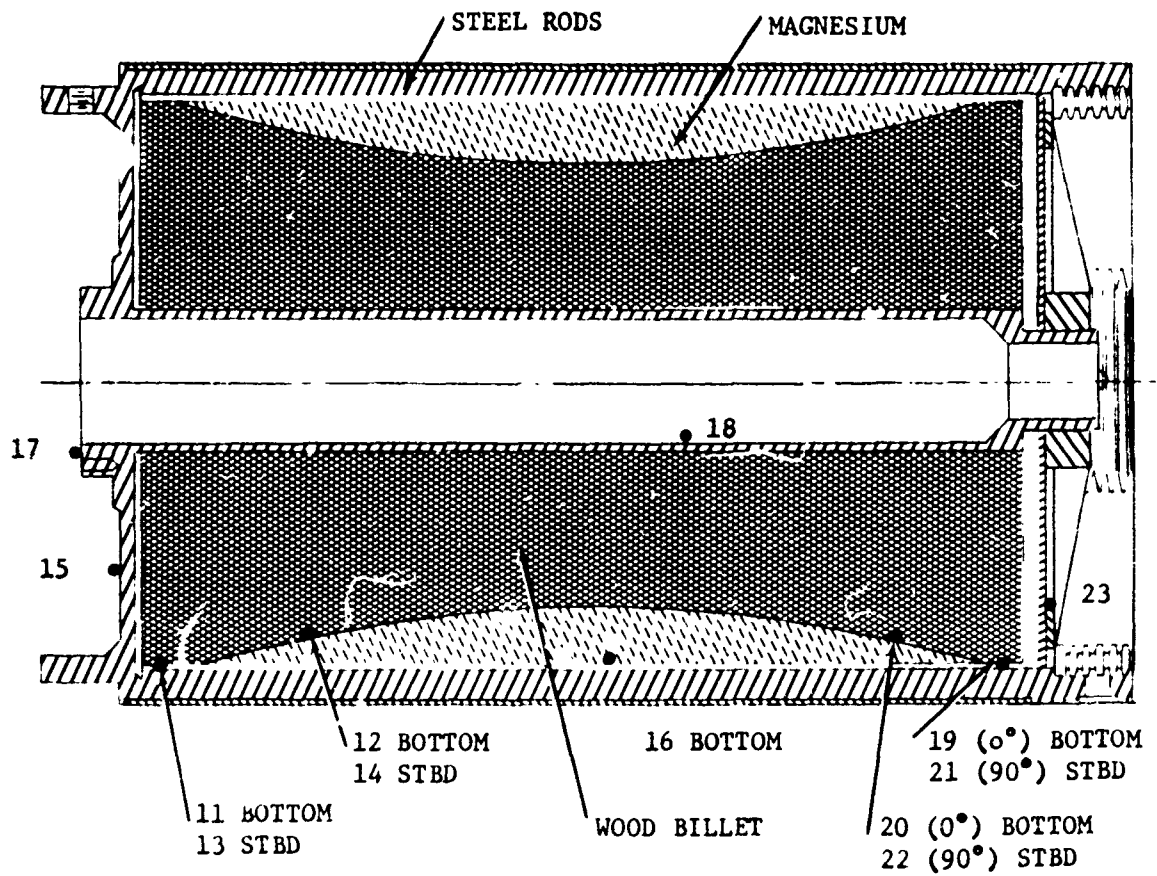
FIGURE D-3 MK 38 Mod 0 Warhead Thermocouple Locations

Thermocouples 11, 13, 16, 19 and 21 were located on the warhead rods (Figure D-3). Their responses are shown in Figure D-17. All became inoperative after 295 sec, when the forward section of the test item fell into the pit. Thermocouples 13 and 16 exhibited peculiar behavior from about 190 sec, and failure of these may have occurred prior to the loud report heard at 220 sec. Again, as expected, TC 19 and TC 11 were hotter than TC 13 and TC 21. The loss of all thermocouples at 295 sec precluded further comparison with SP-3A.

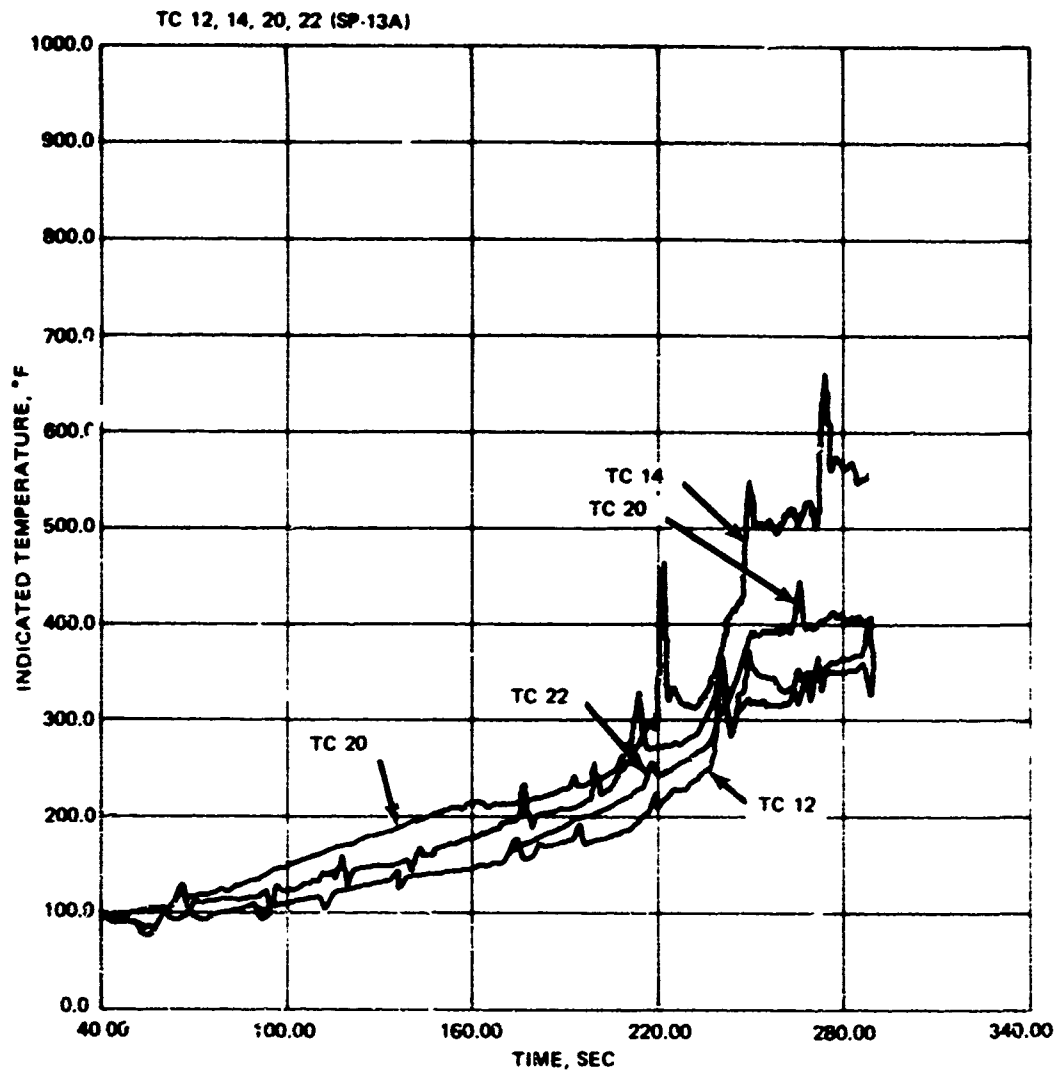
FIGURE D-18. TC 12, 14, 20, 22 Response, SP .3A

Apparent exothermic reaction is given by TC 12, 14, 20 and 22 (Figure D-18). The reactions are not so spectacular as those for SP-3A. This difference may be tentatively attributed to the use of a wood billet in SP-3A as opposed to an explosive in SP-13A. Hence the reverse spikes may be ascribed to exothermic reactions. These thermocouples also were fractured at 295 sec.

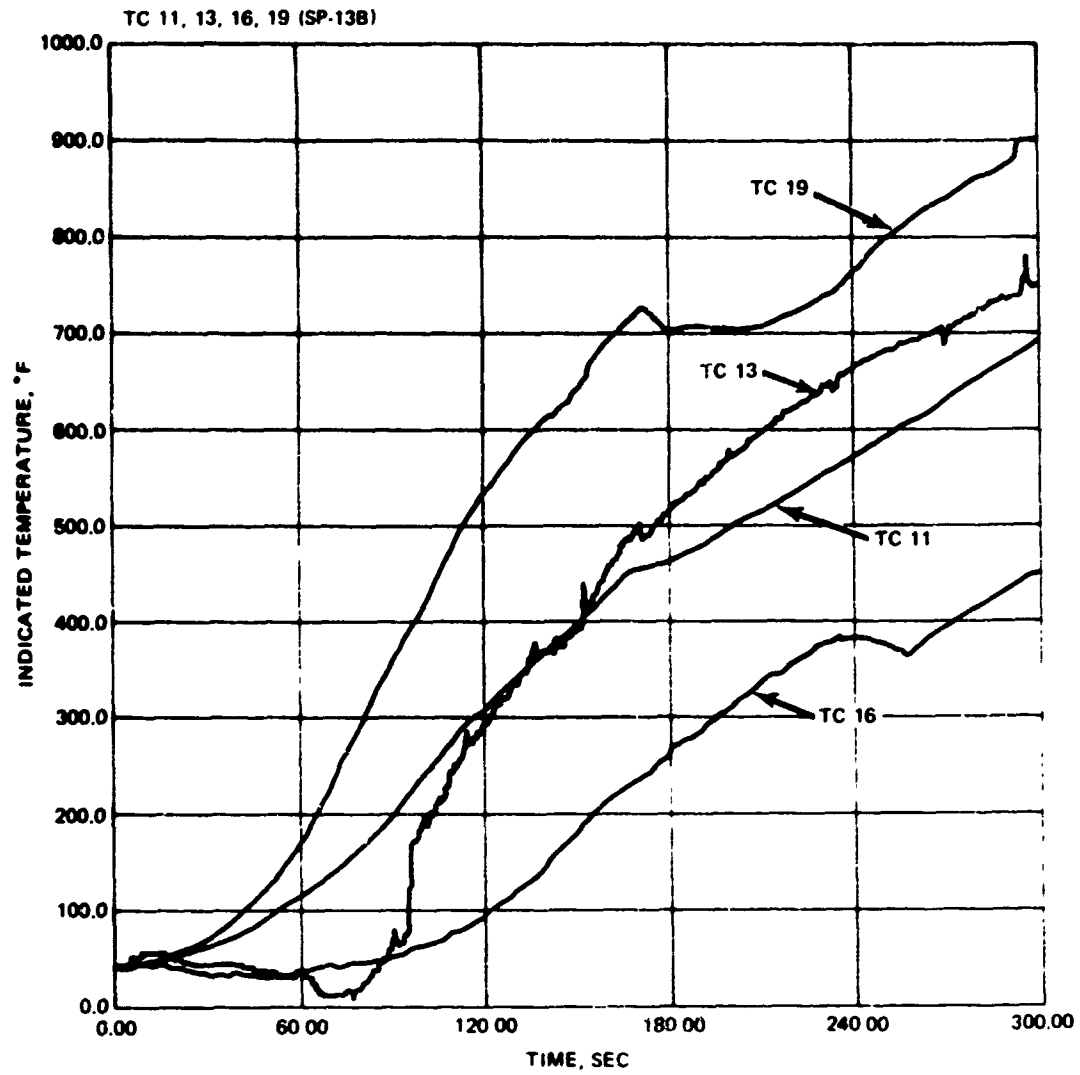
FIGURE D-24. TC 11, 13, 16, 19 Response, SP-13B.

The outputs of the thermocouples attached to the steel rods are given in Figure D-24. There are apparent exotherms for TC 13 at 96 sec, for TC 19 and TC 11 at 152 sec, and TC 16 at 465 sec. TC 19 failed at 535 sec.

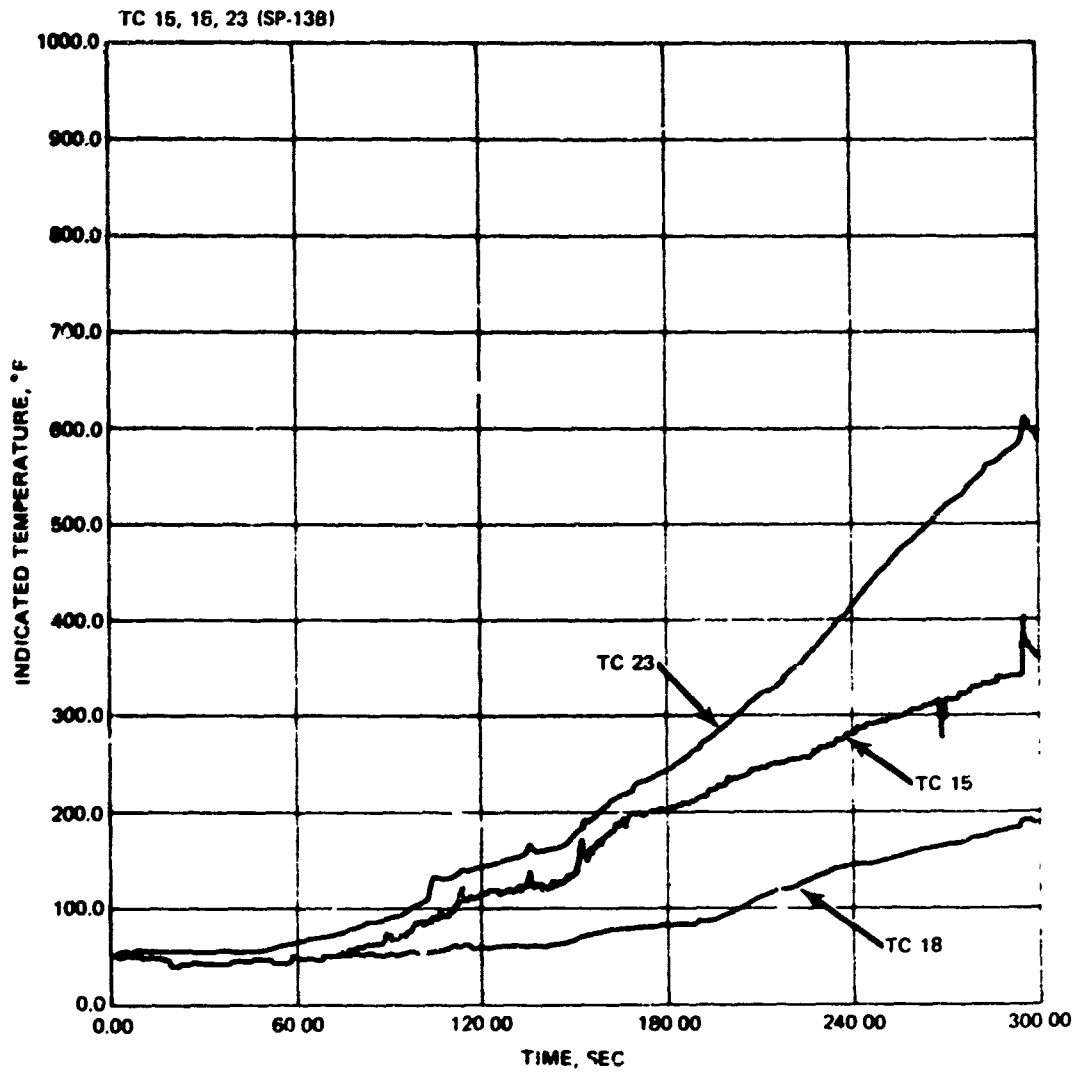
FIGURE D-26. TC 15, 18, 23 Response, SP-13B.

Outputs of TC 15, 18, and 23 are given in Figure D-26. Venting at the aft of the warhead is suggested by the exotherm at 102 sec for TC 23. Venting through the forward thermocouple fillet holes is indicated at 150 sec by TC 15. Venting through the safe/arm cavity is suggested by TC 18 to have occurred by 195 sec, and then again at a higher rate at 490 sec. The magnesium was completely consumed during the test. Further evidence of internal burning with gases exiting through the simulated guidance section and the motor/warhead interface was the deposit of a very fine white ash around the exit regions.

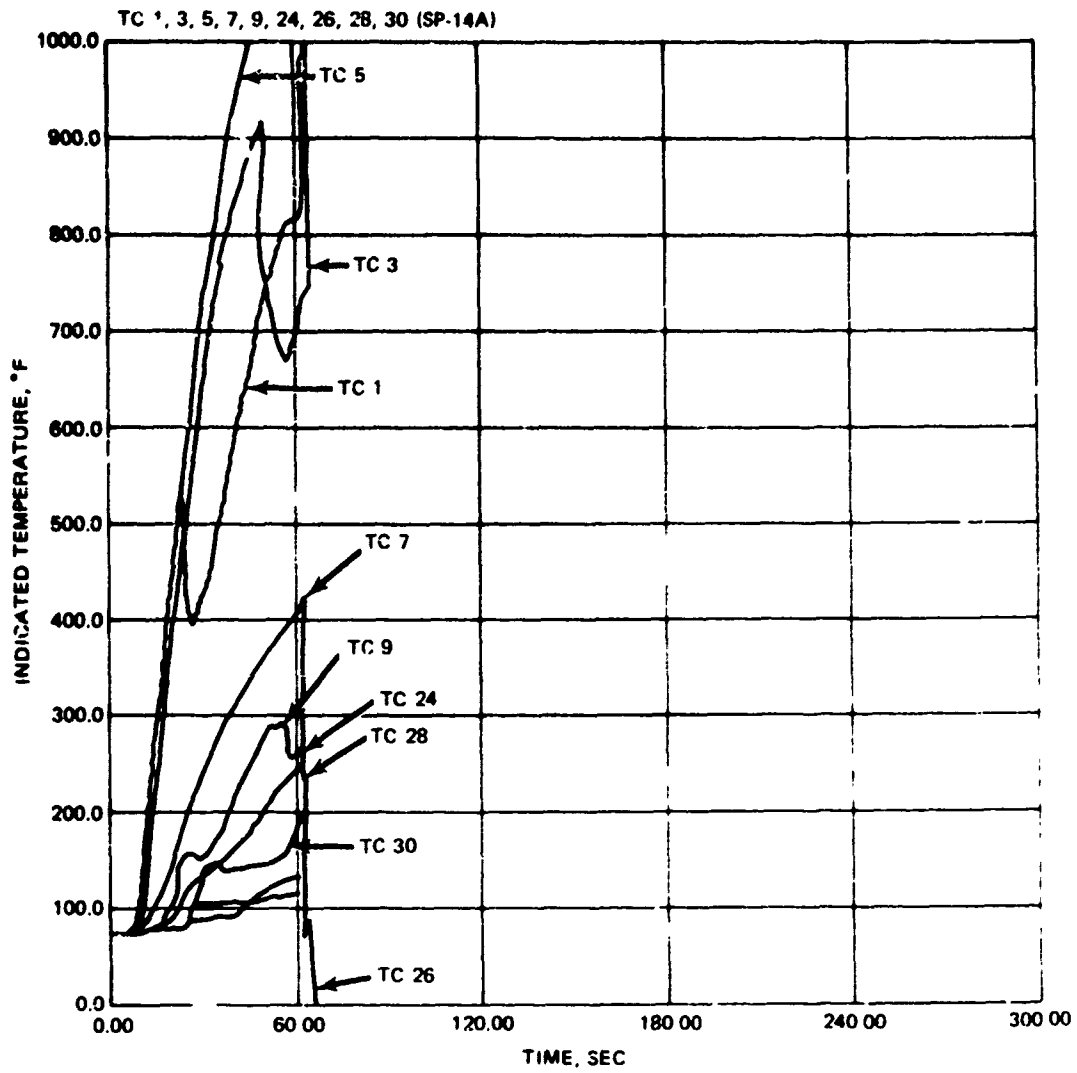
FIGURE D-35. TC 1, 3, 5, 7, 9, 24, 26, 28, 30 Response, SP-14A.

Output from thermocouples 1-10 and 24-36 located in the motor are shown in Figures D-35-D-38. All of these data ended at 62 sec, suggesting that the motor exploded. TC 32-34 (Figure D-38) indicate that the grain bore had not yet ignited at the time the thermocouples were fractured. The same can be said for TC 36 at the igniter (Figure D-37). On the other hand, the airspace behind the nozzle seal began heating at 34 sec. The thermocouple responses from the bottom of the grain are shown in Figure D-35. Thermocouples 1, 7, and 26 are typical of thermocouples in the steel case to glass liner, between the glass liner and air, and between air and propellant respectively. Apparent exothermic behavior of the interface thermocouples 1, 3, 9, 26, 28, and 30 is shown at times between 20 and 60 sec. Thermocouple responses from the side of the grain are shown in Figure D-36. These data are similar to those in Figure D-35, except that apparent exothermic behavior is observed only for the interface thermocouples 10, 12, 27, 29 and 31.

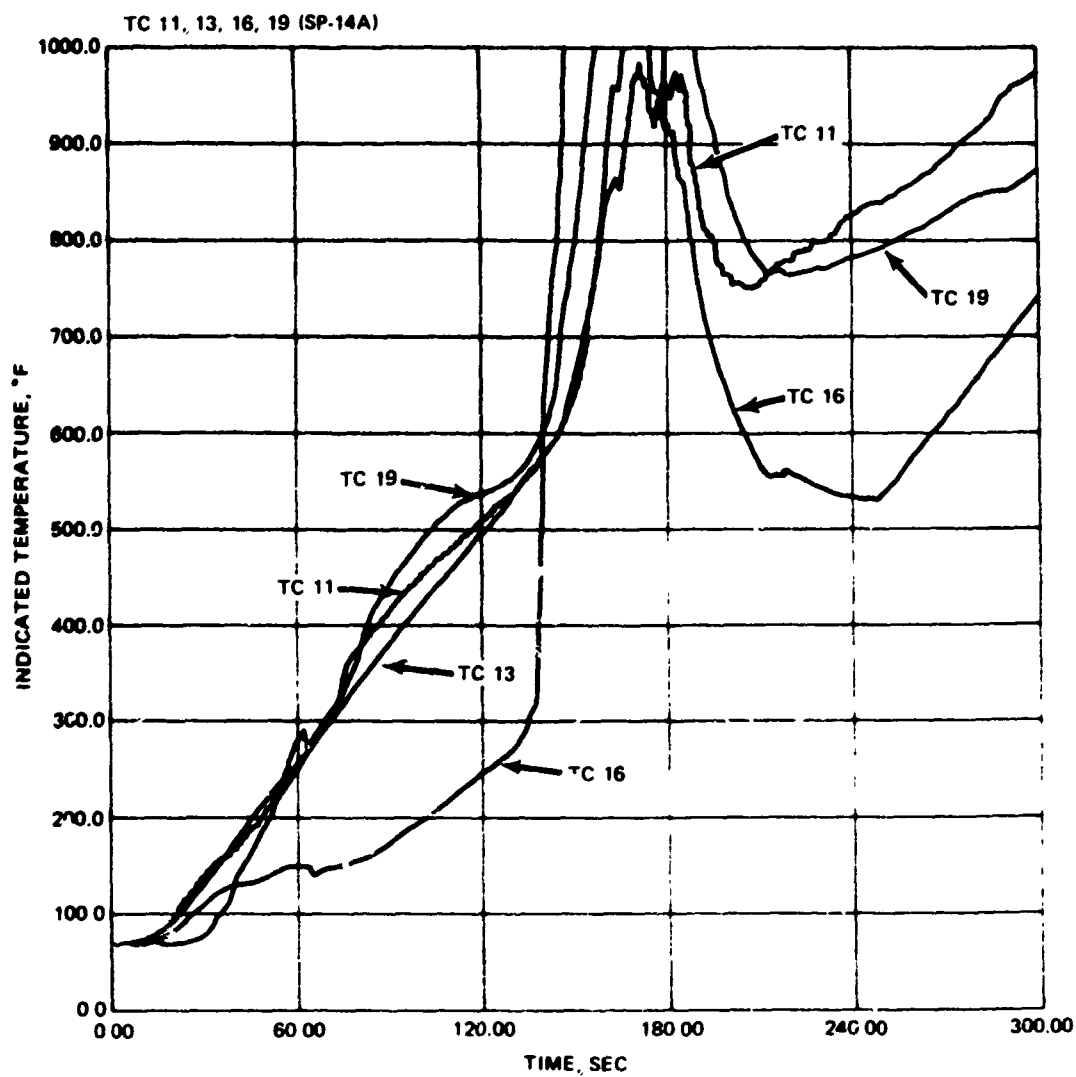
FIGURE D-39. TC 12, 14, 20, 22 Response, SP-14A.

Outputs from thermocouples 11-23, located in the warhead, are shown in Figures D-39, -40, and -41. Thermocouple 21 was inoperative. The outputs of TC 12, 14, 20, and 22, located on the magnesium liner, are shown in Figure D-39. Again apparent exothermic behavior is observed for all thermocouples. It is possible that both the magnesium liner and explosive were ignited by 152 sec, since TC 14 was fractured at that time. The data for TC 11, 13, 16, and 19 located on the steel
