INVESTIGATION OF HELICOPTER DOOR,  
WINDOW, AND ACCESS PANEL LOSSES

Naval Air Development Center

15 January 1975

| REPORT DOCUMENTATION PAGE | | READ INSTRUCTIONS<br>BEFORE COMPLETING FORM |
|---|---|---|
| 1. REPORT NUMBER<br>NADC-74169-30 | 2. GOVT ACCESSION NO. | 3. RECIPIENT'S CATALOG NUMBER<br>AD/A-005882 |

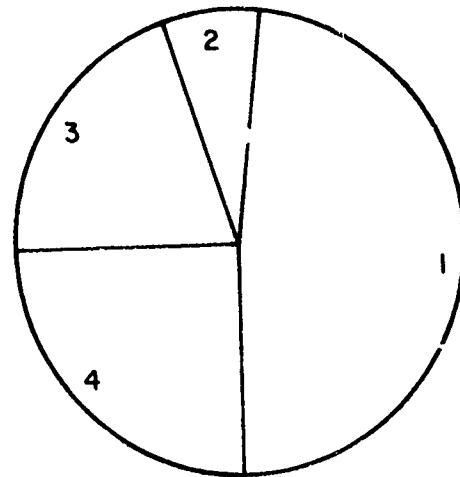
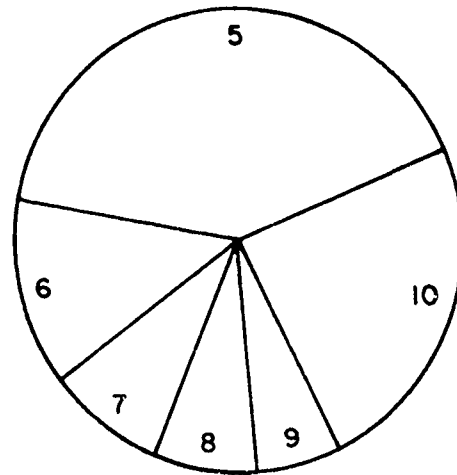
Information obtained from the NAVSAFECEN computer compilation demonstrated that the Transmission Cowling Panel is the primary problem area on this aircraft. Specifically, material failure of the latch mechanism was most critical. History indicates the need for a positive retention feature for the Transmission Cowling. In-flight Transmission Cowling problems accounted for 55% of the UH-1E reports. Figure B-1 provides a general view of the UH-1E aircraft, and the panel details are highlighted in Figure B-2. Figure B-3 summarizes the findings of the analysis of the NAVSAFECEN reports on the H-1 helicopters.

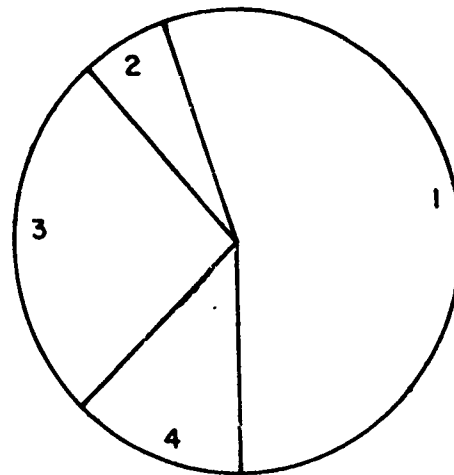
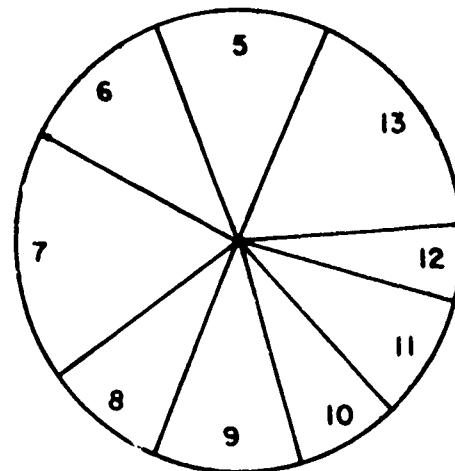
On the H-2C and the H-2D helicopters, the Engine Oil Access Panel has caused the most problems. These rectangular panels open horizontally on each side of the aircraft and are nicknamed "diving boards". The NAVSAFECEN compilation did not indicate a high frequency of in-flight openings of the Engine Oil Access Doors; but in each case reported, the doors became involved in the Rotor System. In two cases the aircraft were lost and the airmen were casualties due to Rotor unbalancing. The panels which are located just aft of the Rotor Blade Hub and just below the blades can be pushed together and closed without being secured. In one of the cases mentioned above, the accident investigation revealed that the panels were not fully locked. During the flight they vibrated open and finally separated from the aircraft on the landing approach. Realizing the critical nature of the panel, some of the active squadrons have made adjustments in their procedures. Some make a last minute, prior to flight, visual, double check to

The Pilot's Rescue Door is an important problem area on the H-2 helicopters. In the NAVSAFECEN study, the Pilot's Rescue Door was the most frequently occurring in-flight discrepancy. The major causes were identified as the lower attachment structure/ bracket/slide track. Normal wear, vibration, and fatigue were all pinpointed as possible reasons for failure. A similar attachment and sliding design is used on doors on each side of the aircraft fuselage. The doors have adjustable plates which screw over a flange on the airframe. This design makes the entire door jettisonable for emergency egress. In evaluating existing designs, it appears to be more effective to securely restrain the door and design the windows with an emergency egress capability. On the aircraft inspected in the active squadrons, there was very little adjustment available, and the doors were adjusted to maximum tightness. However, there was still looseness in the door runners that could cause the door to tear free in the event of severe vibration and wind currents.

ascertain that these panels are fully secured. Secondly, the underside of this panel, which is visible from the ground, has been painted bright striped colors to maximize the probability of observation. Thirdly, since the panel can be closed and may not latch, some squadrons have adopted the policy that any time the panel is not fully open, it is fully closed and latched. During visits to squadrons, it was observed that a locking pin has also been added to the latch to insure that panels do not open.

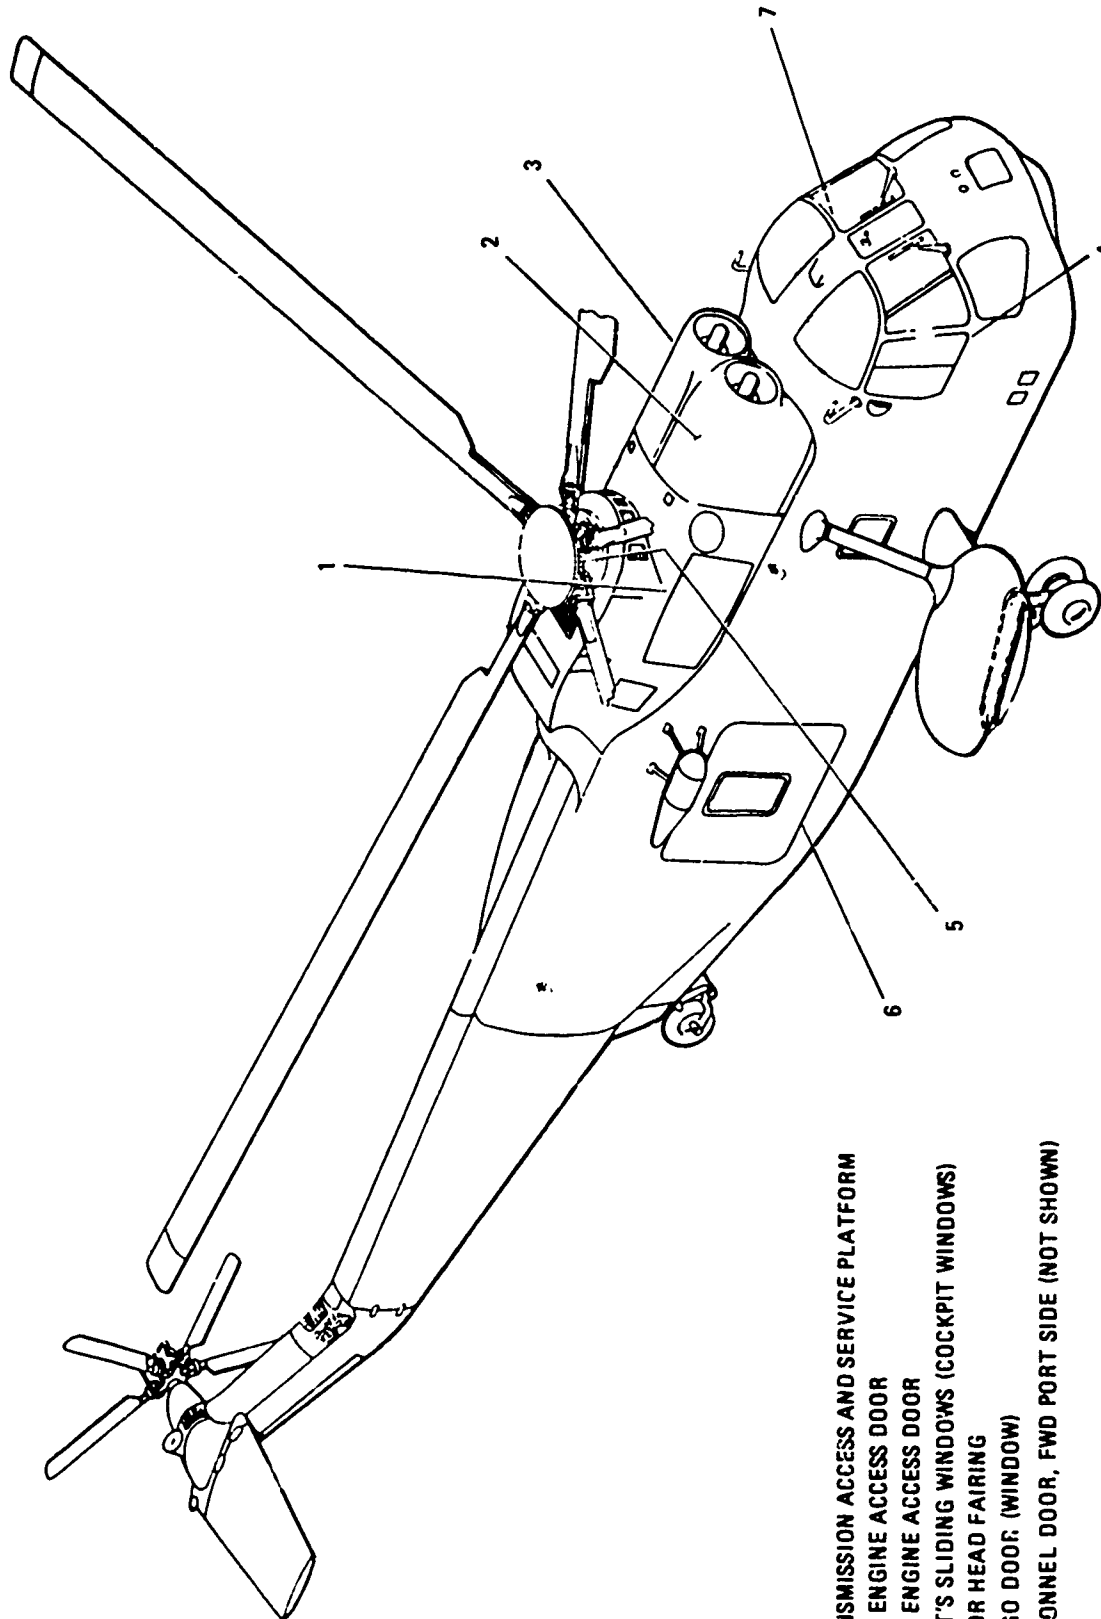
FIGURE D-2. H-3 HELICOPTER - GENERAL ARRANGEMENT EXTERIOR

There is a significant amount of in-flight vibration experienced with the window open which in turn causes the locking handle to vibrate out of the locked position. Handle actuation is sometimes a problem but pilots prefer that the windows are not made more difficult to release. It is vital that this window release quickly and easily during an emergency.

The NAVSAFECEN compilation indicated that loss of the Cargo Door Window (starboard emergency exit) is the most frequently occurring in-flight discrepancy. Unless this component fails, it generally does not require maintenance as shown by the low 3-M response.

Squadron interviews revealed that the Cargo Door Window has an emergency release handle which is shear wired. Overpressure, fatigue, vibration, normal wear and human error contribute to its failure. The window is relatively small and lightweight which minimizes the possibility of damage to the aircraft. Experience has shown that, because of the airflow around this aircraft, the starboard windows separate and tend to fly away harmlessly. Port-side panels, on the other hand, have a tendency to be blown back against the airframe and cause possible damage.

The Engine Service Platform does not have a high frequency of failure but its size and proximity to the Rotor Blades make it hazardous if it opens in flight. The platform is secured to the airframe with two "J" hooks which are operated by a handle on the outside of the panel. This handle can close the platform flush

The lower Personnel Door is held by a slamming lock with a spring-loaded bolt on each side of the door. A handle is turned to a detent position to lock the bolts in a closed position. Wear of the slamming lock mechanism has caused the door to become unlocked. In addition, there is not enough overlap between the bolts and the striker plate on the airframe to insure locking. The H-46 and H-53 aircraft have similar Personnel Doors but they have about 1 to 1.5 inches of steel rod overlapping the striker plates. The H-3 upper Personnel Door is secured to the lower door by a single slamming lock. In-flight vibration causes these doors to open. The upper door displays a greater tendency to separate from the aircraft and has a greater potential to strike the Tail Rotor System. The lower door will generally stay with the aircraft. The 3-M compilation indicated that these doors required more maintenance actions than any other panel component on the H-3 aircraft.

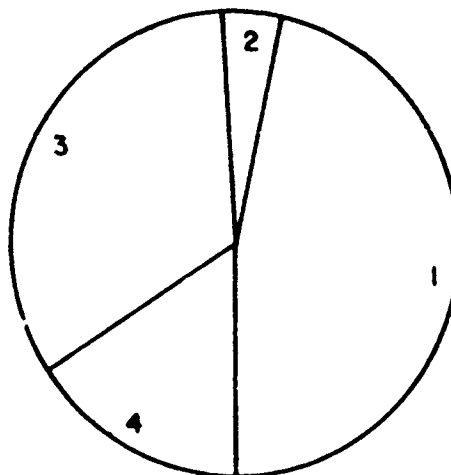
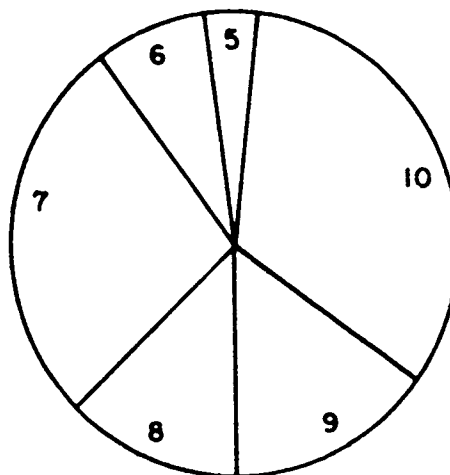
Cockpit Windows encompass a variety of windows such as the Overhead Greenhouse Windows, Windshields, and Pilot's and Copilot's Sliding Windows. These components have been identified in the NAVSAFECEN and 3-M surveys. A number of cases of water leaking into the cockpit have caused electrical problems. The sliding, jettisonable windows on each side of the cockpit were cited for inadvertent release. These windows have popped out with their frame.

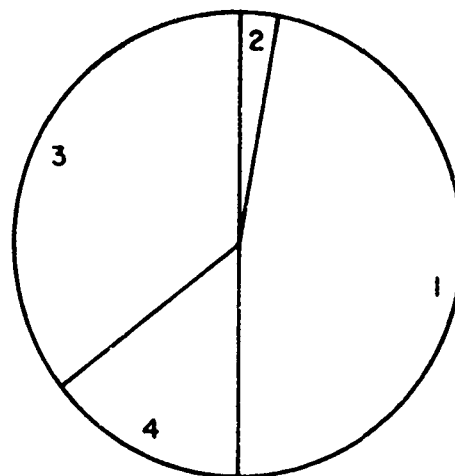
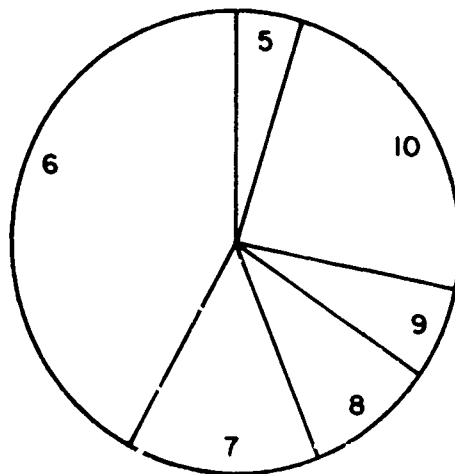
Together the Forward Pylon Forward Clamshell and the Forward Pylon Aft Clamshell doors accounted for the largest number of reports from the NAVSAFECEN and 3-M data. The Forward Pylon Clamshell Doors received about equal emphasis with the Aft Pylon Clamshell Doors on the squadron visits. The squadrons placed most of the blame for the loss of the Forward Pylon Forward Clamshell Door on the warping of the leading edge. This panel becomes warped by maintenance personnel stepping outside the Work Platform area. Another cause suggested by some of the NAVSAFECEN reports and by some of the squadrons is the failure to properly secure the forward latch. It is difficult to see if the latch is properly secured because the latch is internal and located on the upper forward end of the panel. If the latch is not secured, the panel may flex enough to allow the windstream to get under the leading edge and open the panel. If the panel separates, it has the potential of striking either of the rotors.

The Aft Pylon Clamshell doors (Reference: Figure E-2, Annotations 3 and 4) provide another problem area on the H-46. According to the NAVSAFECEN data, Aft Pylon Forward Clamshell Doors are lost more frequently than the Aft Pylon Aft Clamshell Doors. However, the aft doors are more dangerous to lose because of their proximity to the rotors. Those who cite the latches as the main cause say that flexing of the doors causes the latches to fail or that the latches are not properly adjusted causing the failure. Those who report the hinges as the main cause contend that the hinges become loose allowing excessive vibration in the doors and that either the hinges fail first followed by the latches failing, or that vibration causes the latches to fail.

The Swashplate Access Panel (Reference: Figure E-2, Annotation 5) accounts for a significant number of losses. It does have a potential for striking the Rotor Blades (two out of the 21 NAVSAFECEN reports indicated this). The panel is relatively small and light and the possibility of seriously damaging the Rotor Blade and causing the aircraft to go out of control is small, but it does exist. The problem with the Swashplate Access Panel is that the Camloc fasteners are not securing the panel adequately. Failure could be caused by not using enough fasteners, the inability of the fasteners to withstand vibration, or incorrect fastener size.

The Co-Pilot's Escape Hatch accounts for most of the escape hatch losses. Inadvertent actuations and failure to properly shear wire the handle have contributed to the losses of this hatch.

The synchronous Shaft Inspection Panels (Reference: Figure E-2, Annotation 2) have been troublesome. They usually open in flight and hit the fuselage. They have separated from the aircraft but no cases of them striking the Rotor Blades have been reported. Fastener failure has been the problem. These panels become distorted from either coming open and being banged against the fuselage or by personnel walking on them. They can become so distorted that they rub against the synchronous shaft. Their frequent need for repair or replacement makes them an appreciable maintenance problem.

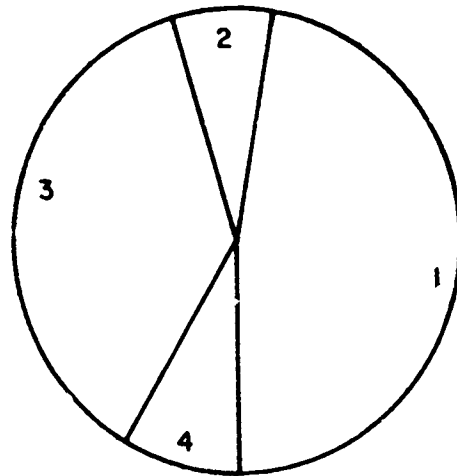
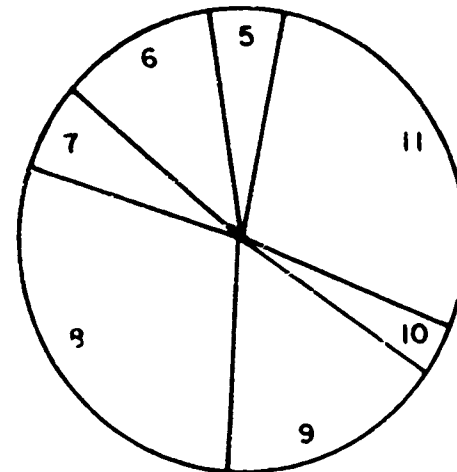
The Rotor Brake Access Panel which is just aft of the Work Platform (Reference: Figure F-2, Annotation 2) stands out in all three data sources as being the major problem on the H-53. The NAVSAFECEN data shows the Rotor Brake Access Panel to be the constant contributor to in-flight incident reports (22.4% for all H-53's, 37.2% for H-53D). The 3-M data indicates it is the panel most frequently in need of maintenance action. This panel was also emphasized by squadron
