**A STUDY OF IN-REACTOR DENSIFICATION
OF UO₂ FUEL IN THE MH-1A REACTOR**

Battelle Columbus Laboratories

FINAL REPORT

December 23, 1974

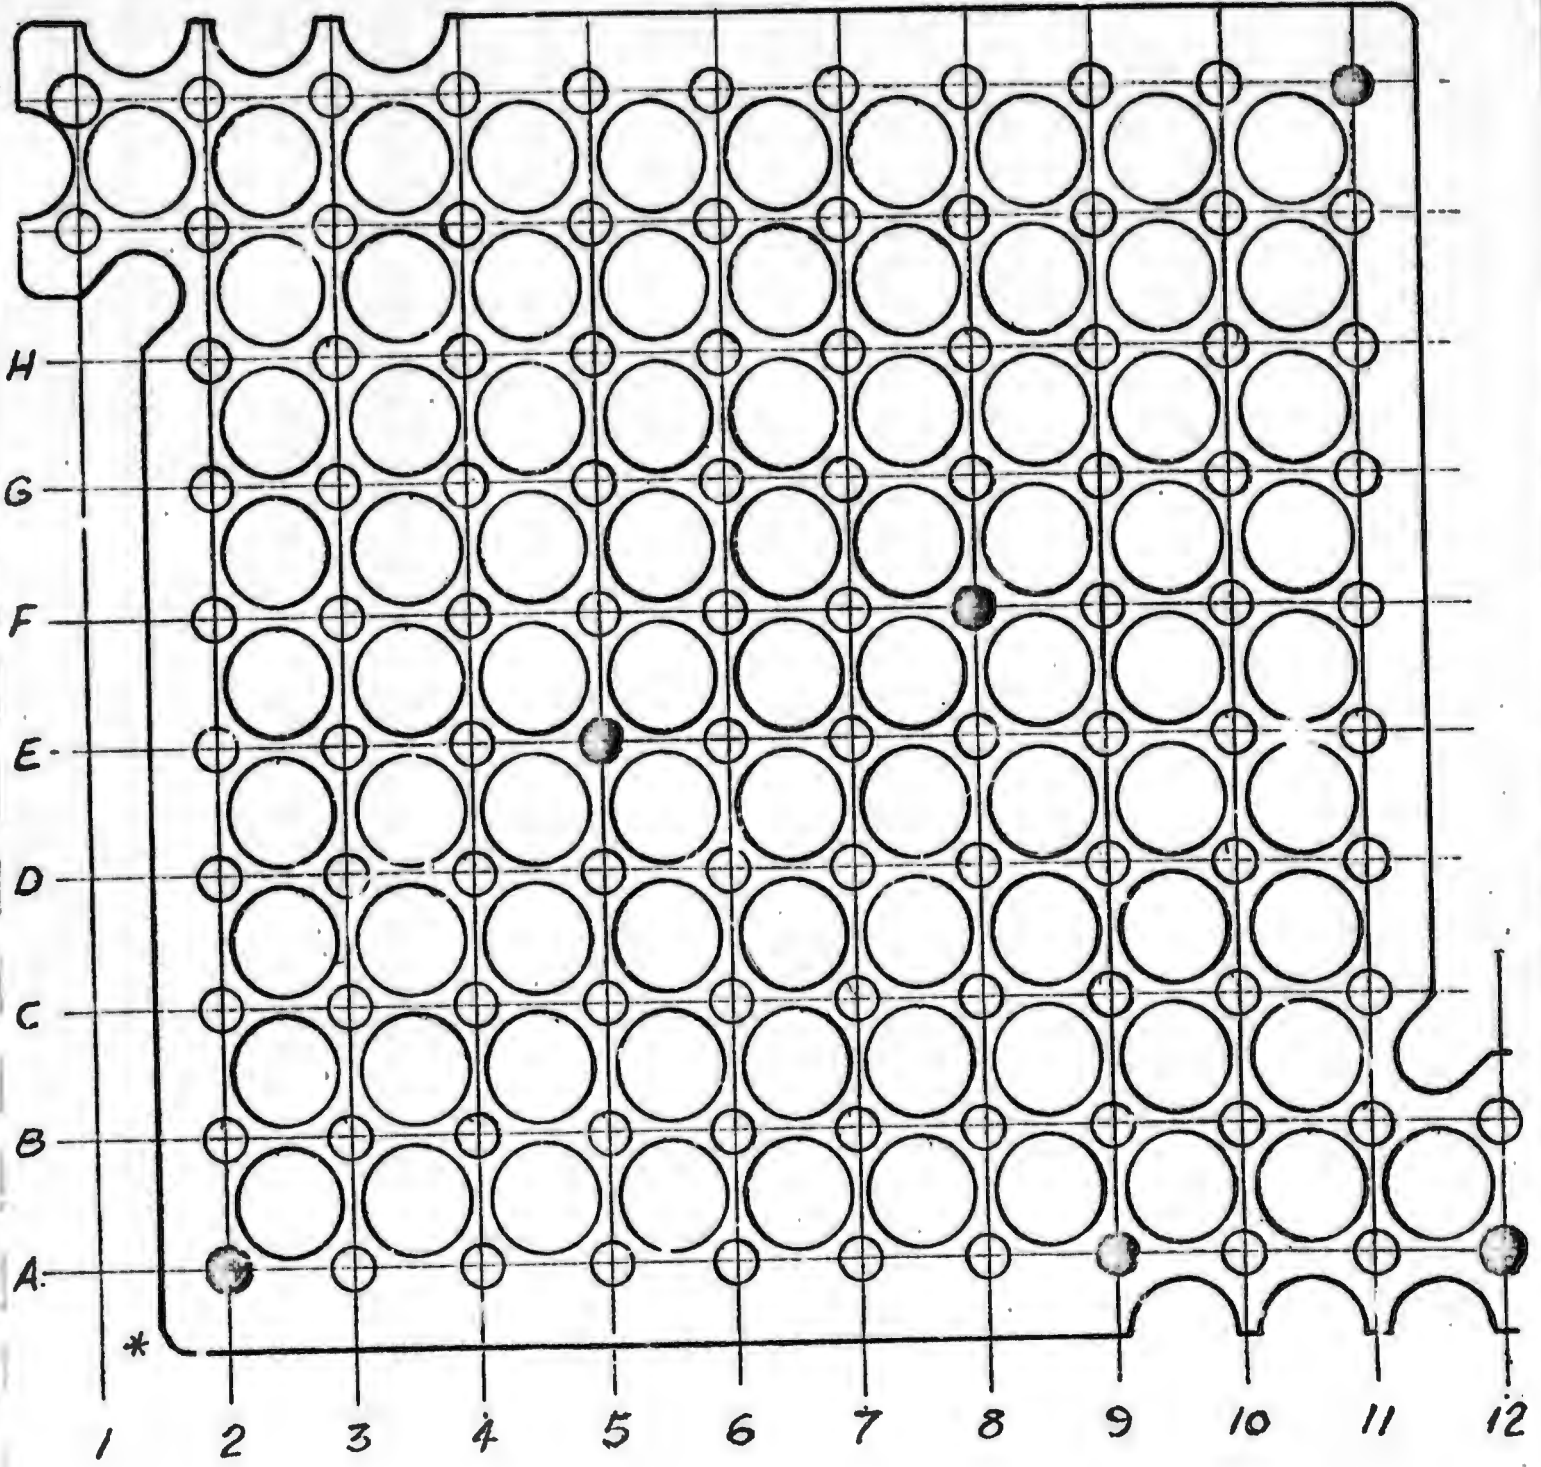
FIGURE 1. SKETCH OF TOP PLATE SHOWING LOCATIONS WHERE FUEL RODS WERE REMOVED FROM MH-1A ASSEMBLY No. 46

Six rods, A-2, A-9, A-12, E-5, F-8, and J-11 were removed from the assembly for detailed examination. Rod locations are shown in the sketch of the top grid plate, Figure 1. Corner rods, A-2, A-12, and J-11 were removed from the assembly by cutting through the top and bottom end caps with an abrasive wheel. To minimize chances of violating the rod containment, the end cap cuts were made as close as possible to the top and bottom grid plates. The inner rods A-9, E-5, and F-8 were removed by cutting 0.625 in. diameter holes through the grid plates and pulling the rods through the holes. The holes were cut with a drill saw.

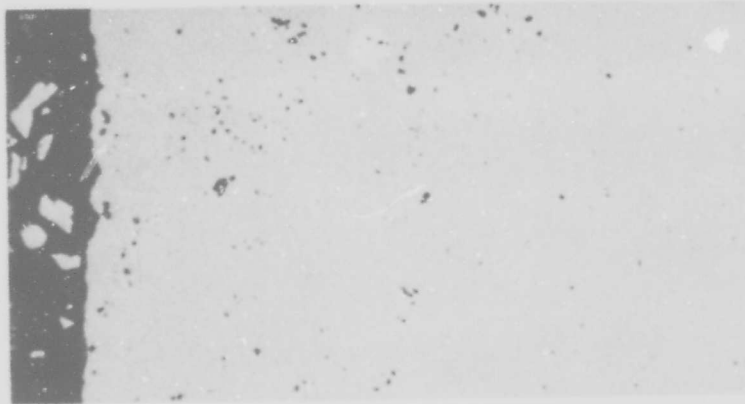
(a) Fuel Surface
500X
HC39668

As-polished 500X photomicrographs of the fuel are presented in order of increasing burnup, Figures 15 through 20. Note that the lowest burnup sample contains a large number of small round pores plus a small number of large angular pores. With its low burnup, this sample probably best represents the as-fabricated pore structure. As burnup increases, the distribution of large pores stays about the same while the population of small pores decreases. Note that the high burnup specimens contain very few small pores. On the basis of these observations, it appears that densification occurred via annihilation of the small as-fabricated porosity. This same type of small pore annihilation has been observed in densified commercial reactor fuel.

FIGURE 16. AS-POLISHED MICROSTRUCTURE OF ROD A-2 AT 28-5/32 - 28-3/4 IN.
FROM BOTTOM OF FUEL COLUMN. Burnup 8,600 MWD/MTU.

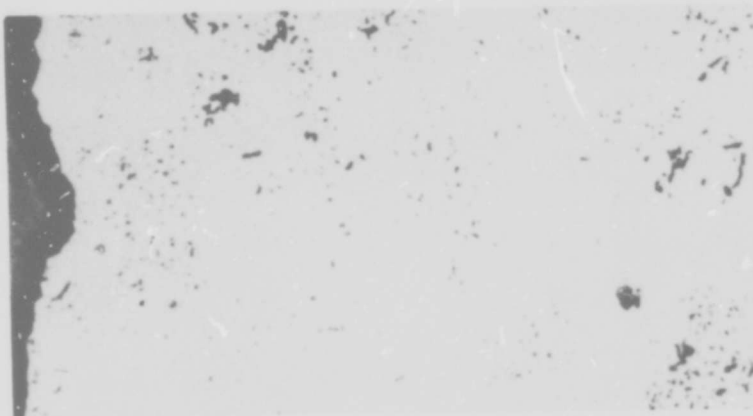
(a) Fuel Surface
500X
HC39660

FIGURE 17. AS-POLISHED MICROSTRUCTURE OF ROD F-8 AT 4-3/16 - 4-13/16 IN. FROM BOTTOM OF FUEL COLUMN. Burnup 9,400 MWD/MTU.

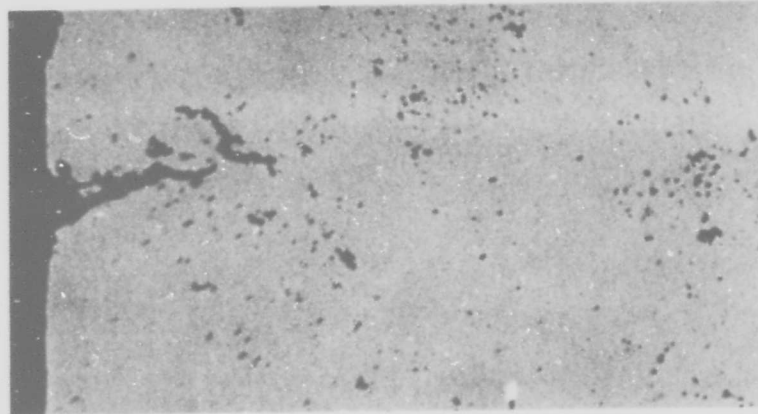
(a) Fuel Surface
500X
HC39676

FIGURE 18. AS POLISHED MICROSTRUCTURE OF RCD A-2 at 4-3/4 to 5-11/32 IN.
FROM BOTTOM OF FUEL COLUMN. Burnup 12,700 MWD/MTU.

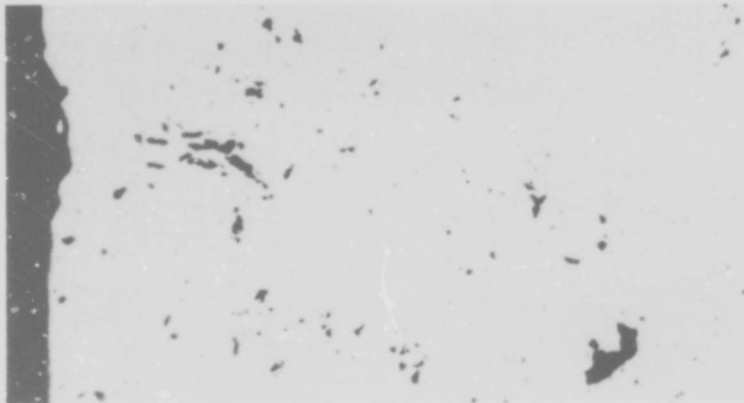
(a) Fuel Surface
500X
HC39661

FIGURE 19. AS-POLISHED MICROSTRUCTURE OF ROD F-8 AT 13-25/32 -
14-3/8 IN. FROM BOTTOM OF FUEL COLUMN.
Burnup 14,700 MWD/MTU.
