ANALYSIS OF LIQUID ROCKET TANKAGE

Bell Aerospace Company

Air Force Rocket Propulsion Laboratory

April 1975

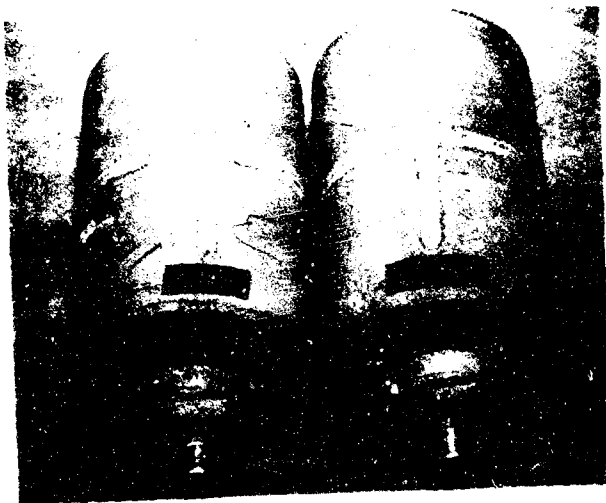
Figure 10

The unaged cylinders loaded with  $\text{N}_2\text{O}_4$  are shown in Figure 10. Two of them, S/N's 4 and 7, had a small amount of minor pitting on exterior welds at one end, but this was not considered significant. The other two were completely clean with no corrosion. The interiors of these cylinders were very clean and untarnished with only the faintest indication of a "waterline" to show the level of propellant stored in them.

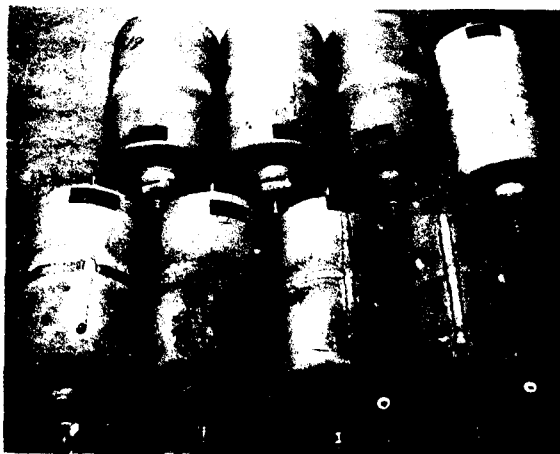
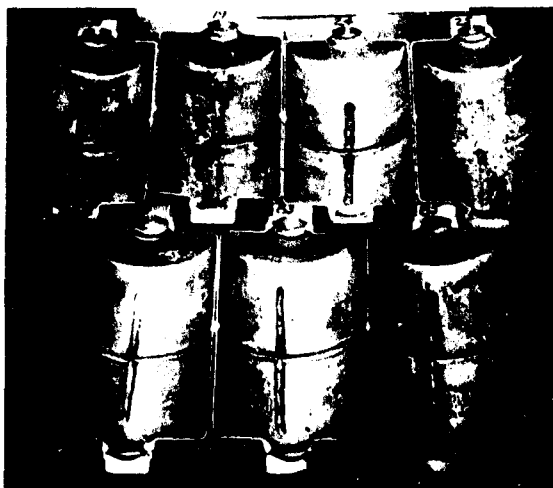
Figure 12. Surface Appearance of aluminum -1" and -1/4" diam. tubes as an loaded with 21K. The tubes are in the left hand

The aged tanks loaded with  $\text{N}_2\text{O}_4$  are shown in Figure 12. The exteriors of these cylinders showed no attack or corrosion. As with the other aged tanks, the interiors were dull and stained a light brown. The  $\text{N}_2\text{O}_4$  exposure had left a "waterline" about 2/3 up the sides of the cylinder, with the liquid phase surface slightly darker than the vapor phase. There was no corrosion or attack visible.

NTPR: Task S/G 41 incorrectly identified as containing, in fact a light material, see Figure 12

Pitted  
interior of  
-1" and to  
a lesser  
extent -1/4  
were subjected  
to detailed  
and  
confirmatory  
analysis

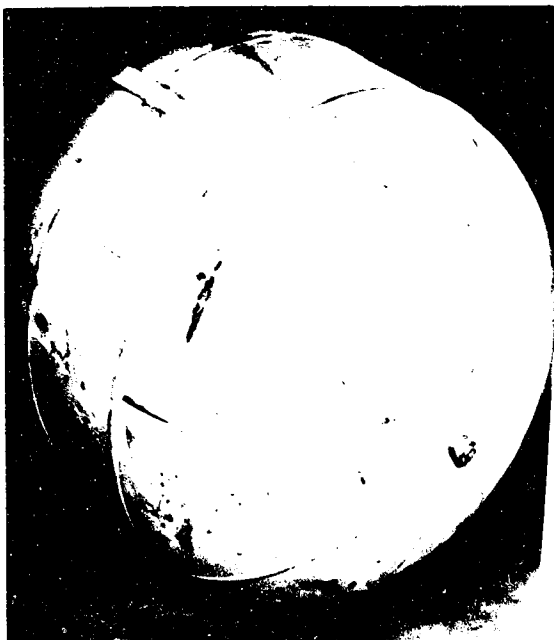
External View

The corrosion leading to perforation of the subject tank shell wall was externally initiated. Location of the corroded and perforated area is shown in Figure 44 of Section VI. Close-up views of the corrosion and perforation are shown in Figure 82. The actual perforations can be seen in Figures 82 and 83. A view of the internal surface, showing severe abrasion of the weld root and the perforations at the edge of the weld, is presented in Figure 83. The natural step formed by the transition from a heavier flange assembly wall thickness, is accentuated by this clean-up, as shown in the Figure 83 cross section. Note the start of a pit on the external surface of the weld bead.

Internal view is essentially identical  
to S/N N-11 shown in Figure 43

Figure 44. External Appearance of Aluminum 6061-T6  
Tank (General Dynamics-Convair)  
Loaded with  $N_2O_4$  for Five and One Half  
Years

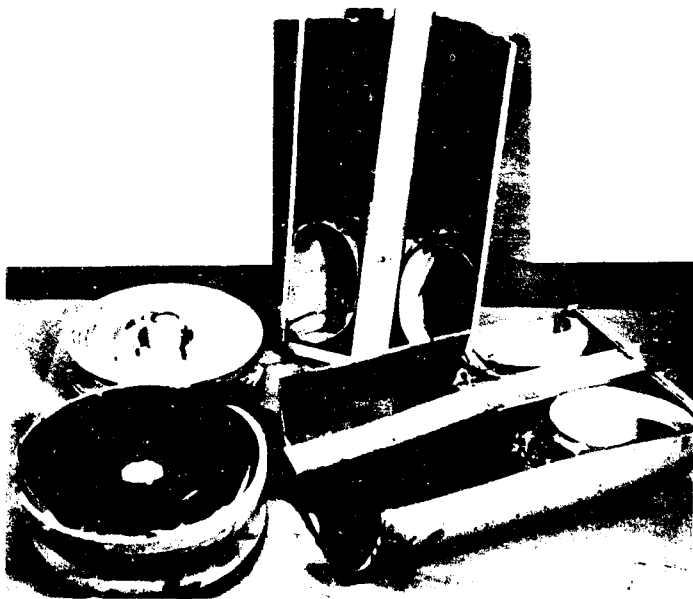
The external surface appearance of the tanks could be divided into two categories. The tanks loaded with  $N_2O_4$ , Systems 7, 9, and 14, shown in Figures 29, 31 and 32, had an etched and lightly frosted external surface. The other tanks, all loaded with MHF-5 were unattacked on their exteriors. This observation correlates well with the observations on individual tanks evaluated in this program, all containing oxidizer, that the oxidizer storage room environment was at times quite corrosive to aluminum components when leaking  $N_2O_4$  or  $ClF_5$ .

NOTE: This system was a loaner unit to manufacturer, General Dynamics, and was filled with 100% propellant as APB-1. The motor was for four and one third second before expulser. Exterior surface is covered in black material.

Figure 29. View after Preliminary Section of Propagated System S/N 000 Showing Exterior Surface, Internal Surface and Expulser Condition

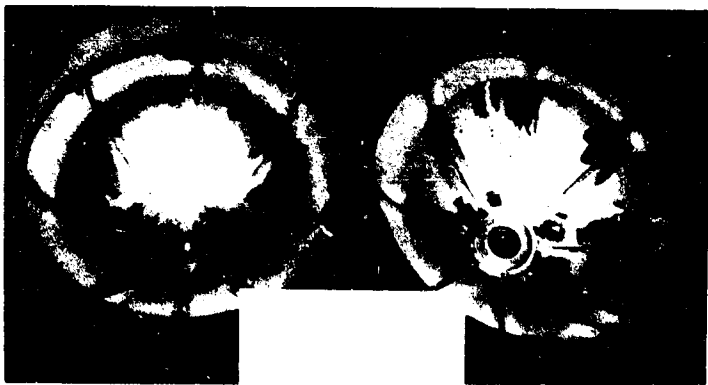
The general, interior surface condition of the large capacity vessel selected for confirmatory analysis, S/N N-10, is shown in Figure 43 of Section VI. Discoloration and staining of parent metal and weld deposits are clearly visible. Scattered corrosion deposits were observed on the welds and parent metal, at sites of incipient pit formation. Close-up views of two areas containing a fairly large number of pits are shown in Figure 64. The early stages of pit formation and a well-defined pit are shown in the cross section views of Figure 65. Note the similarity in appearance of intergranular penetration occurring in this tank with that shown in Figure 63 for the solid state bonded tank. The mechanism of corrosion is identical.

Interior view showing nozzle, unattached nozzle, exterior of this tank is essentially identical to that shown in Figure 10.

Figure 11. Typical appearance of Aluminum 7075 Tank No. 1 (General Dynamics-Jonvaire, S/N N-11) loaded with  $\text{NaO}_2$  for Five and Three Quarter Years.

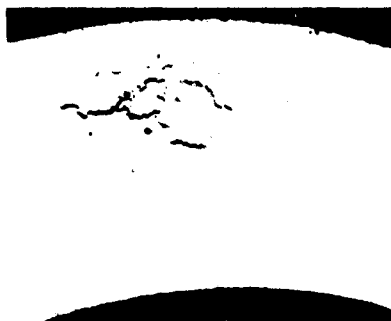
- b. Fracture surface showing alignment of corrosion product.  
Corrosion product is visible at arrow.

Micrograph of fracture surface showing alignment of corrosion product.  
Corrosion product is visible at arrow.

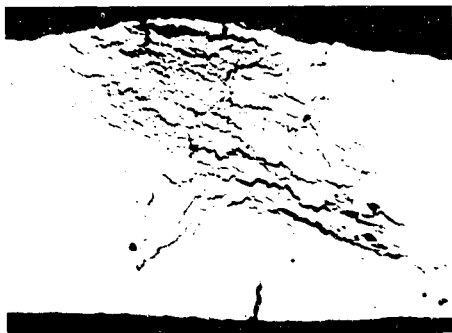
Figure 51. Tube Weld Leak in Bottom Outlet Tube from Martin 10-gallon Tank No. 4 (S/N 003) used to Store RLE Propellant. Note Small Crack on Internal Surface and Similarity to Figure 49 and Figure 50

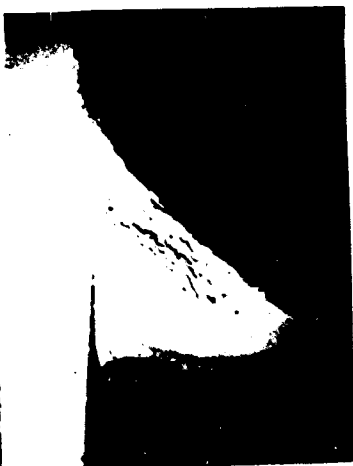
- a. Overall view showing corrosion b. Cross section showing weld corrosion

Figure 1. Corrosion Observed in Flange to Tube Weld of Martin 15-gallon Tank No. 1 After Six Months Exposure to  $ClP_4$

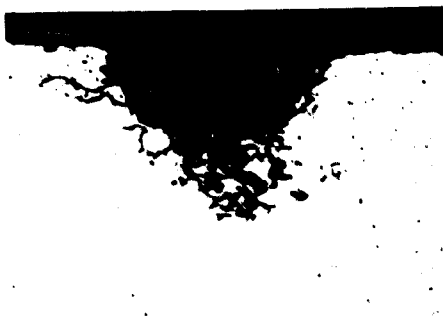
- a. View of pitted surface near bottom pole of tank

- b. Cross section of an pit showing corrosion penetration of seal boundary

Figure 63. Pitting on Inner Surface of Solid State Bonded Tank

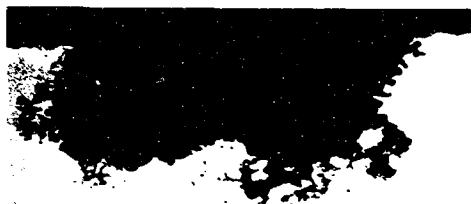
Figure 60. Cross Section of Deepest Pit Observed on Internal Surface of 2014-T6 Aluminum Alloy Container S/N 19, in Contact with  $\text{ClF}_3$  Propellant for 42 Months

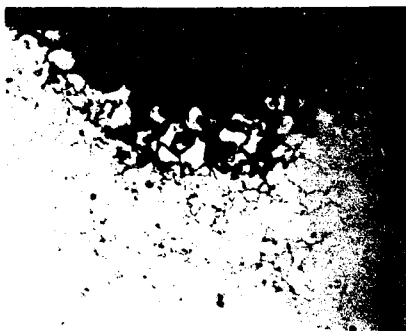
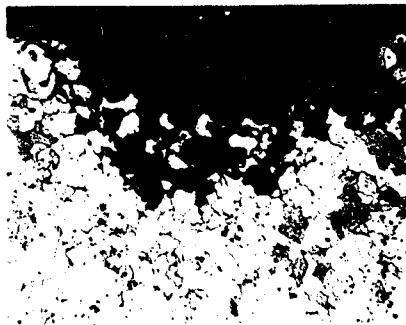
overall appearance, both externally and internally was also similar. Pit depth and frequency however were much less than those noted in S/N 19. White deposits of a corrosion product associated with the pits are shown in the photomicrograph of Figure 70. Cross sections of a fully developed pit and one in the early stages of development are shown in Figure 71. The pitting attack is intergranular in nature and identical to that observed previously for the S/N 19 container.

Intergranular  
pitting  
attack -  
Unetched

Same as  
above -  
Etched  
with  
Keller's  
Reagent

Figure 71. Cross Section of Pit Formation Observed on Internal Surface of 2014-T6 Aluminum Alloy. Exposed to  $\text{ClF}_3$  Propellant. Note Early Stage of Pit Formation Shown in Bottom View.

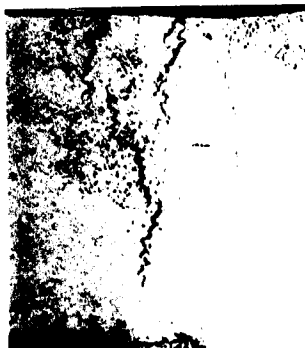
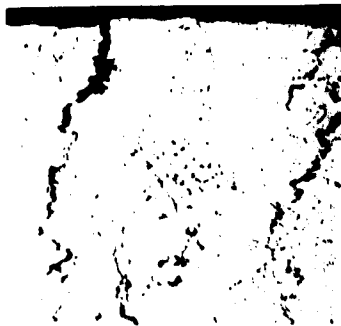
- a. Weld underbead cracks near weld cross over. Note absence of any corrosion products

- b. Cross section view through weld cracks interdendritic cracks are characteristic of shrinkage cracks

Figure 72. Transverse cracks observed in Root of Longitudinal Weld on 2014-T6 Aluminum One Quart Container S/N 24

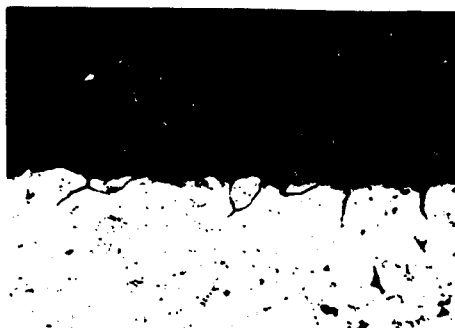
Note intergranular attack along surface

Note pitting corrosion and intergranular attack  
to intergranular attack

Figure 70. External Surface of 7075-T6 Aluminum Alloy Shell  
Exhibited a highly corroded area outboard  
of corrosion in Figure 71. Marine Tank No. 3  
showed intergranular attack and the start of  
pitting.

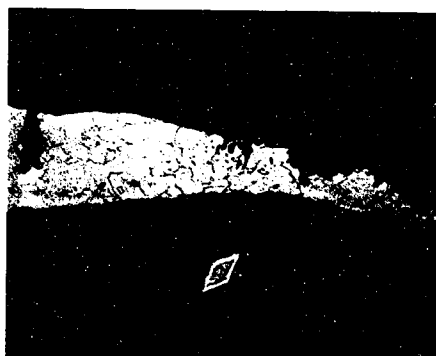
Figure 84 presents a cross section view of one of the perforations. Note the location of the perforation, immediately at the edge of the weld. Attack of the A-286 base metal in this area was primarily transgranular in nature.

Figure 84. Cross Section of a Perforation Shown in Figure 83. Note Location of Perforation Immediately at Edge of Weld, in HAZ of the A-106 Alloy. HAZ Propagation is Transgranular

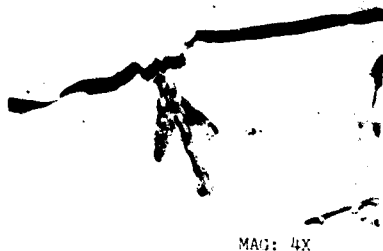
The tensile test data did not indicate the directionality observed in handling and from "hand tear" tests of the material. It was postulated that surface flaws or discontinuities could possibly contribute to the apparent directionality observed. To probe this possibility further, random sections of this material were taken from the same unit sample, cut into approximately 2" x 2" sections and stretched by hand in both directions. Some pieces could be stretched a considerable amount in both directions, without failure. Others failed on the first stretching, with little or no ductility. Samples of each type were then examined carefully under the microscope, to determine surface condition and origin of failure of the low-stretch material. Photomacrographs of each type of material are shown in Figure 87 and 88. Note the uniform, continuous surface of the high-stretch material as compared to the mottled, layered appearance of the low-stretch material. The failure origin can be seen at the edge of one of the round, surface flaw depressions. This edge, of reduced cross section, acts as a sharp stress concentration point, leading to a low-stress failure with very little ductility.

Figure 28. Surface of cross-section of RTV-66 Silicone Rubber Rocket Motor. The material is a cross-section of a Rocket Motor. Note Mottled, Distorted Surface of Surface and Point of Failure (indicated by Arrow)

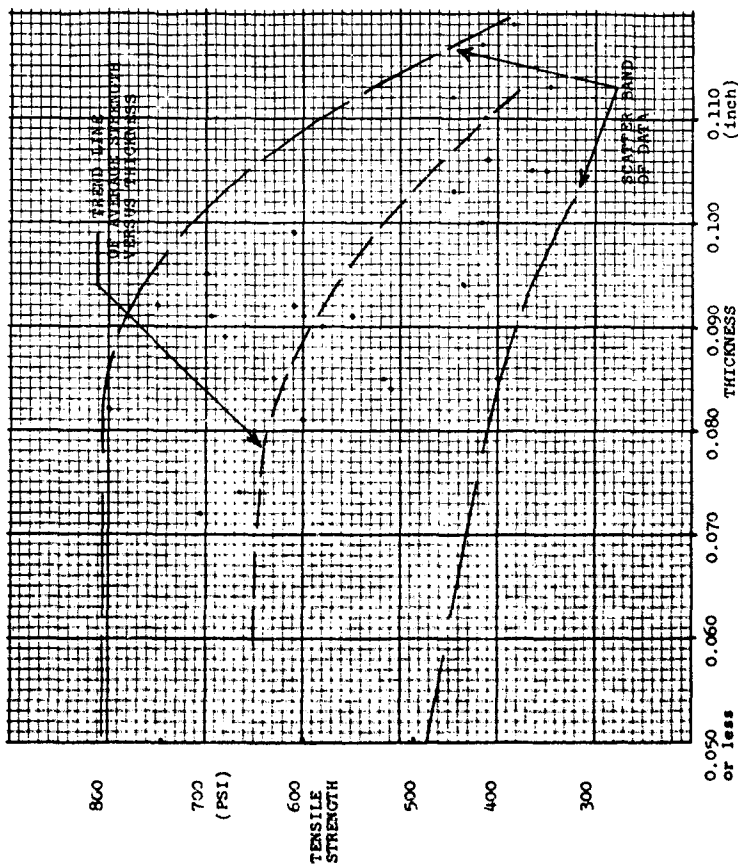
The direct measurement of tensile strength and elongation in the two principal directions of the tank did not show any consistent variation in properties that would explain the apparent difference in behavior. The tensile strengths, Table I, do show a rather large variation with much of the data being above the reported typical strength properties of 400-500 psi. The strength variations are too great (minimum/maximum readings of 347/800 psi respectively) to be explained simply as the expected variation due to mixing, pouring and curing inconsistencies. When the tensile data were analyzed as a function of thickness of the layer, a definite trend and correlation was found, with the thin liner samples showing generally higher strength than the thicker material. The data are shown graphically as strength versus thickness in Figure 89. The annulus between diaphragm and shell will inevitably have some variation in thickness, and it appears that this variation produced variations in cure behavior or other effects controlling the strength. These variations are probably not significant to the performance of the liner, particularly since liner failure will almost always be by a tearing mode, as discussed below.

Figure 89.  
Strength  
Versus  
Thickness  
Characteristics  
of FV 634  
Silicone  
Rubber Liner  
Material from  
Prepackaged  
Feed Systems.

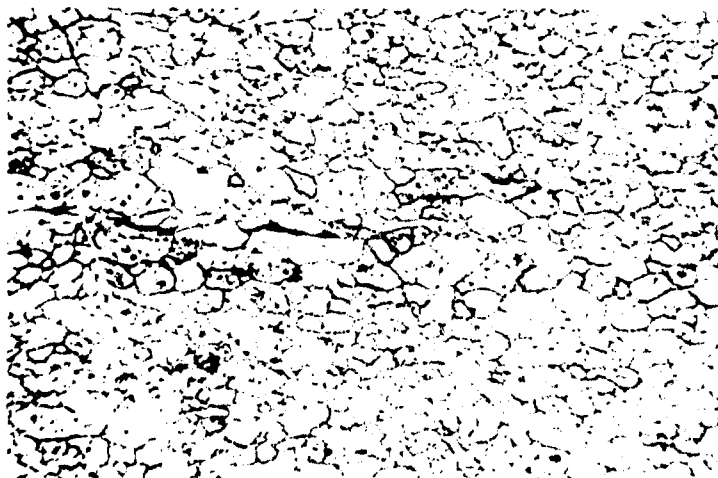
- c. Etched view showing extension grain boundary network of  $\text{CuAl}_2$

Figure 24. Solid State Bond Joint Shape and Microstructure
