FAILURE ANALYSIS OF TAINTER GATE CABLE-ADJUSTING  
BOLTS5. TYPE OF REPORT & PERIOD COVERED  
FINAL

James Aleszka

CONSTRUCTION ENGINEERING RESEARCH LABORATORY  
P. O. Box 4005  
Champaign, IL 6182010. PROGRAM ELEMENT, PROJECT, TASK  
AREA & WORK UNIT NUMBERS

April 1975

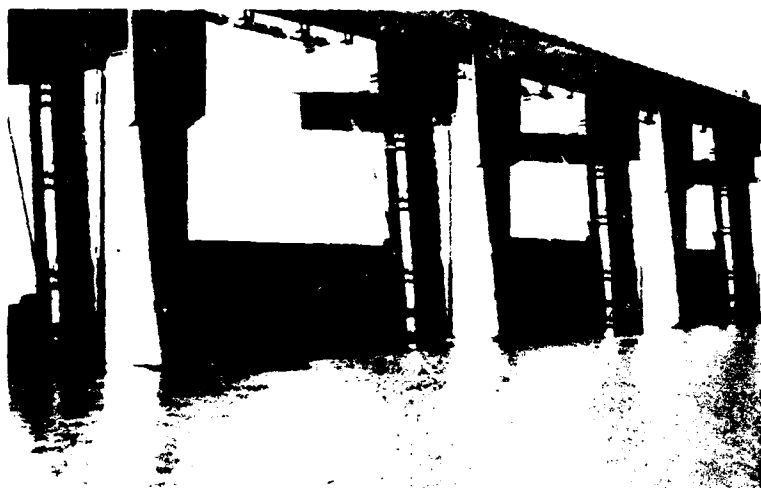
Background. The Uniontown Locks and Dam, located on the Ohio River near Uniontown, KY, consists of ten Tainter gates and two Miter gates. The Tainter gates are raised and lowered using a cable-and-winch system, as illustrated in Figure 1. Thirteen cables are attached to each side of the Tainter gates by a bolt assembly, as shown in Figure 2. The cables are tensioned until each pair of the stainless steel bolts securing them is subjected to a load of about 25,000 lbs. The bolt assembly on each side of the gate consists of two rows of 13 bolts. The bolts are 2 ft 4 1/2 in. long and 1-7/8 in. in diameter. Under normal maximum load conditions, each pair of bolts could experience a 33,000 lb tensile load. It has been calculated that if, for any reason, a gate should jam, each cable would be loaded to 2.8 times 33,000 lbs, or 92,500 lbs.<sup>1</sup>

Figure 1. Tainter gates at Uniontown Locks and Dam.

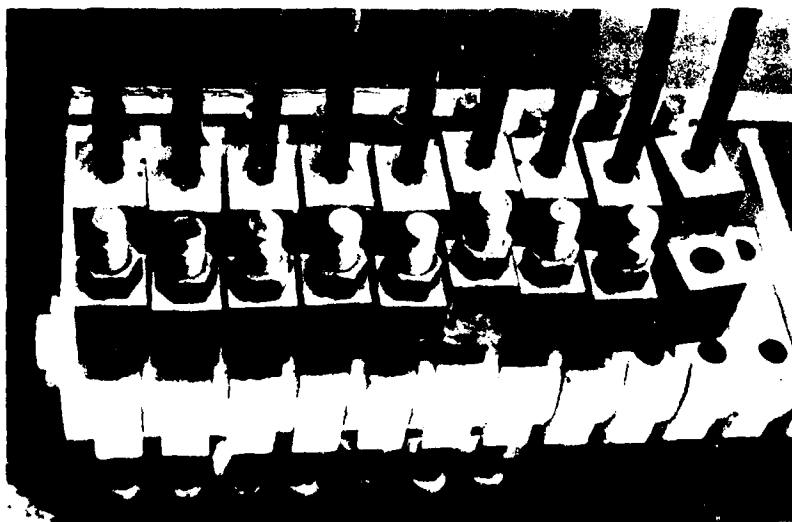
Figure 2. Bolt assembly securing lifting cables.

g. The high-velocity, turbulent water flow at the ends of the Tainter gates imposes a cavitation erosion condition on the bolt assembly. This condition should be eliminated by installing baffles or a protective cover for the bolt assembly in long-term applications of this Tainter gate design.

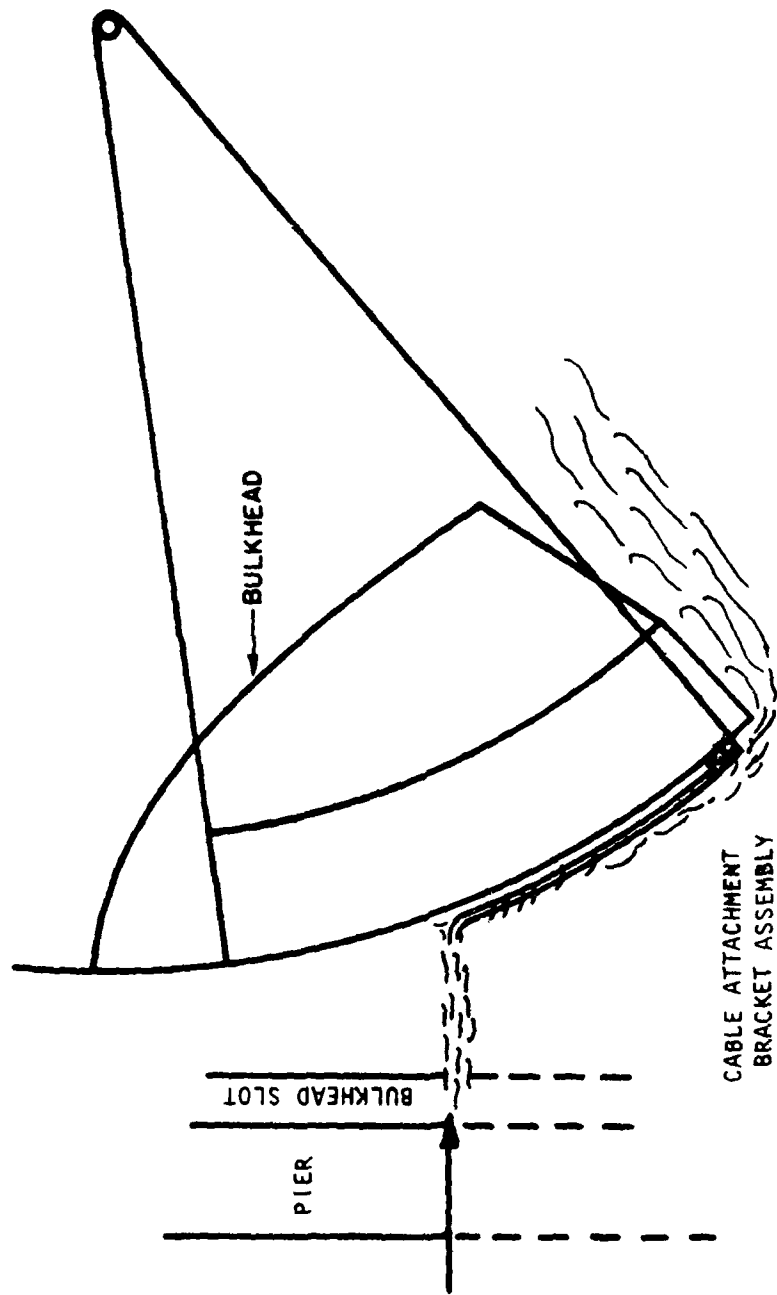
The current cable attachment assembly is a modification of a previous design used at the McAlpine and Cannelton Locks and Dams. In the current design, shown in Figure 3, the assembly is located on the face of the gate. In the previous design, illustrated in Figure 4, the cable was wrapped around the gate, and the bolt assembly was located on the opposite side of the gate. The cable was therefore able to transfer part of the load to the gate itself instead of applying it all to the bolt assembly. The bolts used were forged from type 304 stainless steel, which has less strength but more corrosion resistance than the type 416 stainless steel used in the new design. There have been no known bolt failures on dams using the older design.

Figure 3. Sketch of Tainter gate at Uniontown Locks and Dam.

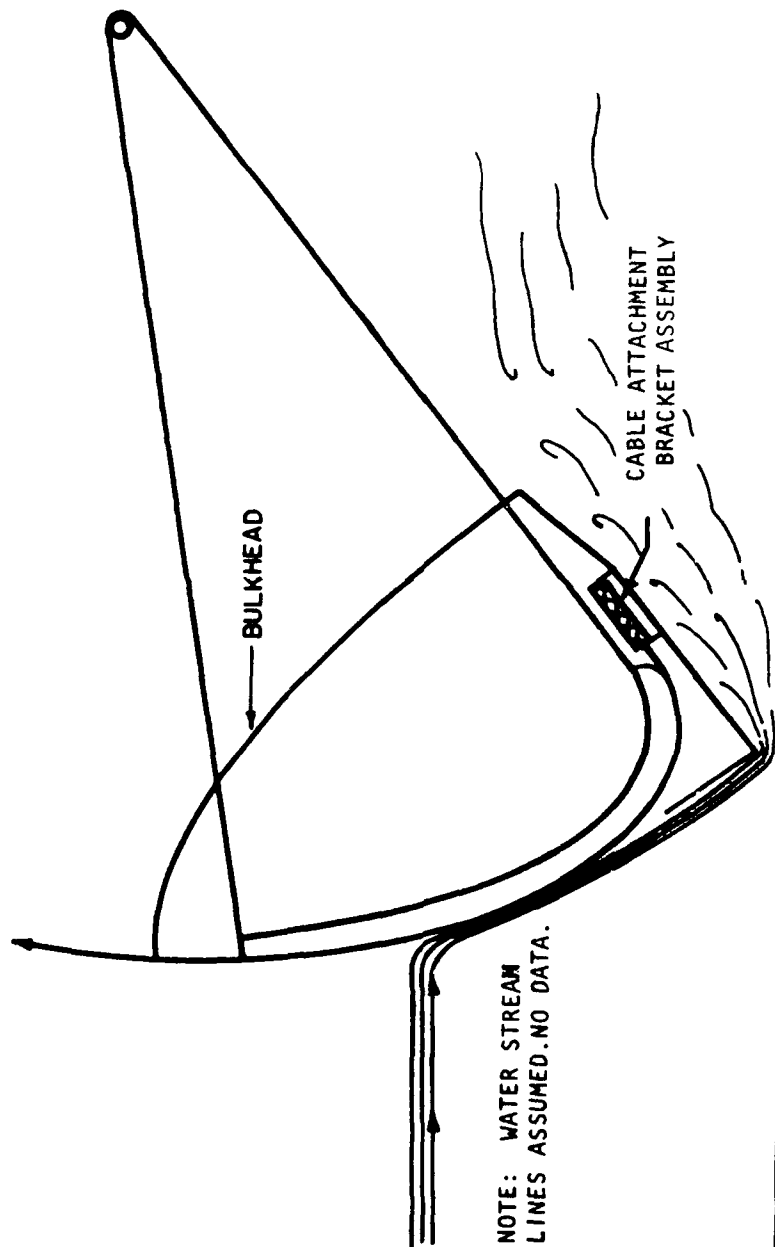
Figure 4. Sketch of Tainter gate at McAlpine Locks and Dam.
