LOCARCH SHELTER

AFCEC-TR-75-7

Final Report For Period December 1973 to August 1974

| REPORT DOCUMENTATION PAGE | | READ INSTRUCTIONS BEFORE COMPLETING FORM | |
|---|---|--|--|
| 20. ABSTRACT (Continue on reverse side if necessary and identify by block number) The report describes the erection, field testing and disassembly of the LocArch air transportable aircraft shelter, manufactured by the Lockheed Georgia Co. Marietta, GA. The outcome of the shelter evaluation revealed the design concept to be basically sound but deficiencies existed in the arch panels and the end closures. An in depth analysis of the shelter components was conducted during the test program. The entire shelter system was subjected to simulated environmental tests to evaluate its performance for possible world wide use. | | | |

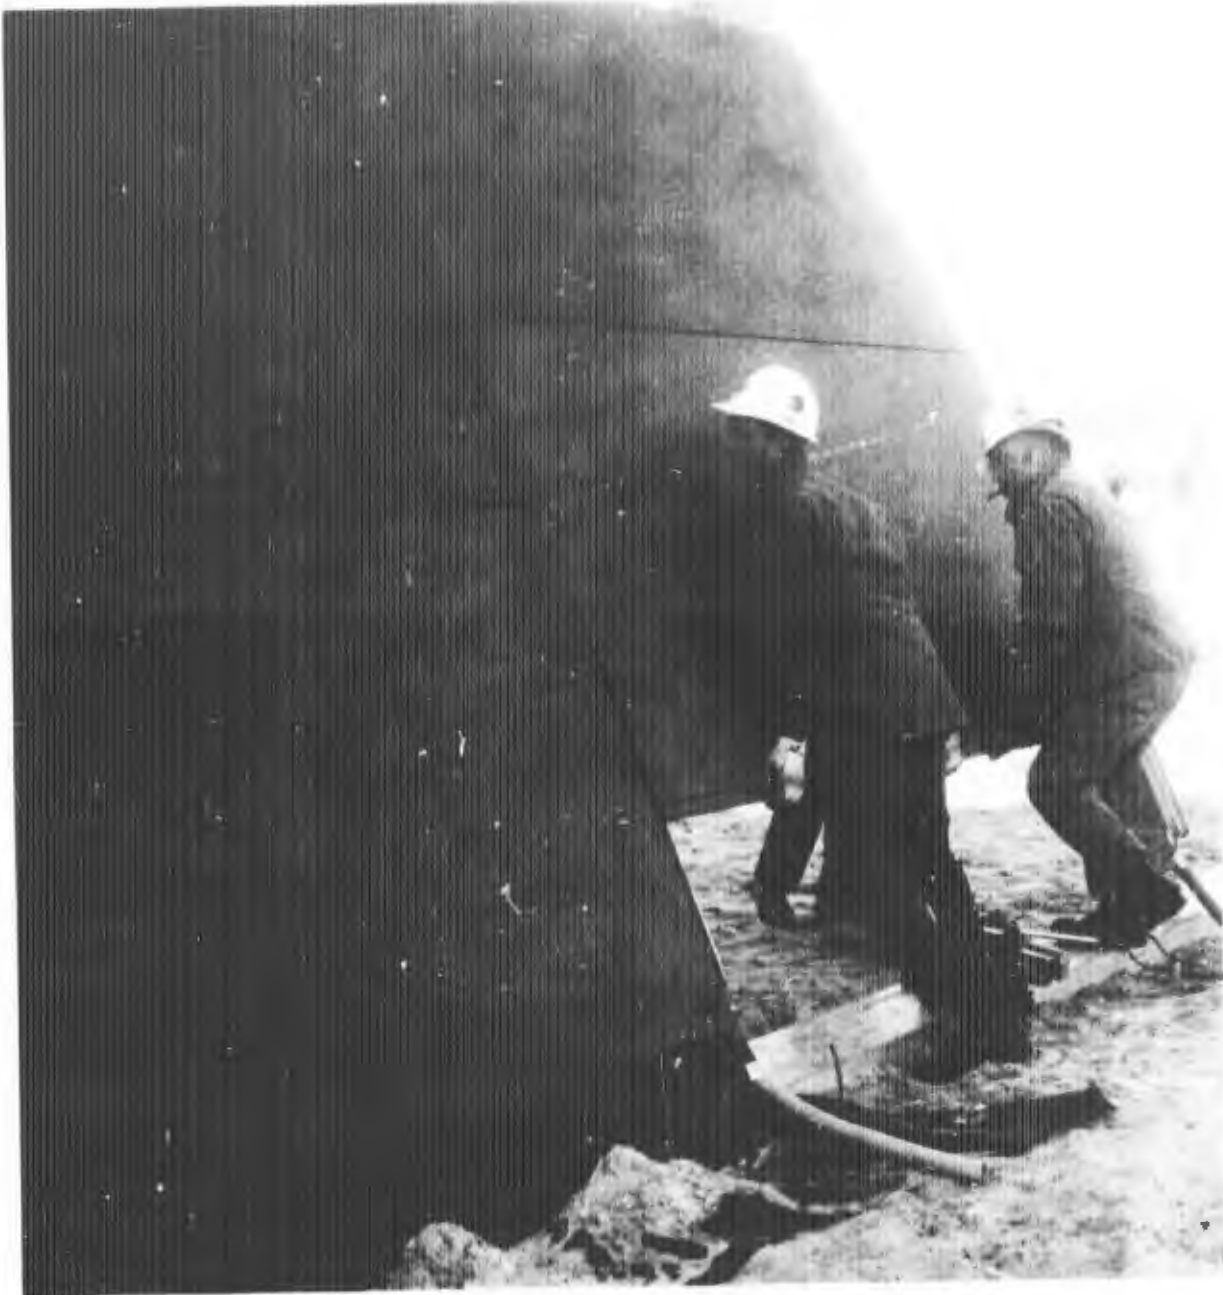
The third arch beam was then raised to the vertical position and the panels were subsequently installed. Time was reduced by 50 per cent to install the panels, partially because the track was cleaned and a 3/4 inch drill motor was used to turn the panel installation winch rather than strictly manpower. The drill worked well with only minor overheating. During the installation of the panels between the third and fourth arch beams, a manual panel insertion was attempted rather than using the panel winch. Figure 30 shows two personnel were able to

Figure 30 Installing Panel Manually

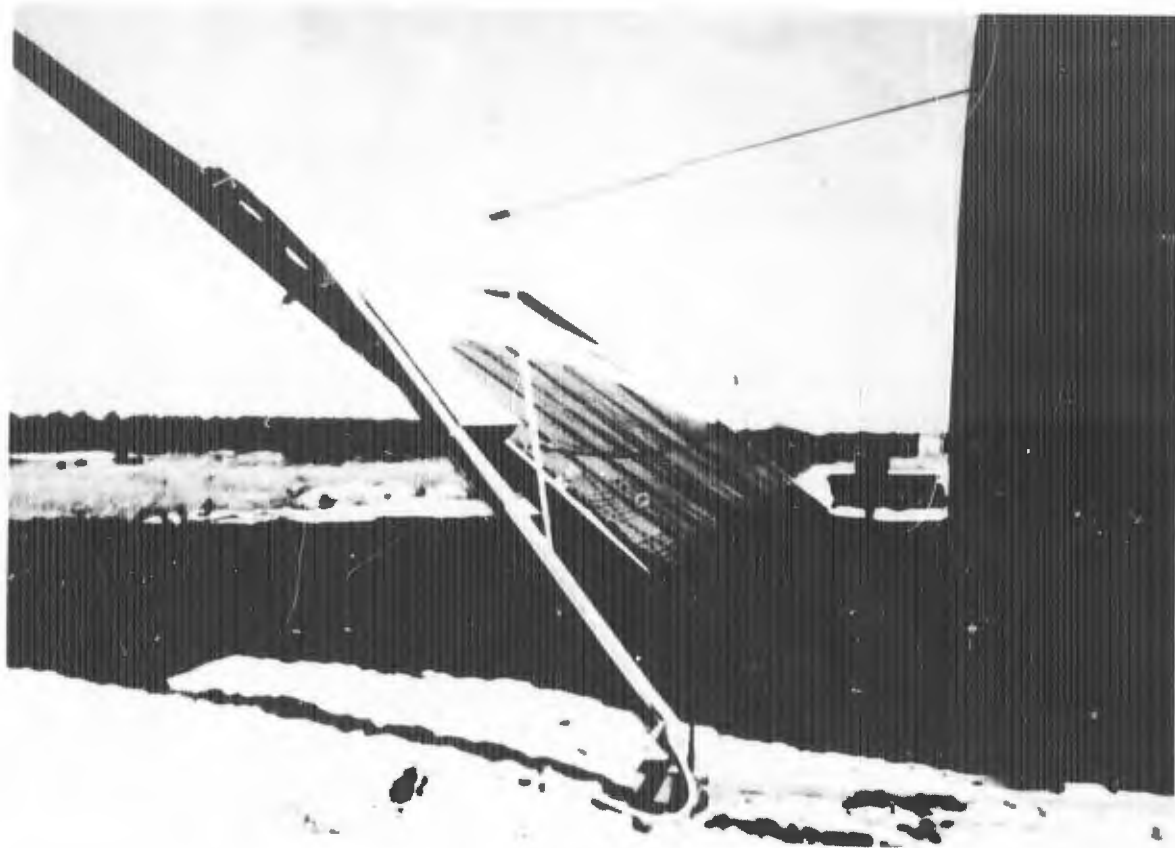
position with no problems (Figure 37). The last row of panels were then installed between the eighth and ninth arch beams. Only four panels were able to be installed by hand and then the drill motor was used. The last four panels were extremely difficult to install and the work had to be stopped after each of the panels were installed to cool the motor.

Figure 37 Vertical End Wall Being Pulled to Vertical Position

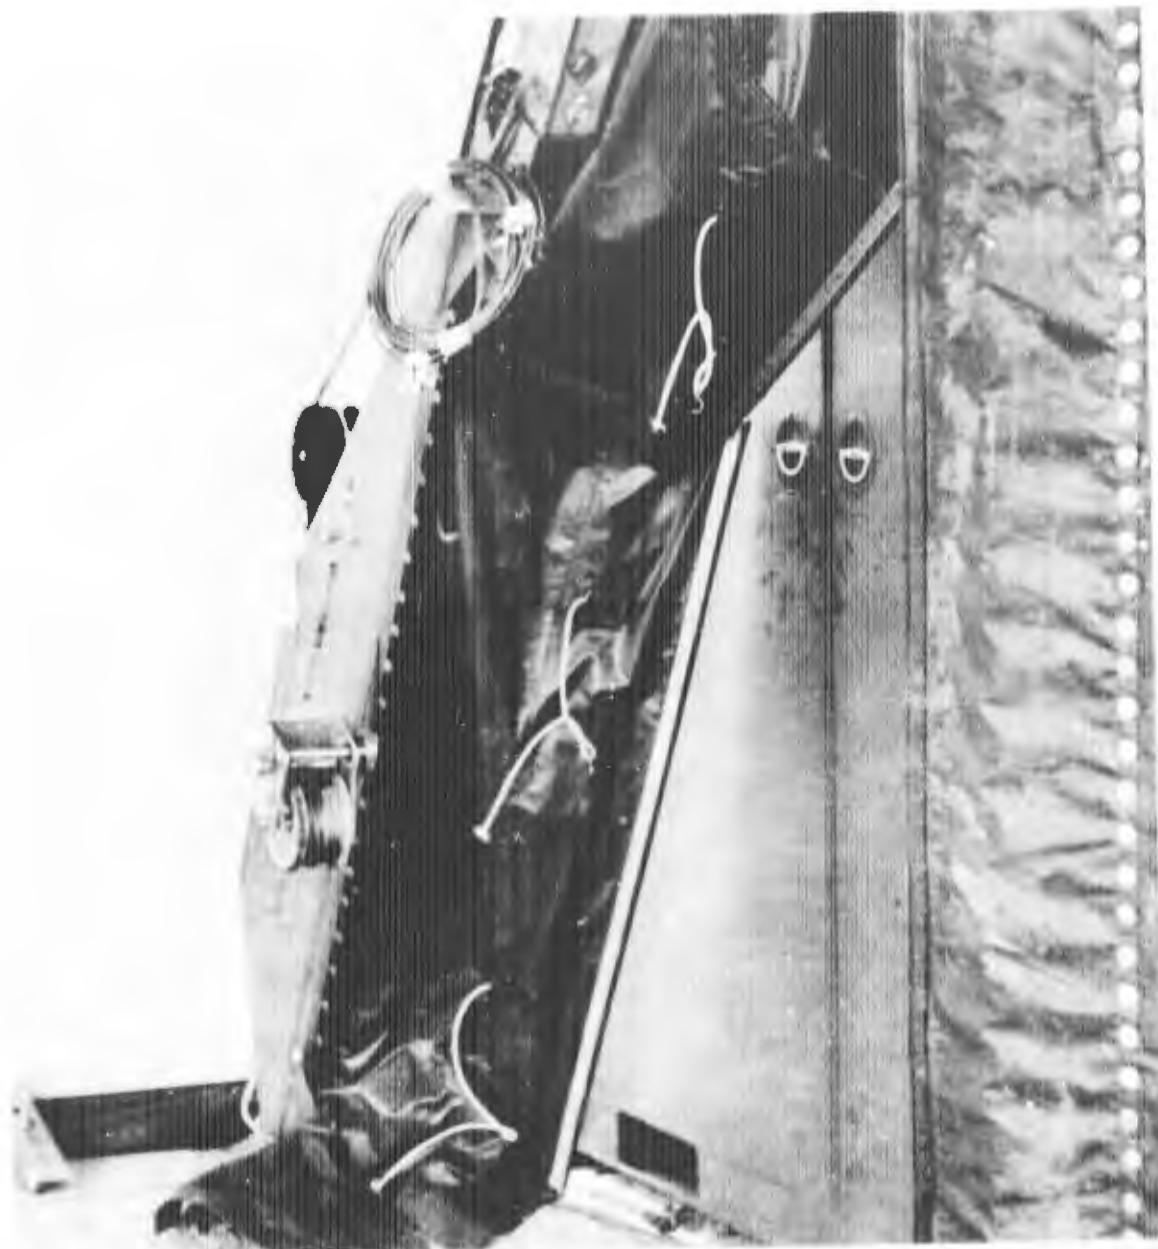
Figure 40 Fabric Door Cable Winch, Container Side of Shelter

arch beam to the container. This system was satisfactory but did not provide a total weather-proof shield. Some water did come down between the container and the transition piece. Also during the 7-month period of the test, the base channels spread a little and the door from the container was not able to be fully opened because of the movement. The exact positioning of the container was required in order to open and close the door into the shelter (Figure 40).

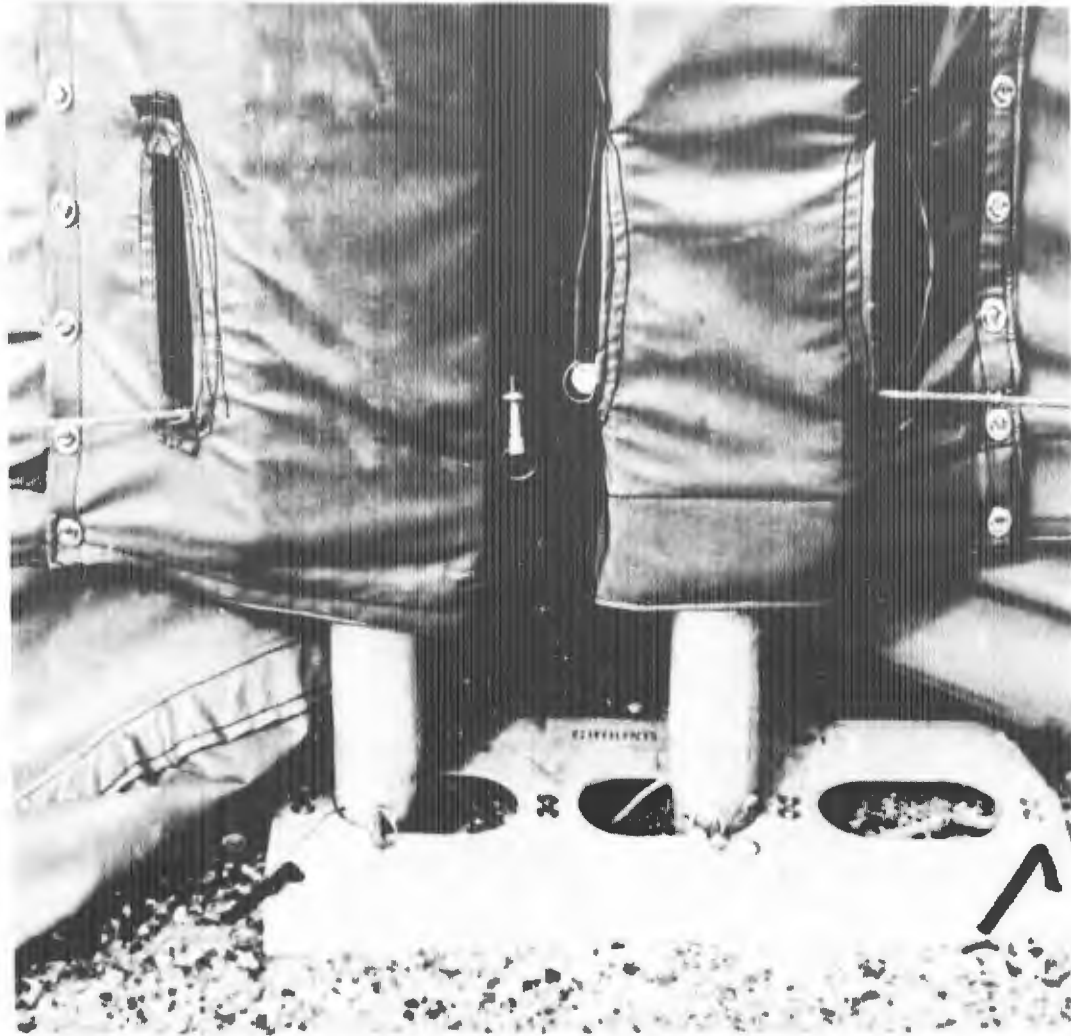
Figure 43 Vertical Beam Telescoping Pipes Attached to Ground Anchor at the Center of Fabric Door

at the uppermost part of the center vertical beams but did not force the bottom of the vertical posts together. The slots that were cut in the ground plate to anchor the vertical posts were elongated holes and allowed the bottom of the door to remain open approximately three inches. This presented a problem during the wind test on the door. If a strap was attached to one side of the center vertical posts, the

doors could have been manually forced together in the closed position and a strap attached between the vertical beams to hold them securely closed. After the initial opening and closing operation, the door was completely cycled ten times to determine an average time for opening and closing and to observe any other problems that might occur. As the opening and closing of the door progressed, the personnel operating the winches became more familiar with its operation and the time improved as the test progressed (Table III). Several problems were noted during this test with reference to the opening cable wearing various components of the door. Figure 44 shows where the cable had worn the slot in the vertical support beam as the door was cycled. The beams were

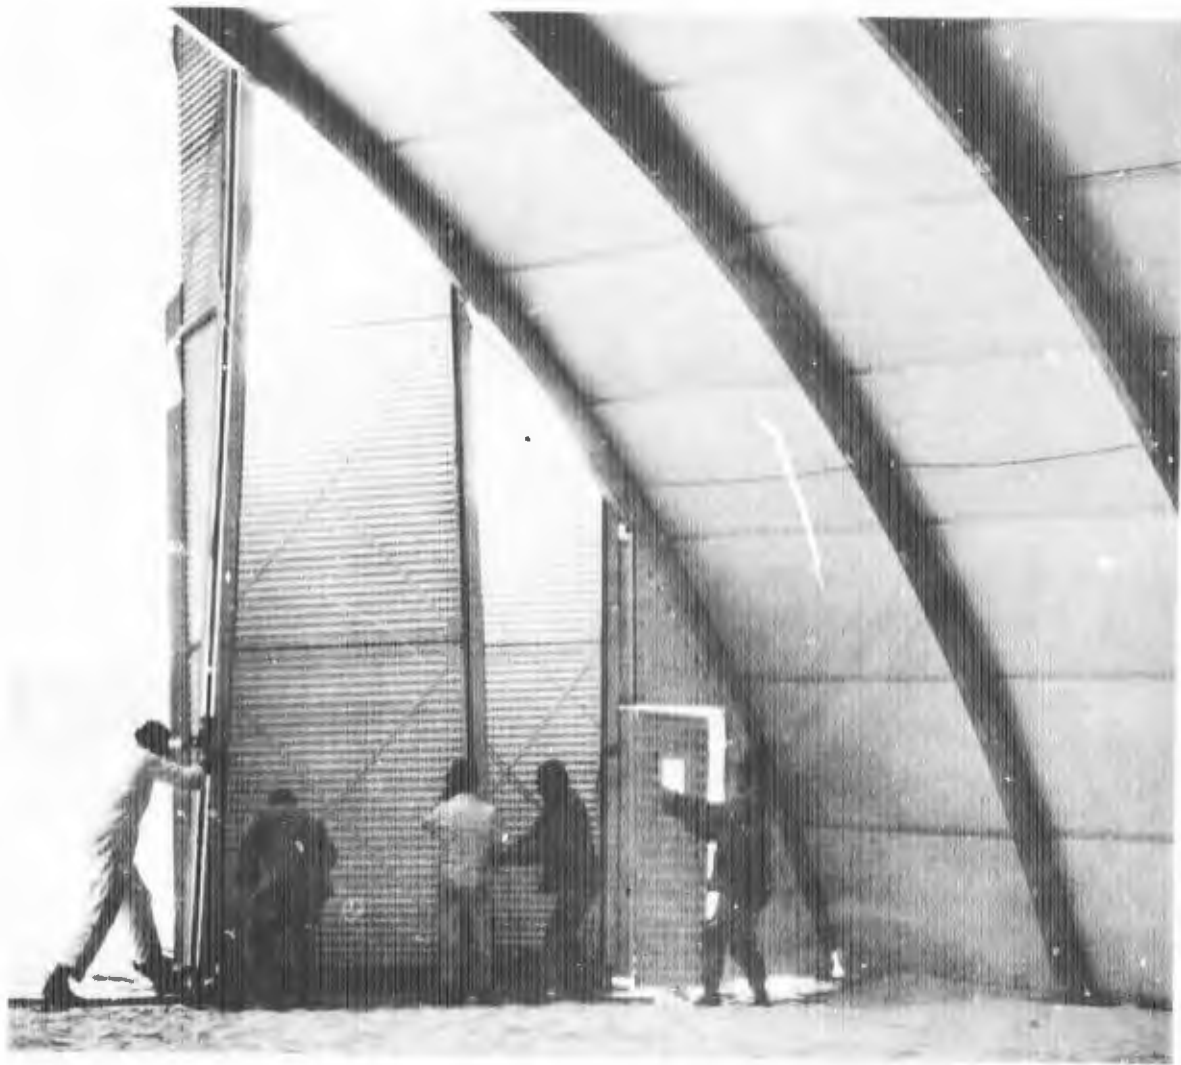
door rides along the ground rail to the outer extremity of the building. To open the door to the full open position, a second keeper pin must be released where the door rides in the upper rail. This allows the center of the two sections to be released from the rail and then the door is folded as shown in Figure 52. Difficulty was experienced moving the door along the upper guide rail because the building was somewhat distorted during the first erection,

Figure 52 Metal Door Being Opened to Full Open Position

due to the ground elevation. This caused the upper trolley rail to be unlevel. As the personnel tried to open the door, it bound in the upper trolley rail. The keeper release ropes were used to pull the upper portion of the door laterally as it rides in the rail and physical force is used at the bottom. Figure 53 shows the vertical beam inside the trolley rail. When the beams started to twist,

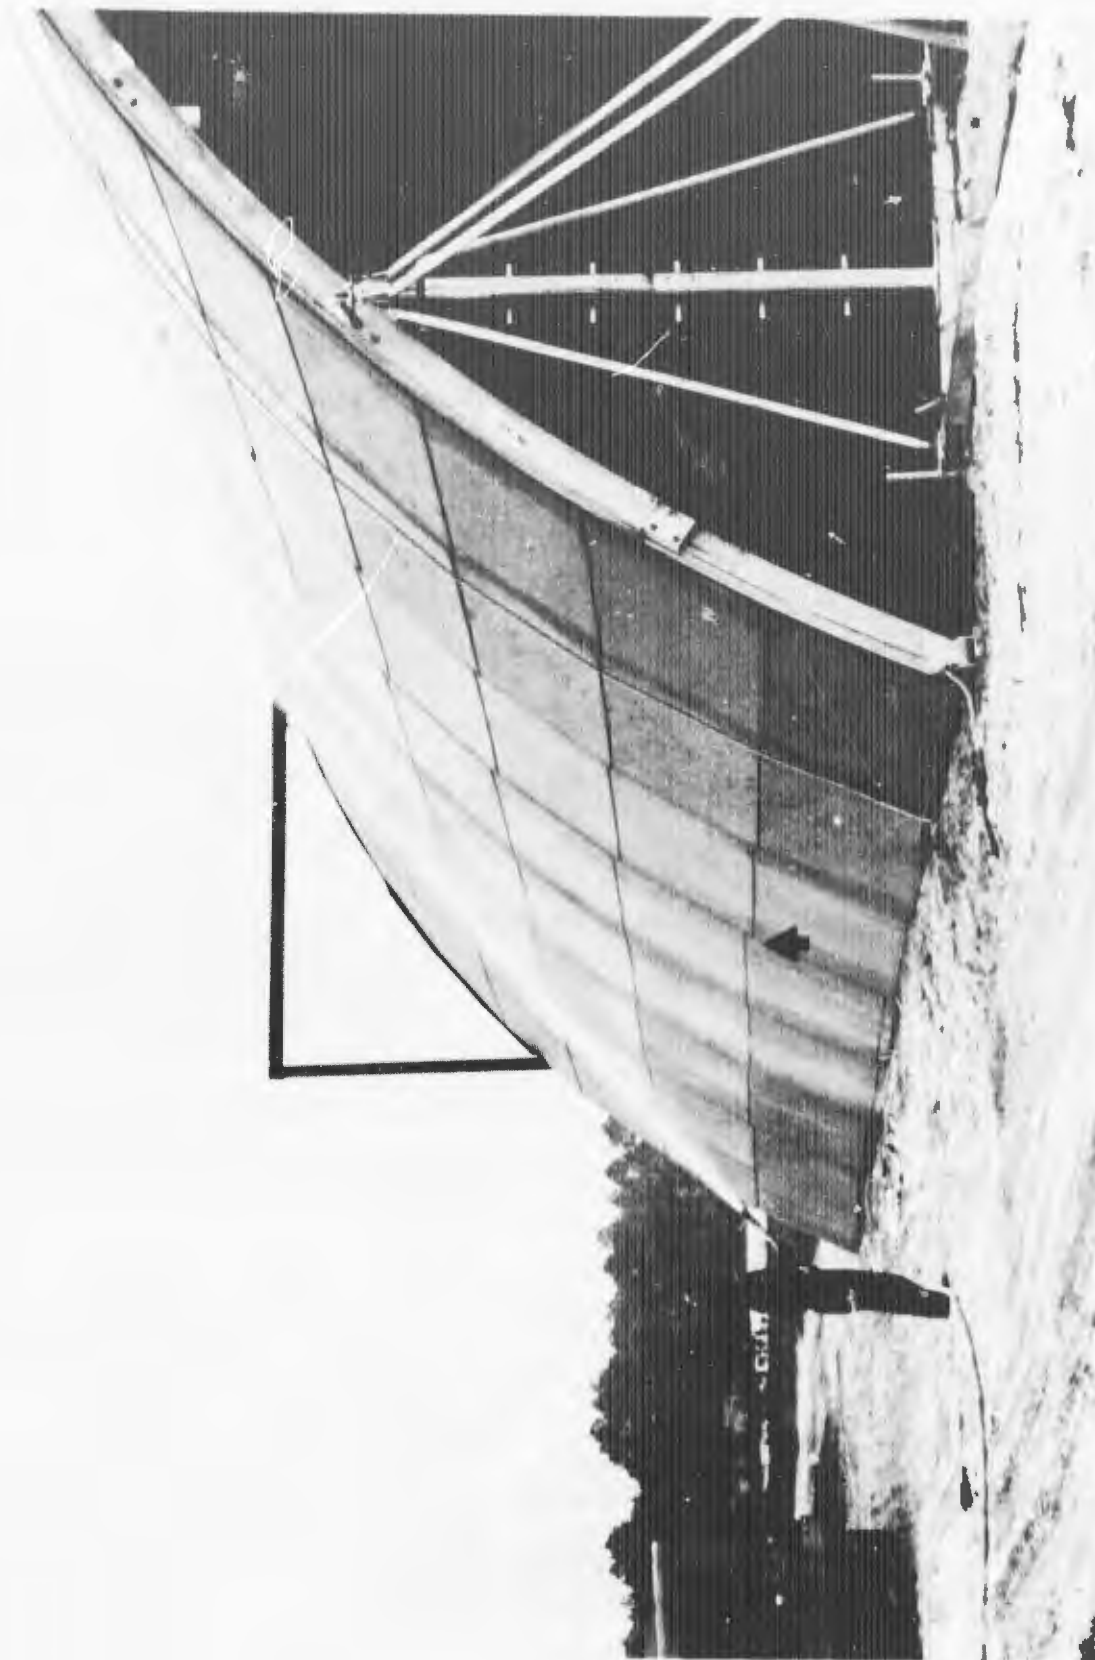
tensioning in the afternoon did decrease this problem. One panel did separate at the panel to panel connection in the middle of the arch, although the ends of the panel were still joined. This, of course, allowed large volume of water to come into the shelter. Figure 61, is a typical example of the water testing that was accomplished on the building. One can observe that the panels are not in a horizontal line along the length of the building. This was due to the different ground elevations of the base rails.

Figure 61 Water Testing on the Shelter

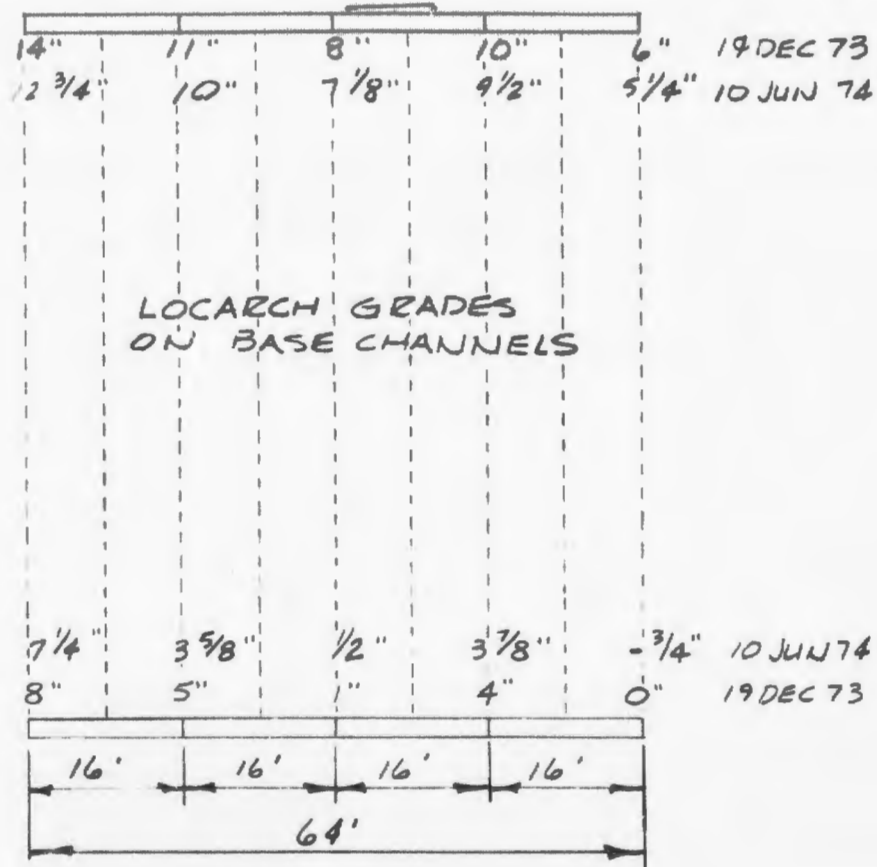
Elevation of the base rails was taken immediately after the first erection and was again taken before the building was disassembled. Winds up to 60 mph were recorded on the wind measuring device from the south, southeast and east. The building did not experience any undue difficulties as a result of these winds. Figure 62 shows the difference in elevations from the first erection to its final position just before disassembly. The base rails spread approximately one inch on an average over the entire length of the shelter. The anchoring cables did show signs of slack since their initial placement, but the building was not damaged and considering the soil conditions, the shelter performed quite well.

Figure 62 Elevations Taken on Base Channels During Six Month Test Period

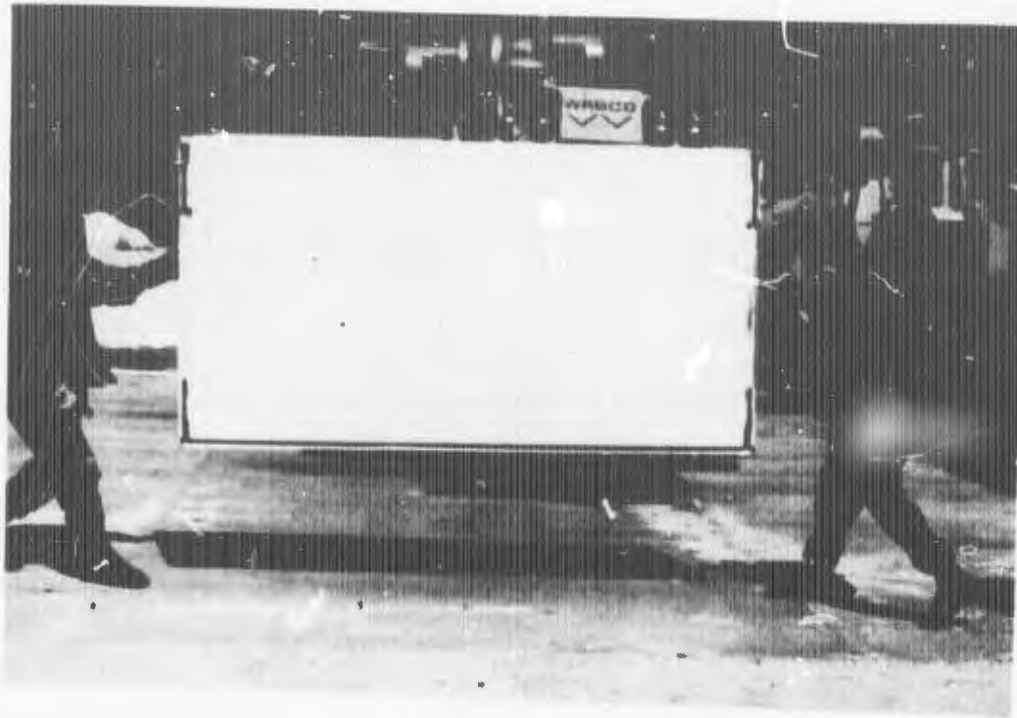
Figure 65 Panel Drop Test at Three Foot Height

in the vertical position for the drop and when it impacted the ground on the edge it fell over on a small rock. The weight of the panel falling on the rock on the concrete surface penetrated the .017 inch thick aluminum skin without any difficulty. This was noticeable throughout the test phase of dropping panels on the concrete. A surface puncture such as this would allow the water to migrate inside the panel and render it useless in a short time. If the panels were handled carefully through the erection process, no damage resulted. Under field conditions, one can assume somewhat rougher handling than the panels experienced during the test. The thin aluminum skin, the edge members and panel inserts would most likely undergo a great deal of damage during the life of a shelter.

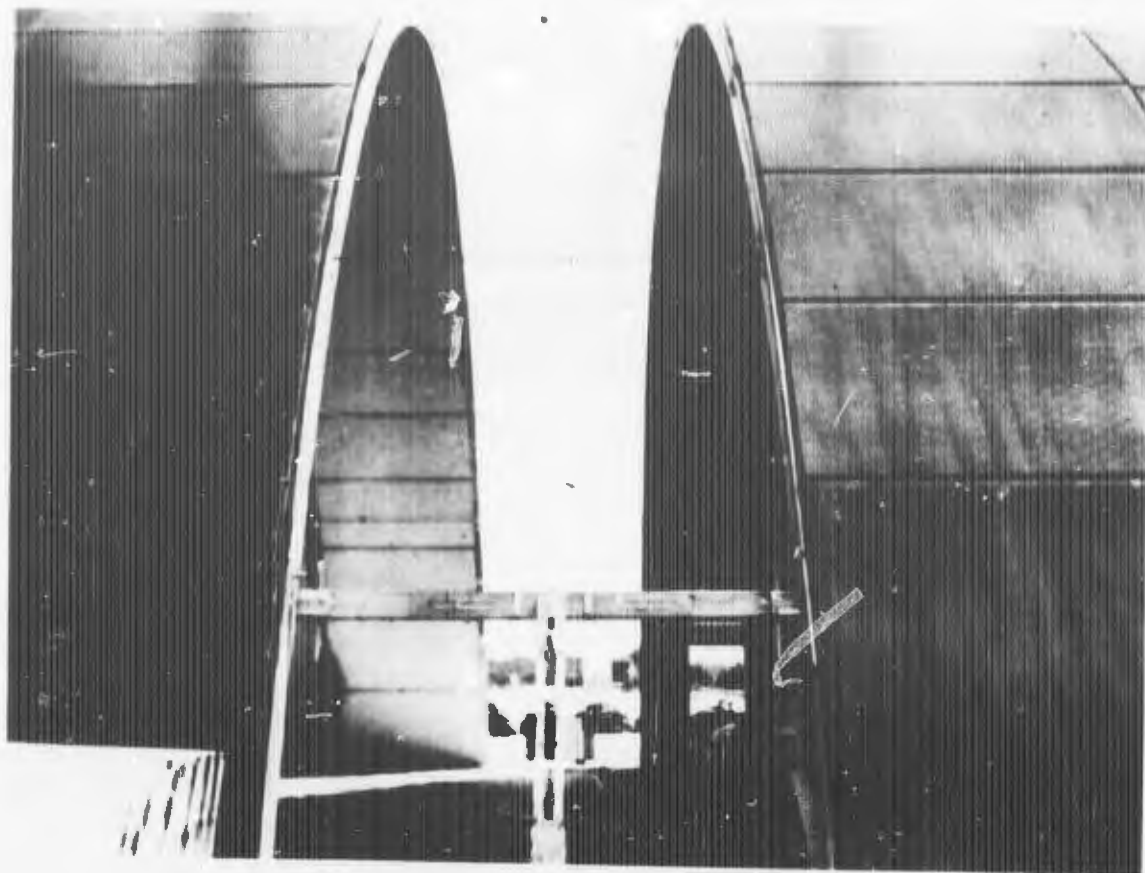
The time required to remove the panels was 6 manhours, approximately the same time it took to install the panels in the arch, at that point (Figure 70). The removal of the panels was accomplished without

Figure 70 Panels Removed Between Fourth and Fifth Arch Beam

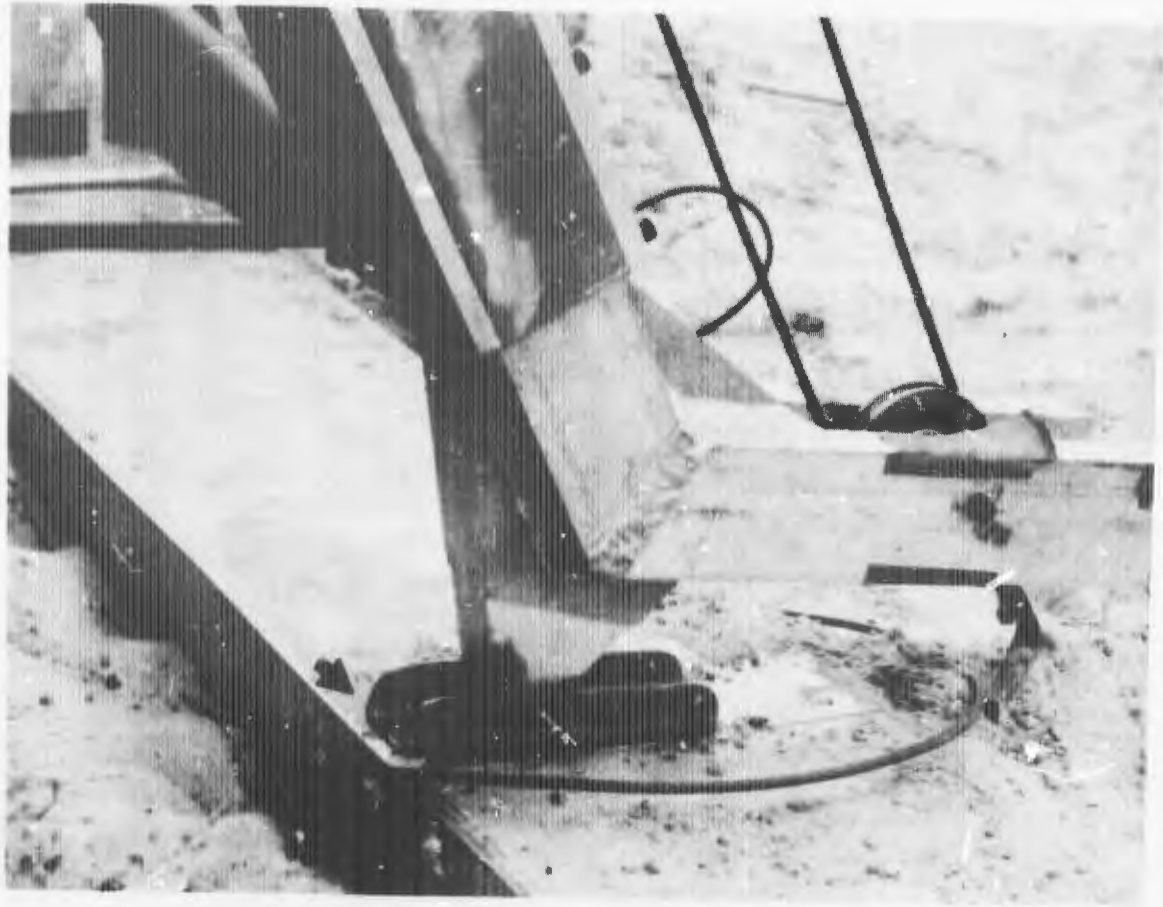
much difficulty with the exception that the foot of the T-bar installation winch kept jumping off of the bolts that were prepositioned on the base channel. This problem had not been encountered before during the installation because the force exerted through the winch pushed the panels upward and forced the foot down onto the base channel. In removing the panels, the force was reversed and tension was exerted in the cable to pull the panels out of the arch beam, and creating a lifting action to pull the foot off the base channel. This was easily corrected by installing bolts that could be tightened down to

Figure 71 Base Attachment Raised During Panel Removal

hold the foot securely on the base channel (Figure 71). After all the panels were removed, it was observed that there was no appreciable damage but there was a build up of sand in the panel inserts that rode over the arch beam tracks. The sand was mixed with the silicone lubricant and had become almost a greasy paste-like substance. These deposits apparently built up over a 3 month period, since the time that the building was first erected (Figure 72).

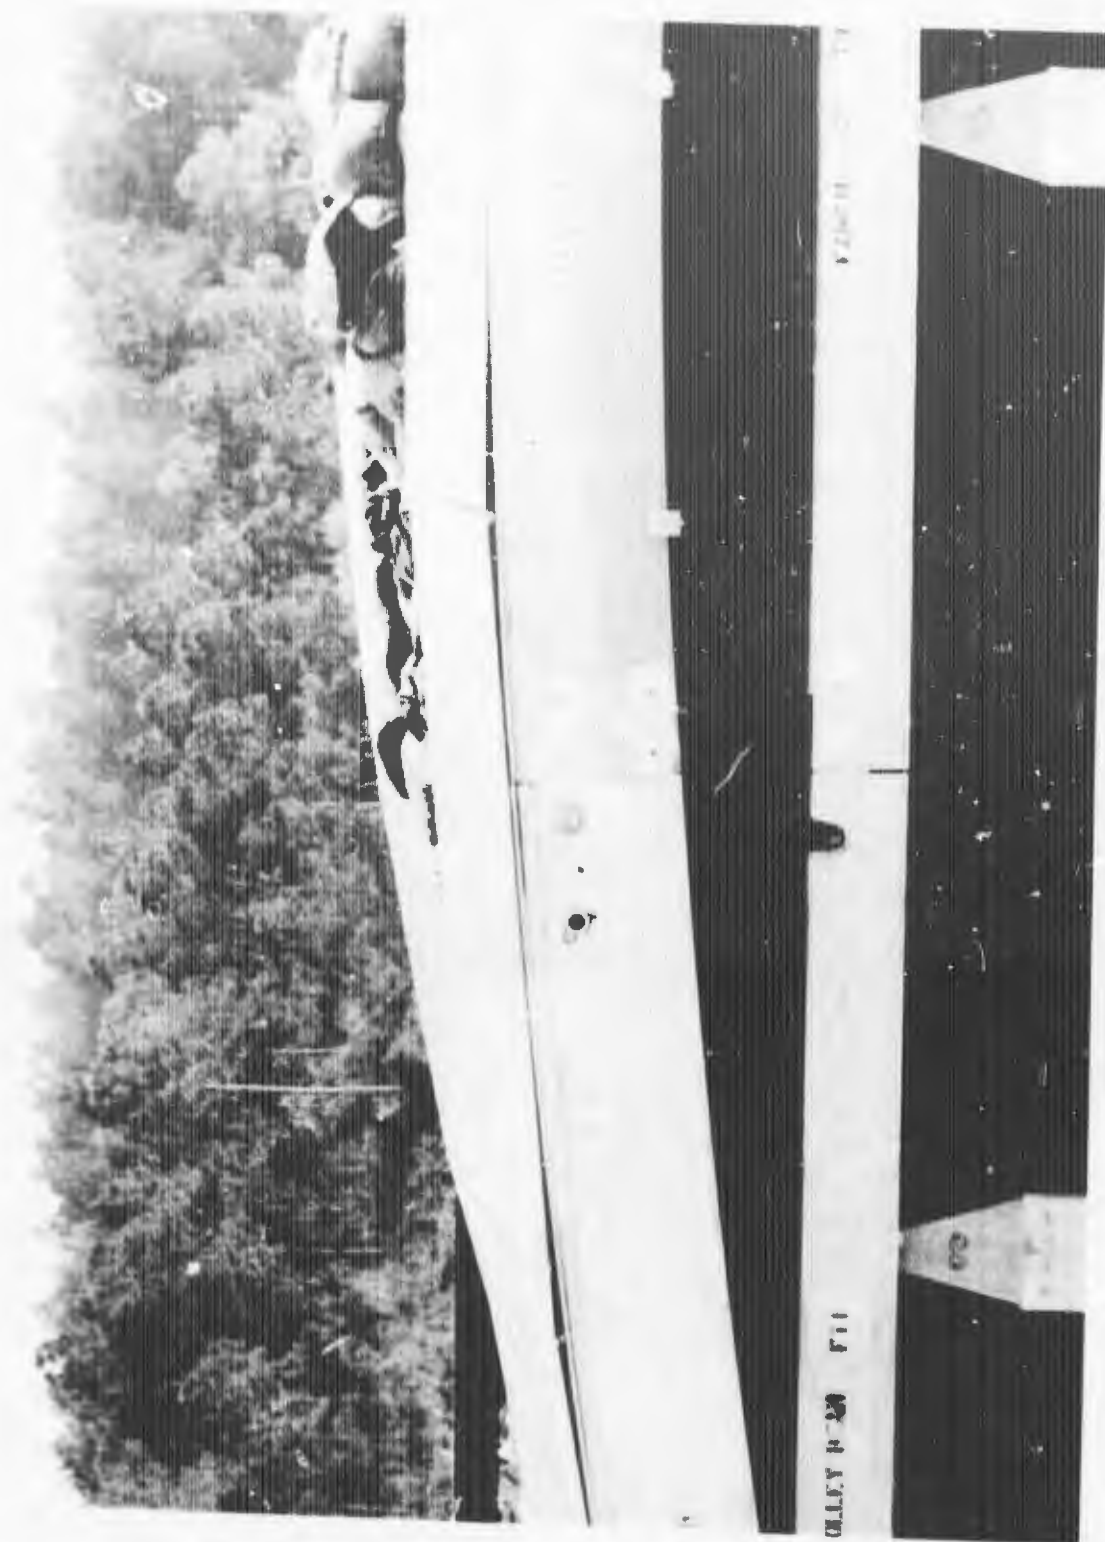
Figure 78 View From Fabric Door End of the Shelter With Sandbag Load

an end view of the shelter illustrating how the test area deflected. The top of the second layer of sandbags was almost level with the elevation of the panel at the end of the shelter.

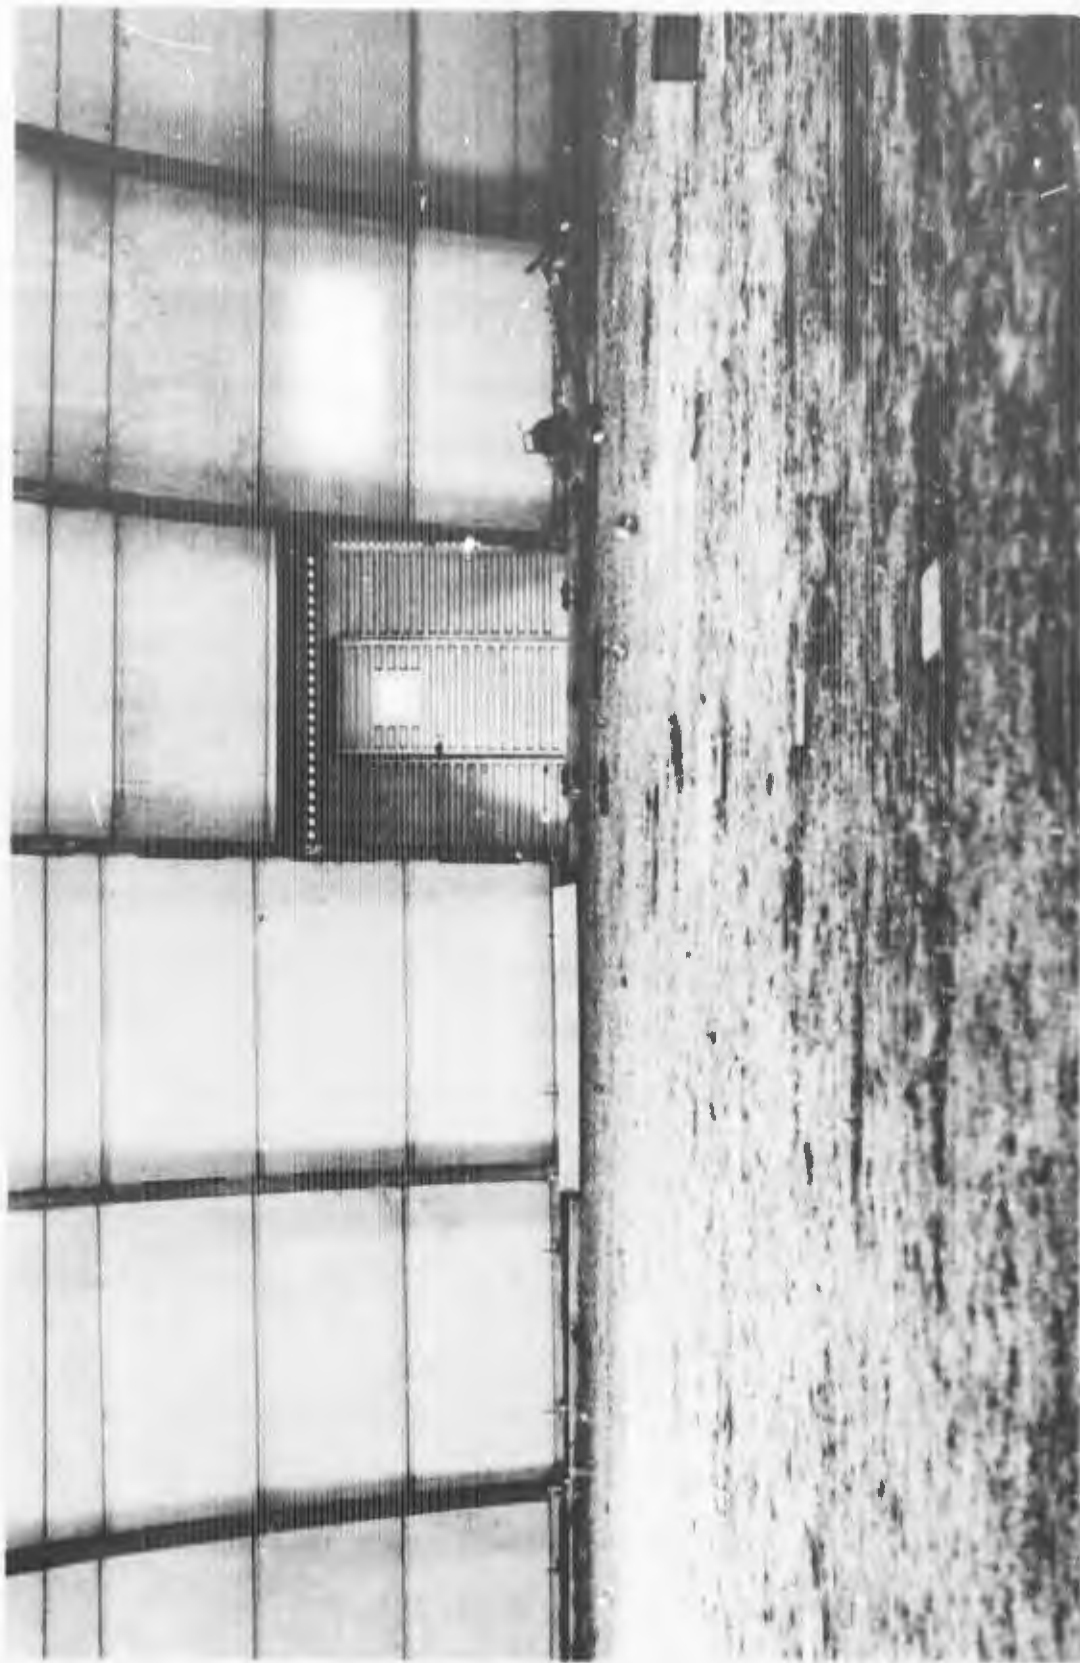
Figure 86 Overall View of Data Collection Points and Deflection
Across the Arch Beams

increasing the load on the building. After the rain had subsided measurements were again taken to observe if any additional deflection had occurred. Figure 86 shows how the data collection points were located and the deflection that occurred in the building. Immediately after the measurements were taken with the saturated sandbags, the building was unloaded and measurements taken again to record the deflection that remained in the shelter. Table VIII is a summary of all the deflections that were measured during the test. Visual observation indicated that there was no permanent damage to any of the components of the shelter. The center arch beam did not undergo the deflections as in the previous test. Only a fractional amount of separation at the center joint could be observed. The erection pins remained in the round shape in all the arches. Only one panel separated at the panel-to-panel joint, whereas in the previous test four panels separated.

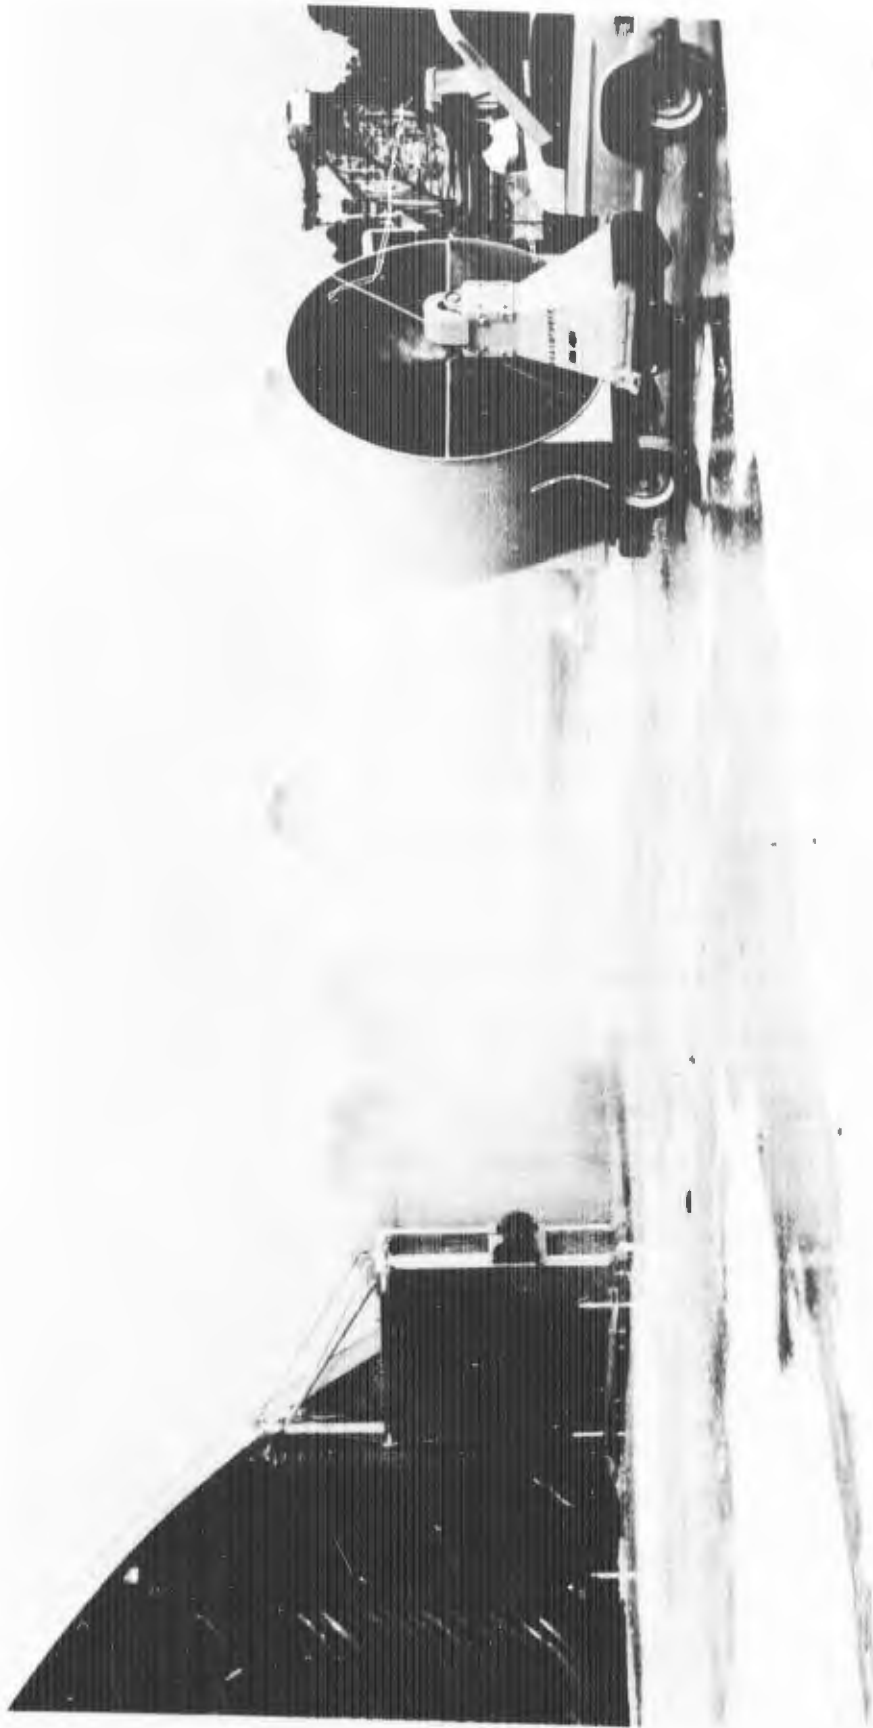
Figure 87 shows the wind machine in operation while testing the container for water tightness. Some leakage was observed at the center rib joint of the front door and also at the left door where the erection winch was attached. As the wind machine was allowed to run, some water accumulated inside the container and began blowing back into the interior of the shelter. The rear door to the container was left open during the test to record observations inside the container.

Figure 87 Wind and Rain Test on Container

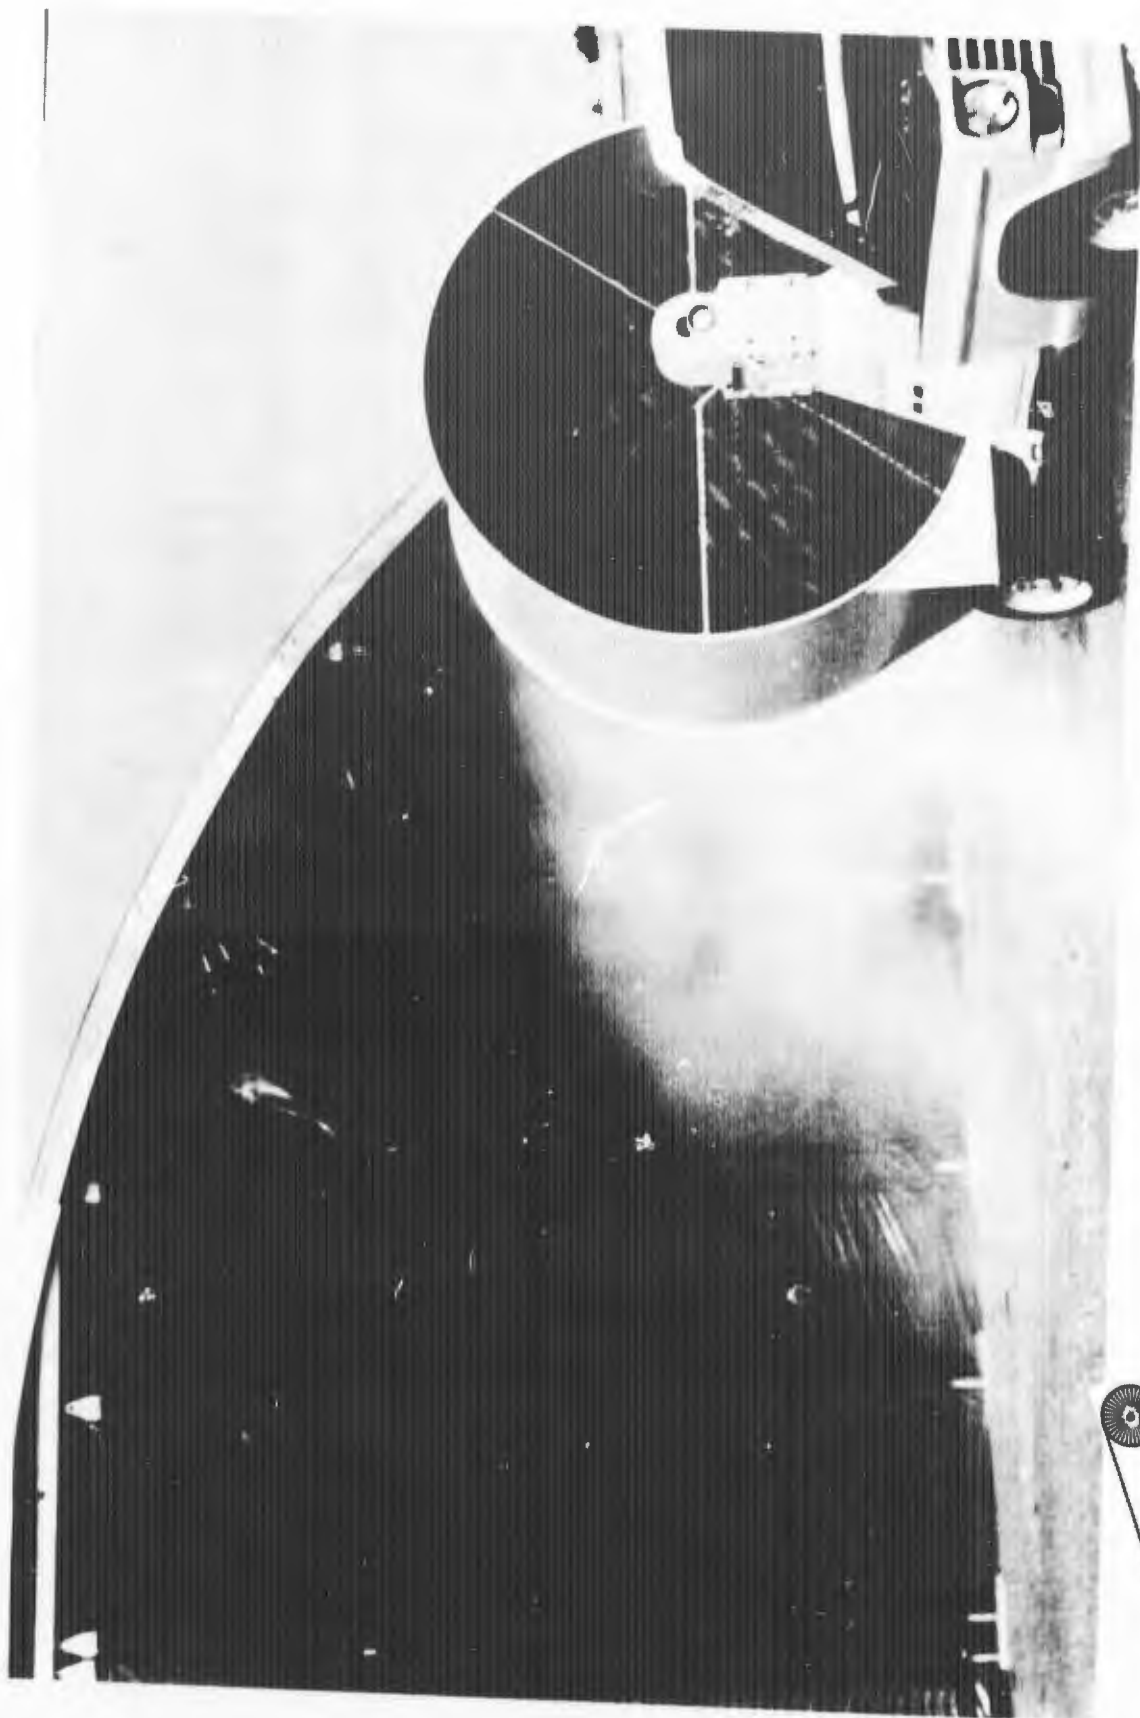
Figure 88 shows the wind machine test on the right side of the fabric door. The machine was positioned approximately 30 ft from the door when the photograph was taken. Most of the force was directed against the lower portion of the door at this point, so the wind machine was pulled another 25 ft away from the shelter in an attempt to provide coverage for half of the door. During this test phase the ground skirt was configured in two ways; first as in Figure 88, with the ground skirt pulled inside the building and sandbagged; and second with the ground skirt pulled outside the building and sandbagged. No water leakage was observed through the fabric or around any of the connection points except at the base of the door. The force of the wind and the volume of water immediately adjacent to the vertical posts where they were anchored in the ground, caused the ground skirt to be blown back somewhat and water entered freely. This was a direct horizontal exposure which would not normally be experienced. Figure 89 is a photograph from the inside of the shelter in the area where the sandbags were on the outside of the shelter to hold down the ground skirt. Water is seen to be pooling at the base of the door but the ground skirt sandbagged on the outside kept water from blowing directly into the shelter.

Figure 88 Wind and Rain Test on the Fabric Door
