LOCARCH SHELTER

AFCEC-TR-75-7

Final Report For Period December 1973 to August 1974

| REPORT DOCUMENTATION PAGE | | READ INSTRUCTIONS BEFORE COMPLETING FORM | |
|---|---|--|--|
| 20. ABSTRACT (Continue on reverse side if necessary and identify by block number) The report describes the erection, field testing and disassembly of the LocArch air transportable aircraft shelter, manufactured by the Lockheed Georgia Co. Marietta, GA. The outcome of the shelter evaluation revealed the design concept to be basically sound but deficiencies existed in the arch panels and the end closures. An in depth analysis of the shelter components was conducted during the test program. The entire shelter system was subjected to simulated environmental tests to evaluate its performance for possible world wide use. | | | |

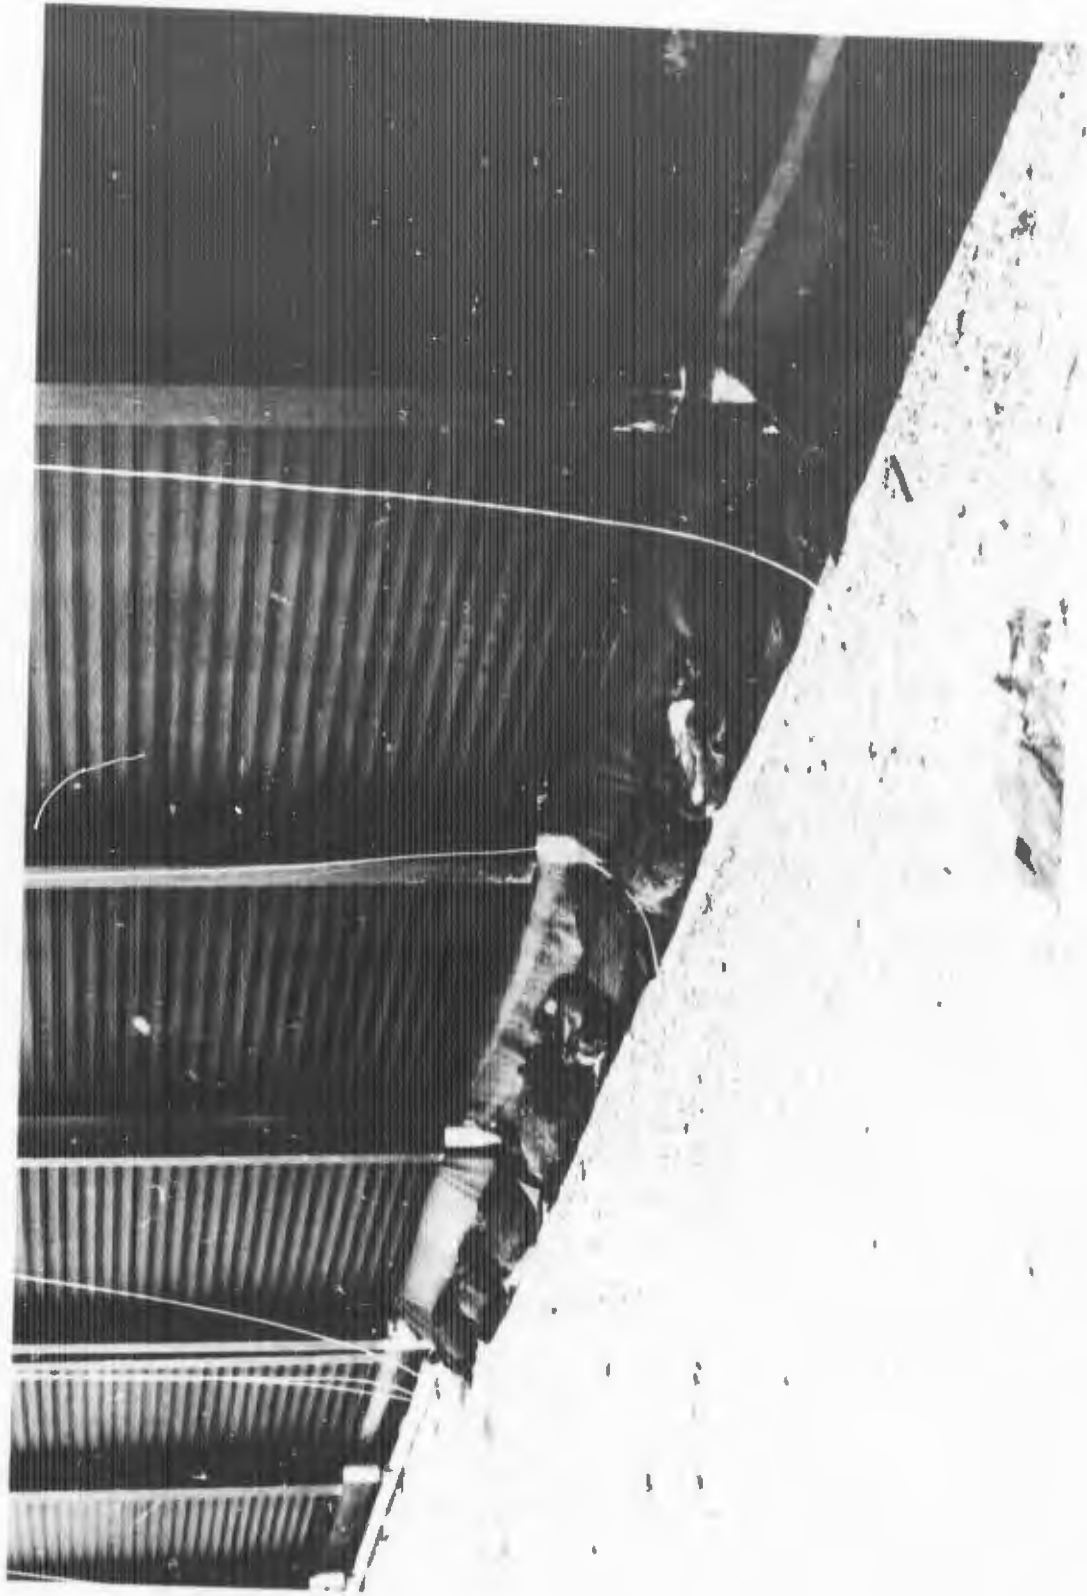
The last component of the building to be subjected to the rain test was the metal end wall. Figure 93 shows the sandbag arrangement for both sides of the door. The area immediately around the vertical posts where they anchor to the ground have openings which would allow the passage of water. On the left hand door with the sandbags inside the shelter the configuration appeared better. The areas at the vertical posts could be sandbagged from the inside. Figure 94 shows the wind machine in operation against the metal end wall. The ropes being blown around are the ropes used for opening and closing the door. In an actual situation they would be secured but during the test they were left to blow freely to see the effect on the door. The area that had the sandbags placed on the inside of the shelter was subject to most of the leakage. When the wind caught the ground skirt, it blew the sandbags

Figure 93 Metal Doors with Sandbags on Ground Skirt Prior to Wind/Water Test
