TYNDALL AFB BOMB DAMAGE REPAIR FIELD TEST, DOCUMENTATION AND ANALYSIS

Lawrence D. Hokanson, Capt, USAF
Air Force Weapons Laboratory

October 1975

Final Report

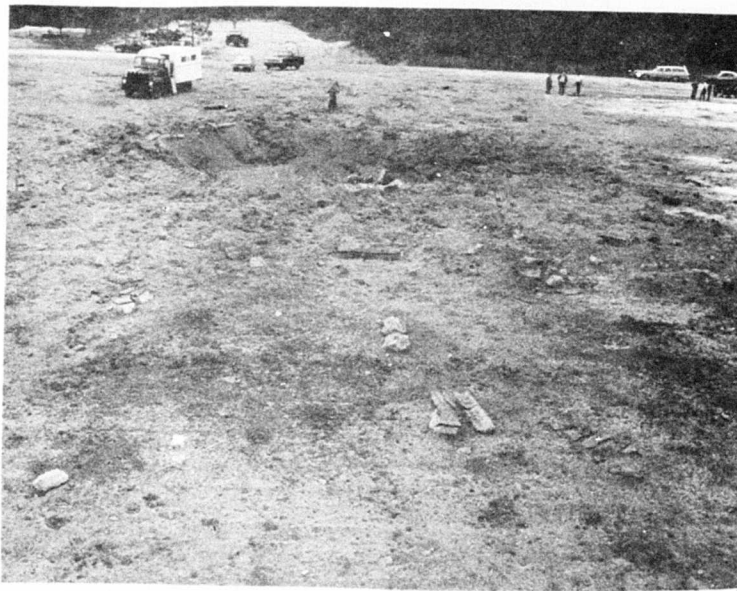
Because of the spread of the ejecta, the ejecta judged as suitable for backfilling by the BDR team was less than the crater volume. Figure 8 shows the ejecta spread in Test 1-2, which was similar to Test 1-1. Extra material was obtained from the shoulder area of the runway and by utilizing coarse aggregate that had been stockpiled for another test. It became evident that the amount of ejecta may not be sufficient to fill the crater

Figure 8. Crater Created by M117 Weapon for Test 1-2, Crater is Similar to Crater Utilized for Test 1-1

if large pavement chunks are discarded. A possible solution is the careful analysis of material on the runway shoulder and inclusion in the base contingency plan of the location of shoulder material suitable for backfilling. Shoulder areas also can be used as stockpile areas for acceptable backfill materials of low value at bases where the ejecta itself may not be suitable. As an example, sand shoulders could serve as stockpiles for locations where a high water table with a highly plastic saturated clay material would preclude using the ejecta as backfill.

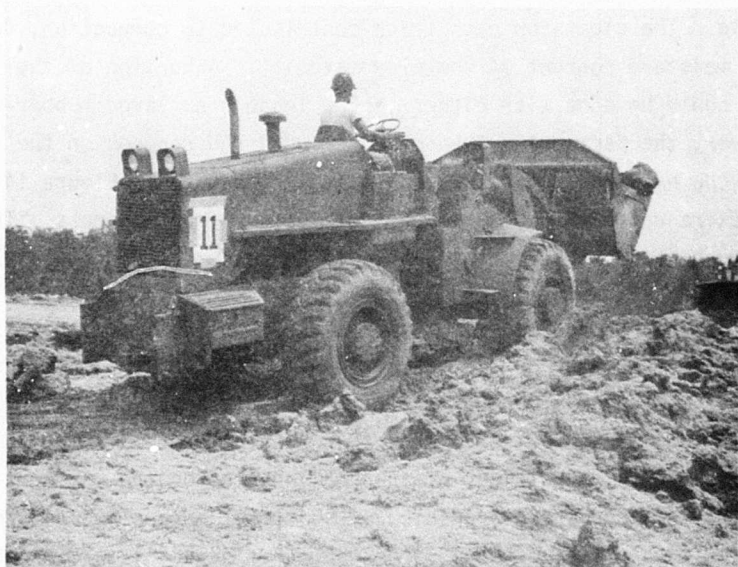
Figure 12. Test 1-1, AC 645 Loader Forced to Lift and Drop Debris into Crater

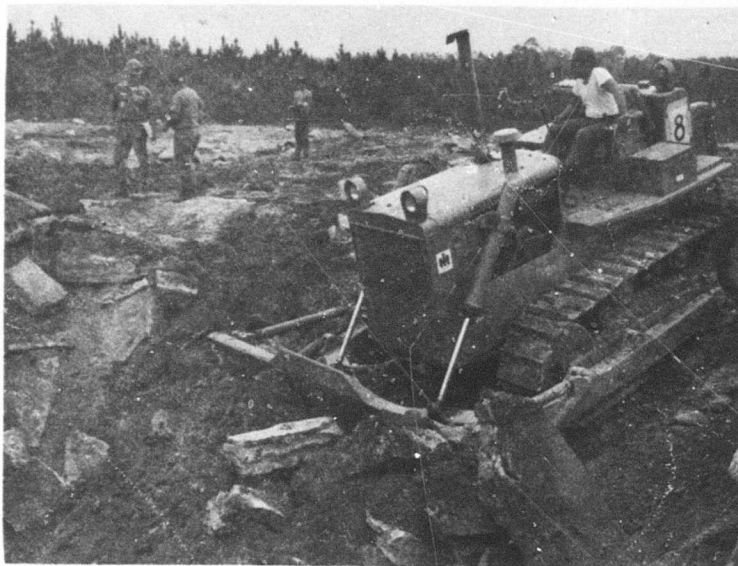
This item proved to be the most versatile and useful piece of equipment in the test. Its capability to push large amounts of debris into the crater and to "walk" into the crater to compact material was excellent (figure 13). However, the large tread size made the actual compactive effort smaller than desirable. The cleats on each track contributed to compaction, due to the near optimum moisture content of the clay material. A portion of the job done by this item could be done with either larger loaders or large rubber-tired dozers; however, the particular type of dozer required depends on the subgrade condition at the base where the BDR capability is required. Figure 14 demonstrates the extra capability of a large dozer versus front loaders. The left side of the crater was worked on by two to three loaders, while only the TD-20 dozer had worked on the right side.

Figure 13. Test 1-1, TD 20 Full Tracked Dozer Pushing Large Debris Directly into Crater

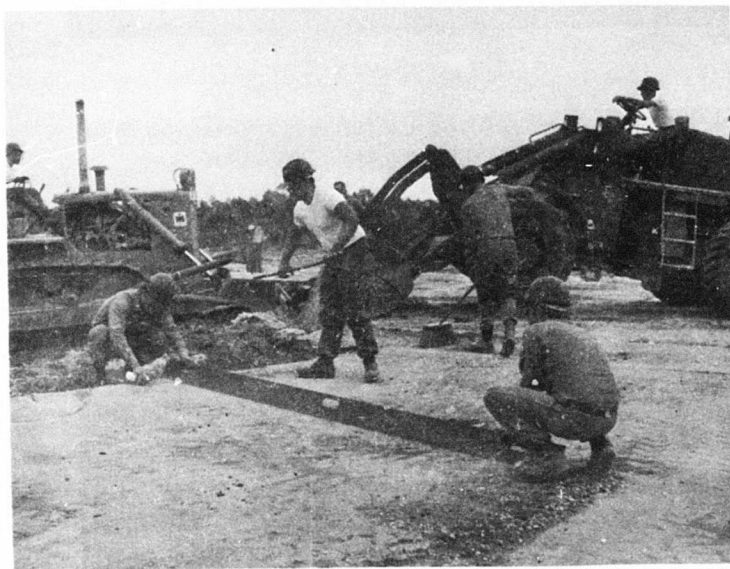
This was the most time consuming and complex problem faced in this exercise. The broken and badly upheaved concrete was readily and easily pushed into the crater early in the repair by the dozer. However, once the obviously damaged material was pushed in, the equipment operators did not recognize the further upheaved areas that required removal. This problem was aggravated by the inability of the OIC to check for upheaval until the pavement had been thoroughly cleared of ejecta, and this came late in the backfill process (1351, figure 16).

Figure 16. Test 1-1, Identifying Subtly Upheaved Pavement with Specified Straight Edge

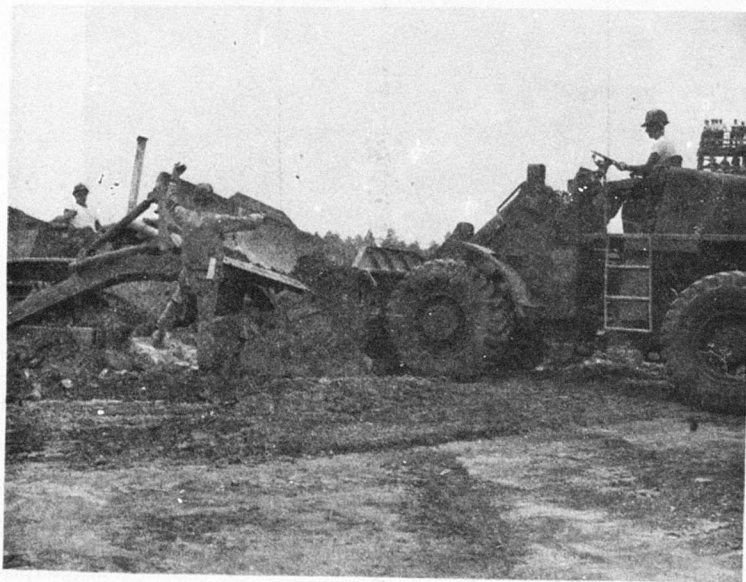
Once the pavement to be removed was identified, a time-consuming process of lifting the pavement out with a dozer or loader blade (figure 17) and then loading the debris into a loader bucket began (figure 18). The equipment in the package is not suitable for this use. Since the overlay of asphaltic concrete physically hides the joints in the pavement, it is extremely difficult to find a point at which the concrete can be broken for removal.

Figure 18. Test 1-1, TD 20 Inside Crater Aiding AC 645 in Removing Large Upheaved Pavement Sections

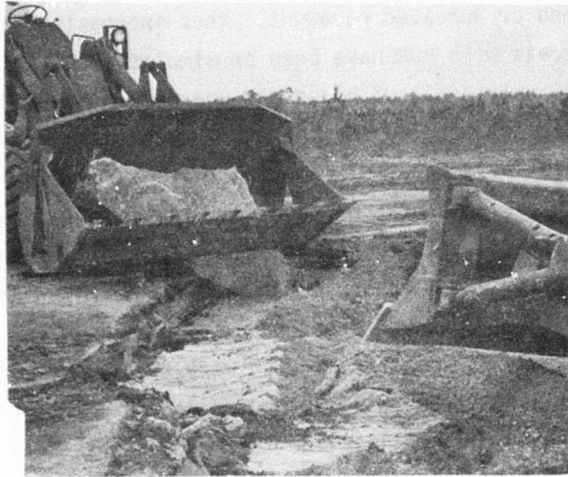
Figure 19. Test 1-1, AC 645 Attempting to Remove Broken and Upheaved Pavement Sections with 4-in-1 Bucket

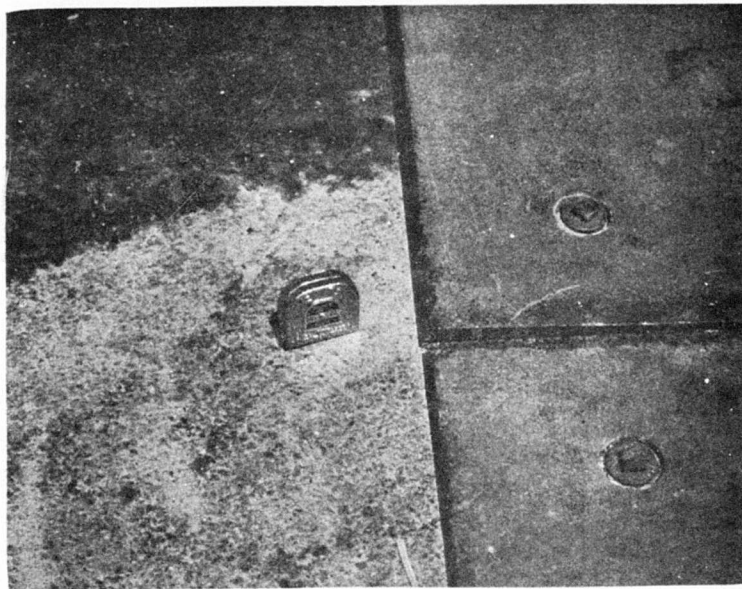
Problems were encountered in the placement of the ramps due to the crown on the pavement section. The ramp was not designed to be able to follow breaks in slope or vertical curves. Figure 23 shows a 1/4-inch height differential between adjoining ramp sections. A redesign of this may be a requirement, although the latest ramp design was not tested.

Figure 23. Test 1-1, Mismatch of AM-2 Airfield Patch Ramp Sections Due to Crown in Runway

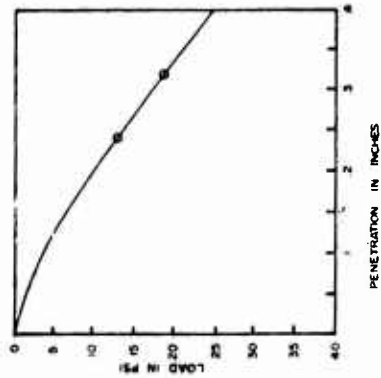
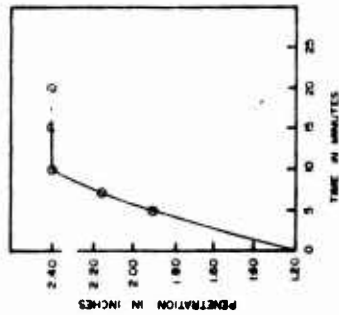
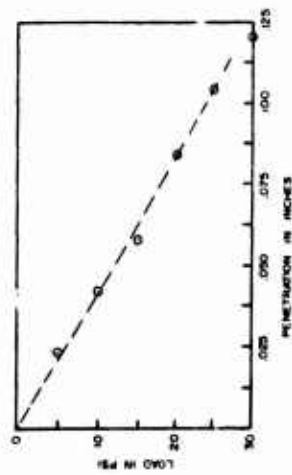
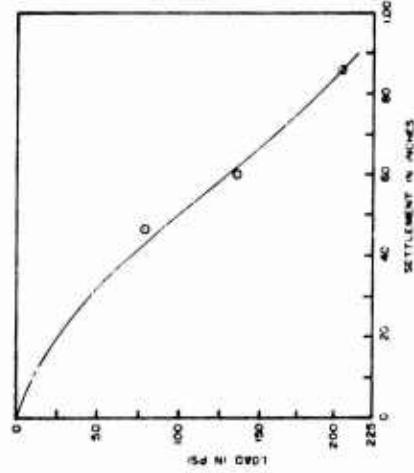
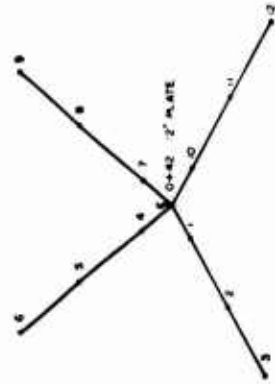
Figure 25. Test 1-1, Plate Loading Deflection and Penetration Curves

NOTE: WHEN CENTER OF AM-2 IS LOADED, EDGES BREAKS CONTACT WITH BASE COURSE

This load testing was conducted to provide parameter input for the NCEL code as well as to evaluate the acceptability of the compaction gained by the AFM 93-2 BDR technique. The performance of this material was very poor, with a stiffness value, K_u , of 54 PCI. The load versus penetration curve is shown in figure 25A. This testing, as was testing of the subgrade, was performed with a 30-inch diameter plate. Laboratory testing of the material showed the optimum density to be 136.3 PCF with a moisture content of 12.1 percent. However, a density of 143.1 to 150 PCF was easily reached when the material was used in the construction of the test site. The material placed in the repair had a density of 132.8 PCF with a moisture content of only 1.4 percent. Some of the poor performance could be attributed to the accidental use of a uniform aggregate by the BDR team; however, most of the deficiency is attributed to a lack of the proper equipment for compaction and the lack of moisture in the material.

50,000 pounds on the plate, thus simulating the high tire pressure of the F-4E aircraft and the total gross gear load of the F-111A aircraft. Figure 25D depicts the load-settlement curve, and demonstrates that nearly a 0.1-foot settlement was generated by a 220-PSI, 25,000-pound total, loading. This loading is less than the PSI loading of the F-4E aircraft (265 PSI) and the total one gear loading (47,000) of the F-11A aircraft as shown in reference 20.

(b) Figure 25E shows the deflection basin formed by the loaded plate. As can be seen, the AM-2 mat lifted off the base course at points surrounding the load due to the extreme deflection under the load plate.

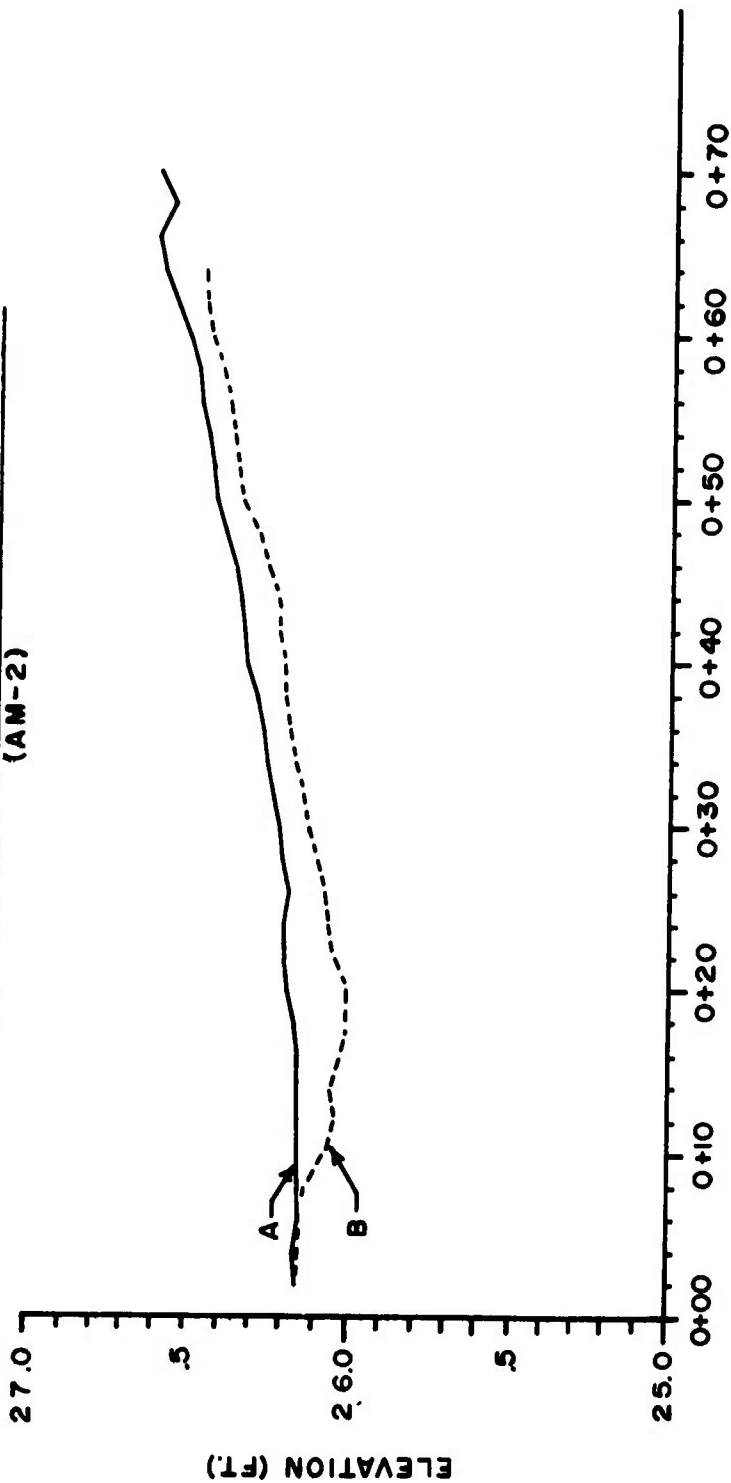
Further testing was done with an F-4 load cart, shown being loaded in figure 28, with a main gear load of 29,000 pounds, exceeding the F-4E aircraft (one gear weight of 27,000 pounds) by 7 percent. Elevations were taken at 2-foot intervals on the mat at three different times as shown in figure 29. These points coincided approximately with the middle of each 2-foot mat section.

Figure 29. Test 1-1, Deflections of AM-2 Airfield Patch Surface
Resulting from F-4 Load Cart Trafficking

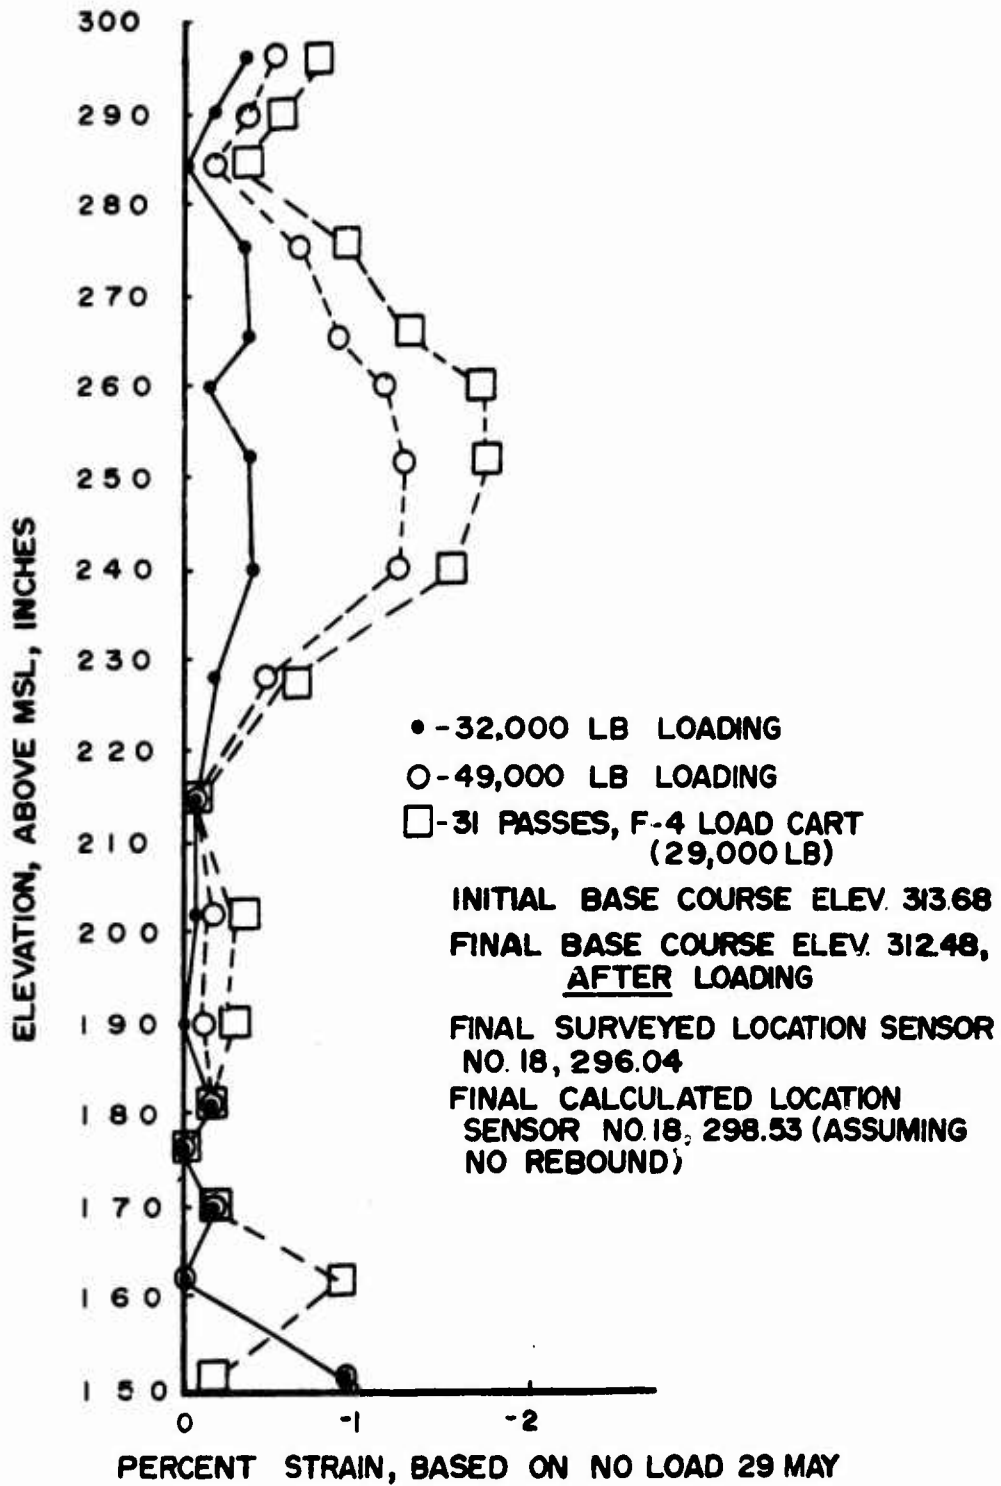
Figure 43, Test 1-2, Loading Strains

The most valuable information gained from Test 1-2 is shown in figure 43. The distribution of the load through the base course and backfill reached a point where rapid consolidation due to short term loading no longer constituted a BDR problem. In particular, it is seen that the influence of loading is minimal below a depth of about 7 feet. If a homogeneous condition could be assumed to exist following the saturation induced consolidation, the conclusion is that maximum consolidation for this 93-2 type repair occurs between 2.5 and 5 feet beneath the surface of the base course material. This leads to the conclusion that one can ignore extensive time consuming compaction on material deeper than 5 to 6 feet below the surface. Maximum compactive effort should be given to material less than 6 feet deep.

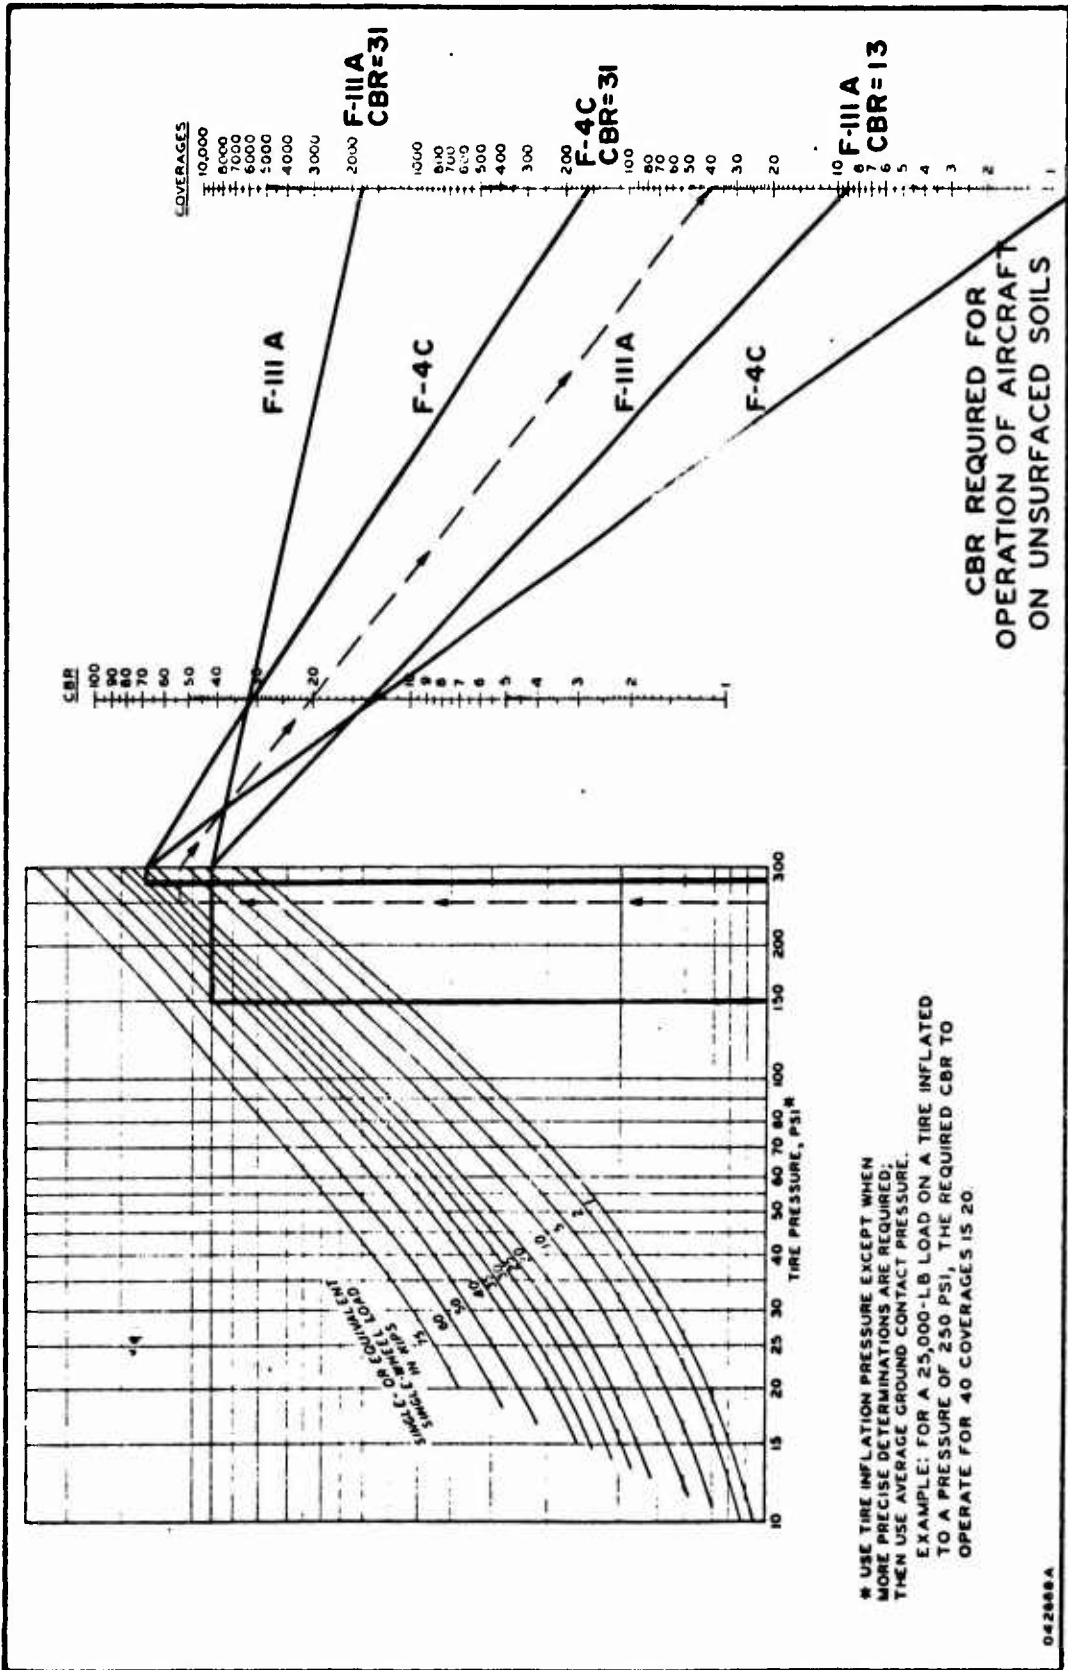
The second observation is based on reference 26. The CBR rating of the compacted debris was 13. Figure 45 indicates that the debris subgrade was incapable of being utilized to launch F-4C type aircraft. Had the debris been brought up to the surface level of the runway, figure 45 indicates that it could have been used for up to 9 coverages by F-111A type aircraft without benefit of a capping material. The base course, with a CBR of 31 would have been capable of sustaining 160 coverages of F-4C type aircraft or 1,800 coverages by F-111A type aircraft. Load cart testing of the base course without the AM-2 surfacing was not attempted. Reference 2 indicates that a lengthy method of repair not utilizing AM-2 or other surfacing is acceptable. The above indicates that under the proper conditions consideration can be given to deletion of the AM-2 matting if the timely completion of aircraft mission requirements is in question.

Figure 45. Test 1-2, CBR Requirements for Operation of Aircraft on Unsurfaced Repairs, after Reference 2.

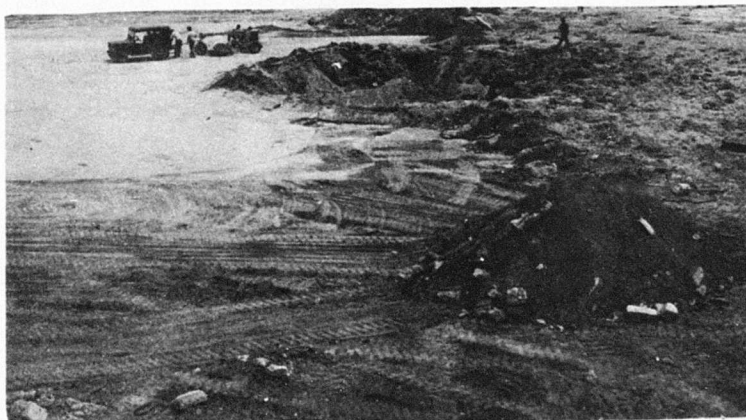
During Test 1-1 it was noted that a primary cause of the excess repair time was the slow removal of heaved pavement. As was discussed earlier, it was noted that the equipment currently in the AFM 93-2 BDR package did not have enough power and/or weight to push the debris directly into the crater and therefore left a lip of debris at the crater edge which hindered progress and caused extra movements of equipment. Figures 46 A, B, and C display the upheaval following removal of fall back and ejecta. In figures 46A and 46C, stockpiled debris to be used in the backfill operation can be seen. Figure 46C shows the break point between the dramatically upheaved, but easily removed, pavement on the crater lip and the more subtly upheaved pavement that can extend 10 to 15 feet beyond the breakpoint.

Figure 46A. Test 1-2, Upheaved Pavement Cleared of Debris on the Left

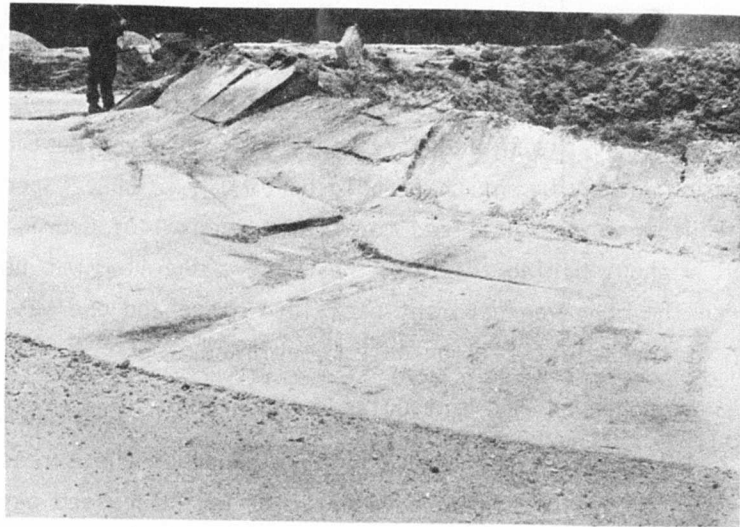
Figure 46B. Test 1-2, Close up of Upheaval

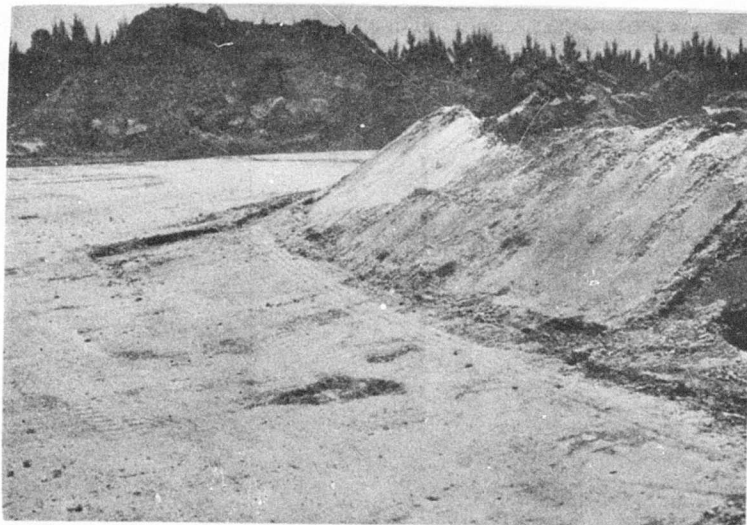
Figure 46C. Test 1-2, Close up of Two Distinct Breaks in Slope, Showing the More Difficult to Identify and Remove Upheaval to the Left

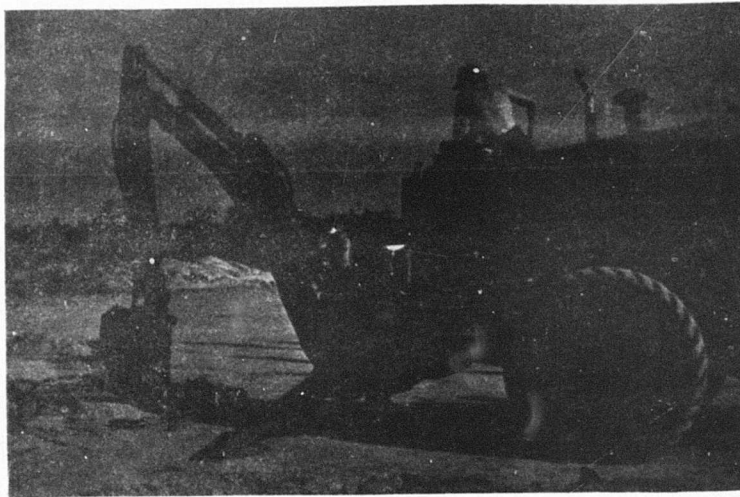
The unit in operation is shown in figure 48. The backhoe proved to be inadequate for this task and could only pull apart small pieces of concrete. It disturbed the base course below the runway, creating additional work for the repair crew (figure 49). While this size backhoe was inadequate, the British use large-wheeled backhoes in their BDR package (reference 23). Tests on this equipment were terminated due to its inadequate size.

Figure 48. Test 1-2, Backhoe Attachment to AC 645 Loader in Operation

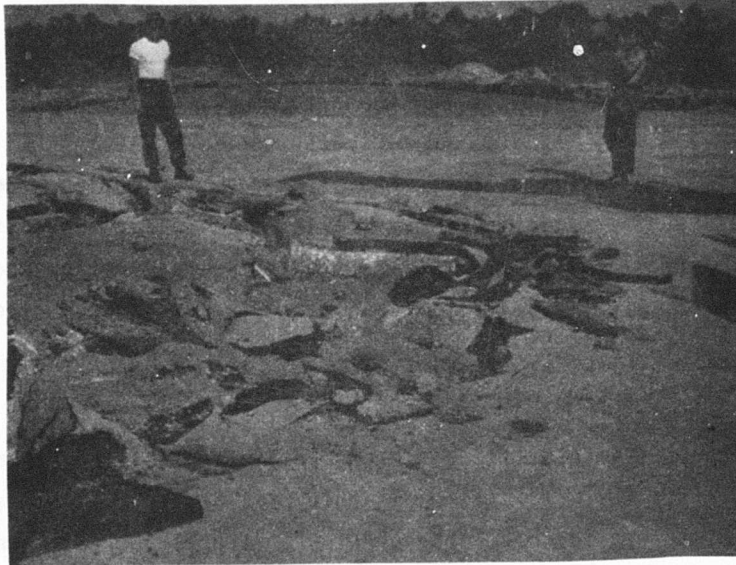
Figure 49. Test 1-2, Base Course Disturbed by
AC 645 Backhoe Attachment

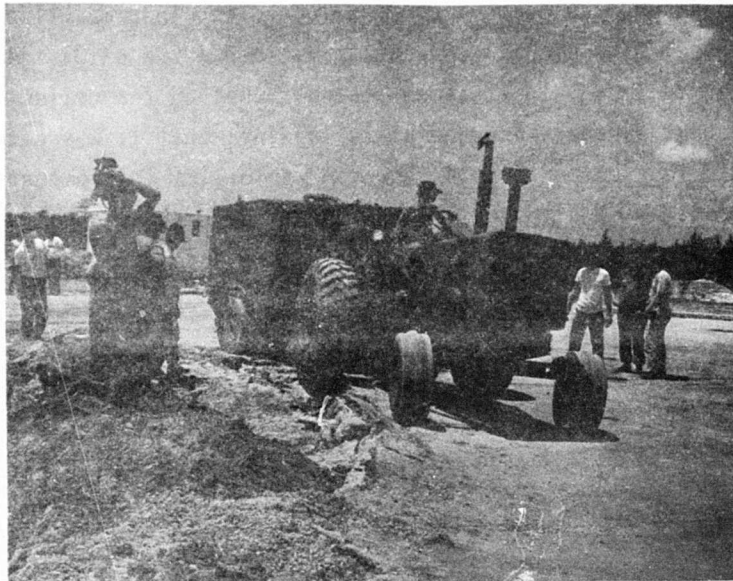
The pieces of equipment used in this application was a bare base Tripactor, constructed solely for the bare base mission and stored and maintained by the 823 CES, RED HORSE, Hulburt Field, Florida (figure 54). Members of the 823 CES who participated in Test 1-1 suggested during an out briefing that a large compactor, such as the Tripactor, might be able to recompact or force down a significant area of the upheaved pavement, thus reducing the amount of upheaved pavement which would have to be removed. Table 10 shows clearly that the Tripactor was ineffective. The most successful use was near the crater lip; however, to become serviceable, this area would require much more deflection than the 0.05 to 0.06 foot achieved. The dynamic forces which displaced the concrete by upheaval are too great to be undone by nonexplosive compaction.

Figure 54. Test 1-2, Bare Base Tripactor Operating on Upheaved Pavement

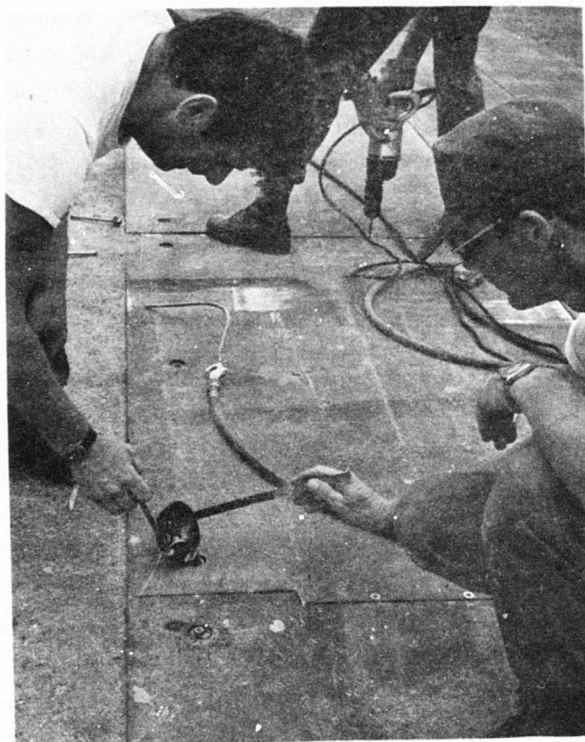
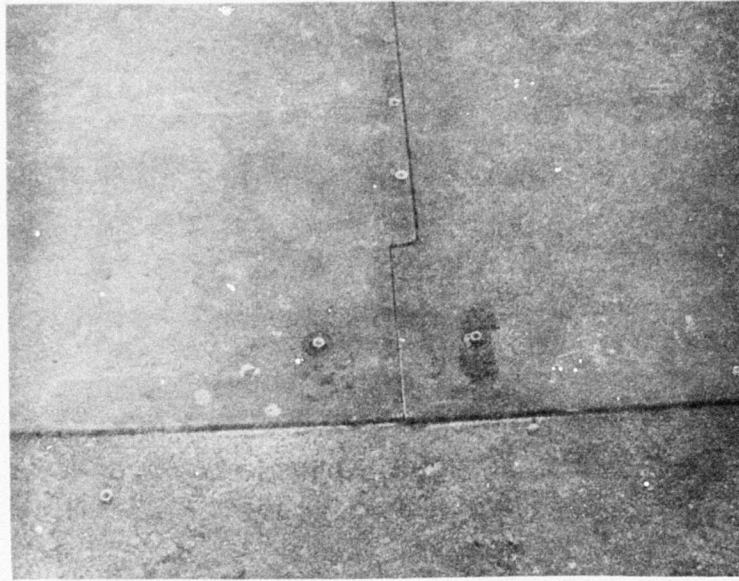
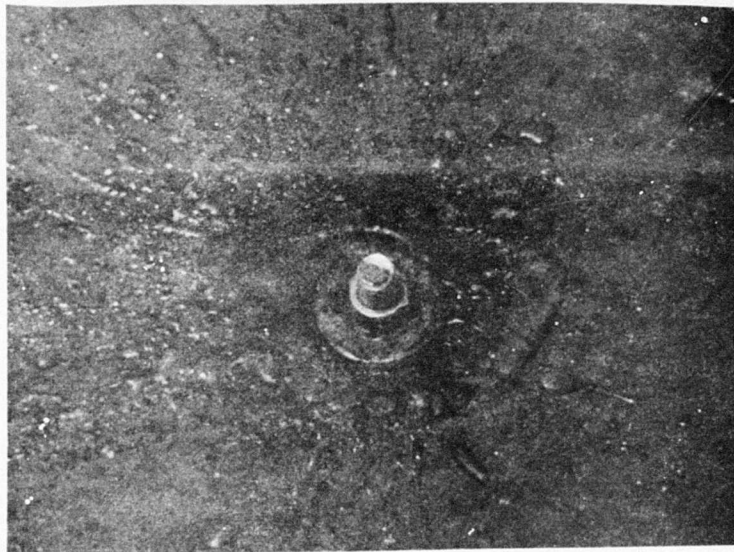
c. The problem of seating the bolts in the hole is more difficult. Several types of expansion bolts were tried, however, a new type of hardware will have to be sought out or designed for this application, and must be matched to the bit used in the rotary hammer. A suitable interim system was devised using bolts anchored head down in a lead-sulphur compound (figures 56A, B, and C). This worked well with the entire job using this method requiring only 19 minutes. An attempt was made to remove the bolts the following day with a grader blade. The bolts bent, but could not be removed (figure 57). However, the electrical equipment required to heat the lead-sulphur must be started in advance. In addition, use of the electrical

melting pots and the laddling of hot lead-sulphur is somewhat cumbersome. Some method of removing the excess bolt head extension must be developed to insure no damage to aircraft tires is possible.

Figure 56A. Test 1-2, Molten Lead-Sulphur Ramp Attachment Method of Pouring Lead-Sulphur Compound into Drilled Hole. Bolts and Device Used to Clean Hole are Visible in the Background

Figure 56B. Test 1-2, Molten Lead-Sulphur Ramp Attachment Method with Anchor Bolt in Place

Figure 56C. Test 1-2, Molten Lead-Sulphur Ramp Attachment Method With Close up of Bolt in Place, Showing Requirement for Grinding

d. The development of a suitable expansion bolt for use in asphalt and concrete should be pursued to eliminate added items of equipment required for the lead-sulphur method. Further work on defining the shear and tension forces which the anchoring system must resist should be done before this development is undertaken.

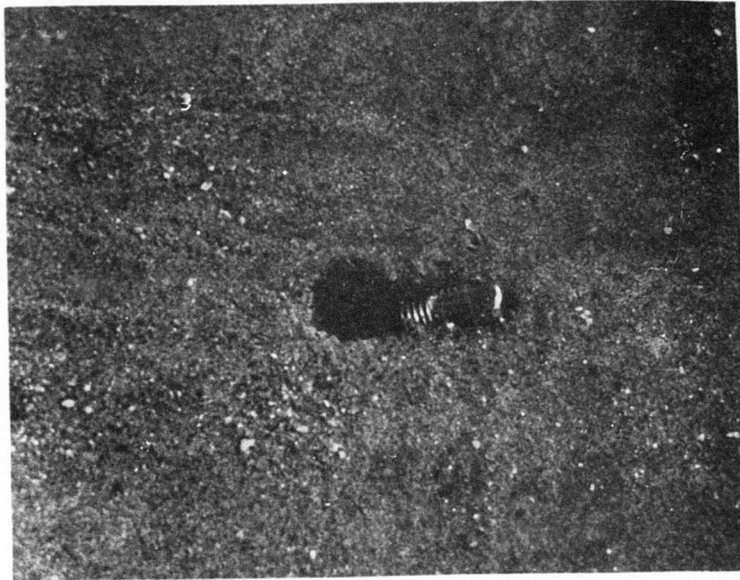
Figure 57. Anchor Bolt after Attempts to Remove with Motorized Grader

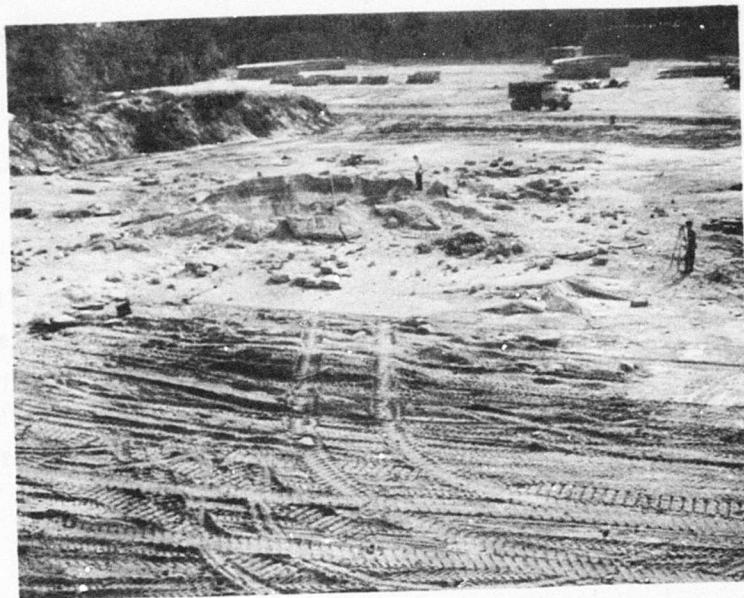
Figure 58. Test 1-3, Crater Prior to Repair

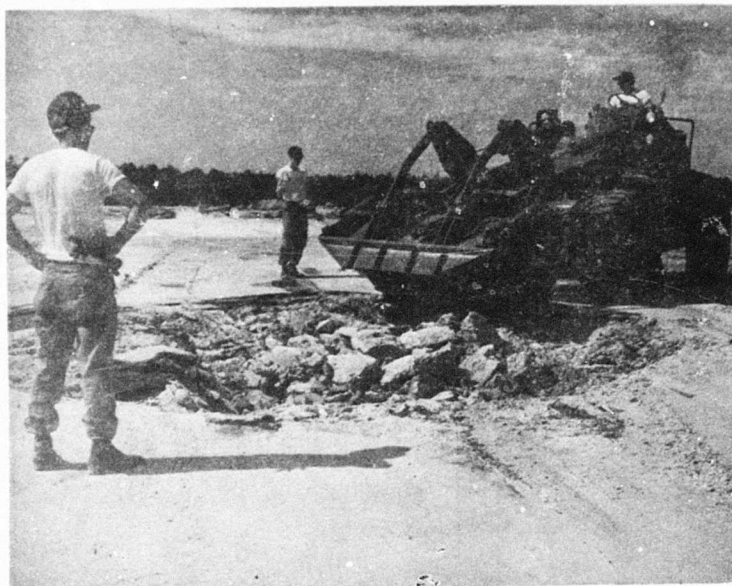
noteworthy. Total equipment usage time was 2 hours and 52 minutes for the AC 645's and 1 hour and 21 minutes for the grader. The total repair time was 2 hours and 30 minutes. This is not a representative minimum time, since the equipment operators were told that a proper repair with proper use of equipment was the objective, not minimum time. No particular advantage was gained by utilizing two AC 645's as opposed to one. The total time during which both 645's were working was only 51 minutes. A portion of this time was spent with mechanical problems on the reverse gear of one of the loaders. The use time of the AC 645's was also increased by the inadvertent over-filling of the crater with debris (figure 66). This required pushing material out of repair area. In addition, it created the presence of large pieces of concrete debris near the subgrade surface. This resulted in difficulties in leveling and compacting the subgrade.

Figure 66. Test 1-4 NE, Crater Overfilled with Debris Requiring Removal

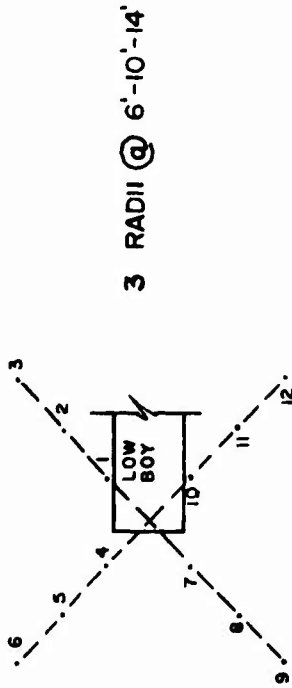
Loading tests performed on the crater (figure 67) showed marginal compaction. The use of the large concrete debris in a crater repair of this size probably aids in the load carrying capability, but hindered the compaction process. The base course had a k value of only 168 pci, with a CBR of only 11.5. The compacted subgrade could not be plate loaded due to the concrete chunks present. The dry sandy nature of the debris and the dry state of the base course was responsible for a lower than normal average CBR reading of nine.

Figure 67. Deflection Basin Study, AM-2 Load Test, Crater 1-4 NE

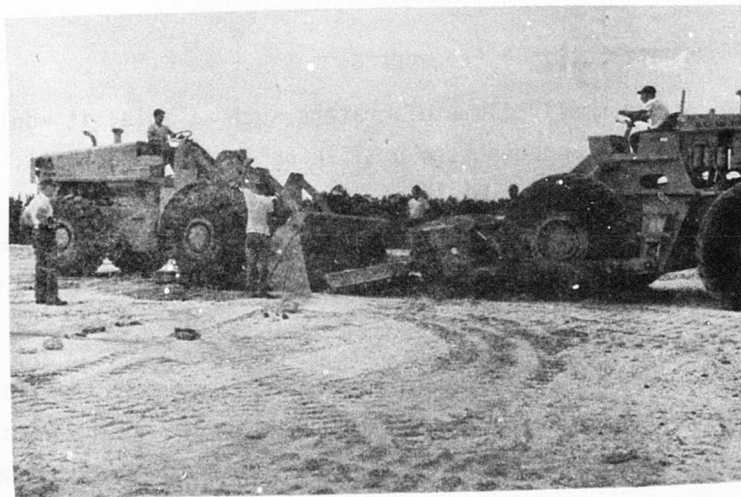
Figure 69. Test 1-4 NW, 280 RT and AC 745 Working on Crater Repair

An equipment package consisting of the 280 RT and AC 745 loader was not well suited to this type repair. The loader alone would have been adequate, especially in view of the requirement to move all material from the crater. The process of removing the lip without being able to push it into the crater is time consuming and would require rather specialized equipment, similar to that used by the United Kingdom (ref. 23). The relatively small size of the crater, as noted in the repair procedure for crater 1-4 NE, limits the useful size of equipment.

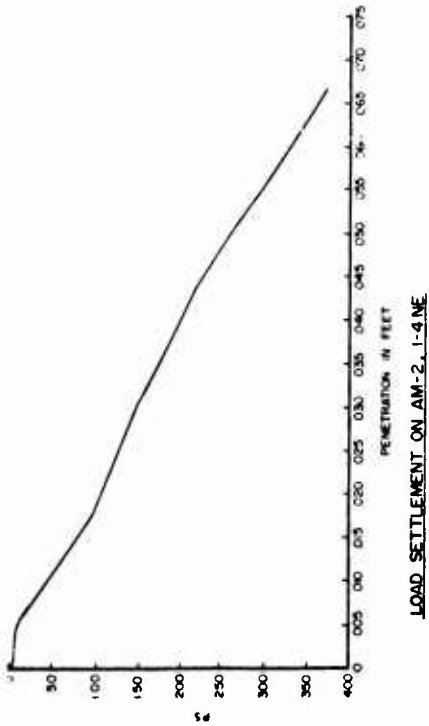
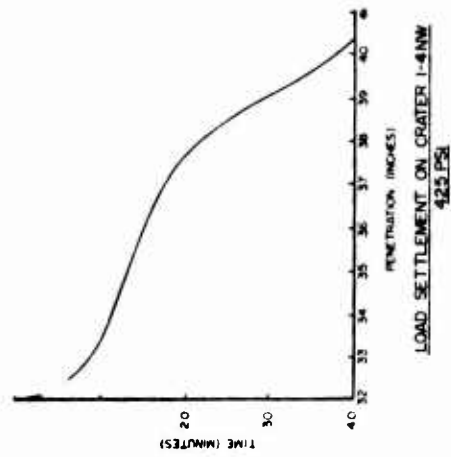
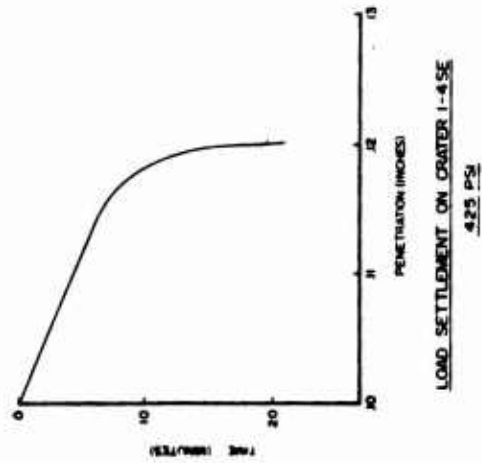
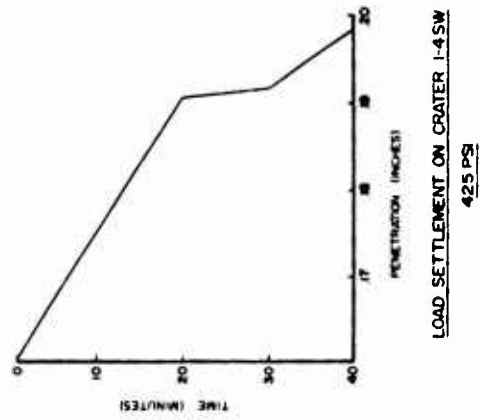
The section was load tested after completion. The equipment difficulties had resulted in a layered pavement system over the center of the repair. The actual loading point was over the originally prepared subgrade rather than the center of the repaired crater, as would have been desirable. The load-deflection curve is shown in figure 71.

(2) The debris subgrade was covered with a 1-foot thick course of uniformly graded aggregate in the 0.5 to 0.75-inch size range. Reg-set cement slurry was infiltrated into this to form a type of concrete. This reg-set operation is covered in section VIII. Loading of the surface was successful, with figure 71 showing the load-penetration relationship.

Figure 71. Test 1-4, Loading Curves

Loading of the slab was accomplished about 1 hour and 30 minutes after the completion of pouring. The repair failed under a 12-inch diameter load plate. The time penetration curve is shown in figure 71. Figure 110 of the failed surface shows that a punching shear of the cap was caused by failure of the underlying material, i.e., the reg-set foam. One possible contributing factor was the floating of foamed cement in the neat

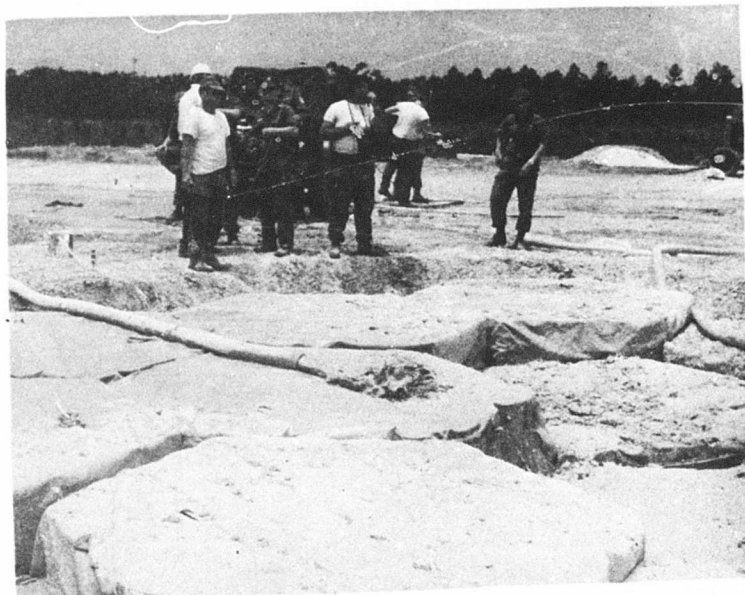
(7) One major problem developed in the placing of the modules. Several of the modules in layer 2 could not be placed exactly level. As a result, the top of layer 3 was extremely uneven, with the difference (figure 86) being as great as 1 foot. While this wasn't critical for load carrying capability, it did create a requirement for approximately 30 percent more reg-set in the crater cap.

Figure 86. Test 2-1, Extreme Unevenness, Top or Third Layer

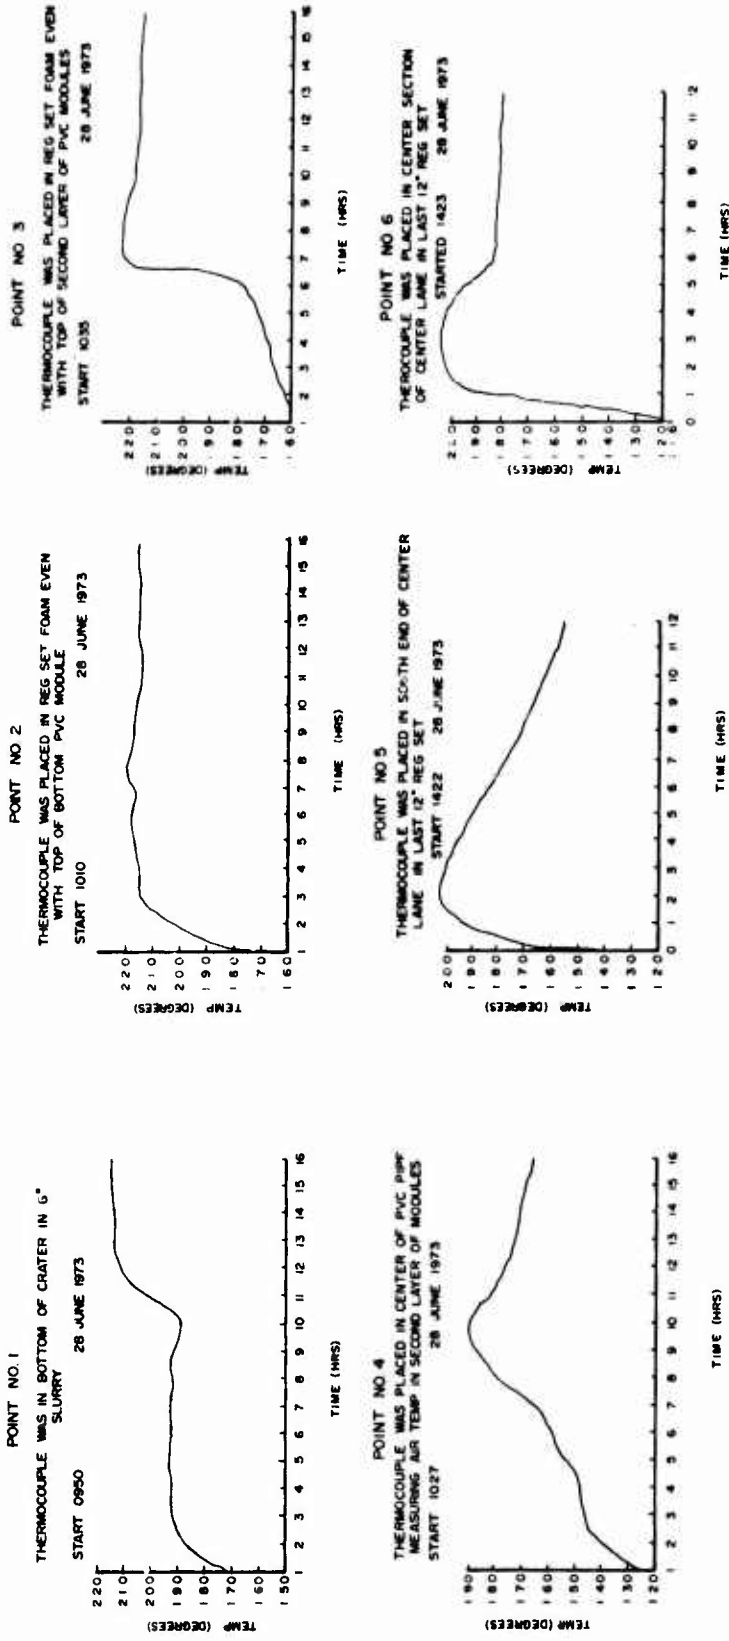
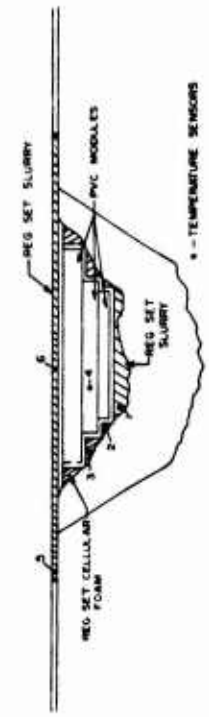
(1) During the test, temperature sensitive thermocouples were implanted as shown in figure 87, a continual record of the heat generated by the curing reg-set.

Figure 87. Test 2-1, Continuous Temperature Recording of Implanted Thermocouples

The importance of the dramatic temperature rises became clear when the loading of the test section was attempted. As in the other tests in this series, a load of 50,000 placed on a 12-inch diameter plate was to be used along with a load cart carrying 29,000 pounds on an F-4 wheel. Problems begin as soon as the loaded lowboy trailer was backed onto the repair. Even though 2-by-8-foot planks of AM-2 matting were utilized to prevent concentrated loading prior to testing (figure 88), failure began almost instantly. Large circumferential cracks (figure 88) occurred along with the release of steam and water vapor from the interior of the modules. The plate load tests were discontinued after a sudden punching failure of the reg-set cap at 30,000 pounds (figures 89 and 90). Although thickness of the cap at the point of failure is uncertain, it was in excess of 12-inches, possibly as much as 20-inches thick. The failure was similar to that experienced in Test 1-4 NW, suggesting a failure of the supporting backfill material. Following this failure, one large slab 10-feet in width cracked and lifted up 3 inches over a 20-foot span along a 2-by-6 inch forming timber, allowing hot gases to escape before dropping back into position. An attempt to use the F-4 load cart failed when the pavement collapsed beneath the load and allowed the aircraft tire to penetrate the pavement, stopping only when the frame of the load cart rested on the pavement (figure 91).

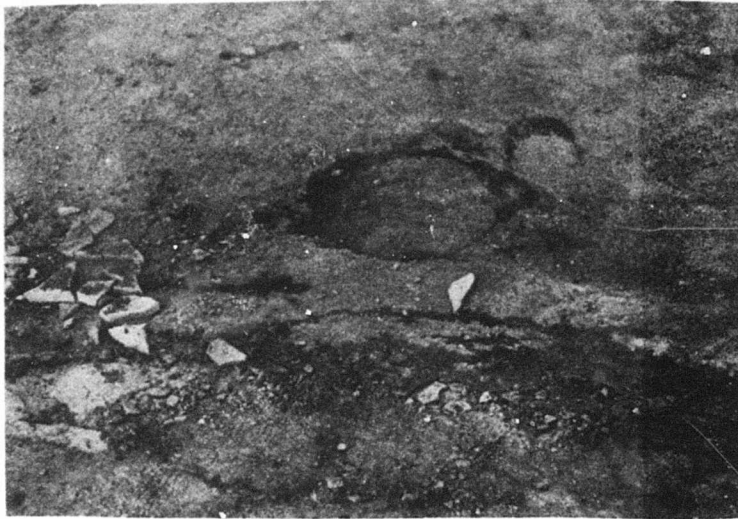
Figure 90. Test 2-1, Punching Failure, Middle, and Concentric Crack, Lower

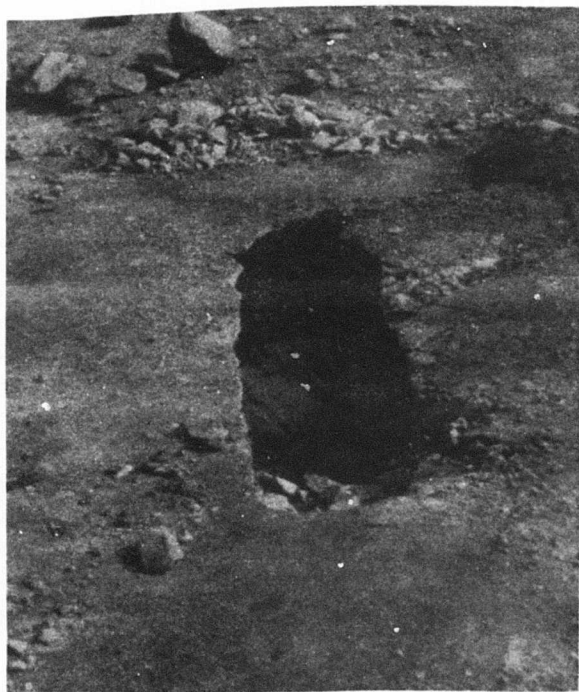
Figure 91. Test 2-1, Punching Failure under Load Cart Wheel
