TYNDALL AFB BOMB DAMAGE REPAIR FIELD TEST, DOCUMENTATION AND ANALYSIS

Lawrence D. Hokanson, Capt, USAF
Air Force Weapons Laboratory

October 1975

Final Report

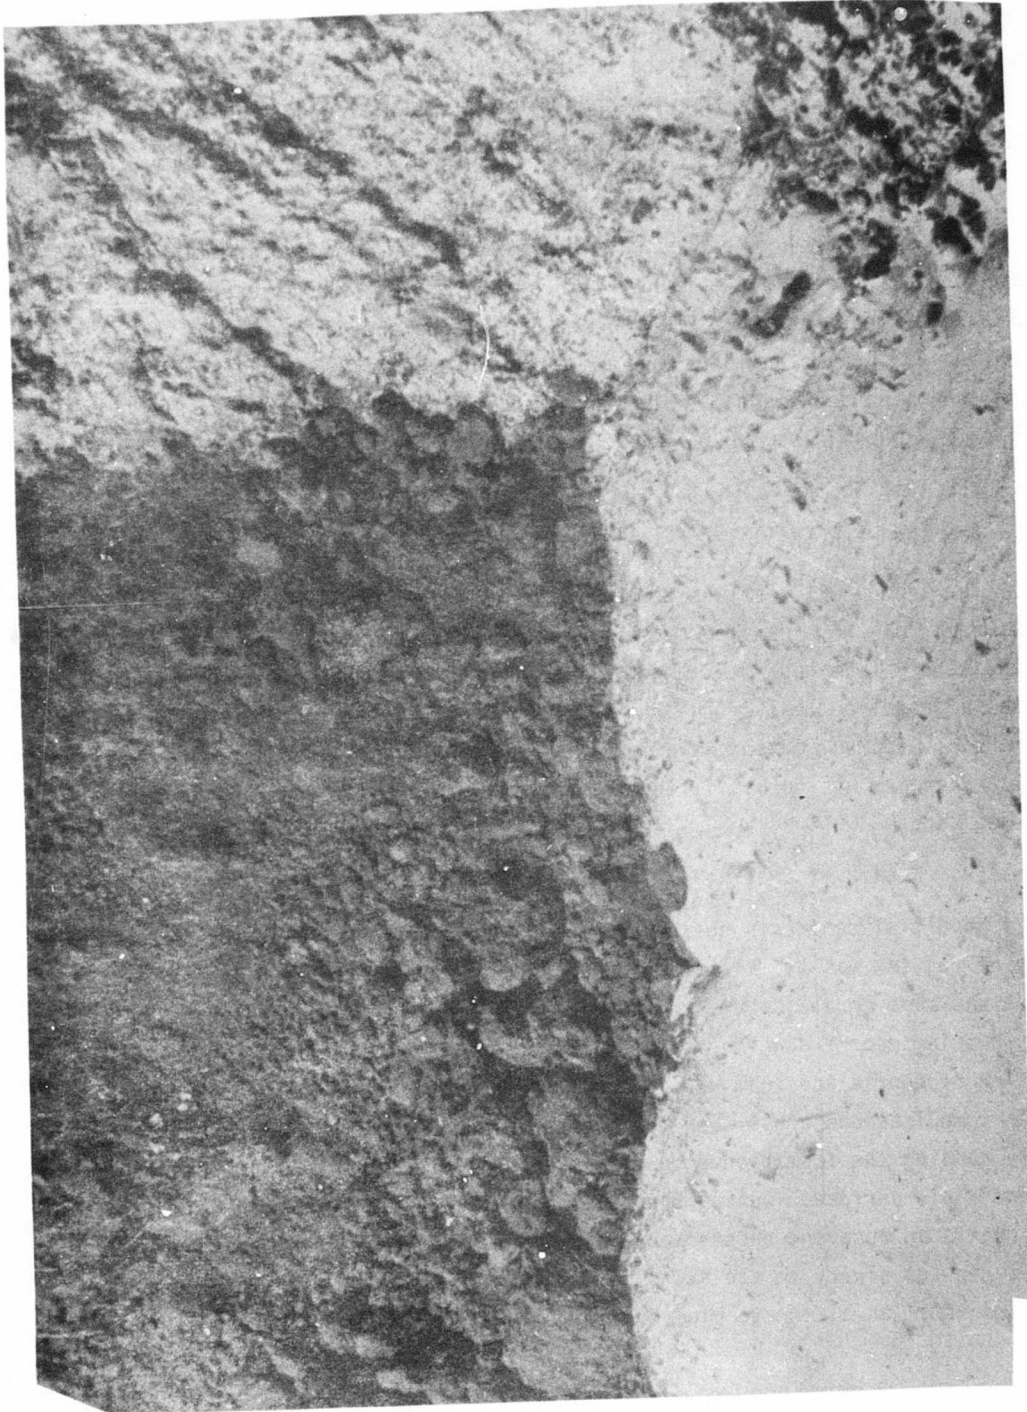
Module placement in the first crater was rapid. In fact, the supply of reg-set was too slow to produce accurate time results. An attempt was made to add debris to the reg-set foam, but the method of merely pushing debris down the side of the crater was inadequate (figure 95). No mixing of debris and foam was accomplished and the attempts were abandoned. Further complications arose when the reg-set placed in the crater cured too rapidly causing the formation of numerous cold joints and a highly irregular and unworkable surface. During the pumping of the cap, a hose connection broke due to an apparent pressure build-up in the system. This breakdown allowed reg-set slurry in the PVC pipe supply system to set up, stopping the operation until an alternate pipe system could be connected (figure 96).

Figure 95. Mixing Problem, Debris with Reg-set Matrix Concept

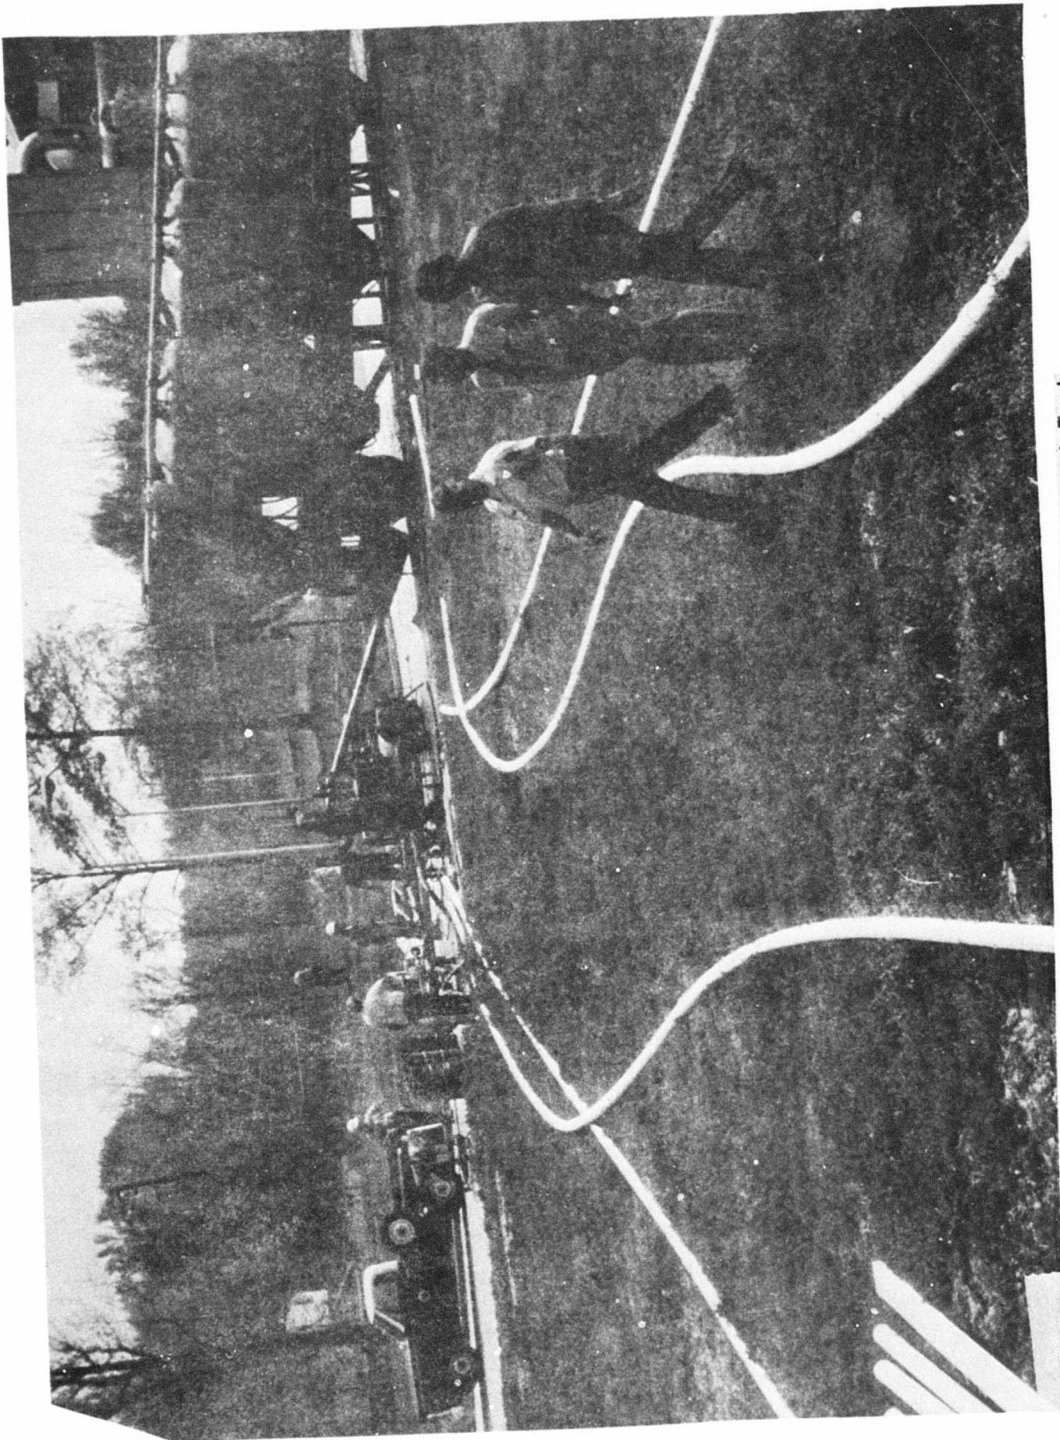
Figure 96. Supply Lines for Second WES Reg-set Test

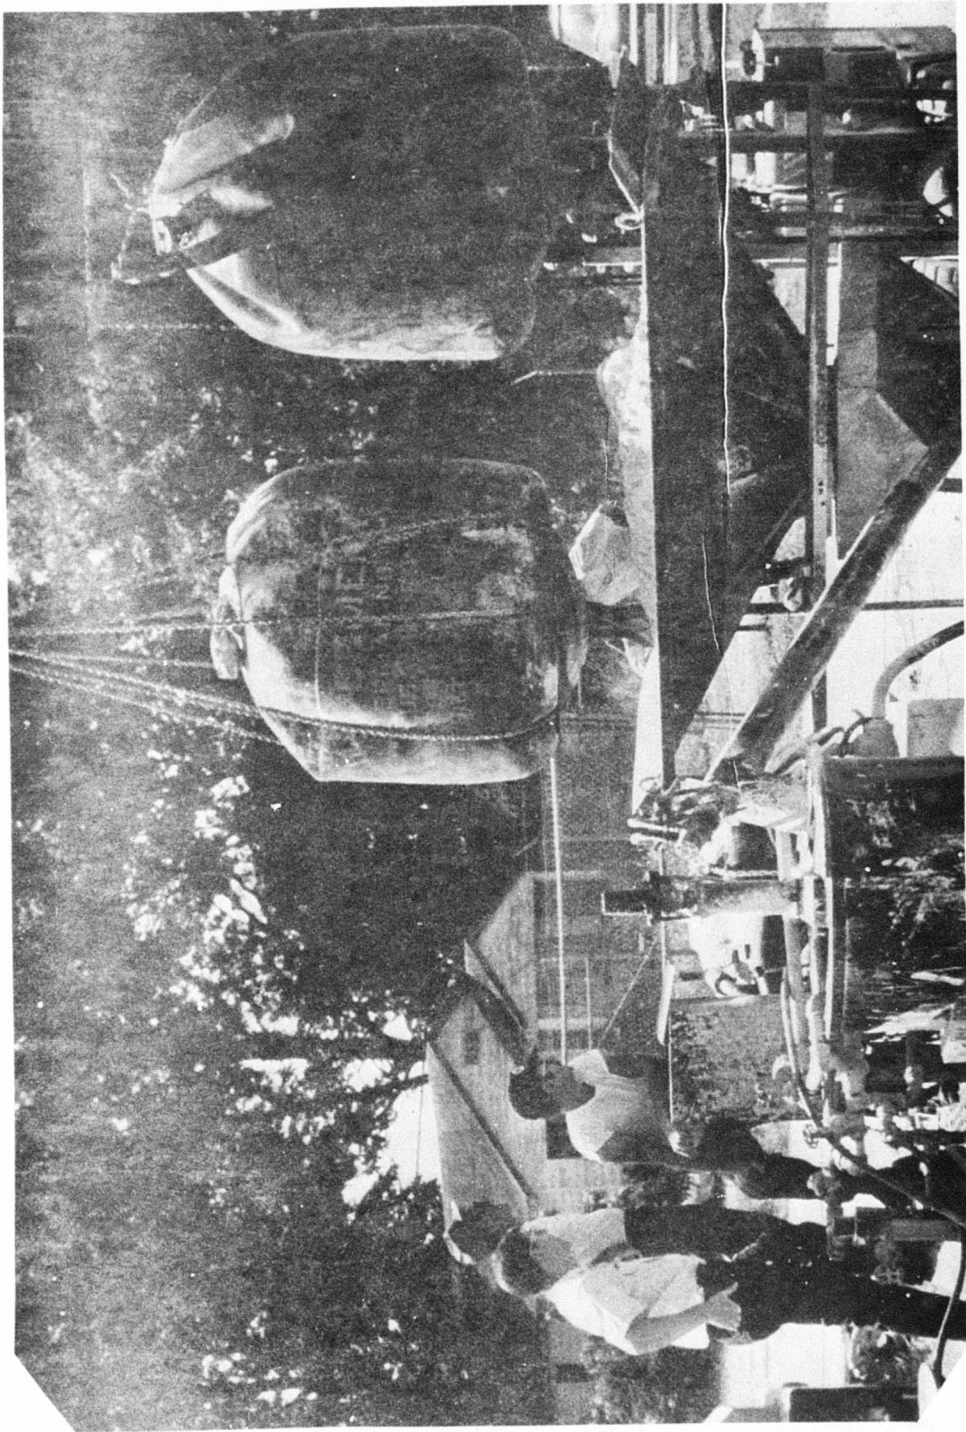
The third WES test used equipment similar to the second WES test, with the exception of the storage of dry reg-set cement. Large rubber containers (figure 101 and 102) capable of holding up to 6,000 pounds each were emptied directly into an open hopper, from which a feed auger was fed by gravity. Removing the reg-set from the bags proved to be too slow a process, and the dry cement feed fell behind, causing at least one system failure.

Figure 102. Rubber Field Containers Being Used in Third WES Test

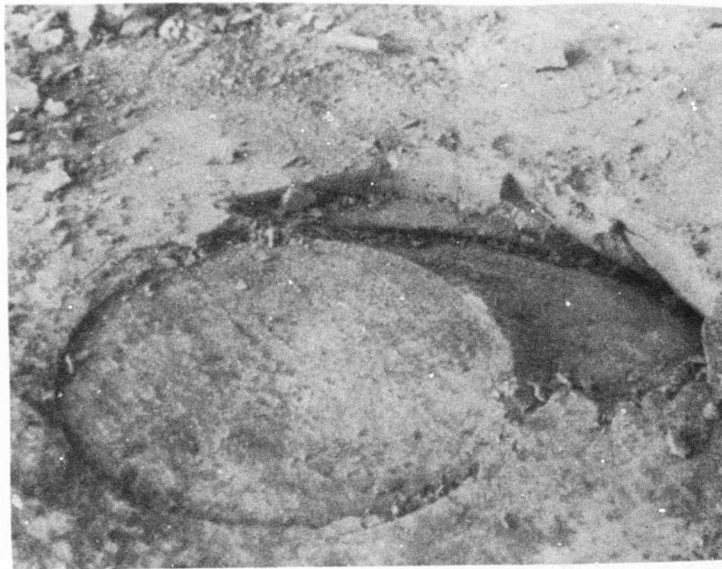
Loading of the slab was accomplished about 1 hour and 30 minutes after the completion of pouring. The repair failed under a 12-inch diameter load plate. The time penetration curve is shown in figure 71. Figure 110 of the failed surface shows that a punching shear of the cap was caused by failure of the underlying material, i.e., the reg-set foam. One possible contributing factor was the floating of foamed cement in the neat

Figure 110. Punching Failure on Reg-set Cap Test 1-4 NW

slurry (figure 111) yielding a possible weekend lower 2 inches of the 12-inch slurry cap. Excavation of the cap, figure 110, showed the failure plane to be very nearly at 45 degrees to vertical, in agreement with Mohr Circle theory defining the plane along which maximum shear occurs. It was noted that the surface temperature of Test 1-4 NW was much higher than the surface temperature of other 1-4 series tests.

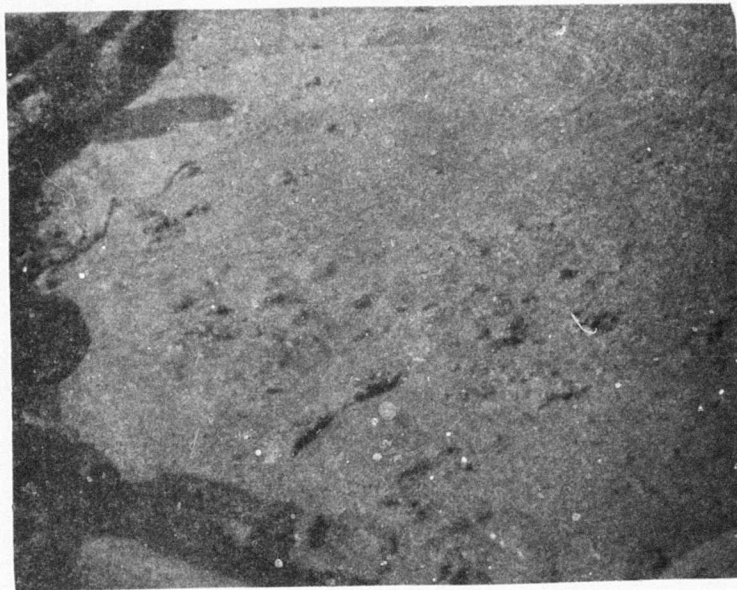
Figure 111. Chunks of Foam Reg-set Floating in Reg-set Slurry Cap, Test 1-4 NW

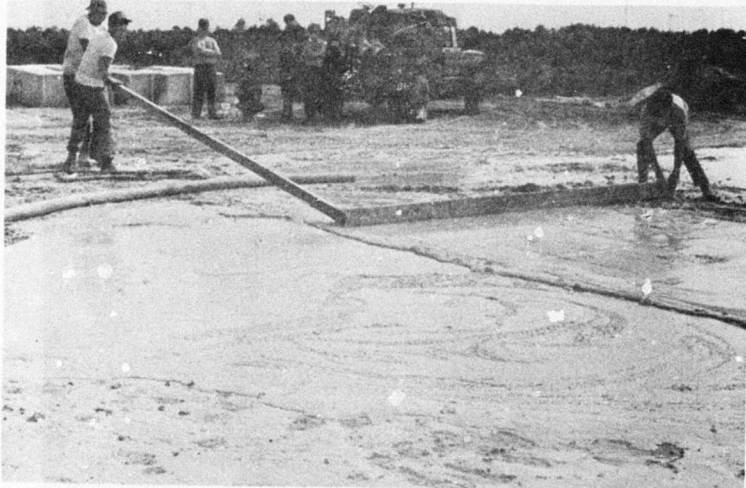
Some problems were experienced in screeding this repair (figure 112) and it was realized that a carefully controlled and prefabricated form system would be essential for further work with reg-set.

Figure 112. Screeding Reg-set Cap for Test 1-4 NW

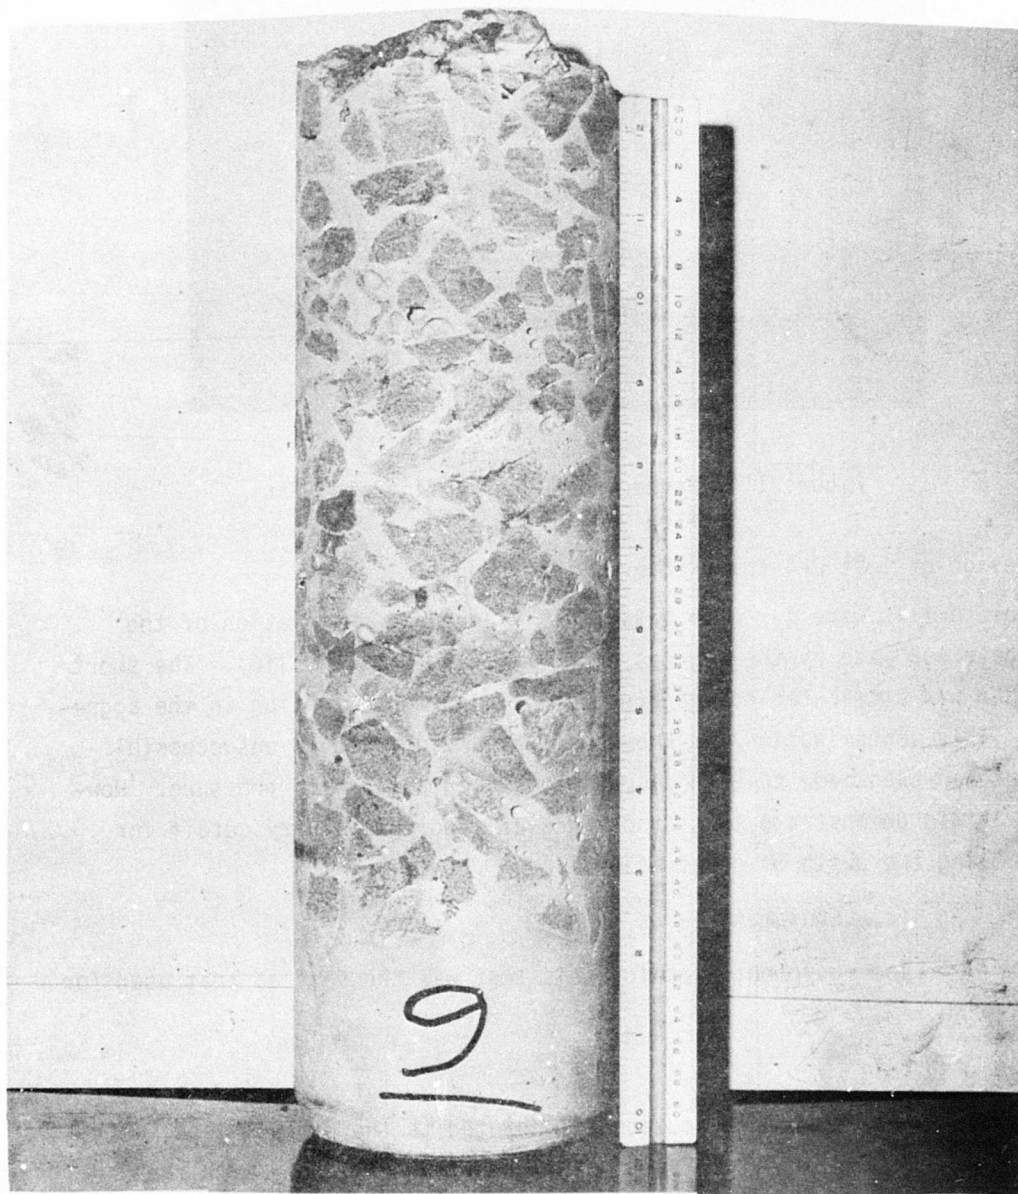
Core drills were taken to determine if adequate penetration of the aggregate was made by the reg-set slurry (figures 115 and 116). The short cylinder was attributed to the presence of sand contamination in the aggregate. This contamination was known before pumping, and an unsuccessful attempt had been made to wash it out with water under high pressure. However, it did demonstrate that sand makes an excellent slurry cutoff for controlling the depth of penetration.

Figure 115. Core Sample of Infiltrated Aggregate Cap, Test 1-4 SE

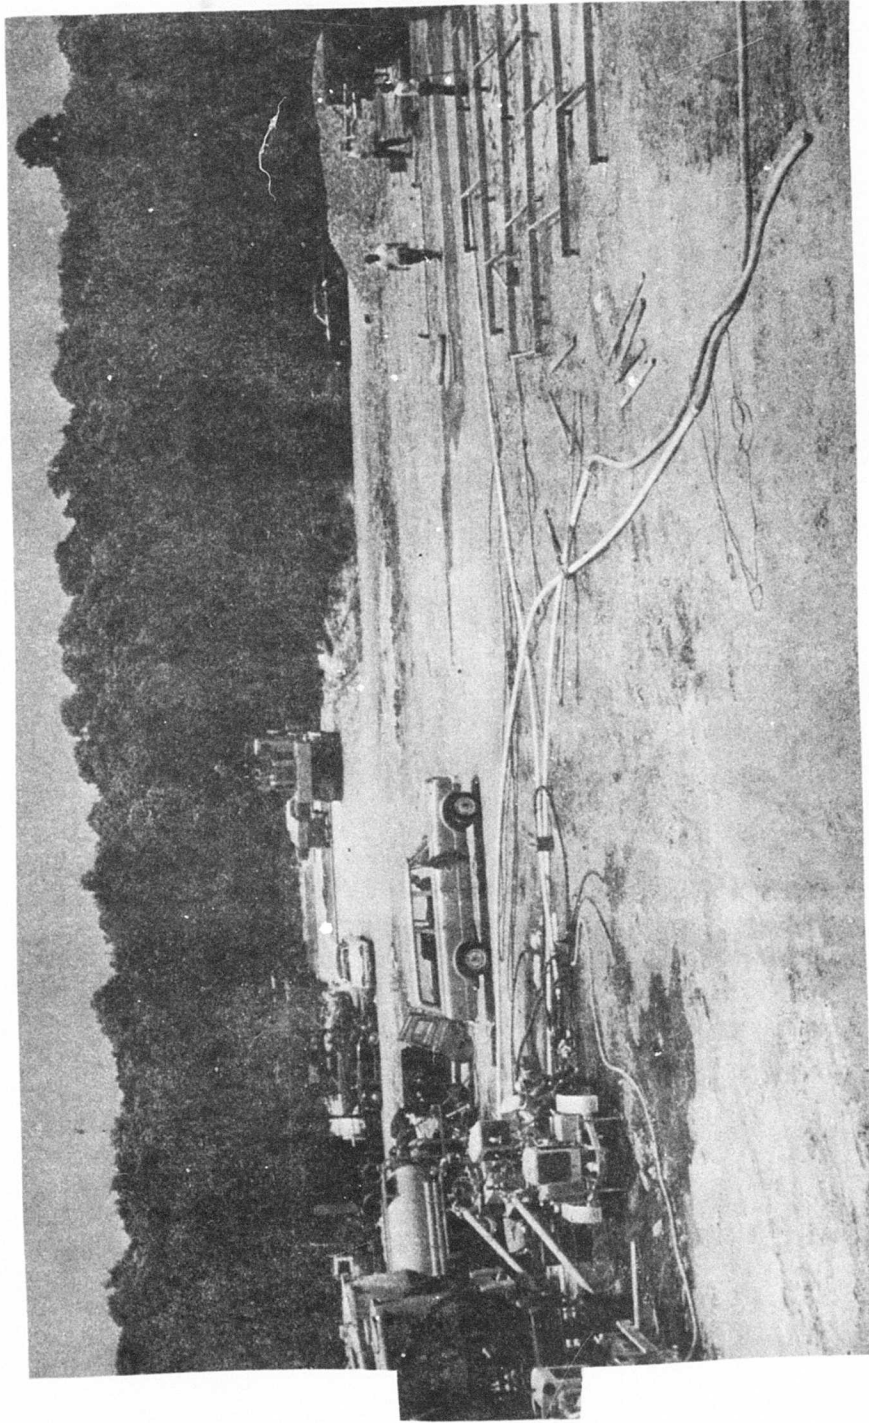
Although three pumps were available, only the two more advanced G-3 pumps on lease were actually used. These pumps ran without incident and were often switched from foam to slurry as the requirements dictated. As seen in table 20, section VII, the pumping of the crater backfill took some 2 hours and 46 minutes to complete, with the pumps running about 2 hours and 29 minutes of this time. The volume of reg-set used in foam and slurry cannot be accurately determined, and so an accurate delivery rate cannot be calculated. However, the maximum pumping rate was not used because of the resultant velocity of the material leaving the hose nozzle and consequent thrust produced. The velocity in the 3-inch hose would be 7.45 FPS, an exceptionally high speed for slurry placement. The actual pump time for the cap was 1 hour and 8 minutes on one pump and 51 minutes on the other. Thus, the whole project took a total of 6 hours and 57 minutes of pump time. If the volume is assumed to be 175 CY of slurry at a density of 110 PCF and 100 CY of foam at a den of 50 PCF, or a total of 275 yards pumped, the pump performance is about 40 CY per hour. A larger hose could have improved this performance but would have caused larger problems in the lengthy supply lines (figure 117) due to reduced velocity and possible premature set-up in the lines.

Figure 117. Lengthy Supply Lines for Test 2-1

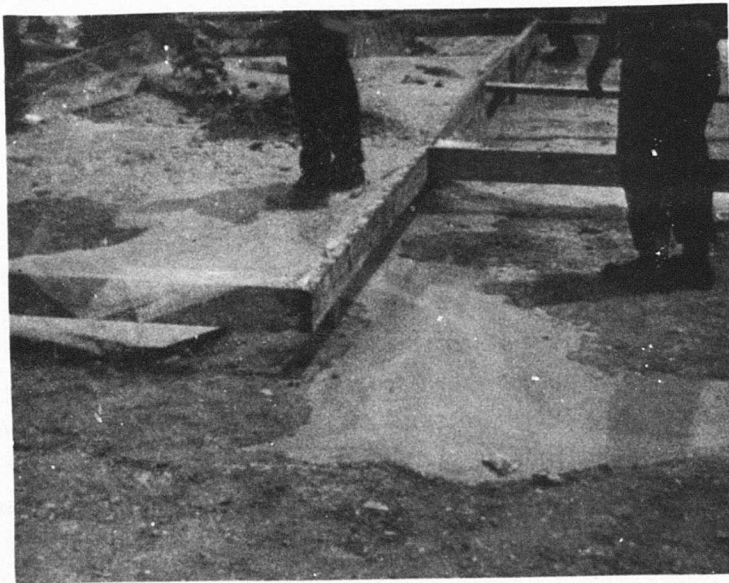
Figure 121. Reg-set Running Beneath Polyethylene Form Liner and Out of Formwork, Test 2-1

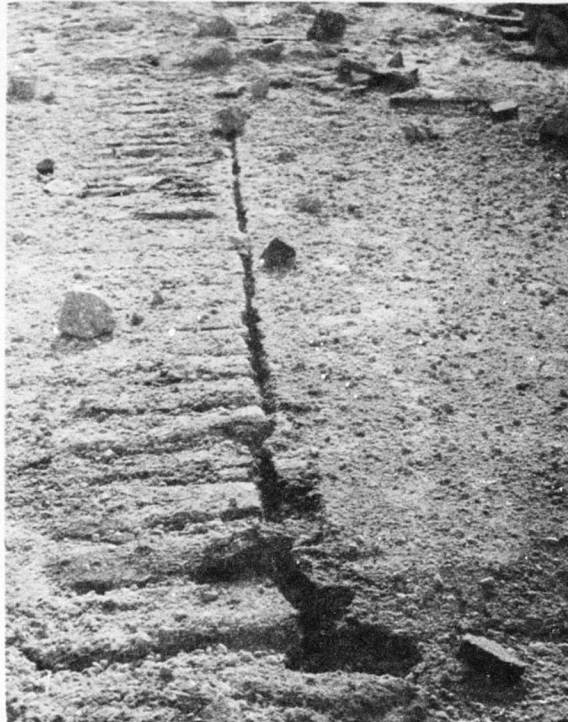
In addition to the crater and upheaved pavement, severe horizontal stresses created large cracks in the pavement at points far beyond the limit of upheaval. These cracks are shown in the plan view drawings of the damage in appendixes III to VII. Figures 125 and 126 show the type of damage incurred. The pavement between the crater and the runway edge was pushed sideways due to a lack of support along the runway edge. In one case, the displacement between two adjacent pavement sections at the runway edge was 6 inches.

Figure 125. Pavement Cracking Outside Zone of Upheaval, Test 1-2
