TECHNICAL REPORT NO. 6-570 -

# DURABILITY AND BEHAVIOR OF PRESTRESSED CONCRETE BEAMS

## LABORATORY TESTS OF WEATHERED PRETENSIONED BEAMS

June 1976

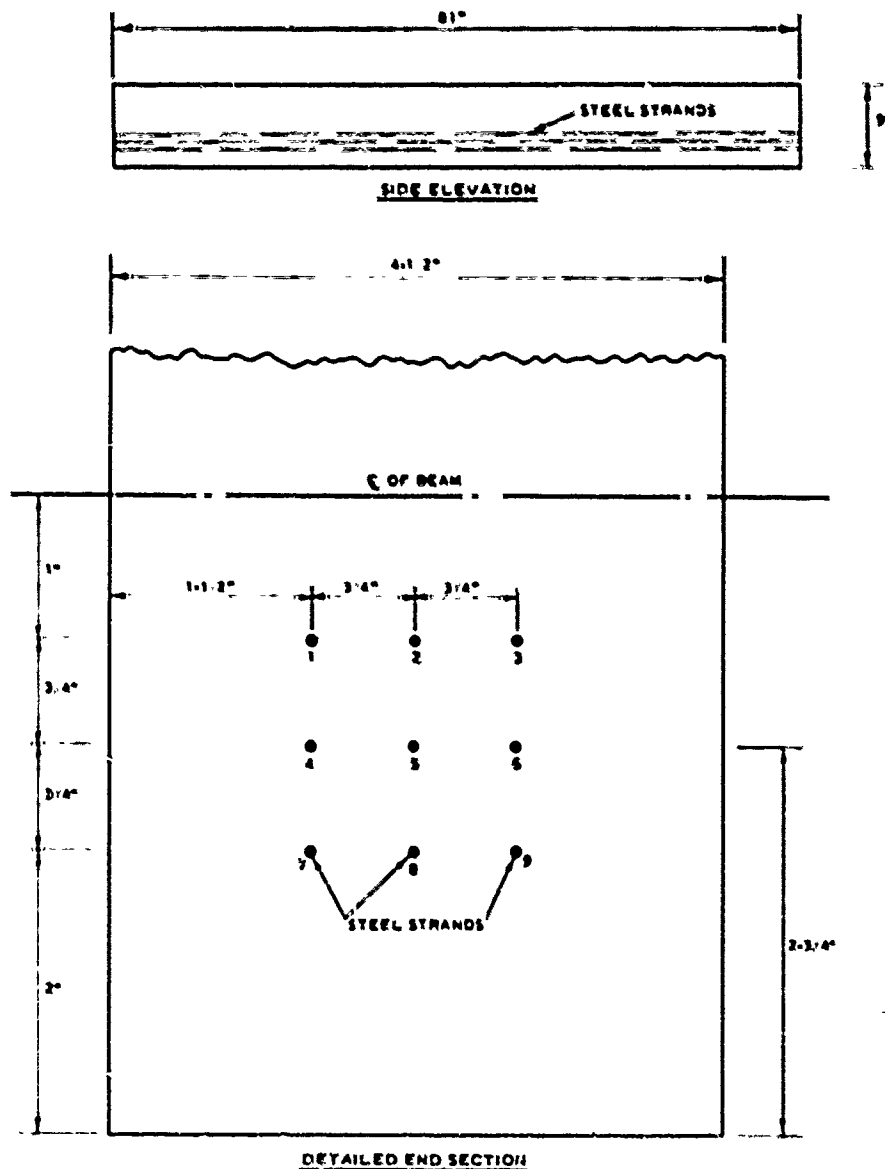
Figure 1. Detailed section of pretensioned concrete beam

10. The locations of the steel strands in each concrete beam are shown in Figure 1. There are three strands in each of three rows: the strands in the row nearest the top of the beam as cast are numbered 1, 2, and 3; those in the middle row 4, 5, and 6; and those in the bottom row 7, 8, and 9. Each strand is a nominal 1/4-in.-diam strand consisting of seven wires, a center wire with six others surrounding it.

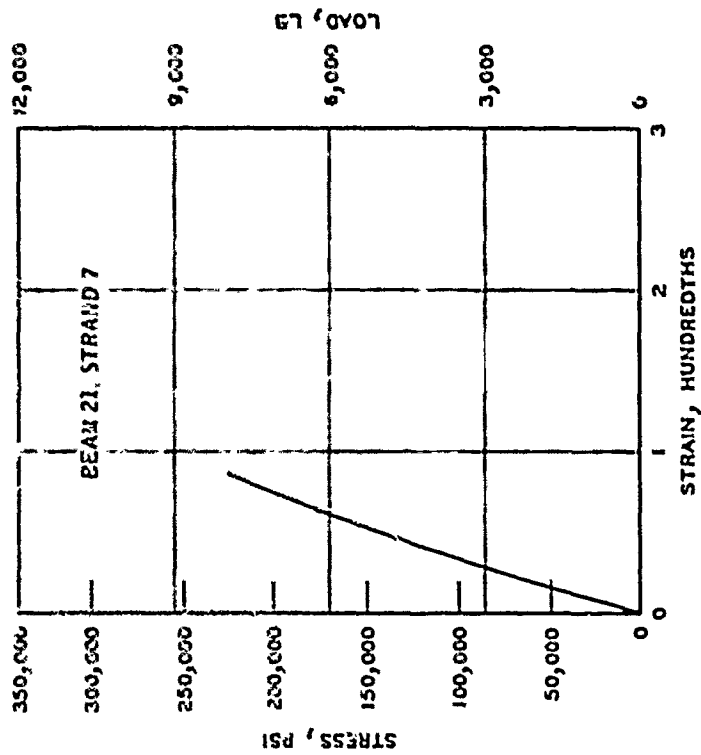
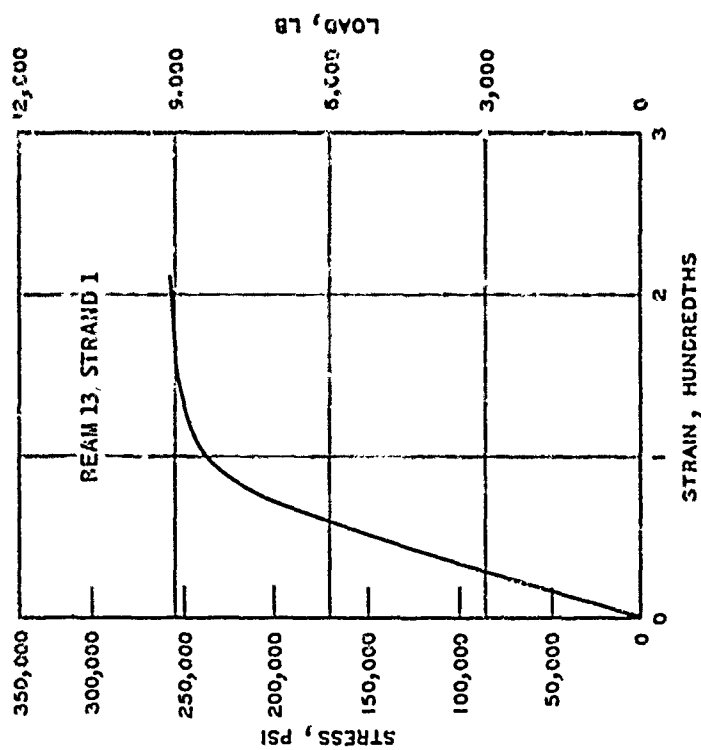
# STRESS-STRAIN CURVES

A typical stress-strain curve for each beam is presented in Plate 1.
