ARMY AVIATION TEST BOARD FORT RUCKER ALA  
TEST OF T53-L-13 ENGINE (S/N LE-14083).(U)  
NOV 68

DEPARTMENT OF THE ARMY  
UNITED STATES ARMY AVIATION TEST BOARD  
Fort Rucker, Alabama 36360

SUBJECT: Letter Report of Test of T53-L-13 Engine (S/N LE-14083).  
USATECOM Project No. 4-6-0150-05

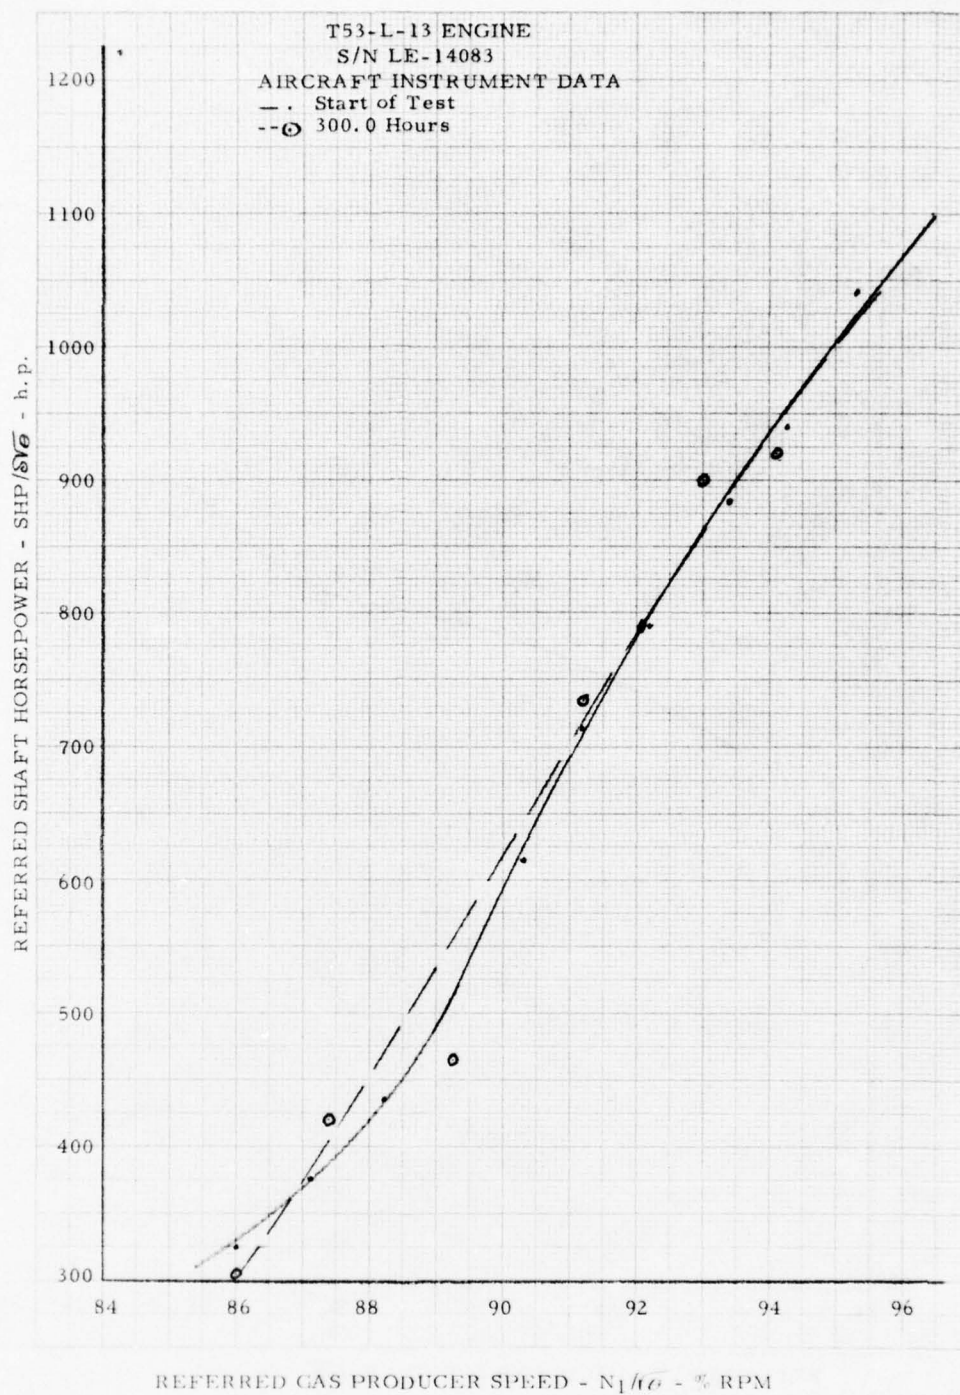
b. Figures 1, 2, and 3 show engine performance prior to the 300-hour inspection compared to performance at the start of the test.

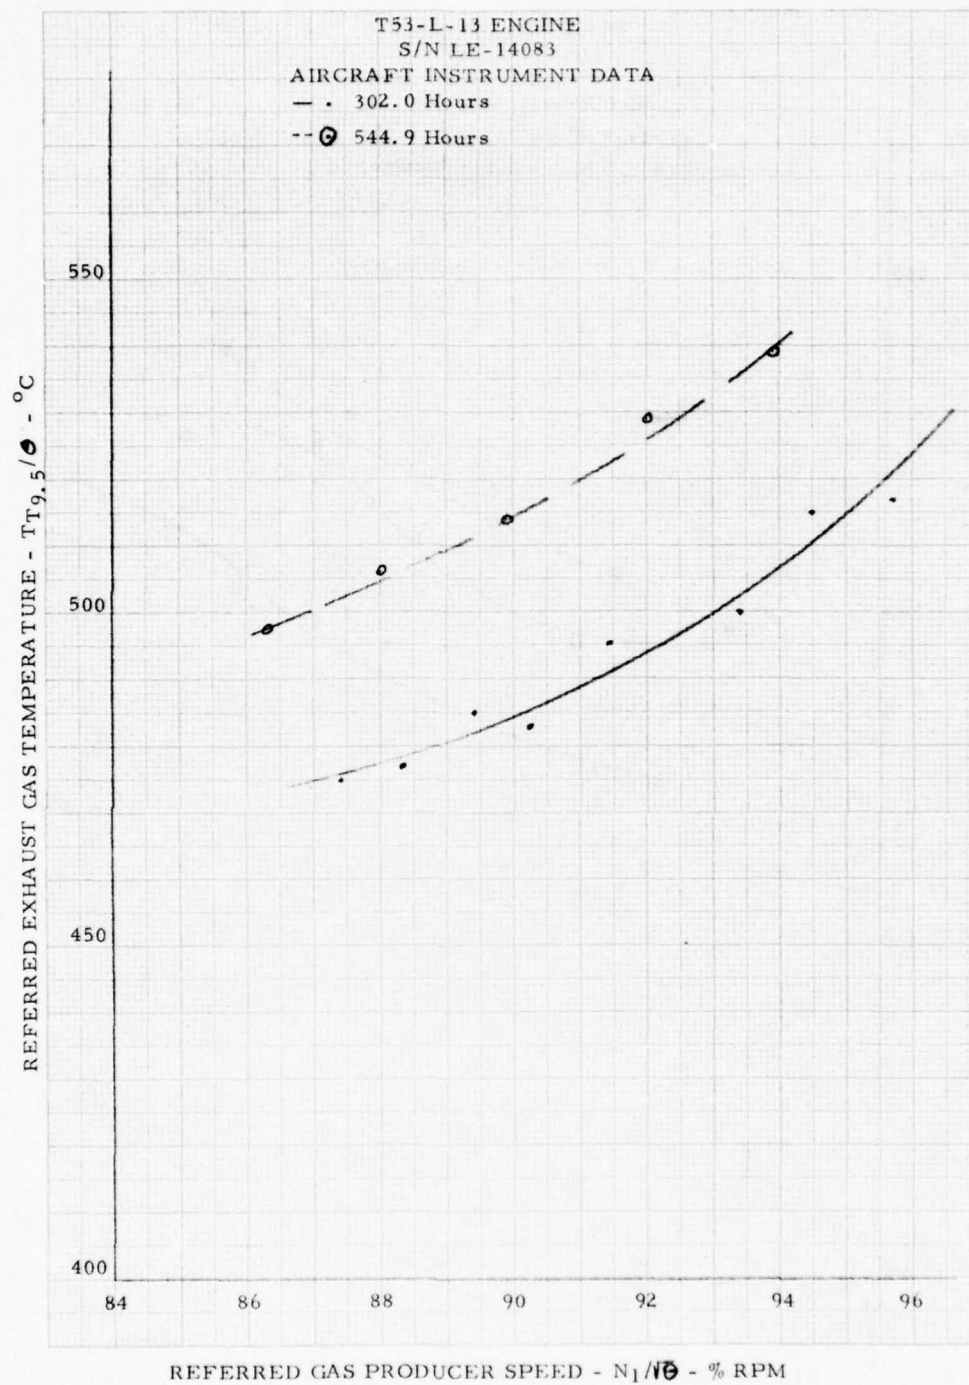
Figure 7.

| <u>Engine Hours</u> | <u>Fault and/or Remarks</u> | <u>Action Taken</u> |
|---|---|---|
| | Engine EGT continued to increase. Approximately 30°C. increase in referred EGT (figure 7). | Engine cleaned by ingestion of cleaning compound while motoring compressor. Referred EGT dropped 10°C. (figure 8). |

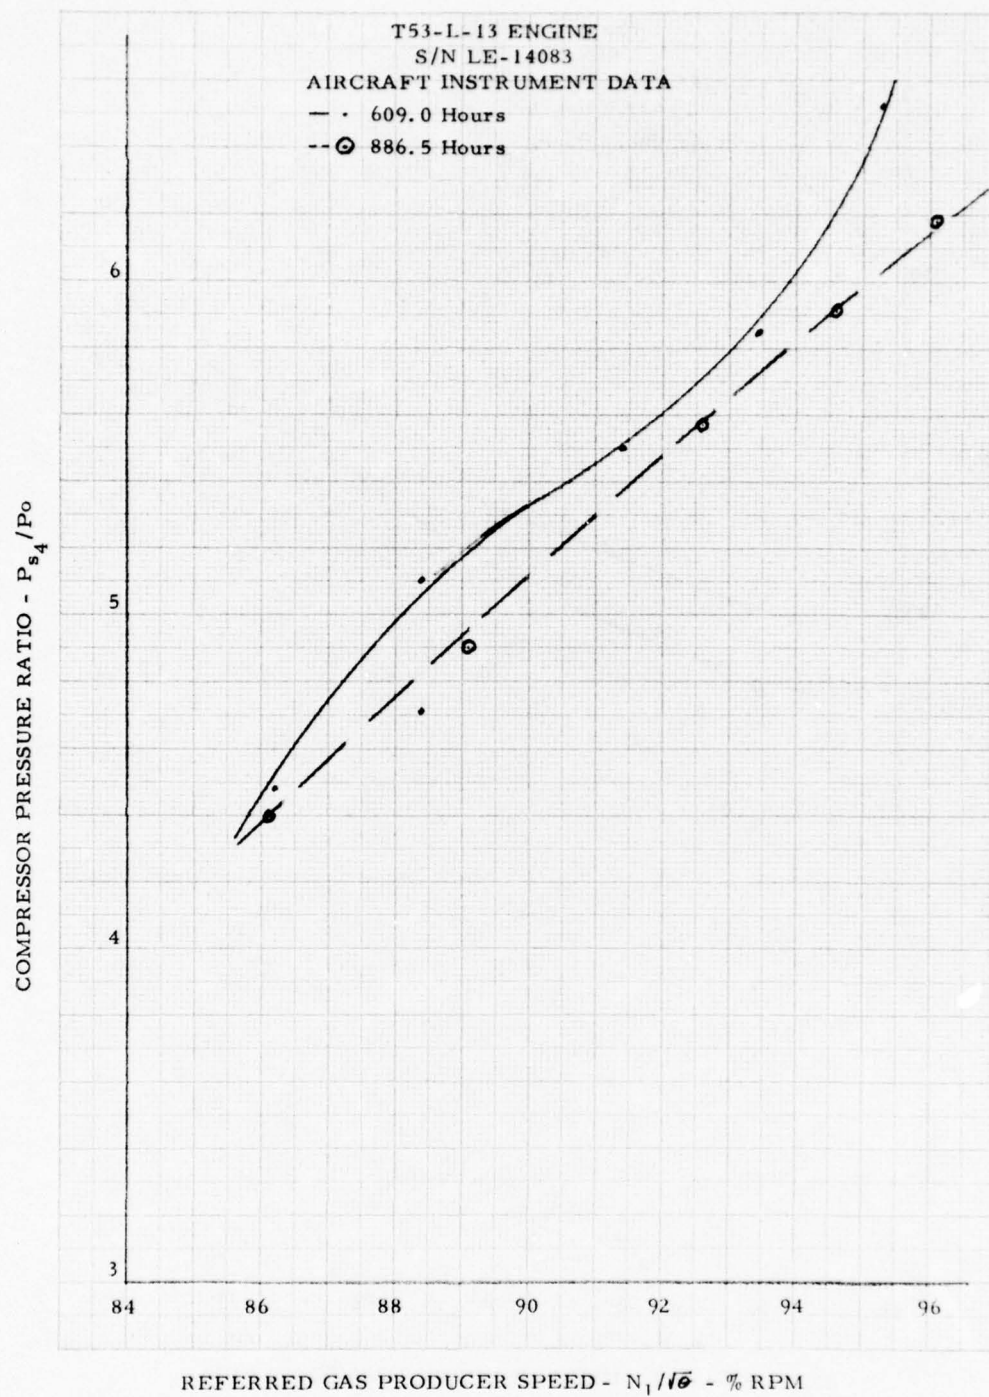
b. Figures 18, 19, and 20 show engine performance prior to removal at 897.3 hours compared to performance subsequent to reassembly after the 557.3-hour analytical hot-end inspection.

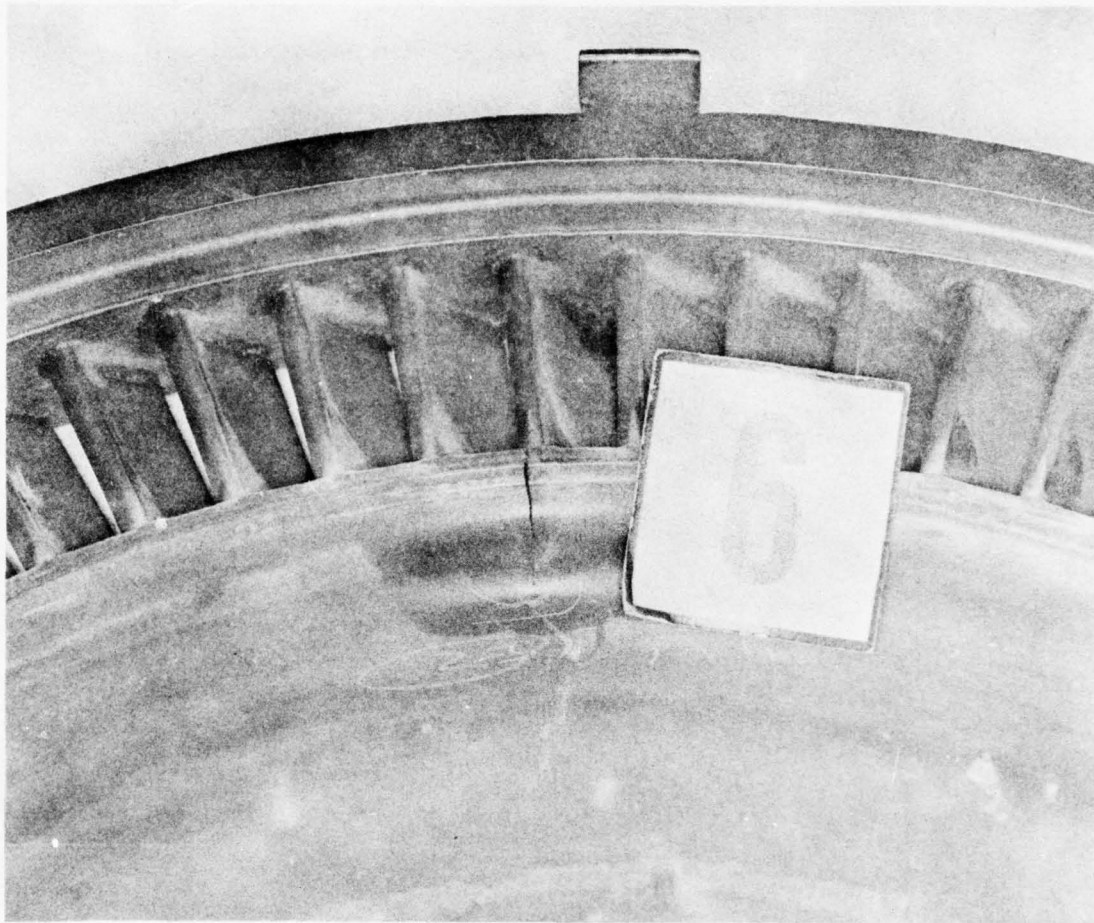
Figure 24.

| <u>Nomenclature</u> | <u>FSN and P/N</u> | <u>Component</u> | |
|---|---|---|---|
| Second-Stage<br>GP Nozzle | 2840-925-9665<br>1-120-000-06D | 897.3 | Three cracks extending across inner shroud with up to 1/2 inch of cracking in vane brazement (figure 23). Two of these cracks extended into both the front and aft supports. One extended only into the front support. The cracks extended between 7/32 and 25/32 inch into the forward inner support and between 3/8 and 1/2 inch into the aft inner support (figures 24 and 25). Thirty-nine vanes had brazement cracks extending 5/16 inch in the outer shroud at the leading edge. At 17 vanes, these brazement cracks extended axially up to 5/32 inch into the outer shroud (figure 26). |

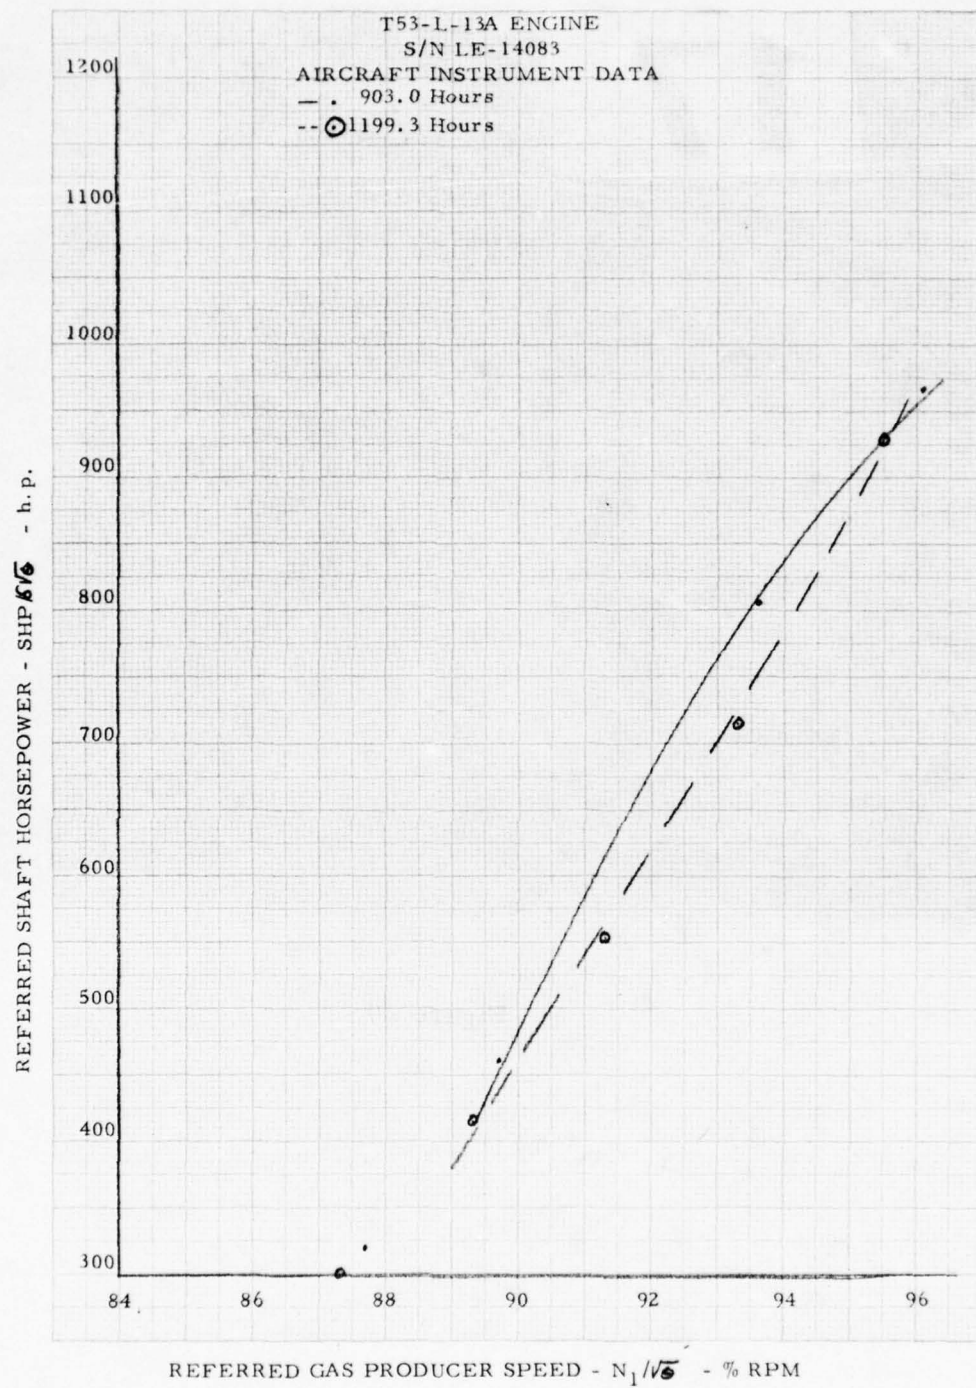
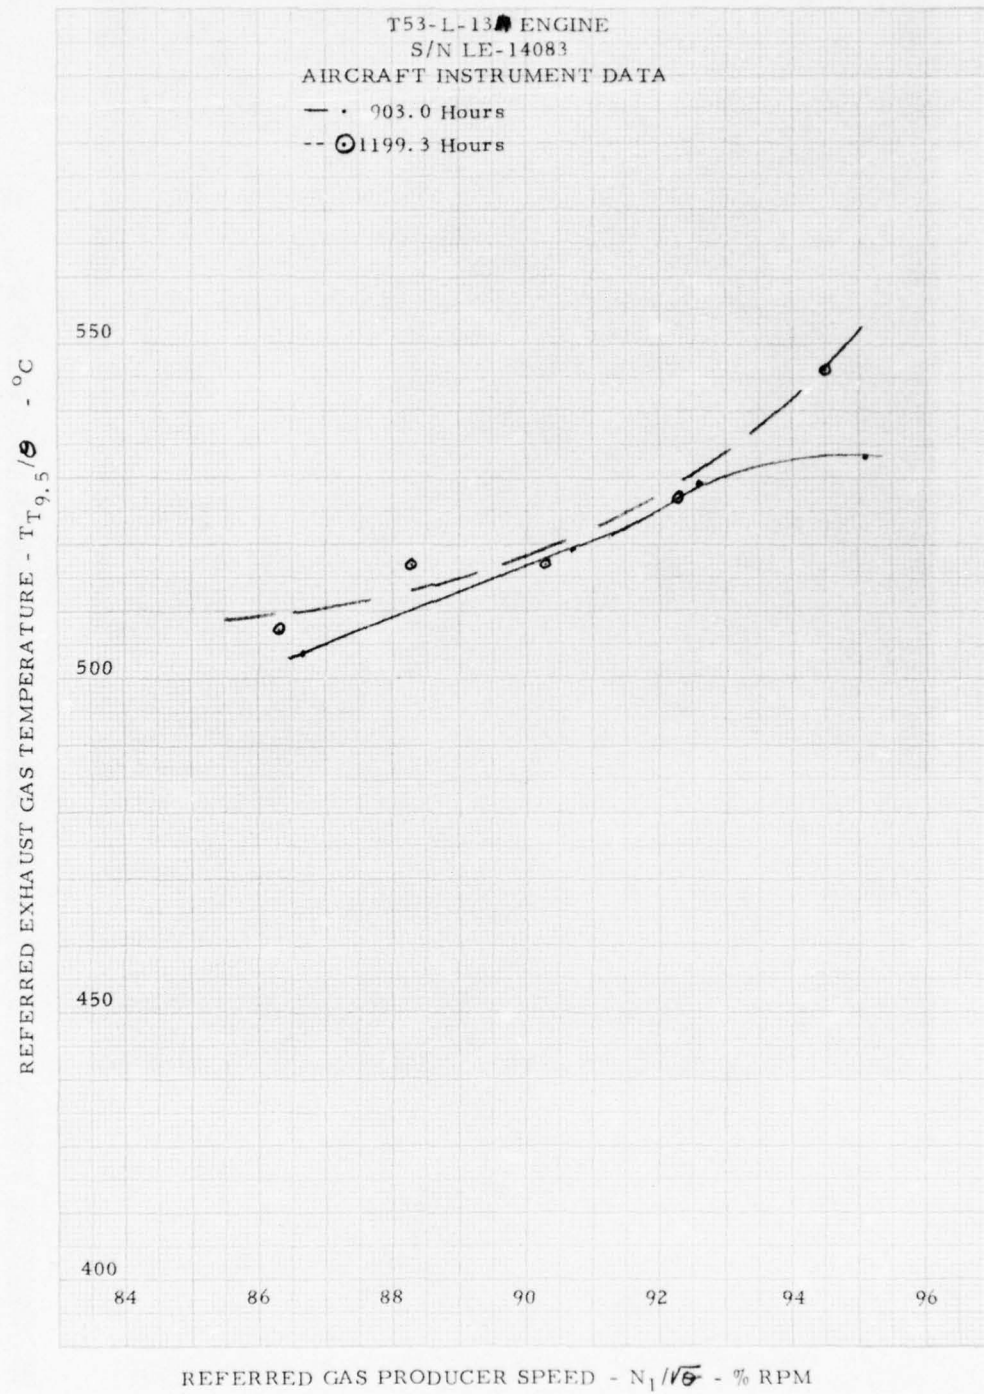
b. The engine received a complete analytical inspection by the engine manufacturer. In addition, the hot-end was analytically inspected by the USAAVNTBD project engineer. Figures 30 and 31 show engine performance prior to removal at 1,199.3 engine hours compared to performance subsequent to reassembly after the 897.3-hour analytical hot-end inspection. Lycoming Report No. 1519.12.7, under Contract DAAE 11-67-C-0452(3), subject: "T53-L-13 Engine LE-14083 Performance Calibration and Inspection After 1,200 Hours of Field Operation," covers the analytical inspection results in detail. Some parts were reworked, primarily those which had corrosion or damage to protective coating.

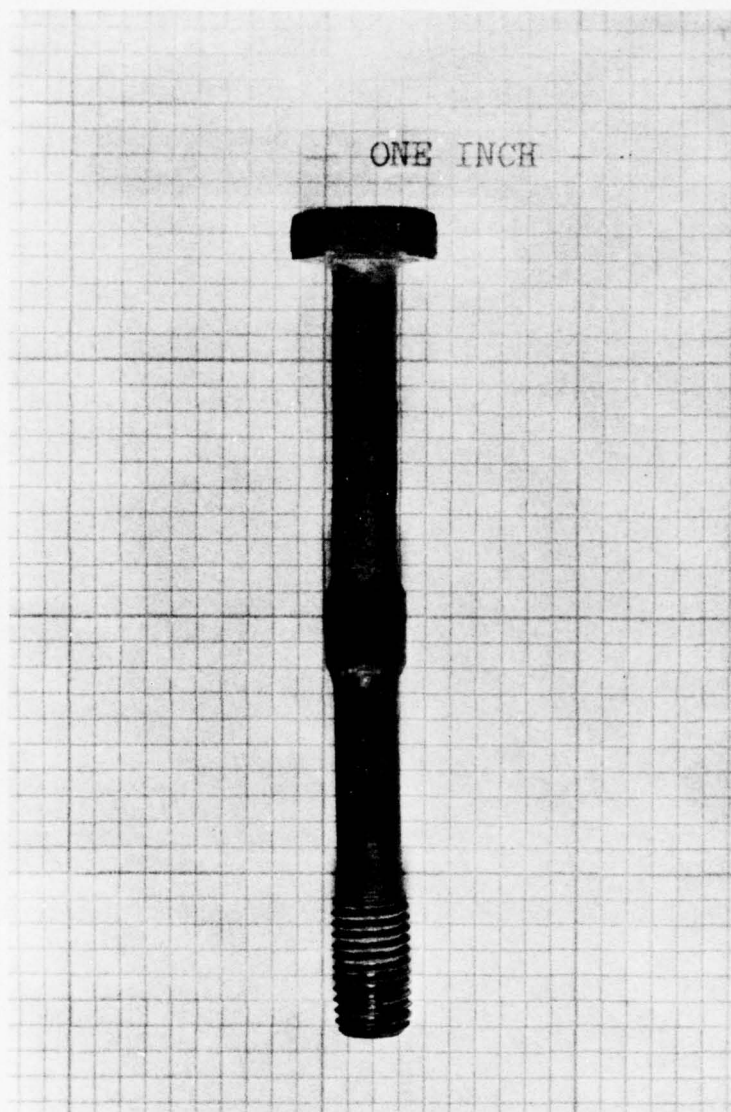
Figure 35.

| <u>Nomenclature</u> | <u>FSN and P/N</u> | <u>Component<br/>Hours</u> | <u>Reason for Replacement</u> |
|---|---|---|---|
| Power<br>Turbine Bolt | 5306-948-3240<br>1-140-168-02 | 1,199.3 | Bowed and distorted. Standard bolt installed (figure 35). |

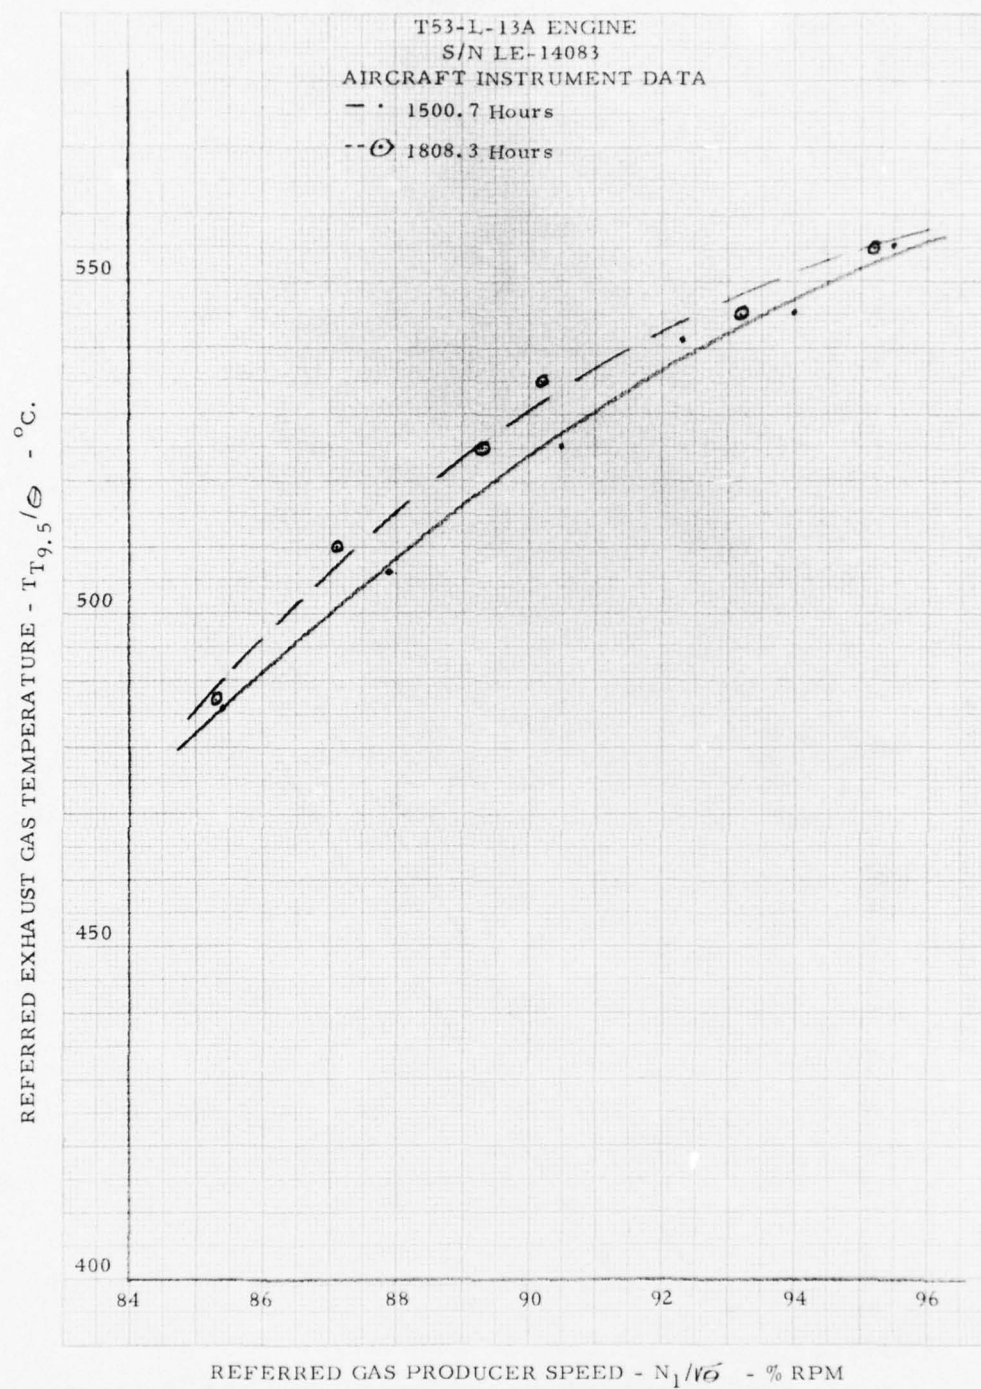
b. Figures 43 and 44 show engine performance prior to removal at 1,808.3 engine hours compared to performance subsequent to reassembly after the 1,500.7-hour analytical hot-end inspection.

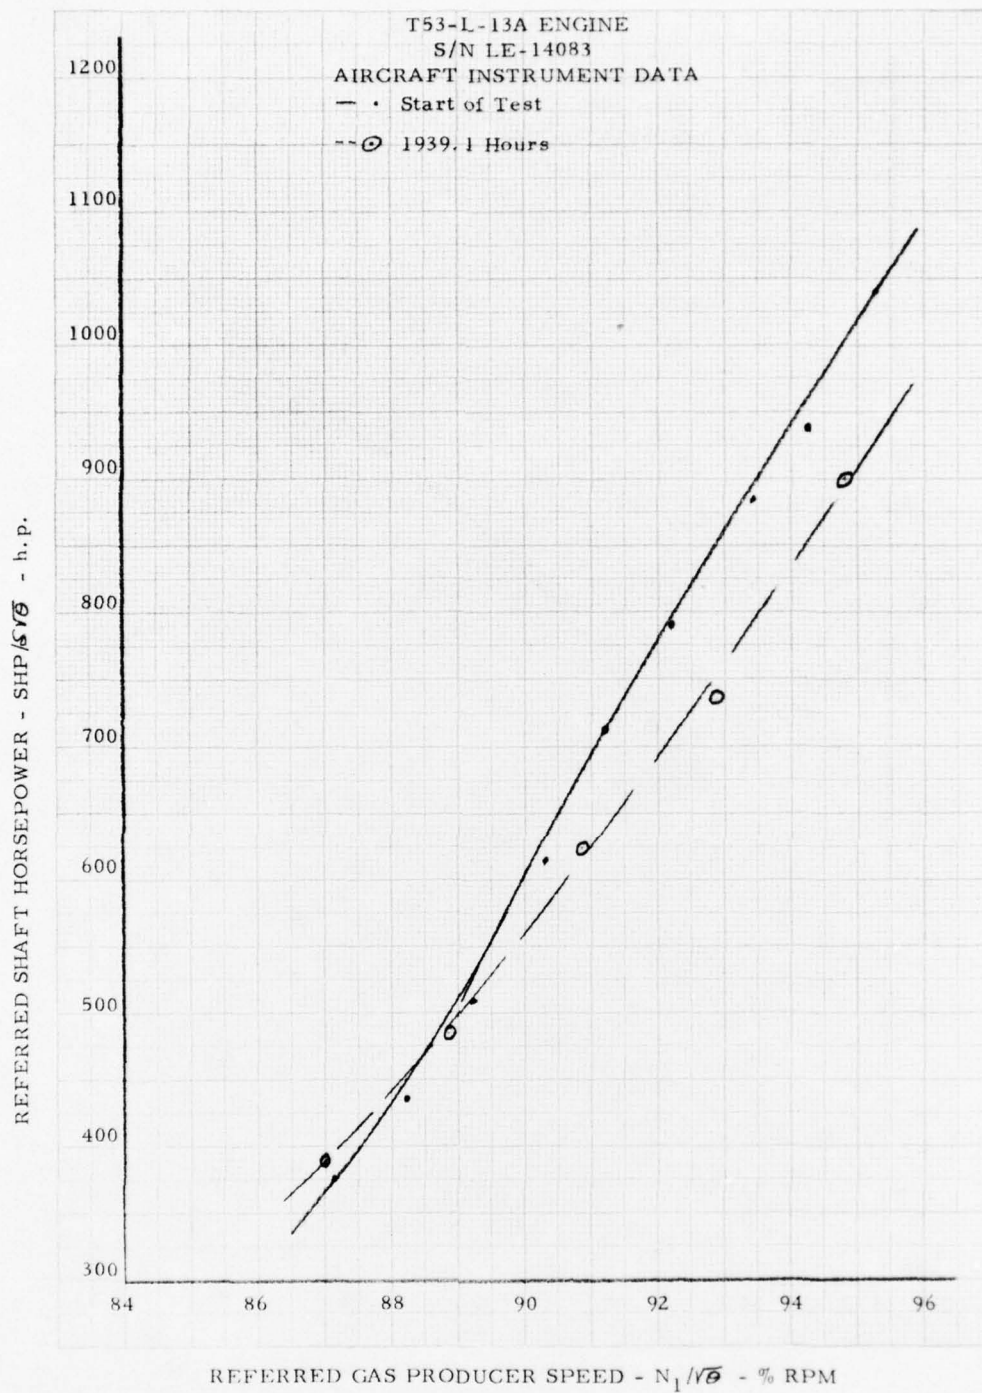
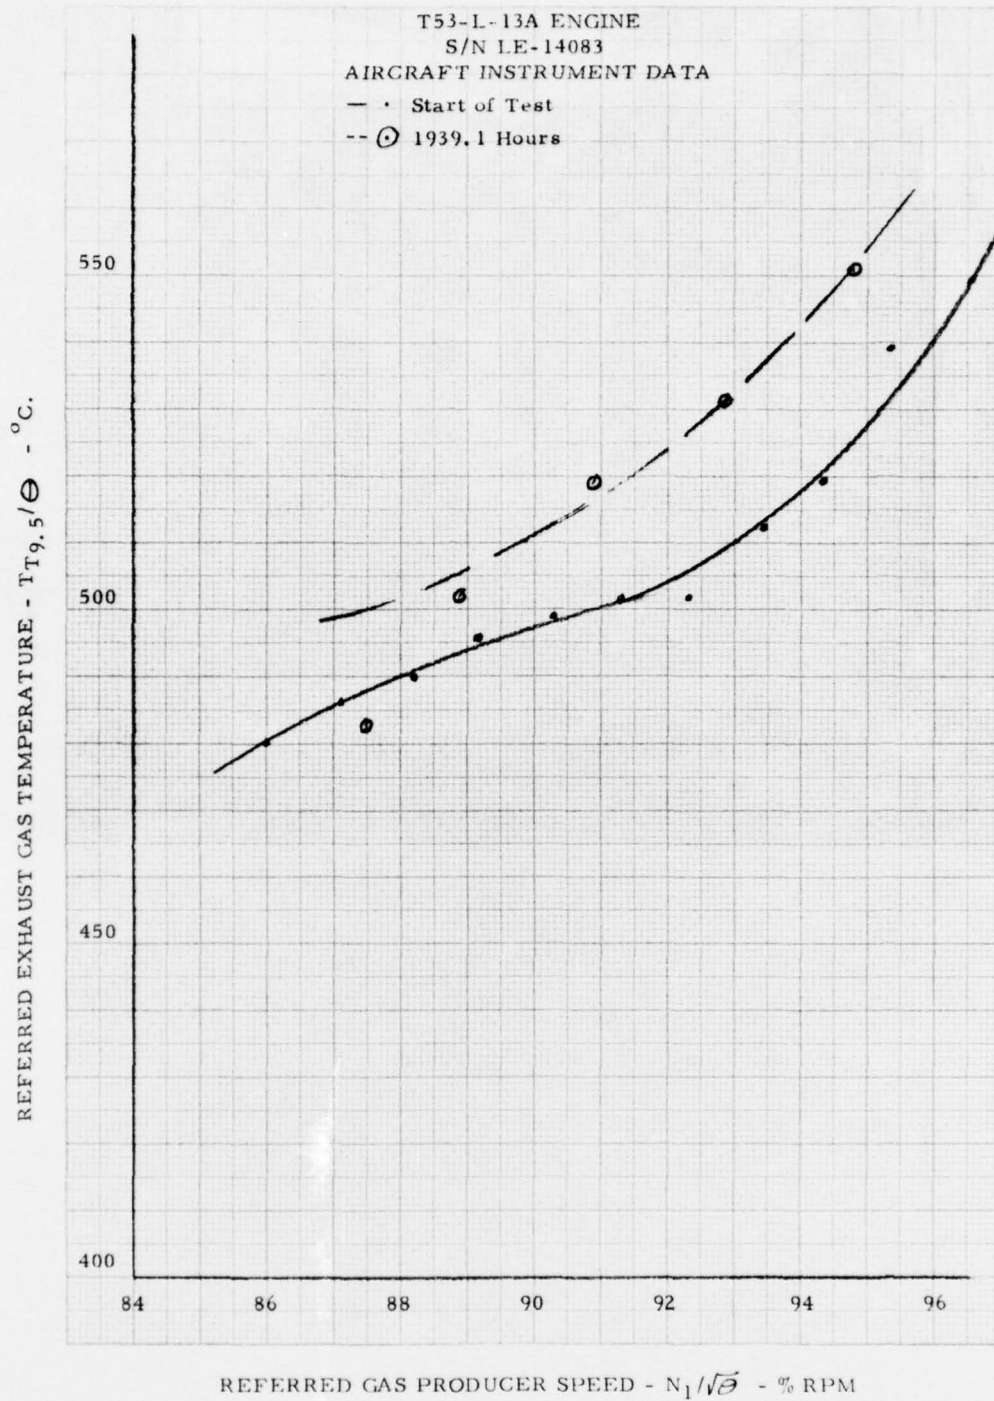
b. Figures 46 and 47 show the engine performance just prior to the compressor disc failure as compared to the performance after the 1,808.3-hour inspection. Figures 48 and 49 show the change in engine performance due to use and nozzle change during the 1,839.1 hours of operation at the USAAVNTBD.

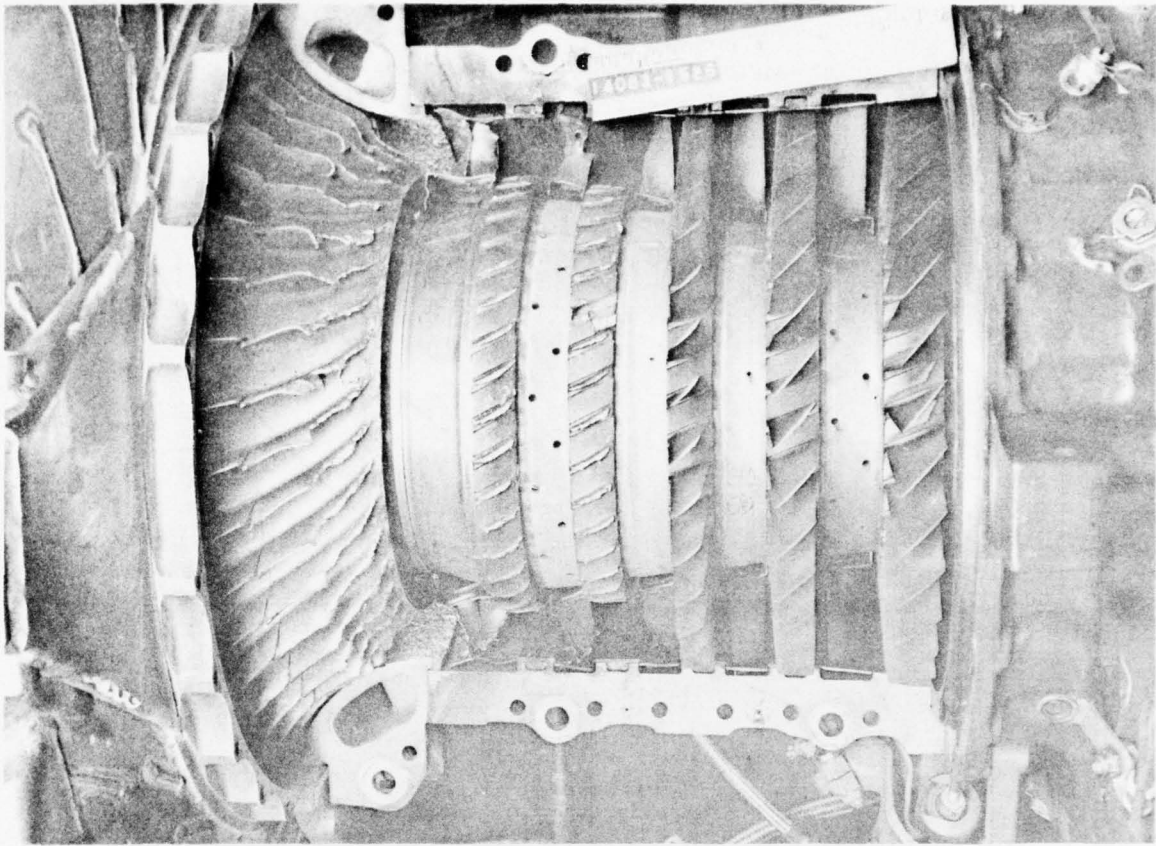
Figure 50.

c. Inspection at the manufacturer's plant revealed that the engine had experienced a fourth-stage compressor disc tenon failure. All the blades in the fourth and fifth stages were broken at the base. Extensive damage was present in the third-, fourth-, and fifth-stage stators. The centrifugal compressor had extensive damage and the hot-end was burned up. Figure 50 shows the compressor and figure 51 shows the failed tenon. The manufacturer stated that evidence of fatigue and stress corrosion were present and that the  $N_1$  overspeed reported at 1,010.0 engine hours might have contributed to the failures. Figure 52 shows a close-up of the failed tenon.
