Special Report 76-8

A SURVEY OF ROAD CONSTRUCTION AND MAINTENANCE PROBLEMS IN CENTRAL ALASKA

E.F. Clark and O.W. Simoni

October 1976

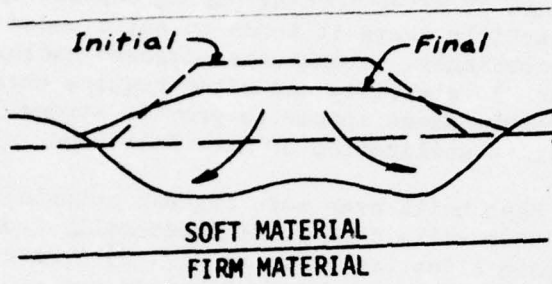
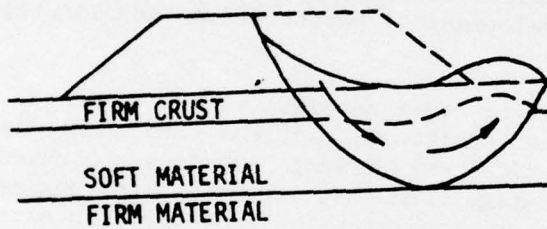
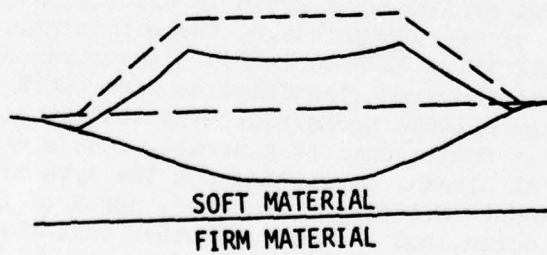
A few roads have been built over soft organic materials (such as peat or muskeg), but these soils tend to flow laterally from under the embankment to one or both sides (as shown in Fig. 2) during trafficking. Current knowledge of peat and muskeg classification and properties, and current practices in testing and engineering construction are reported in Robison and Dodd (1962) and Philainen (1965). The prevalence of peat and muskeg throughout the Subarctic seems to justify an increase in research aimed at development of better design and construction criteria for its use.

Figure 2. Typical embankment problems over soft foundations (Highway Research Board 1971).

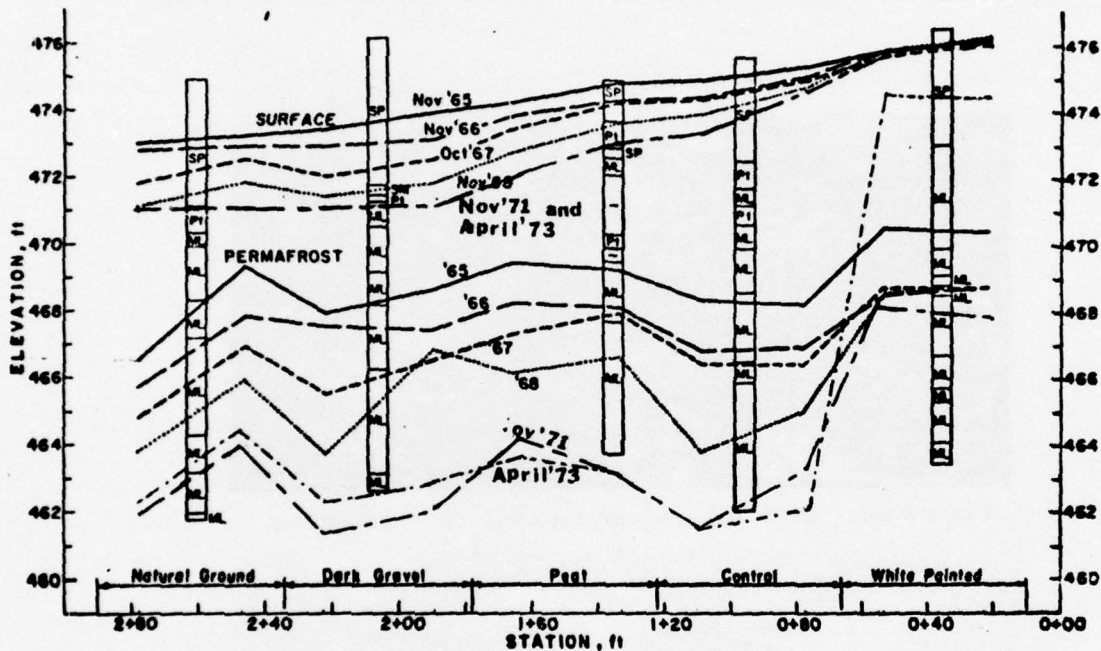
test sections. Surface subsidence and depth of the permafrost table were determined periodically over a period of eight years due to the change in the thermal regime only (Fig. 14)(Berg and Aitken 1973). The sections were not trafficked.

Figure 14. Highway test sections, permafrost degradation and surface subsidence.

As shown in Figure 14, embankments constructed under unfavorable permafrost conditions may not stabilize for approximately 8 to 10 years. In some instances settling may continue for as much as 20 years, because the thickness of most highway gravel embankments in central Alaska, excluding deep fills, is not great enough to insulate the permafrost. The high ice content of permanently frozen silt is widespread in central Alaska, and highways are sometimes unavoidably founded upon such permafrost. The amount of ice, which may vary from interstitial to massive, is responsible for differential settlement as thawing progresses. The normal staged construction practice of the Alaska Department of Highways is to continue regrading the gravel road and filling in low spots for about five years before even considering paving. Paving a highway, even after it has stabilized under a gravel surface, will cause more thawing and subsidence through the increased thermal absorption of the asphalt surface.

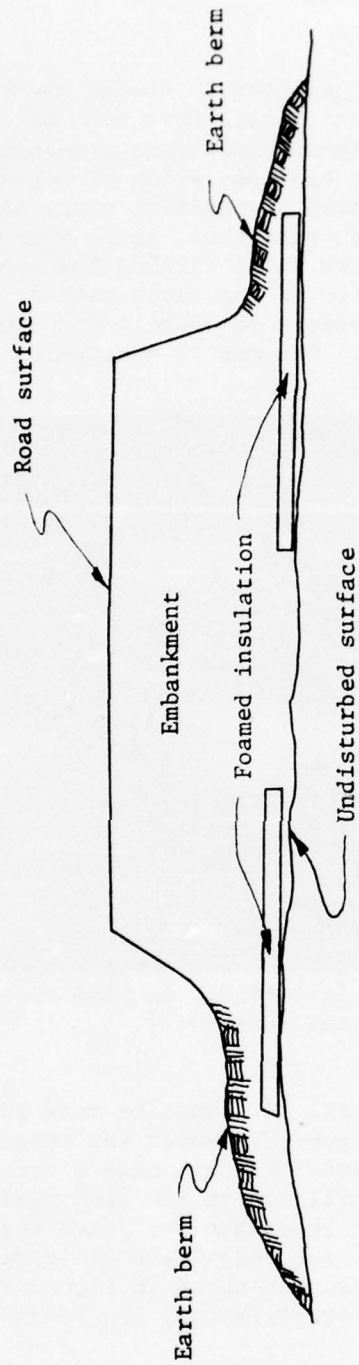
Figure 25. Use of foamed insulation to prevent shoulder failure.

The above photographs illustrate but a few of many such failures observed. In cases in which failures are caused by permafrost degradation at or under the toe of the embankment, use of insulation such as polyurethane or polystyrene in and extending out from the shoulder might provide a solution (Fig. 25). Earth berms extending several yards from the embankment might also serve a useful purpose in preventing this type of failure.

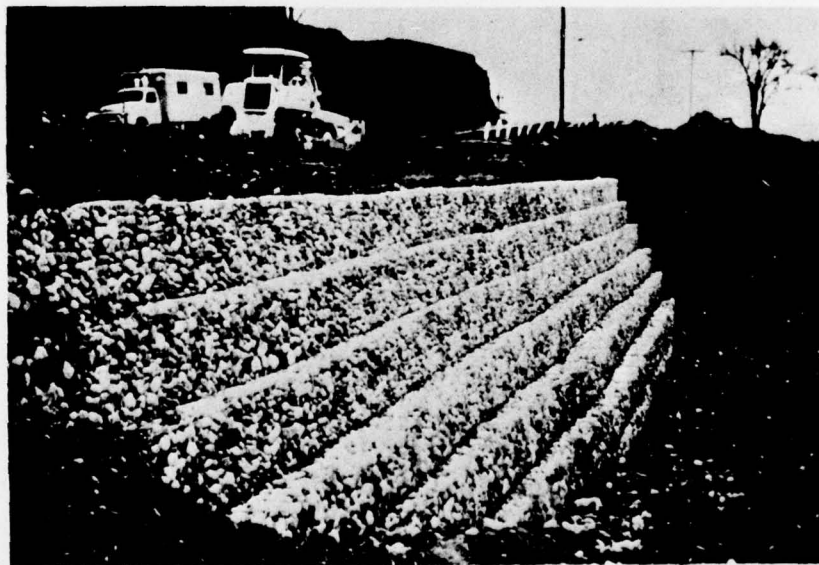
Figure 30. Gabions used to construct a retaining wall.

is considered to be justified. Research approaches might include identification and testing of fast growing plant species, use of organic mats to provide nutrients and conserve moisture, and use of gabions (wire baskets filled with rock) as shown in Figure 30.

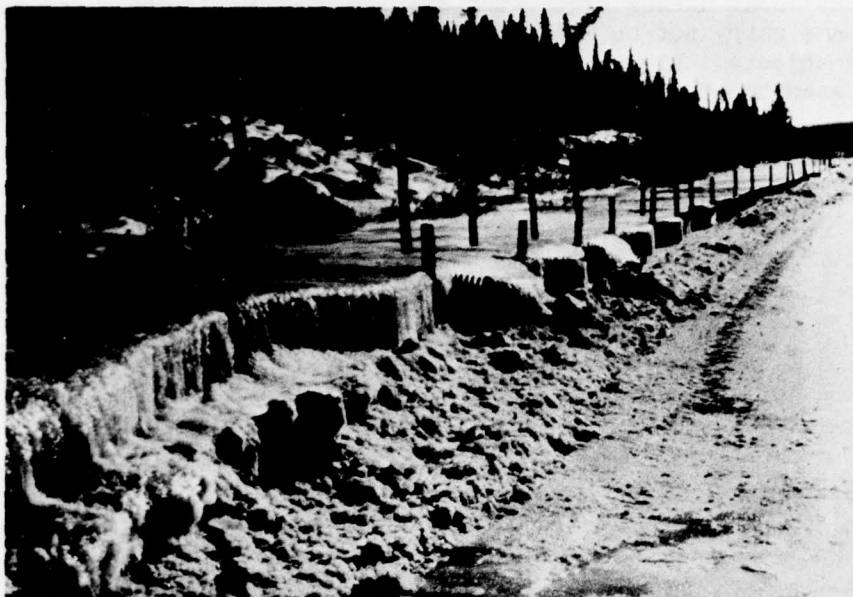
Figure 32. Fence to control icing on the Richardson Highway near Paxson, Alaska.

Another way of minimizing culvert icing is shown in Figure 31. The culverts may be placed at several elevations so that drainage may continue as the lower culvert freezes over. Icing over roadways occurs not only at the streams and culverts but also at side hills. Water seeps out of the upper slope and into the roadway where it freezes. Figure 32 shows a fence erected by the side of the road for control and containment of the freezing water. The Alaska Department of Highways prepared frostbelt areas at suitable sites to control icing. A frost belt area allows deep frost and icing to develop away from the road surface (Carey et al. 1975).

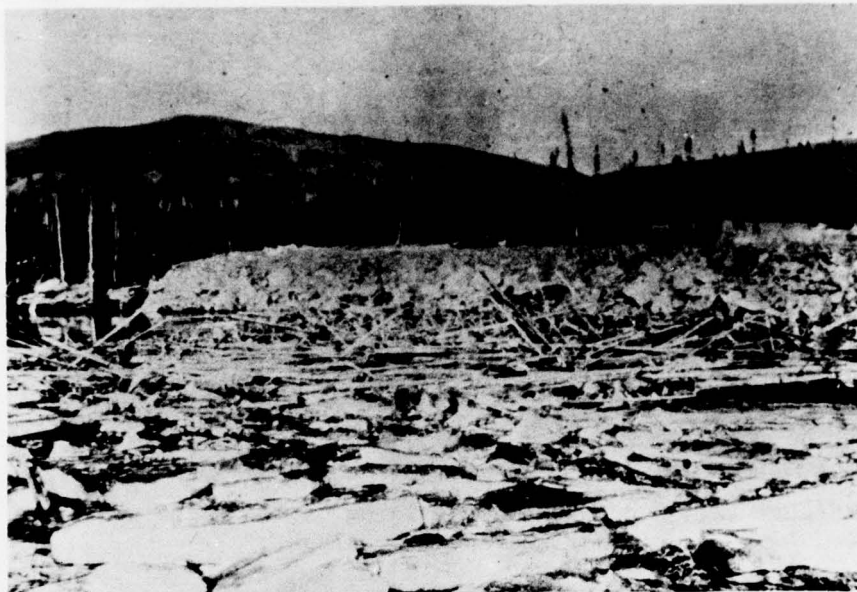
those that occur during high water and ice breakup. During breakup the streams carry not only ice floes but also logs, brush, and other floating objects. Figure 34 (a photograph of Hess Creek, 1973) shows a typical assortment of ice floes and debris during the spring breakup.

Figure 34. Ice breakup at Hess Creek.

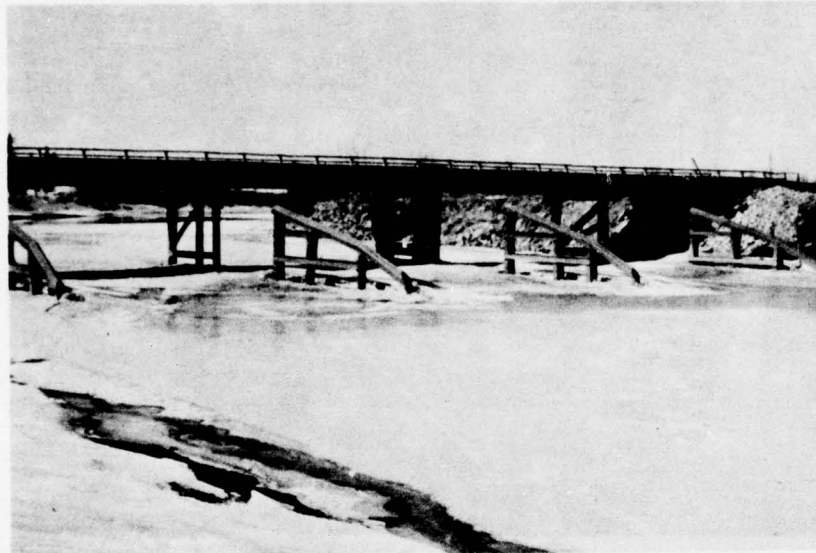
Figure 38. Ice and debris deflectors to protect bridge bents, Engineer Bridge, Fort Wainwright.

deflection devices such as those used for a pile bent bridge across the Chena River on Fort Wainwright (Fig. 38) have been found useful for some bridges. These deflectors are constructed of "H" beams and placed approximately 15 ft upstream from the bents. A crane is used to clear debris from the deflectors.
