# Softbody Impact Resistance of Beryllium/Titanium Composite Blades

Detroit Diesel Allison  
Division of General Motors Corporation  
Indianapolis, Ind. 46241

May 1976

TECHNICAL REPORT AFAPL-TR-76-69  
Final Report for Period July 1975 - March 1976

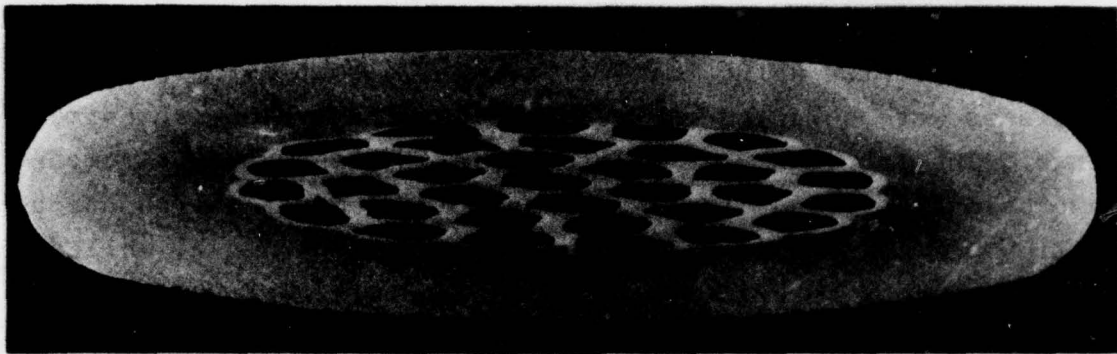
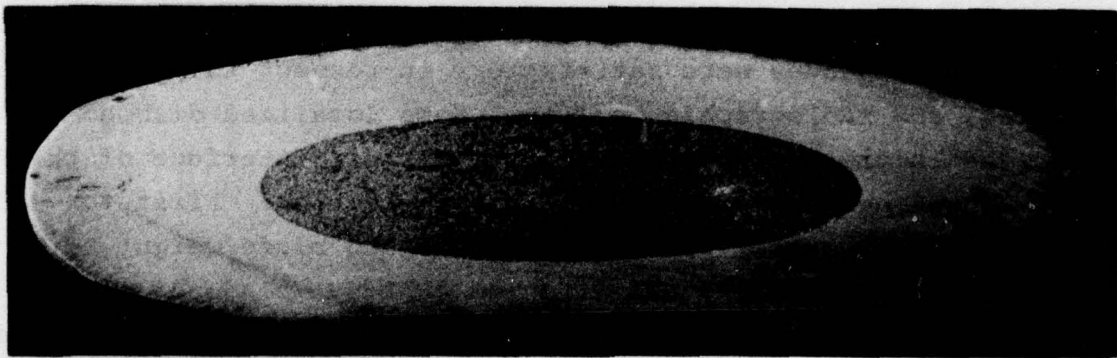
Figure 1. Macrostructures of Be/Ti composite extrusions fabricated from (a) continuous Be rods with wrought Ti and (b) Be and Ti powders (Mag. 2 1/2 X) (Keller's Etch)

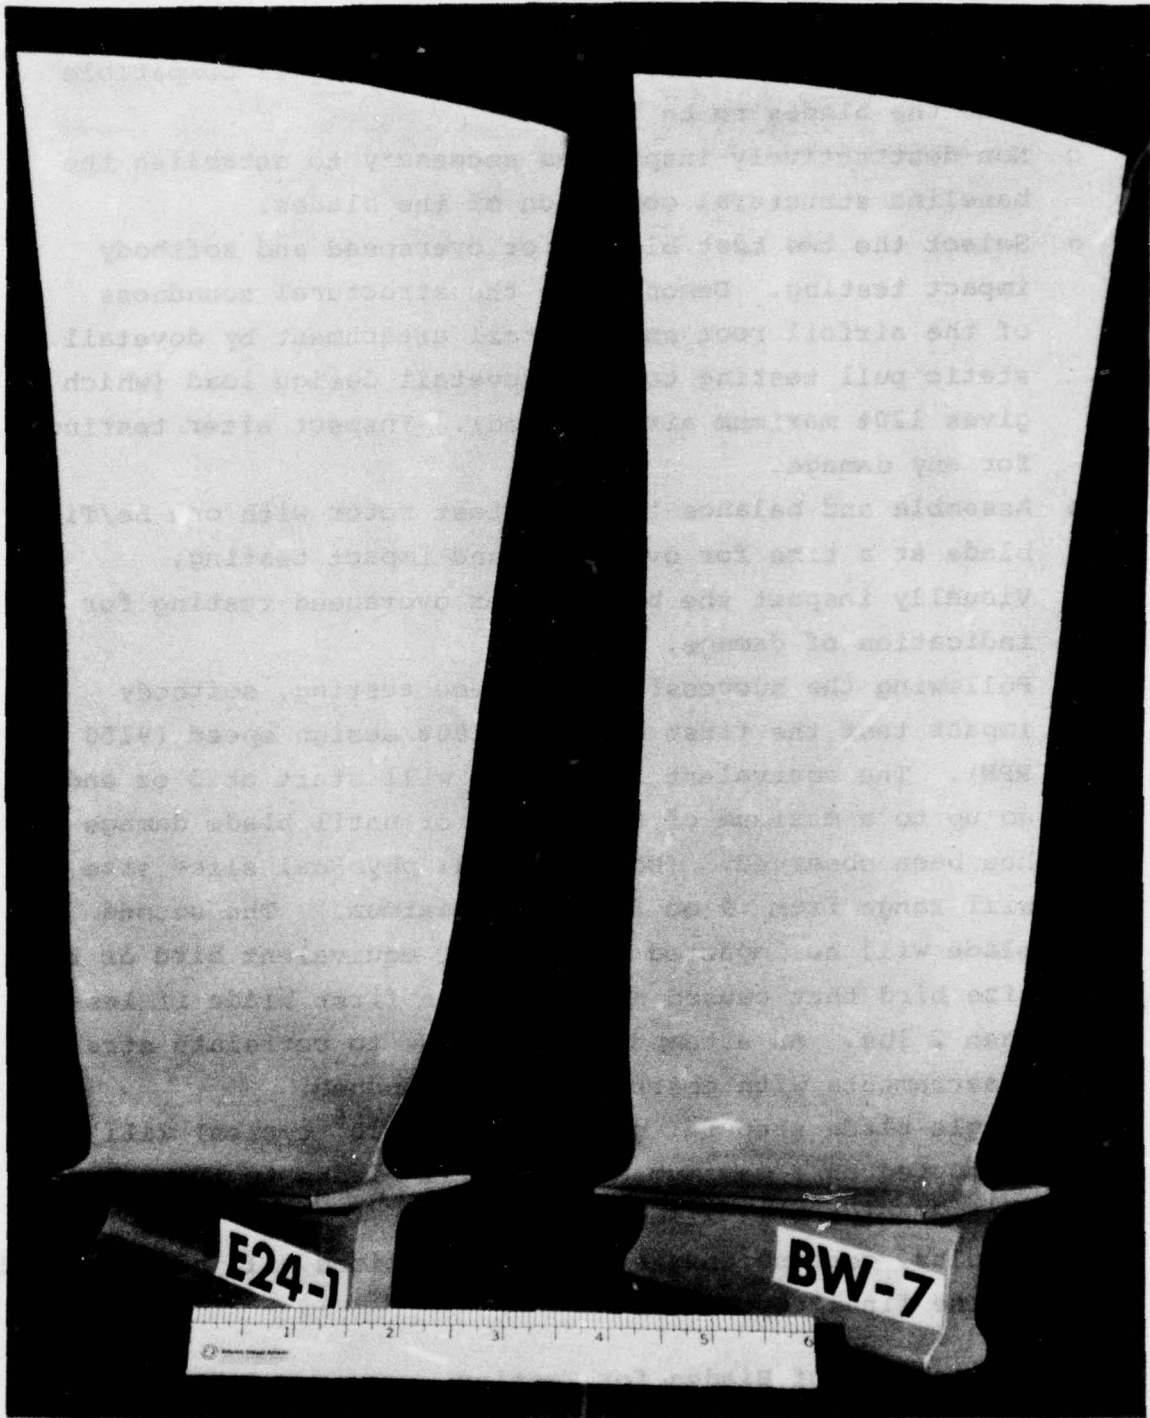
Two of the finished machined Be/Ti blades are shown in Figure 2. All seven of the blades were satisfactory in respect to visual, dimensional, and radiographic quality. Some localized disbond was observed in the root block-composite airfoil interface of the blades as shown by fluorescent penetrant inspection. First torsional resonant frequency was increased 11% and blade weight reduced 9%, compared to the all titanium (6AL-4V) blade of the same basic design. Tensile properties and metallographic structures were determined from one blade forging of each type composite material. Tensile strengths of the Be/Ti rod composite airfoil ranged from 90-91 ksi and the Be/Ti powder composite airfoil produced strengths of 46-67 ksi.

Figure 2. Finish machined TF41 Be/Ti Composite LP-1 Fan Blades  
S/N E24-1 (Be Rod/Ti) and BW-7 (Powder Be/Ti).

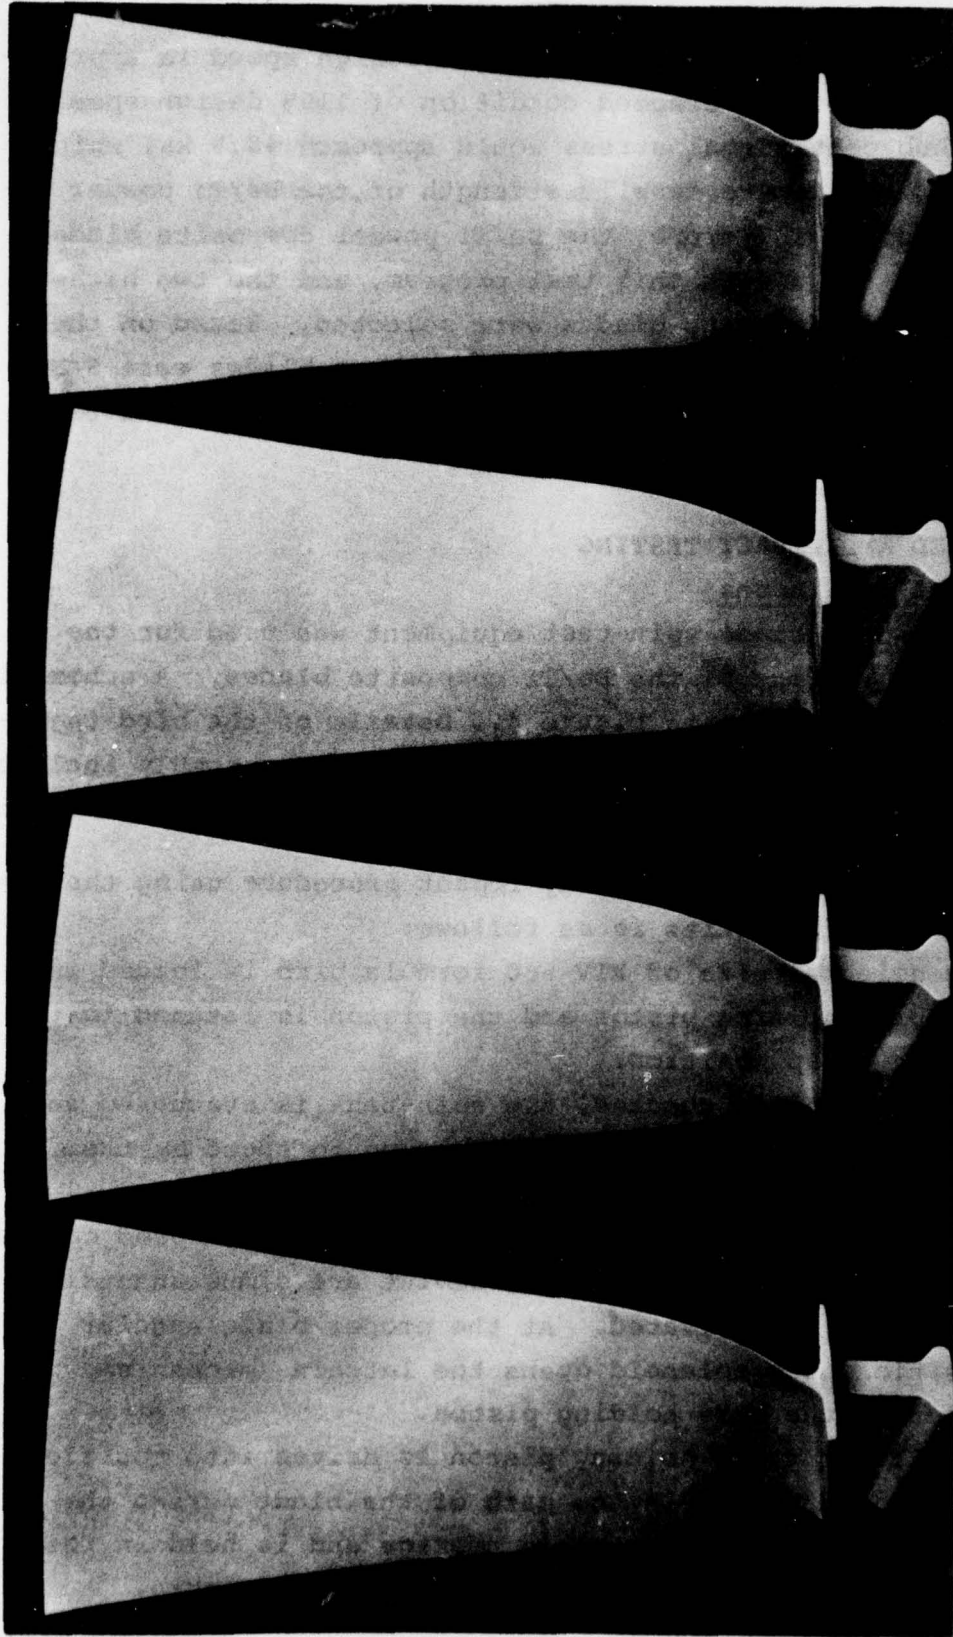
stress at the hub of the airfoil for 100% design speed is approximately 40 ksi. At the overspeed condition of 110% design speed, the average hub centrifugal stress would approach 48.5 ksi which could exceed the ultimate tensile strength of the Be/Ti powder composite airfoil. Therefore, the Be/Ti powder composite blades were eliminated for use in this test program, and the two highest quality Be/Ti rod composite blades were selected. Based on the fluorescent penetrant inspections, the two best blades were S/N E23C-3 and S/N E24-1 with S/N E24-1 being the better of the two (see Figure 3).

Figure 3. Pressure surface of finish machined Be rod/Ti composite fan blades.  
(Magn. .4X)

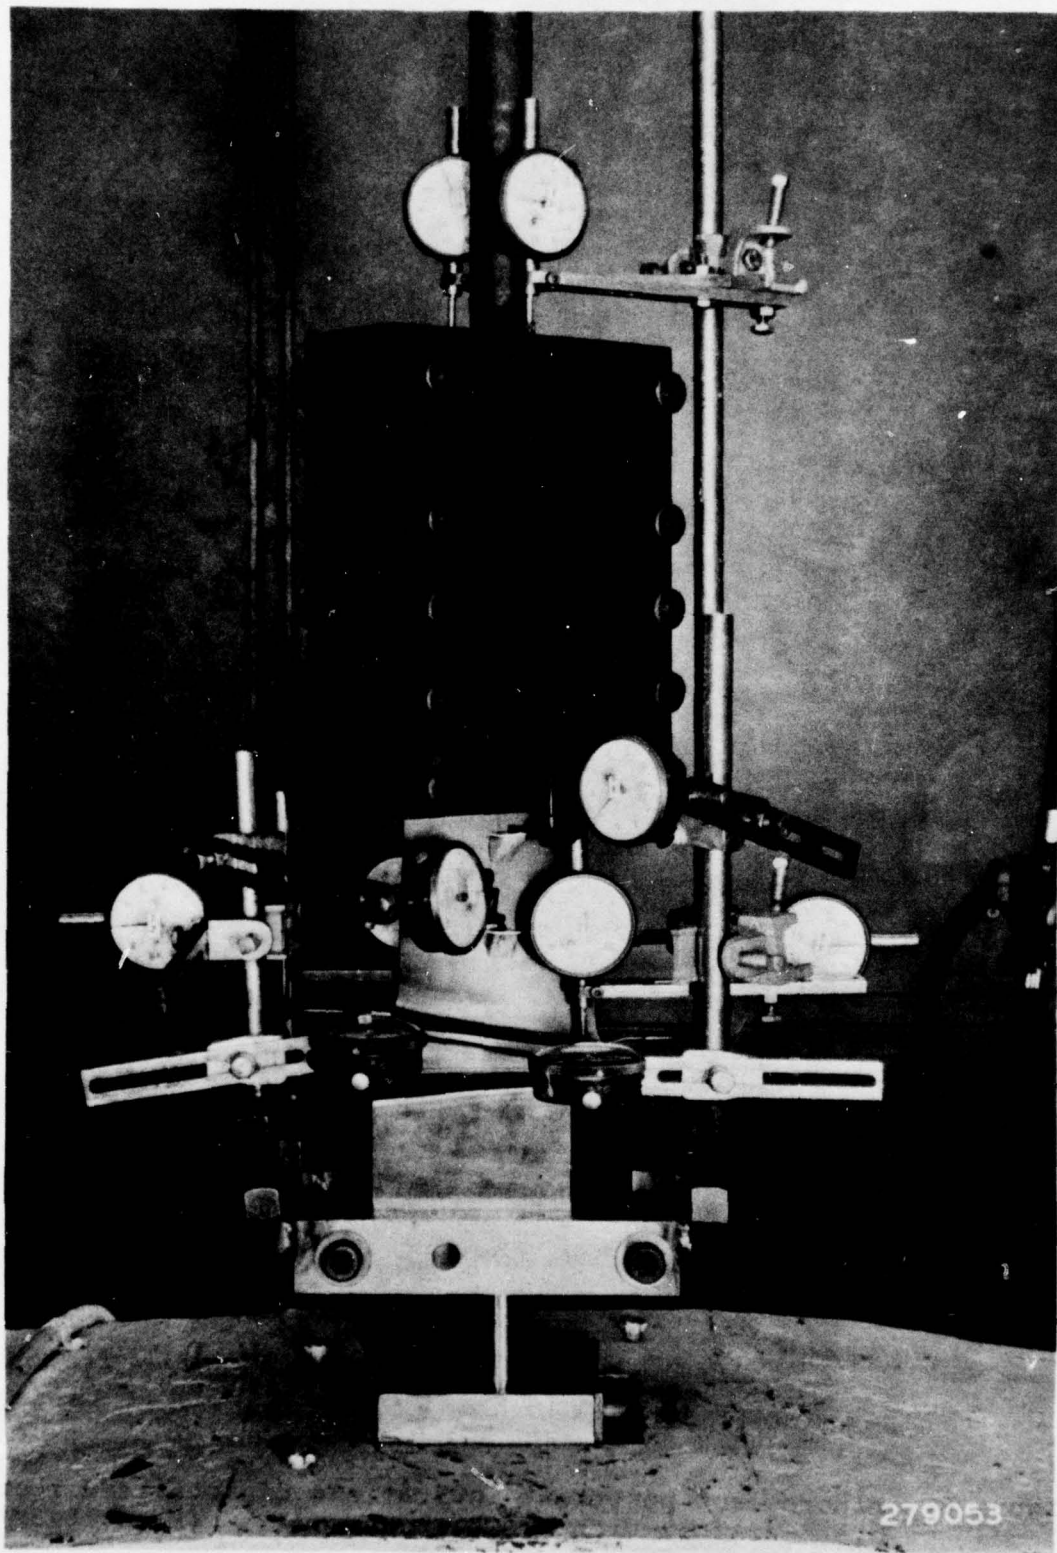
Figure 9. Dovetail-Pull Test Set-Up.

The first Be/Ti rod blade (S/N E24-1) to be spin tested, was mounted in the static pull-test equipment and loaded to 40,000 lbs and held for 3 minutes. The application of load was continued to 51,000 lbs, held for 5 minutes, and then the load was removed. Pinging noises were heard during the application of load; however, an acoustic pick-up mounted directly to the airfoil did not generate any unusual noise such as might occur due to fiber or rod breakage. The pinging noises are thought to have come from the epoxy in the clamping fixture.

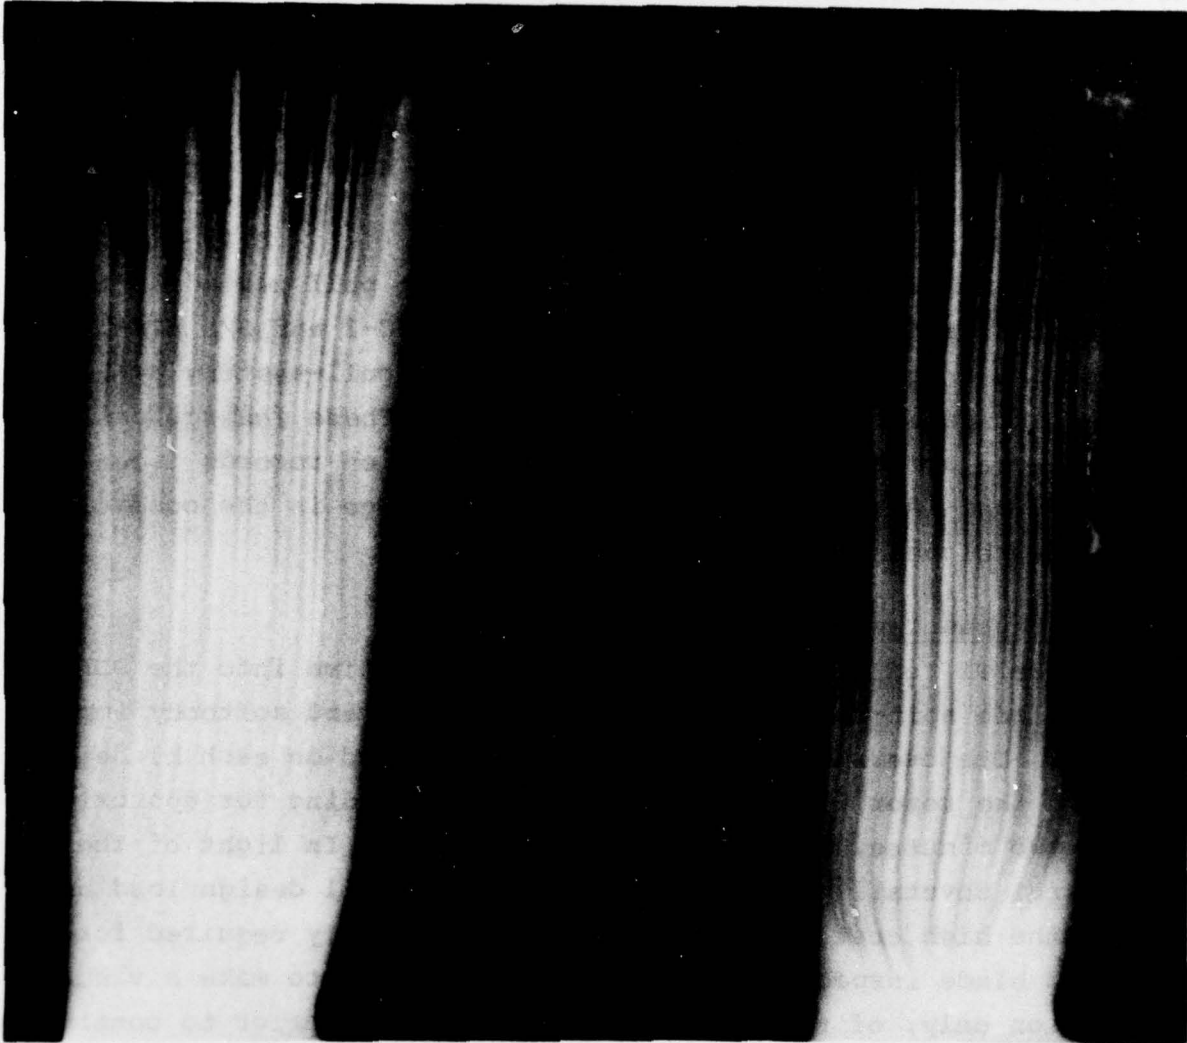
A third Be/Ti rod blade (S/N E23C-3) was also pull tested in the same manner as blade S/N E24-1. Both S/N E23C-3 and S/N E24-1 blades were inspected following the dovetail pull-testing by fluorescent penetrant inspection and x-ray. These inspection results were compared to the previous inspection records (see Figures 8 and 10) with the result that no change in the condition of the two blades was detected.

Figure 10. Radiographs of Be Rod/Ti Composite blade E24-1 after finish machining.

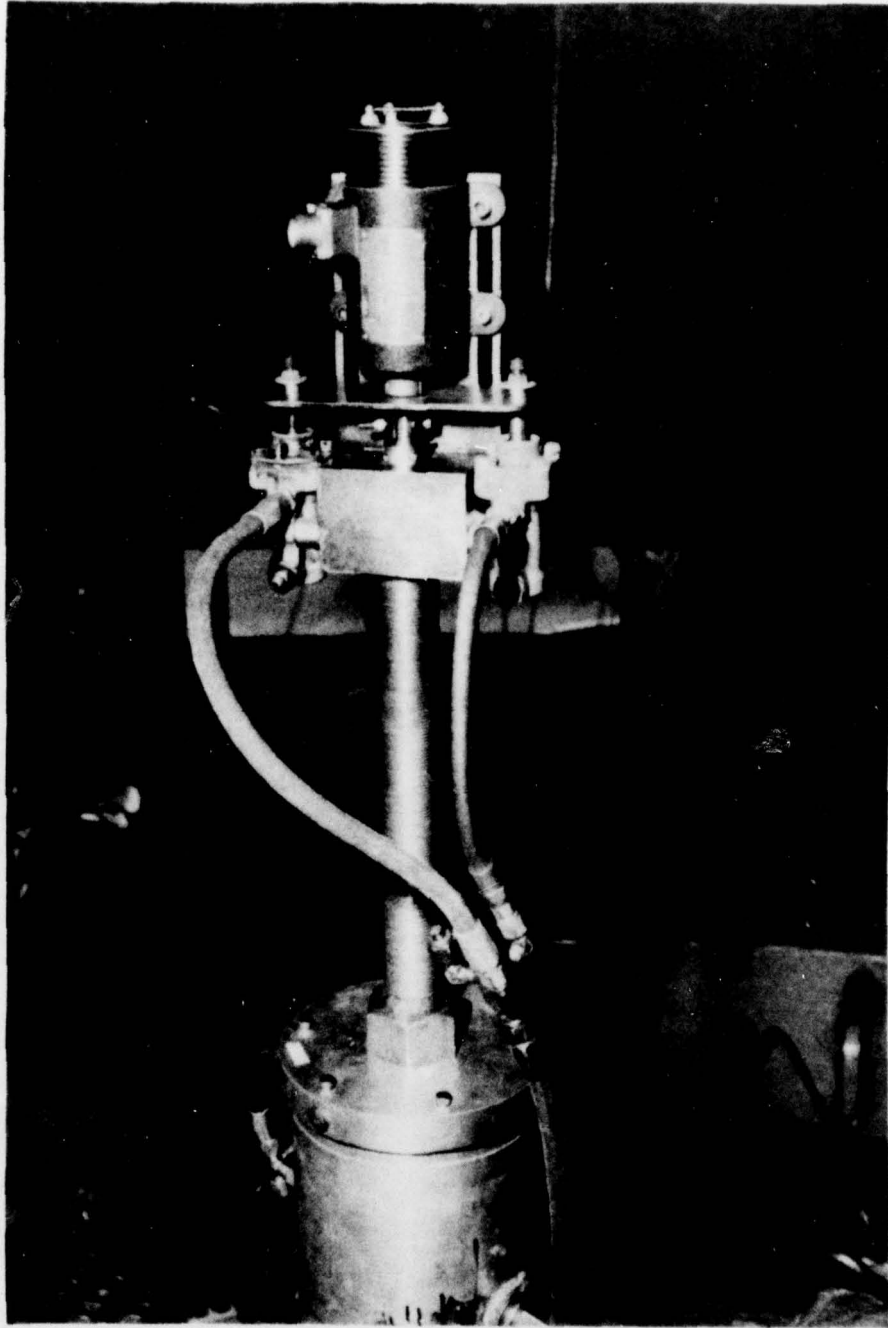
Figure 17. Modified Bird Injection Gun

A bench test setup of the bird gun was made in which vibration of the latch mechanism was induced in an effort to duplicate the misfire sequence. Latch disengagement was obtained with about one minute of vibratory load. Following this, a pneumatic latch lock was fabricated and installed on the bird gun as shown in Figure 17. Vibration of the mechanism was again induced and held for five

minutes without a misfire. The latch lock was then released and the gun was triggered successfully to simulate an actual test shot. this bench test sequence was repeated three times. A new check sheet procedure was formulated to fire the bird gun with no more than a six second delay after the latch lock was released.
