MISCELLANEOUS PAPER S-74-6

# EVALUATION OF DOW CHEMICAL PRODUCTION EXTRUDED TRUSS-WEB LANDING MAT

March 1974

Conducted by U. S. Army Engineer Waterways Experiment Station  
Soils and Pavements Laboratory  
Vicksburg, Mississippi

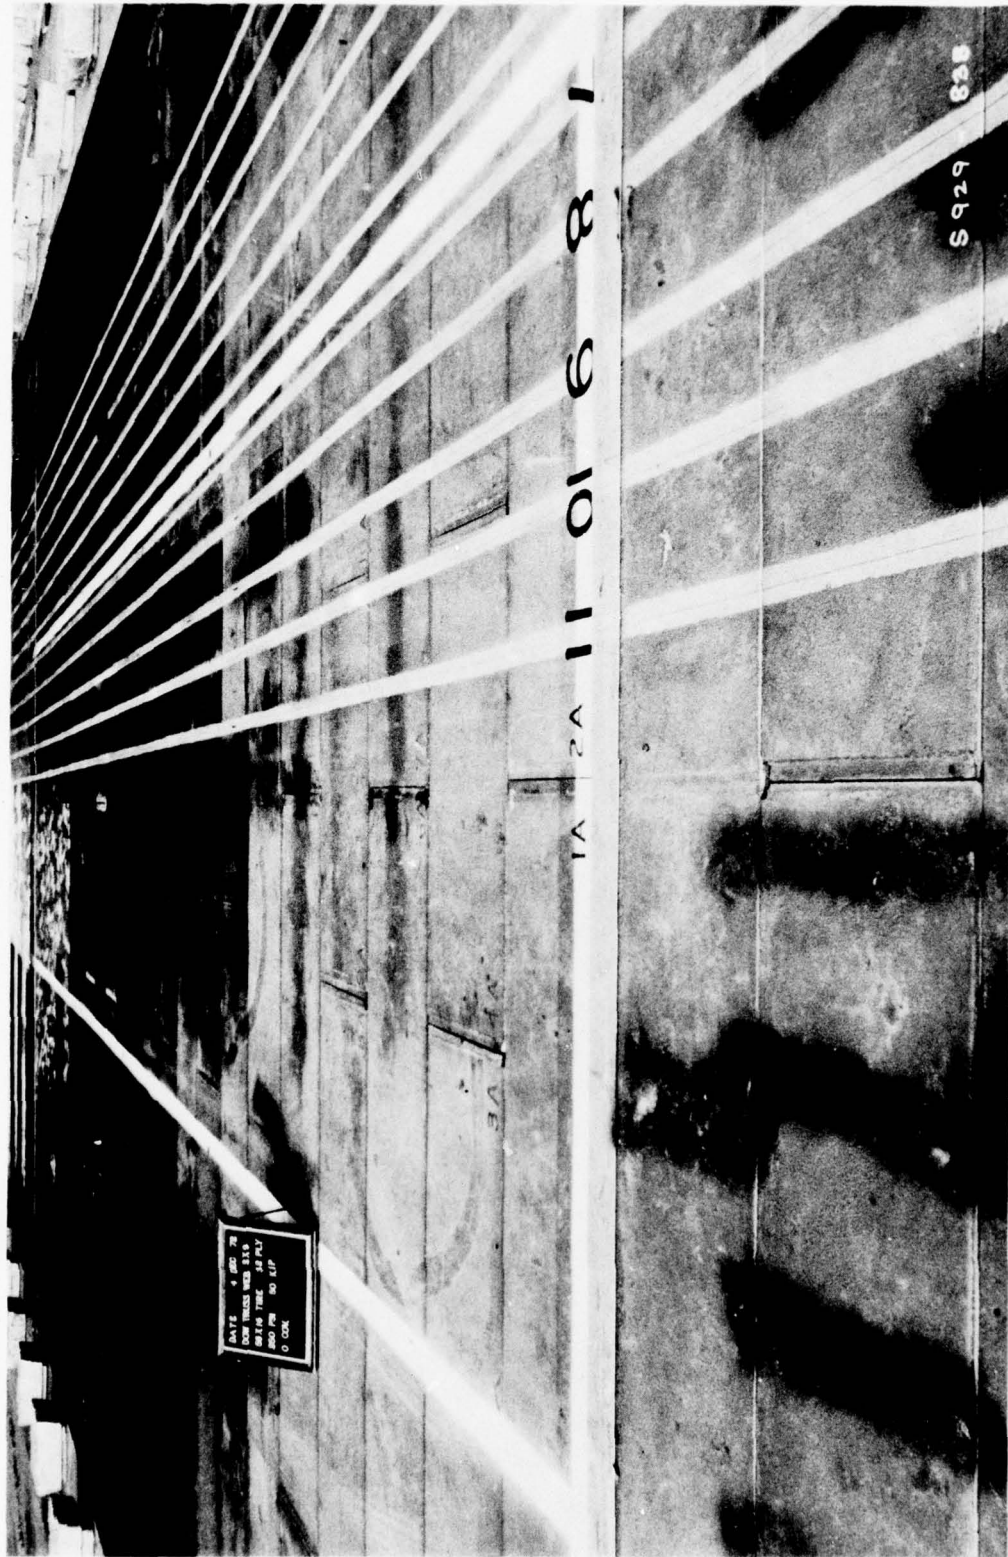
Test section prior to traffic

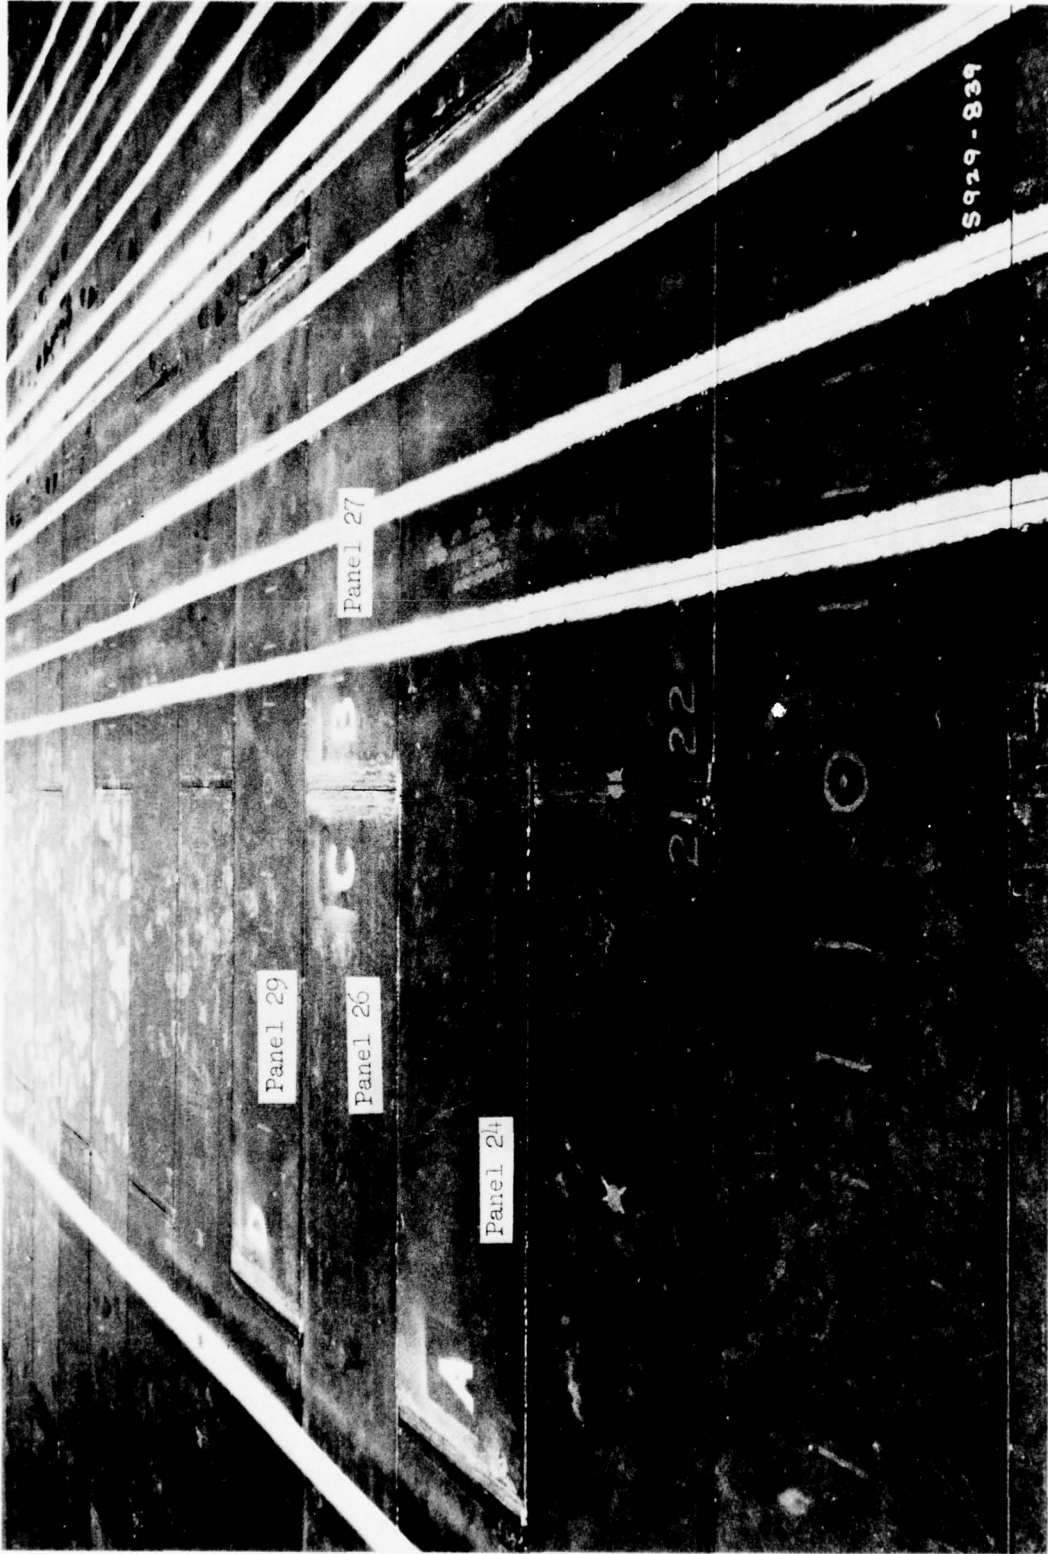
5. Prior to the application of traffic, the mat surface was generally smooth (Incl 9). Panels 24, 26, 27, and 29 shown on Incl 10 are panels which WES furnished APG for weld inspection and which were returned for testing in accordance with Incl 1. Curl at the end joints (Incl 11) was noted immediately during the application of the load cart on the mat for 0 coverage data. After 15 coverages, all panels in the traffic lane contained curls at the female I-lock corners of the end joints. Hairline cracks were noted in some of the panels in the flange of the female connector at the corners. The curls and cracks grew as the coverages were applied. Inclosures 12 and 13 show the typical condition of panels at the end of 100 coverages. Traffic was continued to 240 coverages (Incl 14) at which time the section was considered failed due to tire hazards caused by splits occurring at the female corners of the mat panels. No weld failures were noted in any of the panels. Inclosures 15-17 show the condition of typical failed panels at the end of traffic. The half panels also were curled at the female I-lock corners with one end of panel 9a split from the corner for 2 in. along the female connector. There were 33 full panels that contained cracks in the female connector at the corner from hairline up to 16-1/6 in. long. No attempt was made to replace any panels since the number of panels considered to be tire hazards exceeded the allowable 10 percent replacement criterion. Inclosures 18-21 show a typical split, wear, and abrasion on the connectors of the panels at the end of traffic. These inclosures show the condition of the panels at the end joints and at

Panels APG inspected for weld cracks

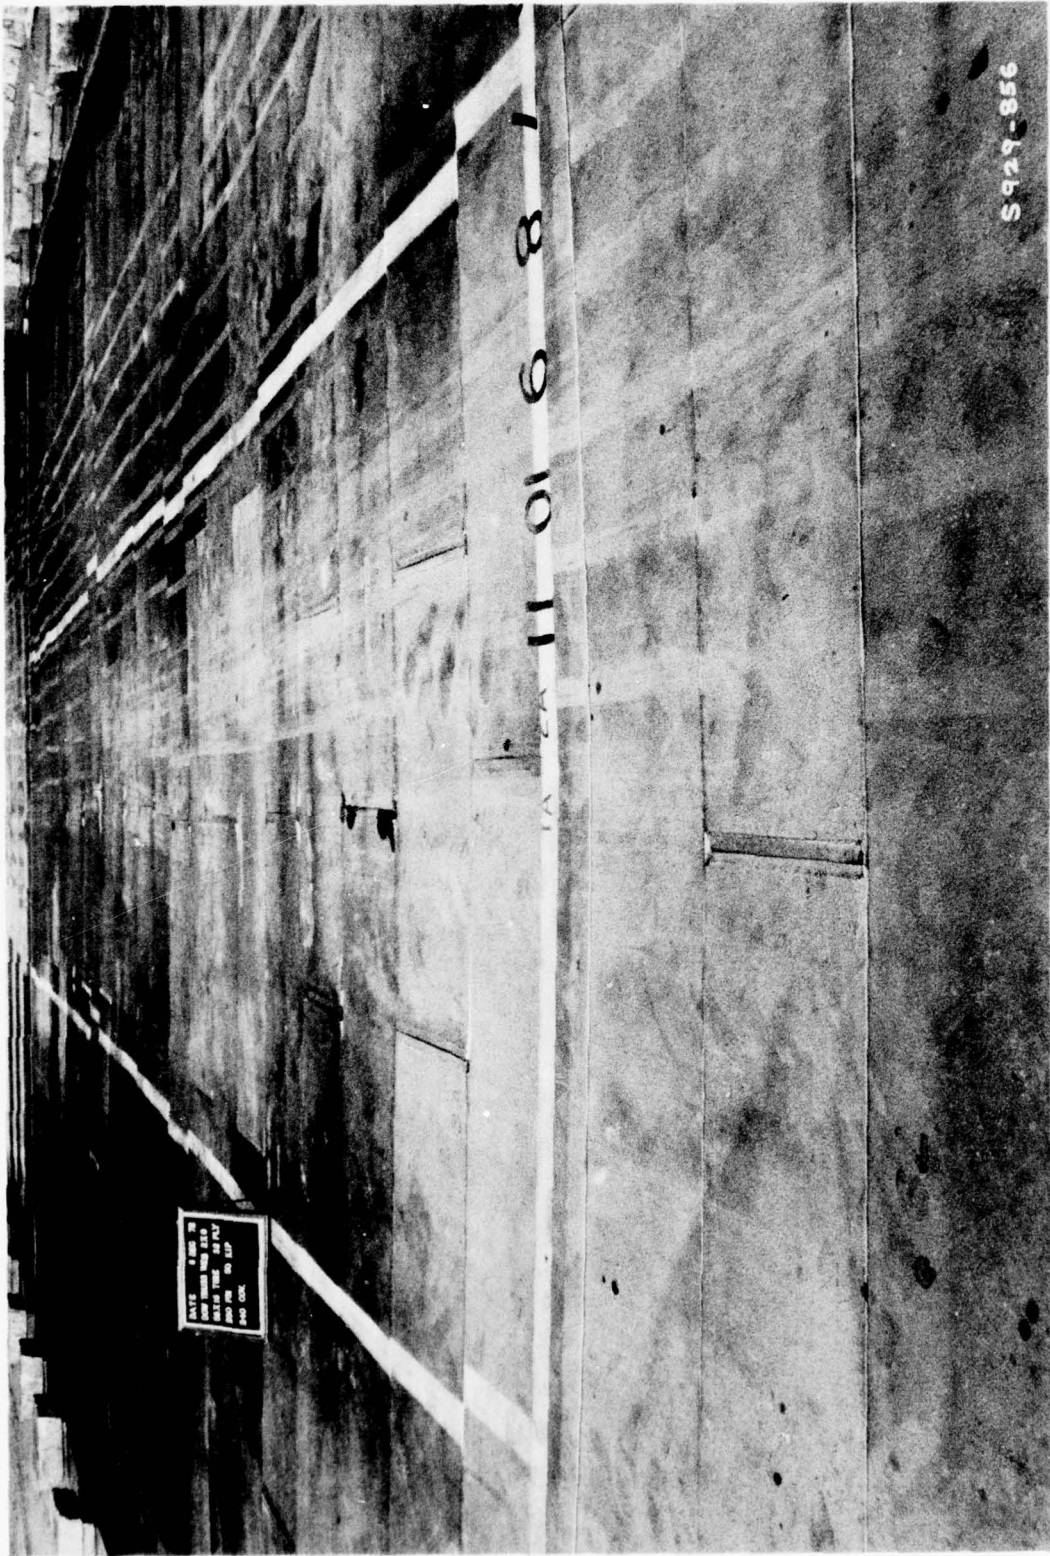
the center of panels where two end joints came together. Subgrade data taken at the end of the test (240 coverages) are given on Incl 6. It will be noted that the CBR at the end of the test was 4.2, thus giving a rated CBR of 4.0 for the test.

Test section after 240 coverages

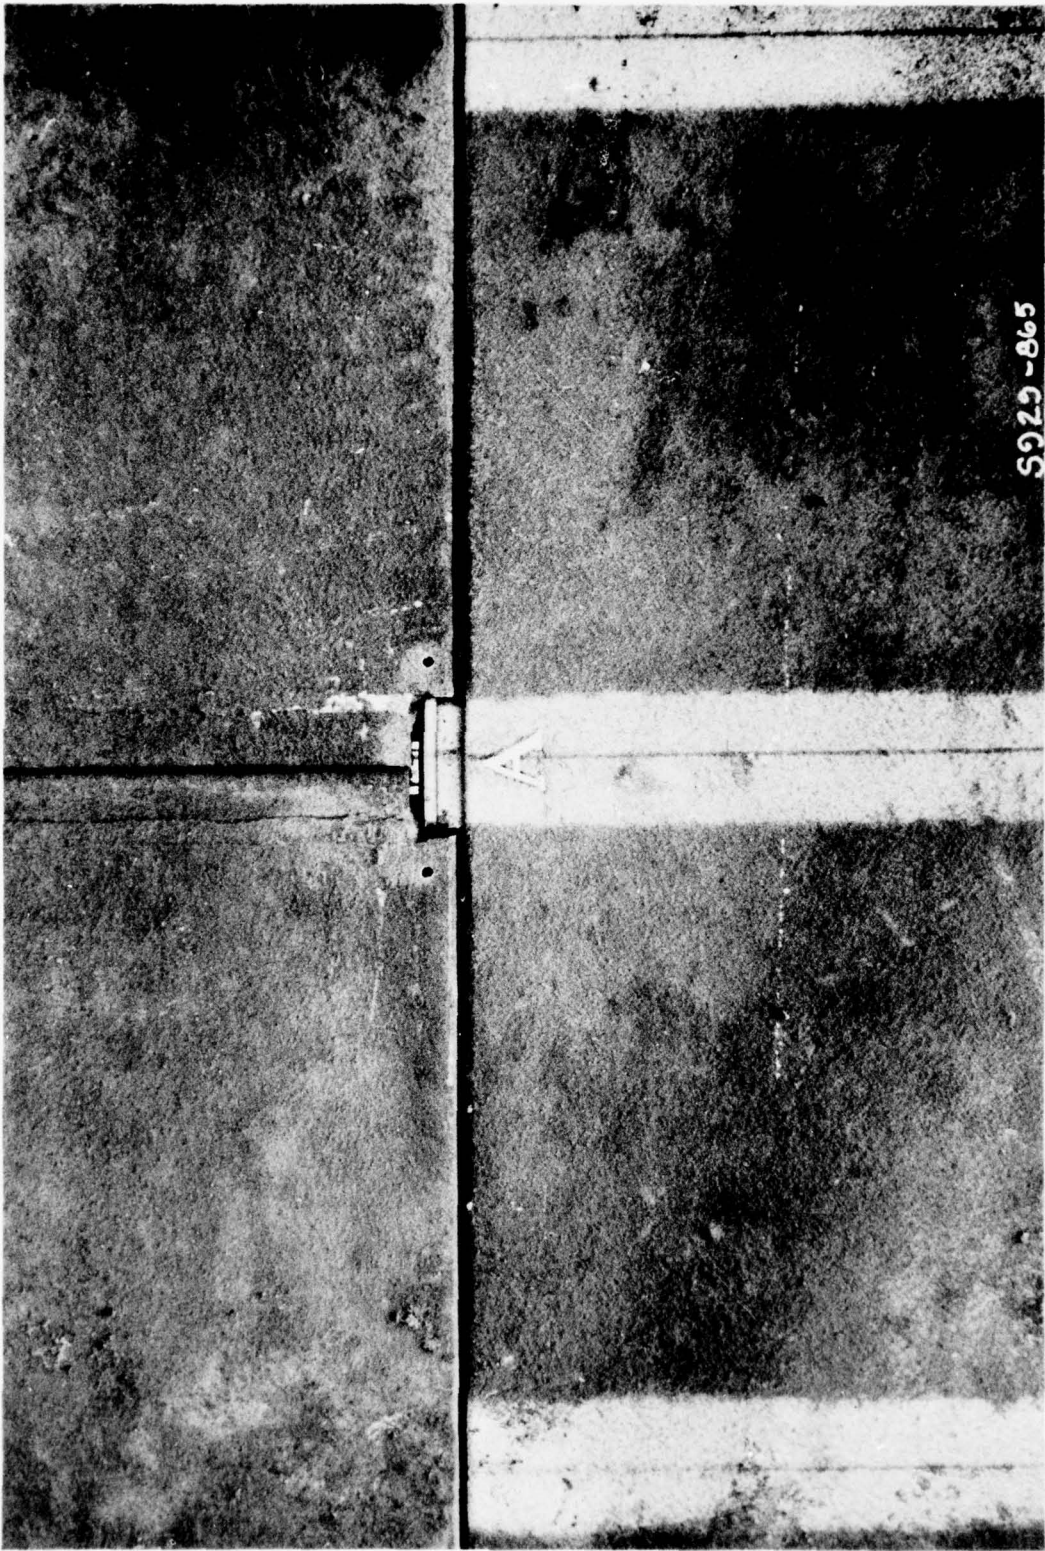
8. Channelized traffic with the same load used in the preceding test was applied on two lanes as shown on the layout. Subgrade data are shown on Incl 6. The first pair of panels (panels 33 and 40) with drilled holes were considered failed due to a tire hazard after 100 coverages due to a split along each female connector. The second pair of panels with drilled holes (panels 38 and 45) are shown on Incl 28 after

Pair of panels with drilled holes at the female corner

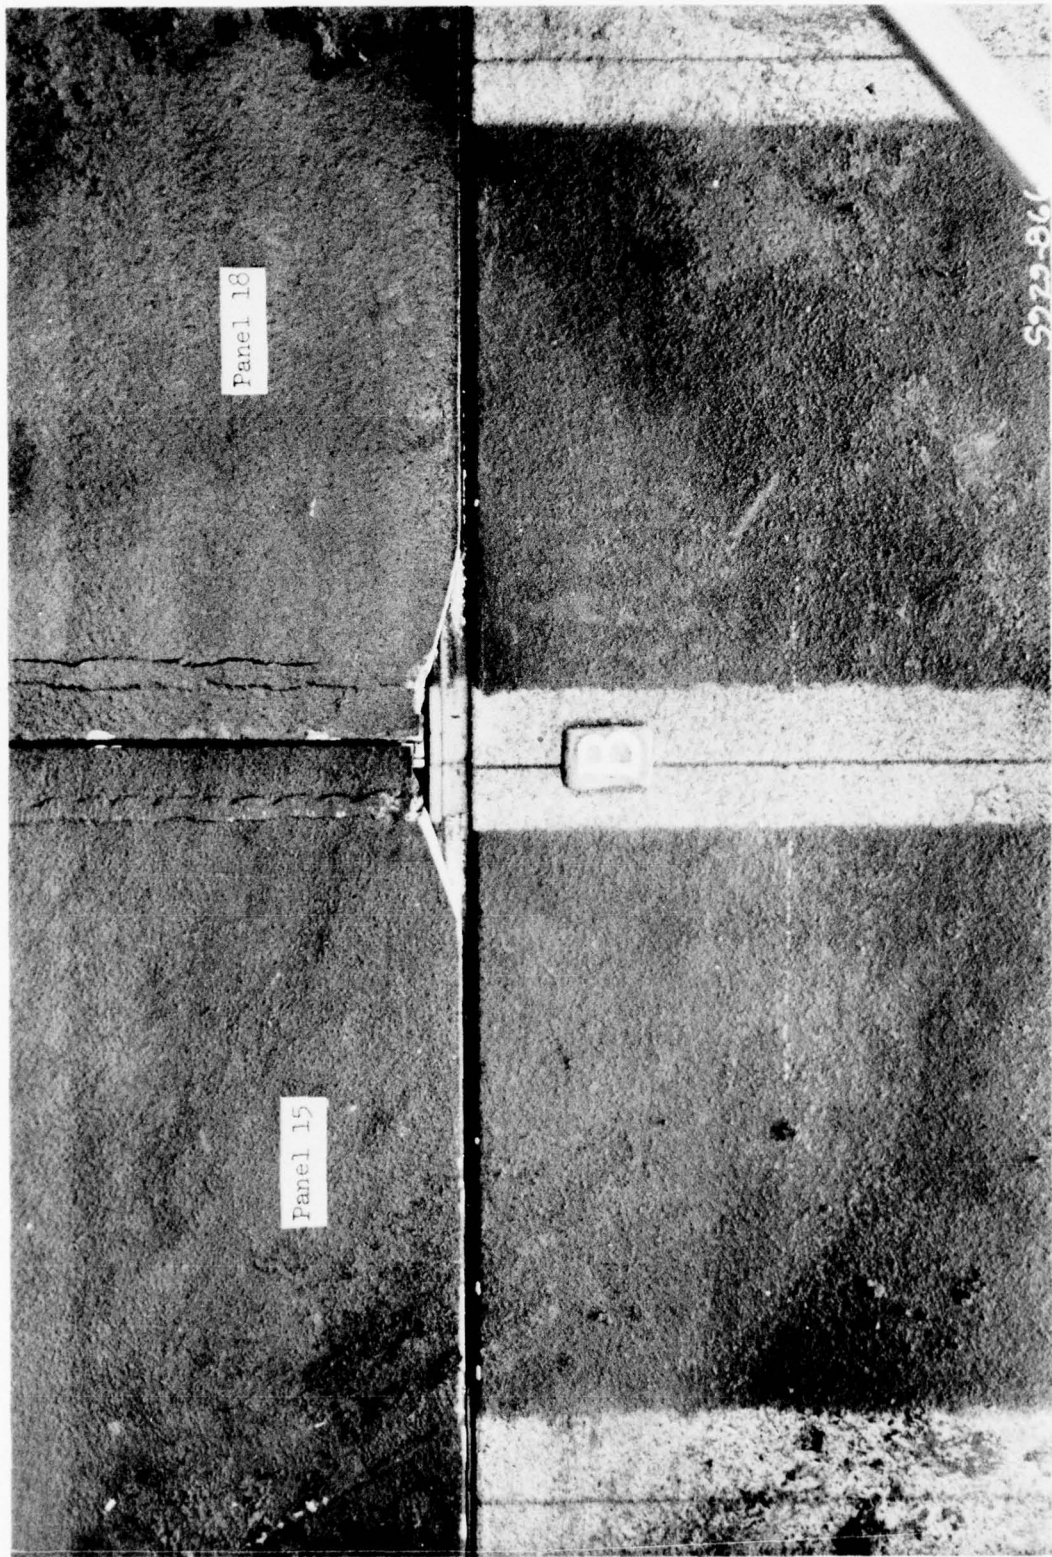
Pair of panels with a taper at the female corner

9. In a discussion with a Dow representative on 18 December 1972 (see MFR dated 21 December 1972, Incl 33), it was brought out that the 2-in. tapered female corner was apparently the modification that would eliminate the panel failure at the corners. Dow agreed to modify enough panels to be used in conducting an additional traffic test to check the tapered corner modification. If this method proved satisfactory, the remainder of the mat furnished under the contract would be modified accordingly.

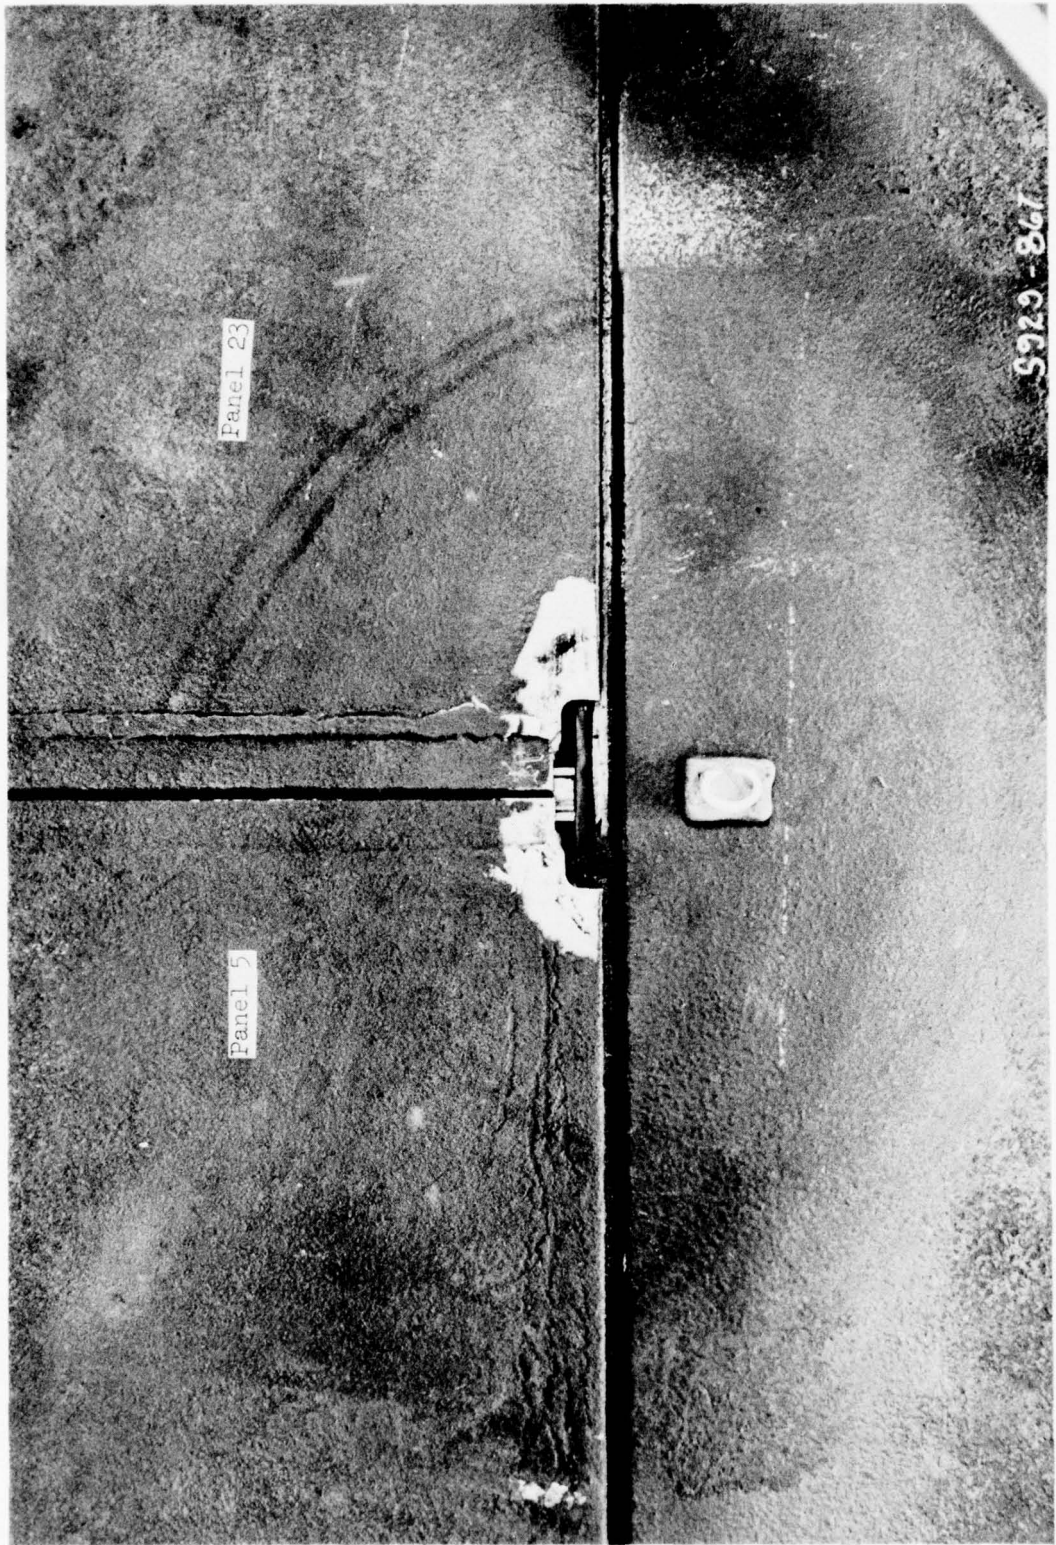
363 coverages of traffic. Both panels were considered failed after 500 coverages due to the splits along the female connector which were tire hazards. The female corners of panels 5 and 23, with 1/4-in. radii, are shown on Incl 29 after 363 channelized coverages. These panels were failed due to splits which were a tire hazard. The female corners of panels 20 and 28, with 1/2-in. radii, are shown on Incl 30 after 363 coverages. Panel 28 contained a split along the female lip and was a tire hazard. Panel 20 was failed after 690 coverages due to a split along the female lip. The end joint of panels 10a and 31 and panels 15 and 18 are shown on Incls 31 and 32, respectively, after 804 channelized coverages. These panels were not failed when traffic was discontinued at this point. The splits along the lips of panels 5, 20, 23, 28, 33, 38, 40, and 45 were cut off after they were tire hazards so traffic could continue on panels 10a, 15, 18, and 31. Subgrade data are given on Incl 6.

Pair of panels with a 1/4-in. radius at the female corner

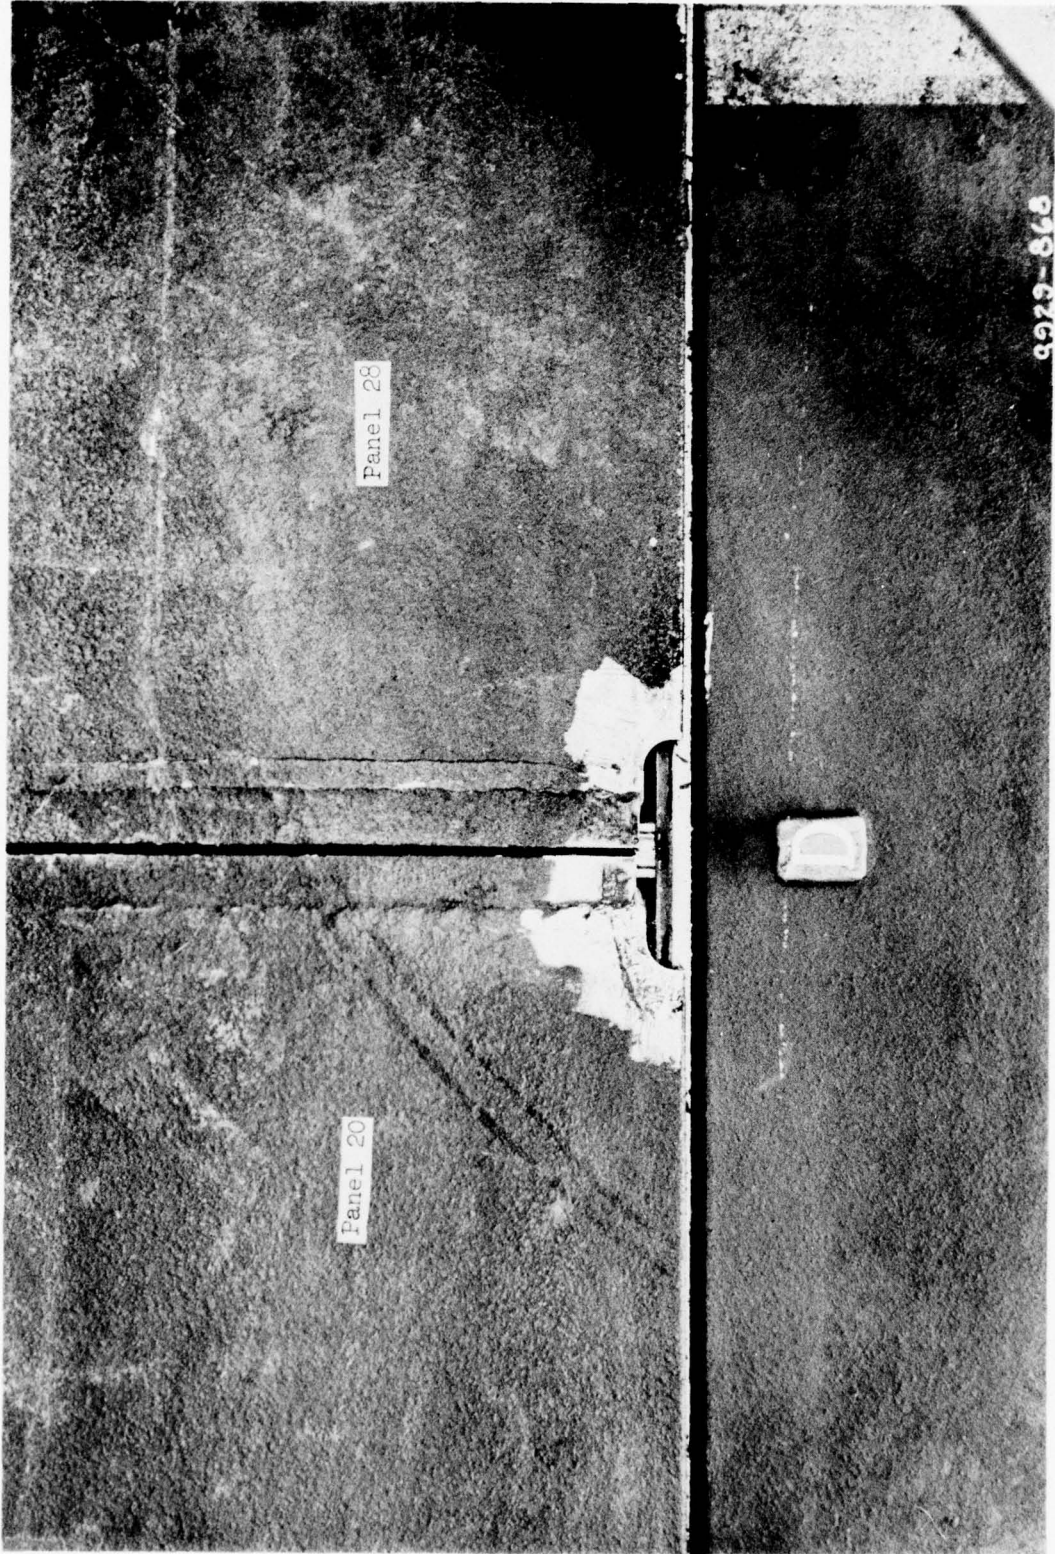
Pair of panels with a 1/2-in. radius at the female corner

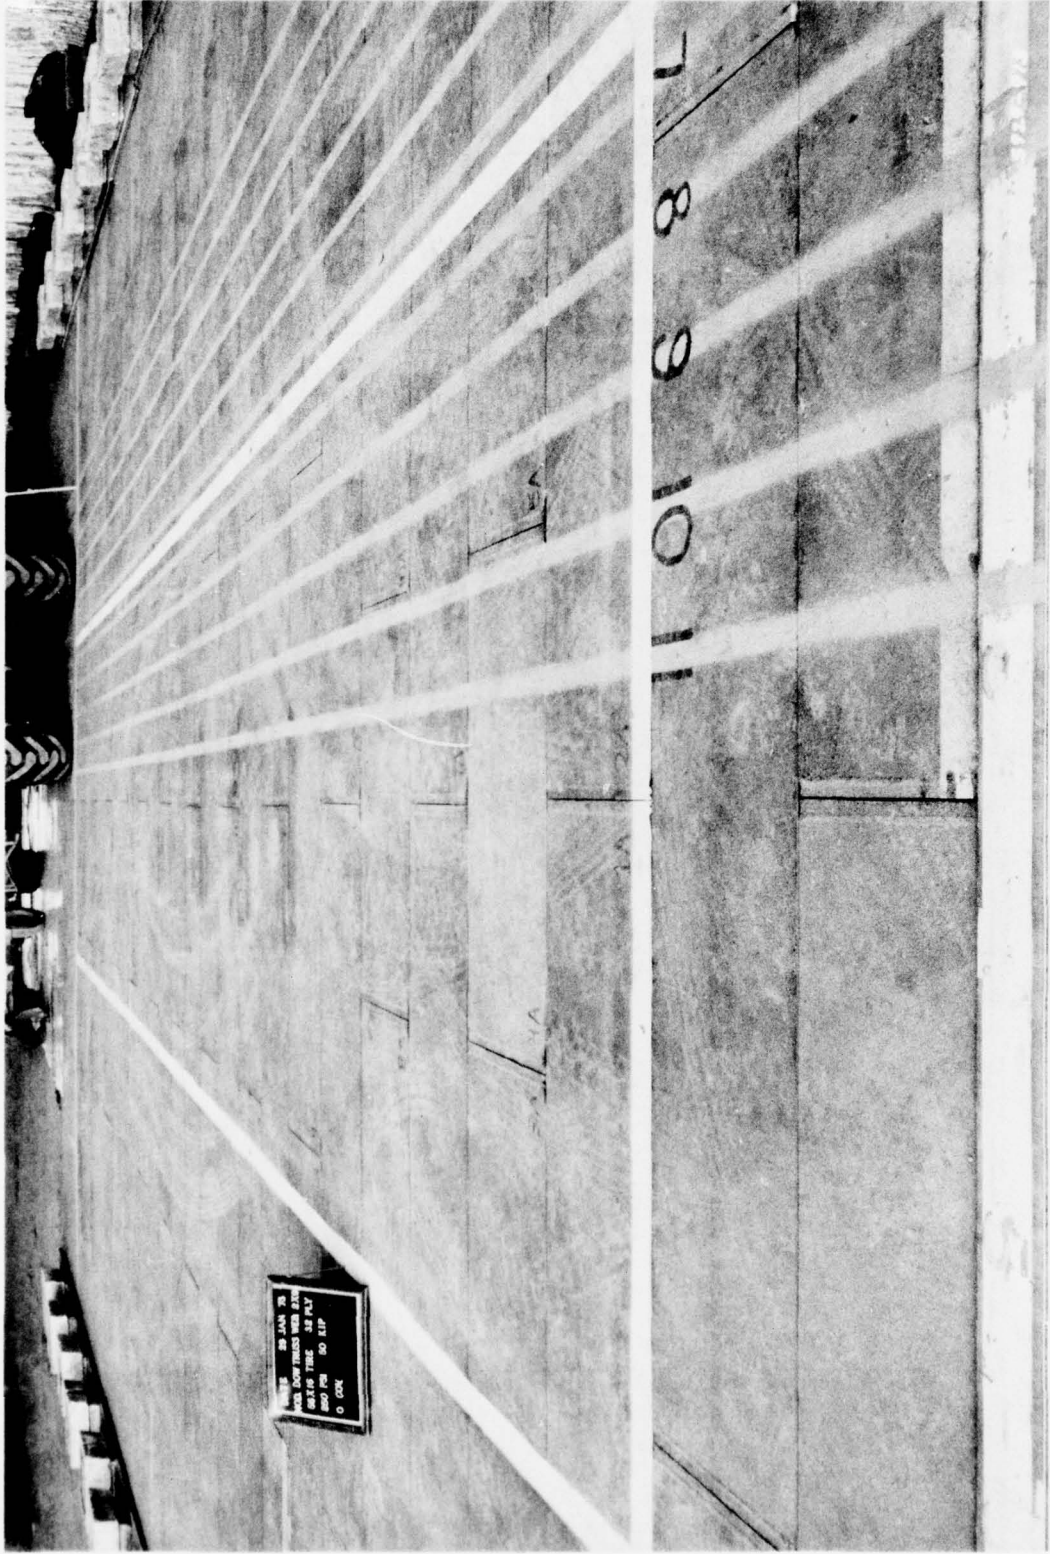
11. The test section prior to traffic is shown on Incl 38. This traffic was applied in the standard pattern and was designated Phase 1. After 90 coverages of traffic, a slight curl was noted in the panels with end joints at the center line of the test section. The test section after 160 coverages of traffic is shown on Incl 39. Typical end joints are

Test section of modified truss web mat prior to Phase 1 traffic

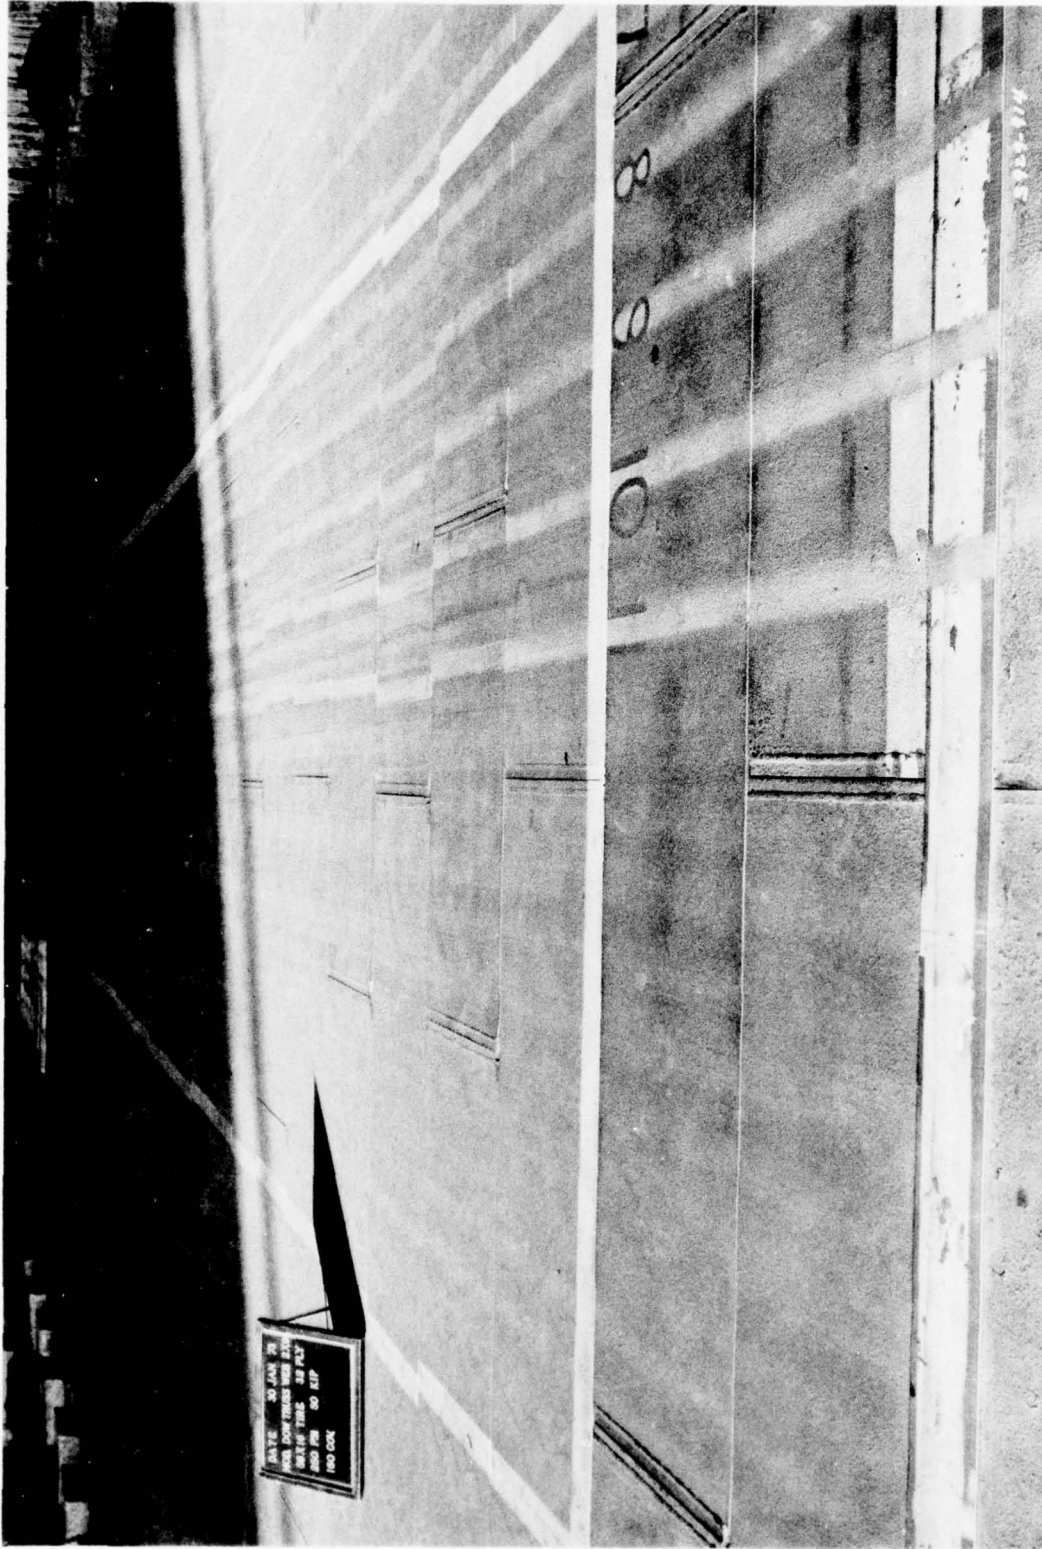
Test section at the end of 160 coverages, Phase 1

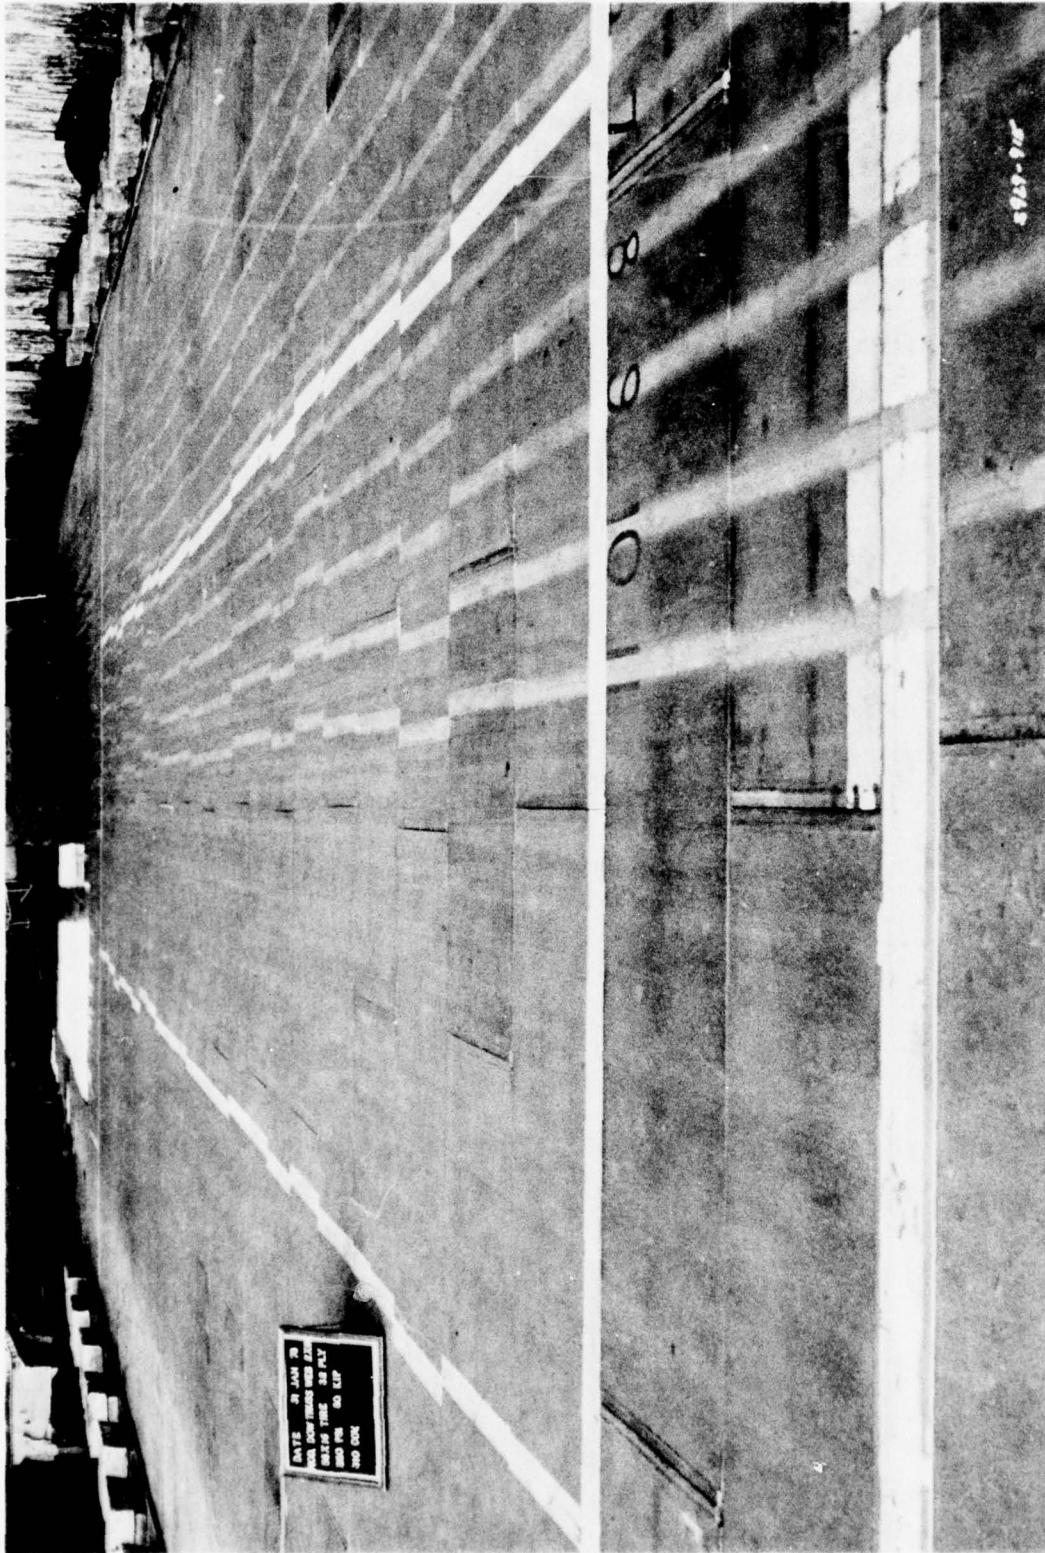
shown on Incl 40. After 310 coverages (Incl 41), four panels had small areas on them where the antiskid had flaked off. There was no noticeable change in the amount of curl; however, the male connectors adjacent to the end joint of two panels were wearing due to the action of the female connectors on the male connector under the load cart. As noted on Incl 41, the mat had shifted and the traffic lanes were misaligned. The weights on the mat edges were removed and the panels were realigned in the traffic lanes.

Test section after 310 coverages, Phase 1

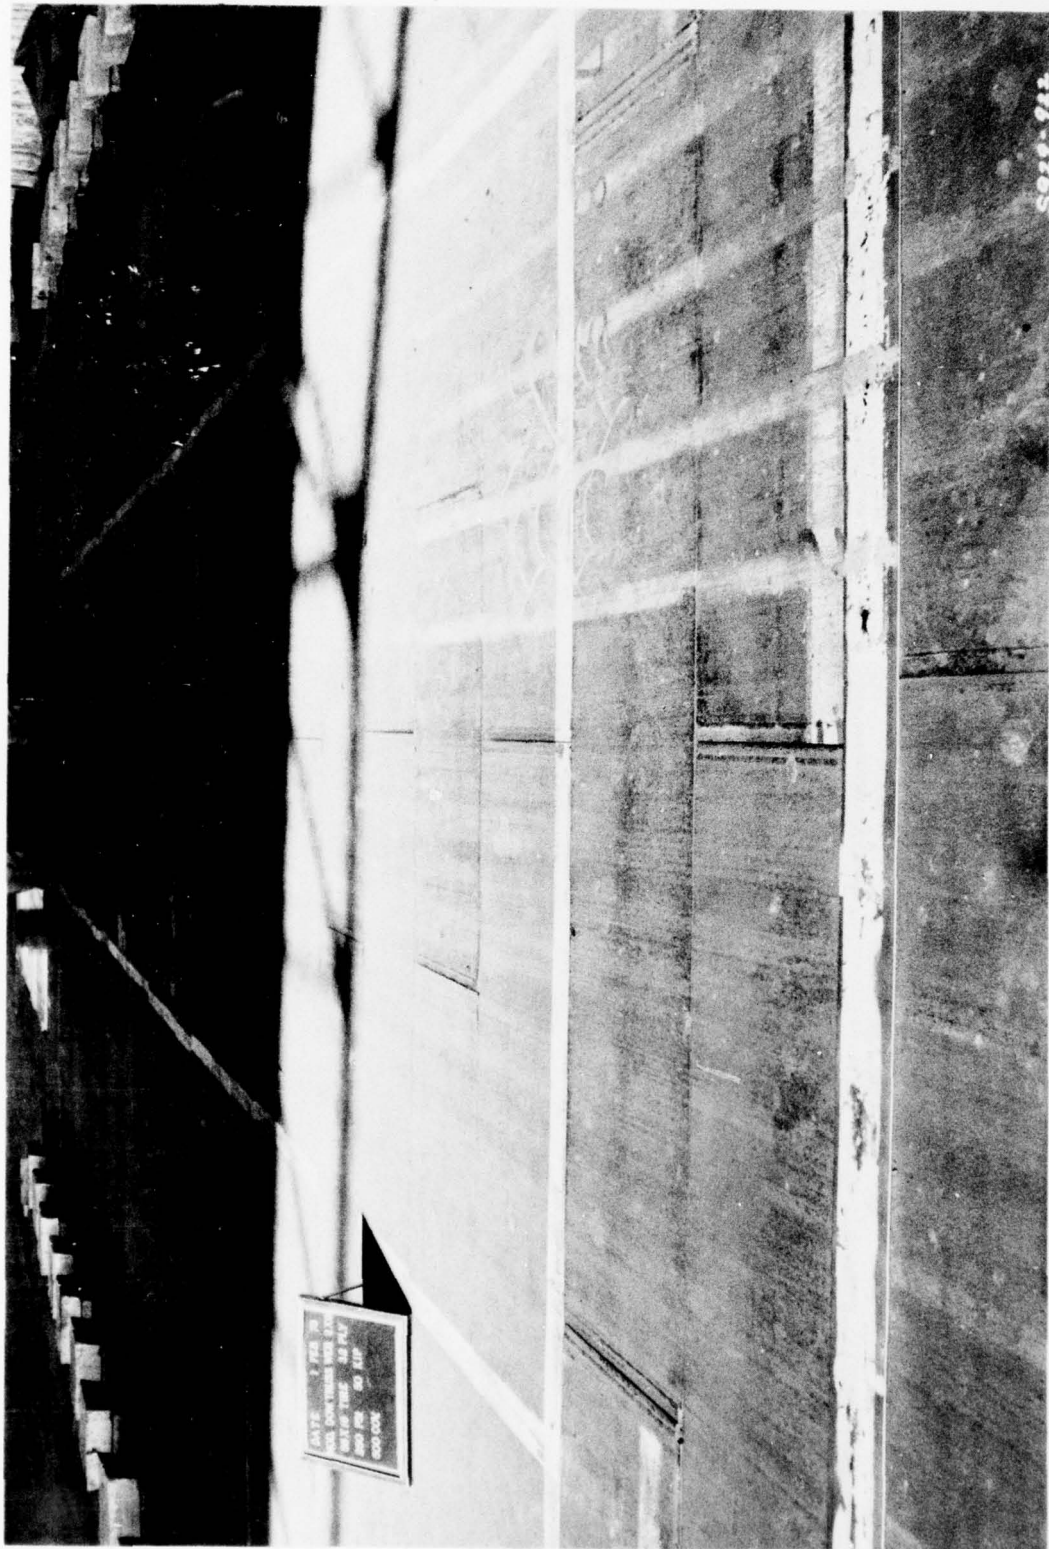
12. An overall view of the test section after 500 coverages is shown on Incl 42. The curl at the female corners of the panels had increased slightly (Incl 43). The increase in the curl on panel 16 caused the antiskid to flake from along the edge of the female connector. Several areas on the panels were bare of antiskid (Incl 44). This is attributed primarily to the spinning action of the drive wheels of the load cart prime mover. Between 400 and 500 coverages, a misty rain fell and due to relatively high wind, this rain was blown onto the mat test section (although the mat was located under a hangar). The mat surface therefore was wet and this caused the load cart prime mover to intermittently spin on the test section. As a result of the spinning and action of the load wheel on the mat, some antiskid flaked off.

Test section after 500 coverages, Phase 1

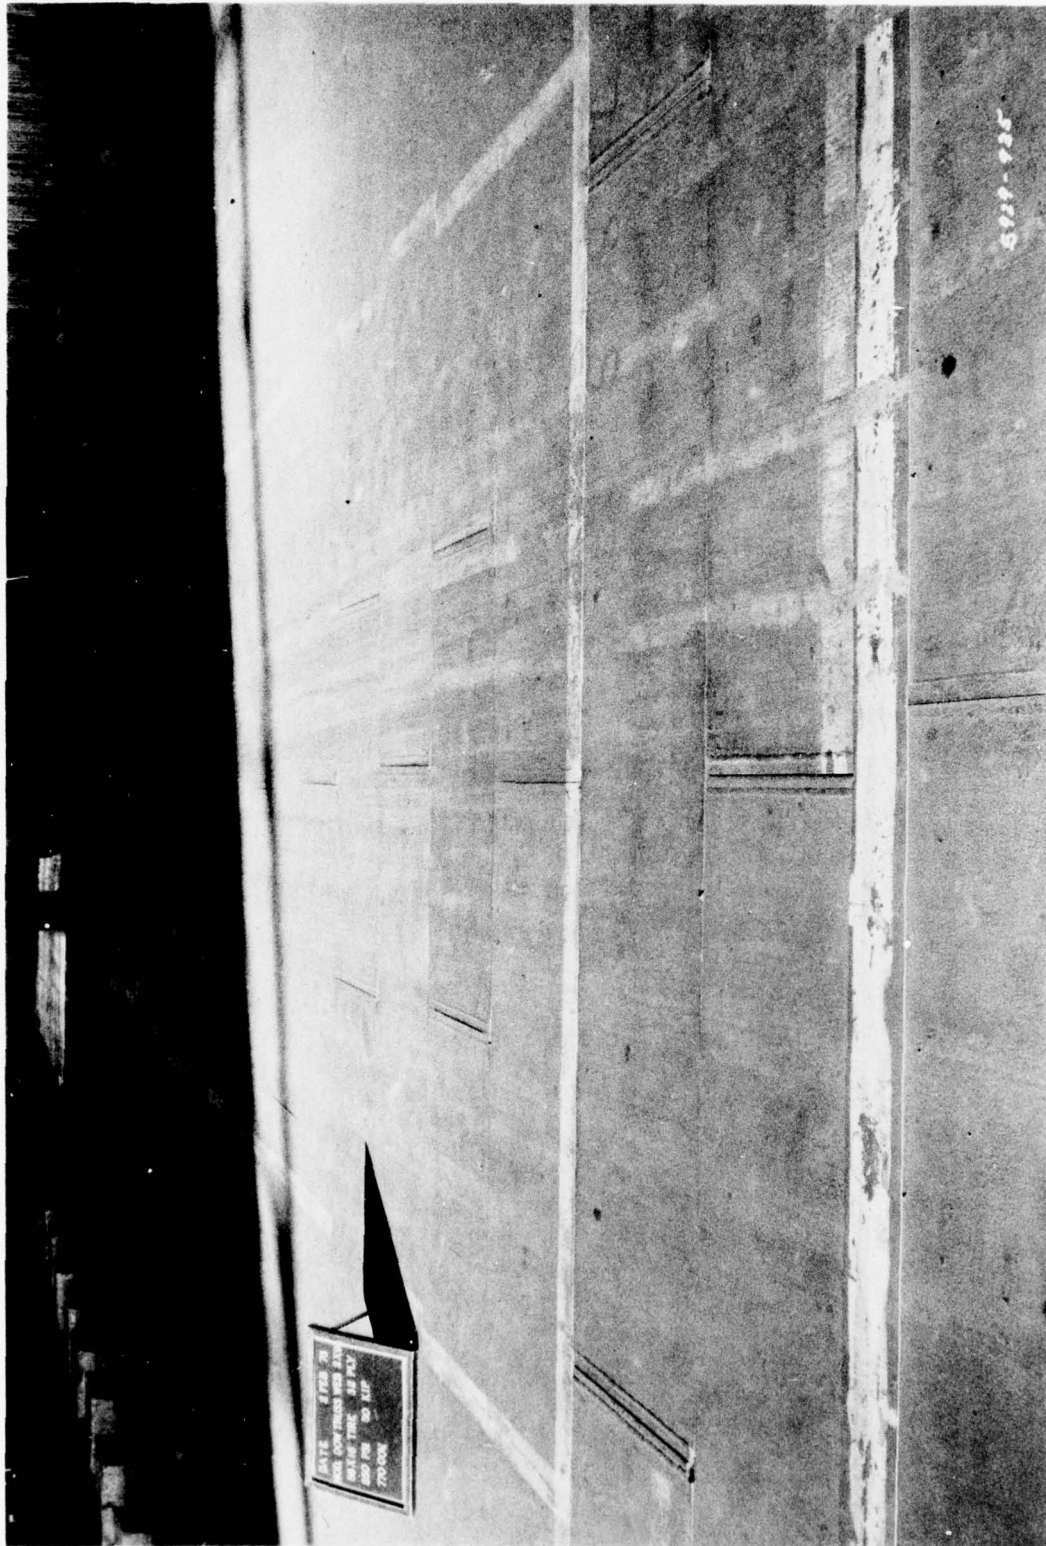
Test section after 770 coverages, Phase 1

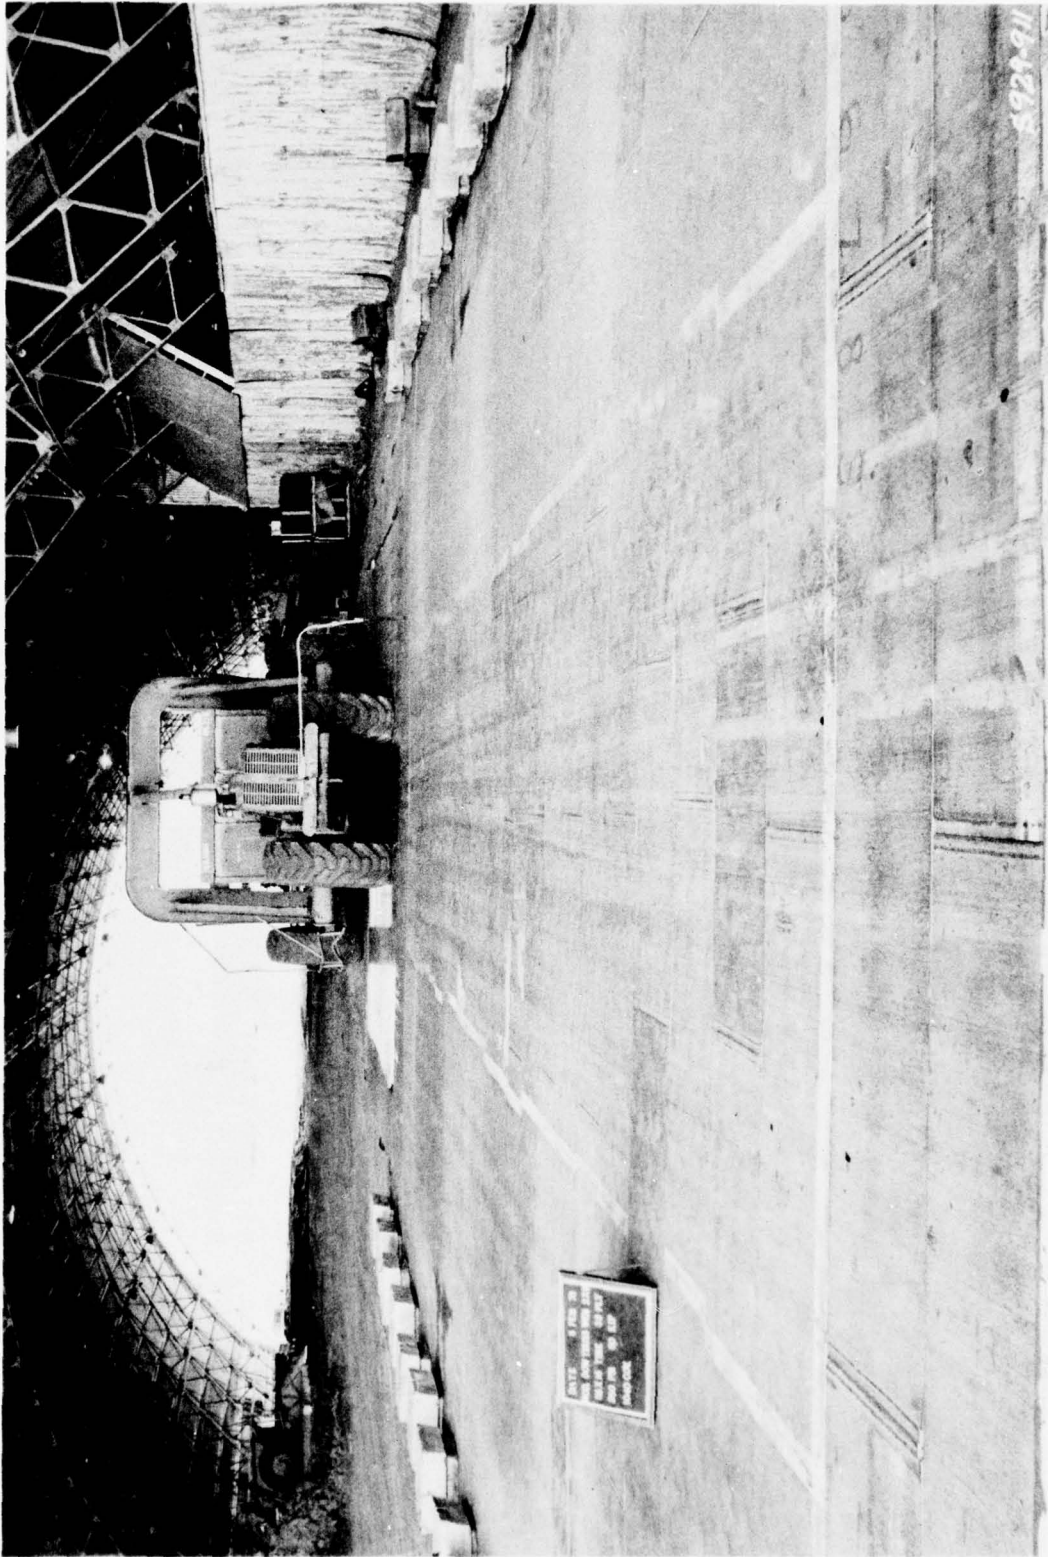
14. At the end of 1040 coverages (Incl 49), CBR data were taken under panel 14 (Incl 37). The rated CBR of the subgrade through 1040 coverages (Phase 1) was 4.0. There were no other failed panels at this time. However, three panels (panels 2, 4, and 13) contained hairline cracks in the female I-lock corner weld, two panels (panels 41 and 49) contained cracks in the weld at the male I-lock corner with the longest being 5-1/2 in. (panel 41, Incl 50), and two panels (panels 21 and 36) were split along the female connector at the female I-lock corner. The split in panel 21 (Incl 51) was 5-5/8 in. The corners of half panels (panels 4a and 9a) were curled along the female connector with one end of panel 9a (Incl 52) split for 3-1/2 in. along the female connector.

Test section after 1040 coverages, Phase 1
