MISCELLANEOUS PAPER S-74-6

# EVALUATION OF DOW CHEMICAL PRODUCTION EXTRUDED TRUSS-WEB LANDING MAT

March 1974

Conducted by U. S. Army Engineer Waterways Experiment Station  
Soils and Pavements Laboratory  
Vicksburg, Mississippi

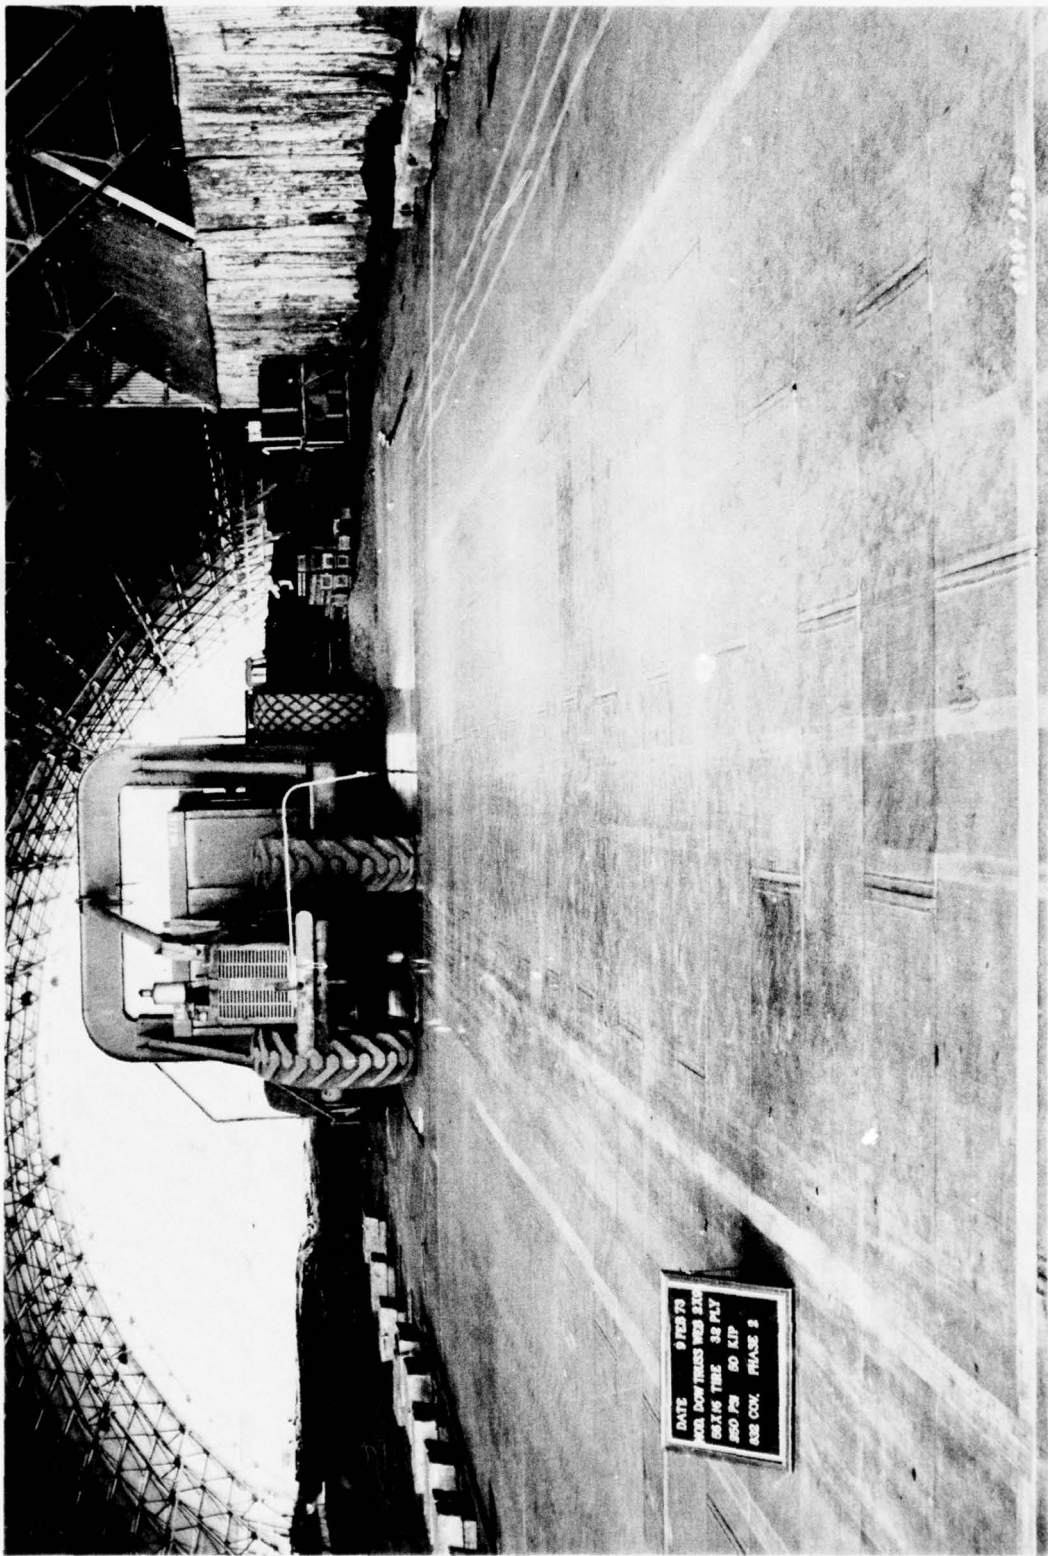
Test section after 832 coverages, Phase 2

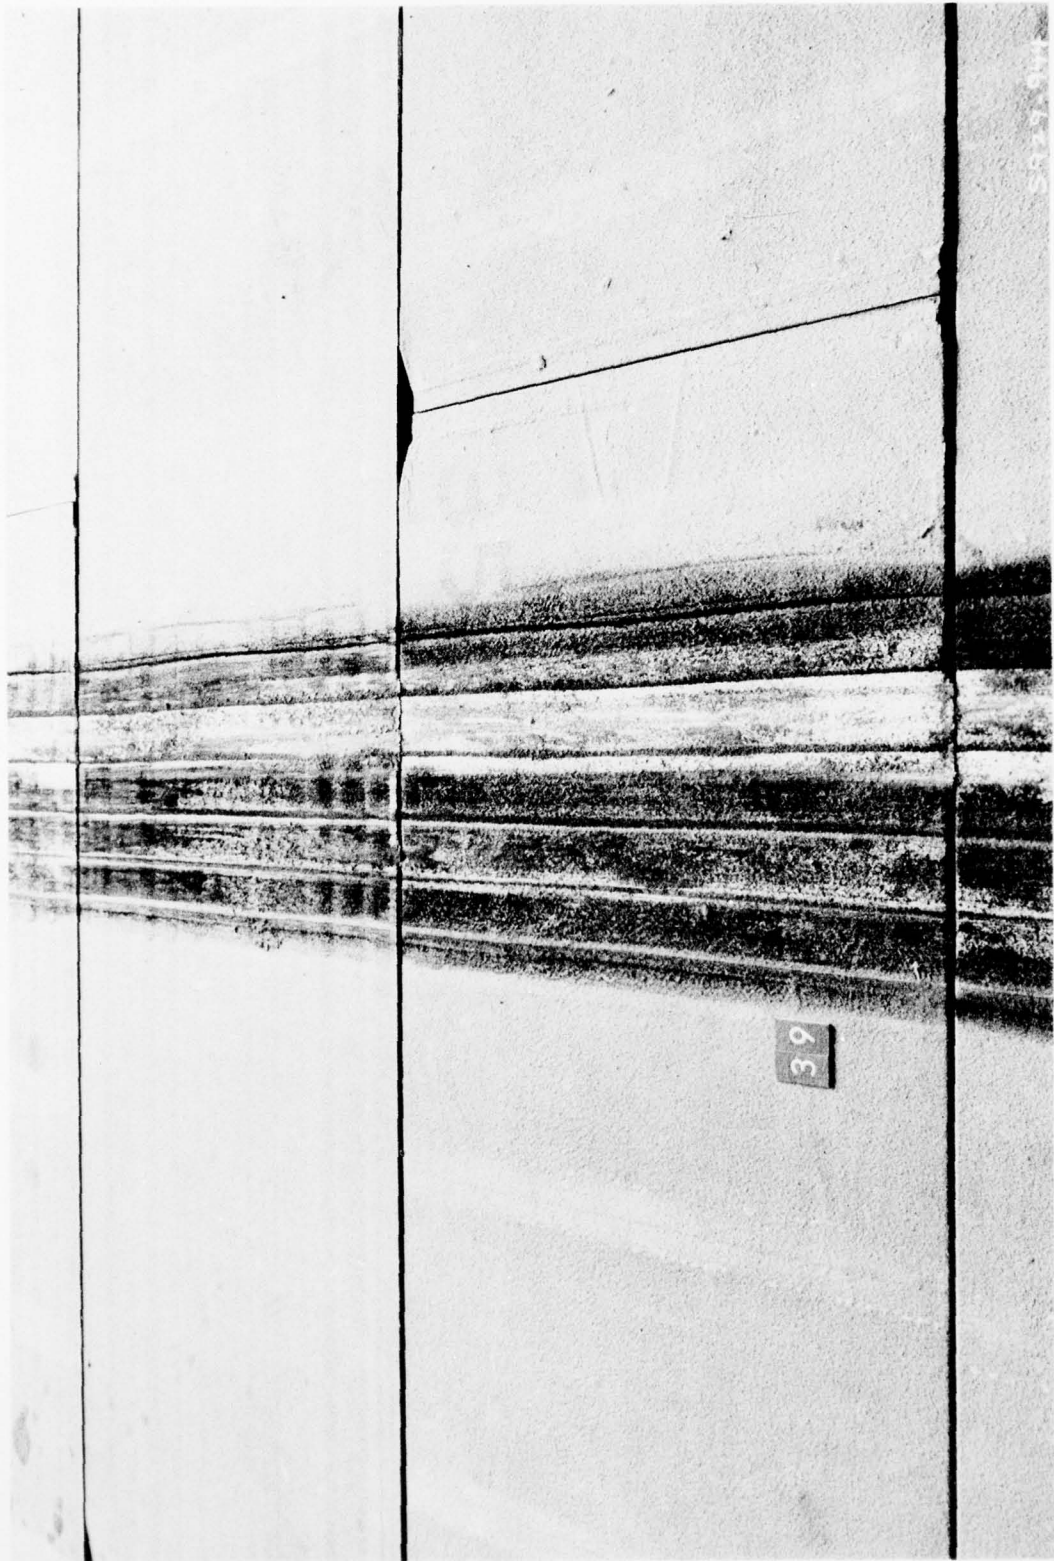
Skid tests conducted on this mat resulted in values for the coefficient of friction on wet (0.40) and dry (0.62) surfaces that meet the requirements of the revised Qualitative Materiel Requirement (runway condition reading of 13-25 or coefficient of friction of 0.40 to 0.80).

Mat surface after dry skid

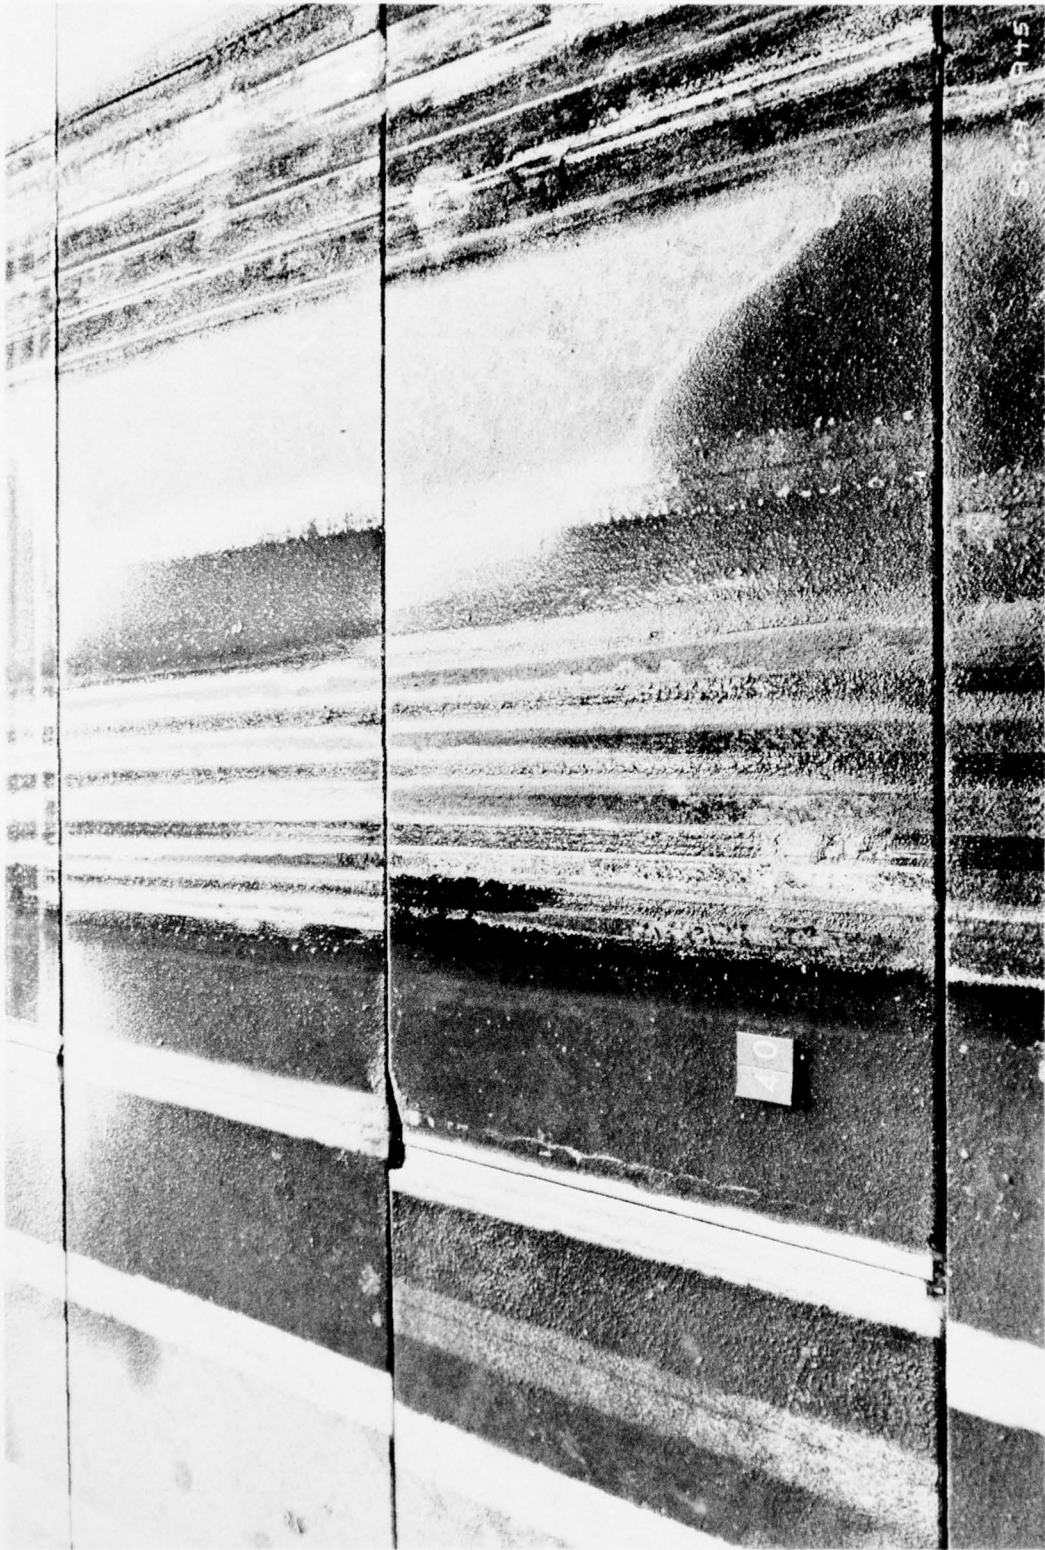
Mat surface after wet skid

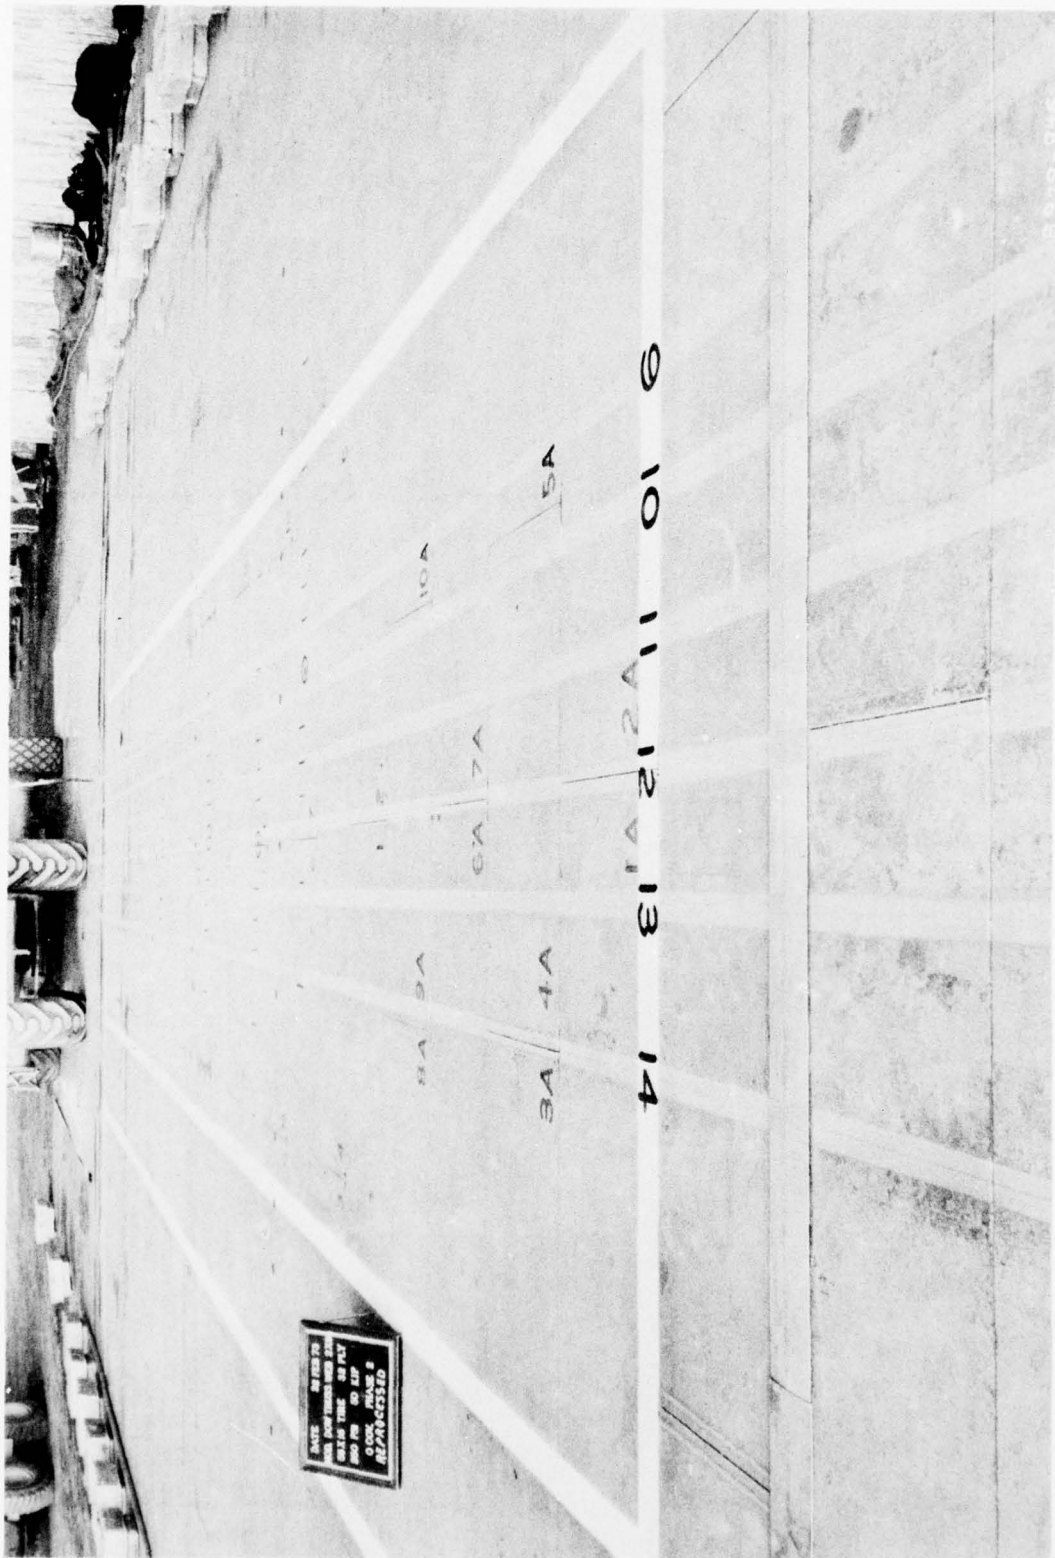
18. The subgrade was reprocessed to a CBR of 3.5 (Incl 37). The mat was replaced (Incl 64) for additional traffic in order to bring lanes 9-11 up to 1000 coverages on a rated 4-CBR subgrade. Also, panel 21 was replaced with a new panel prior to traffic after reprocessing. A summary of actual and rated coverages already applied to lanes 9-11 and additional coverages required to bring these lanes up to 1000 coverages on a rated 4-CBR subgrade are given below.

Test section at 0 coverages, Phase 2, subgrade reprocessed

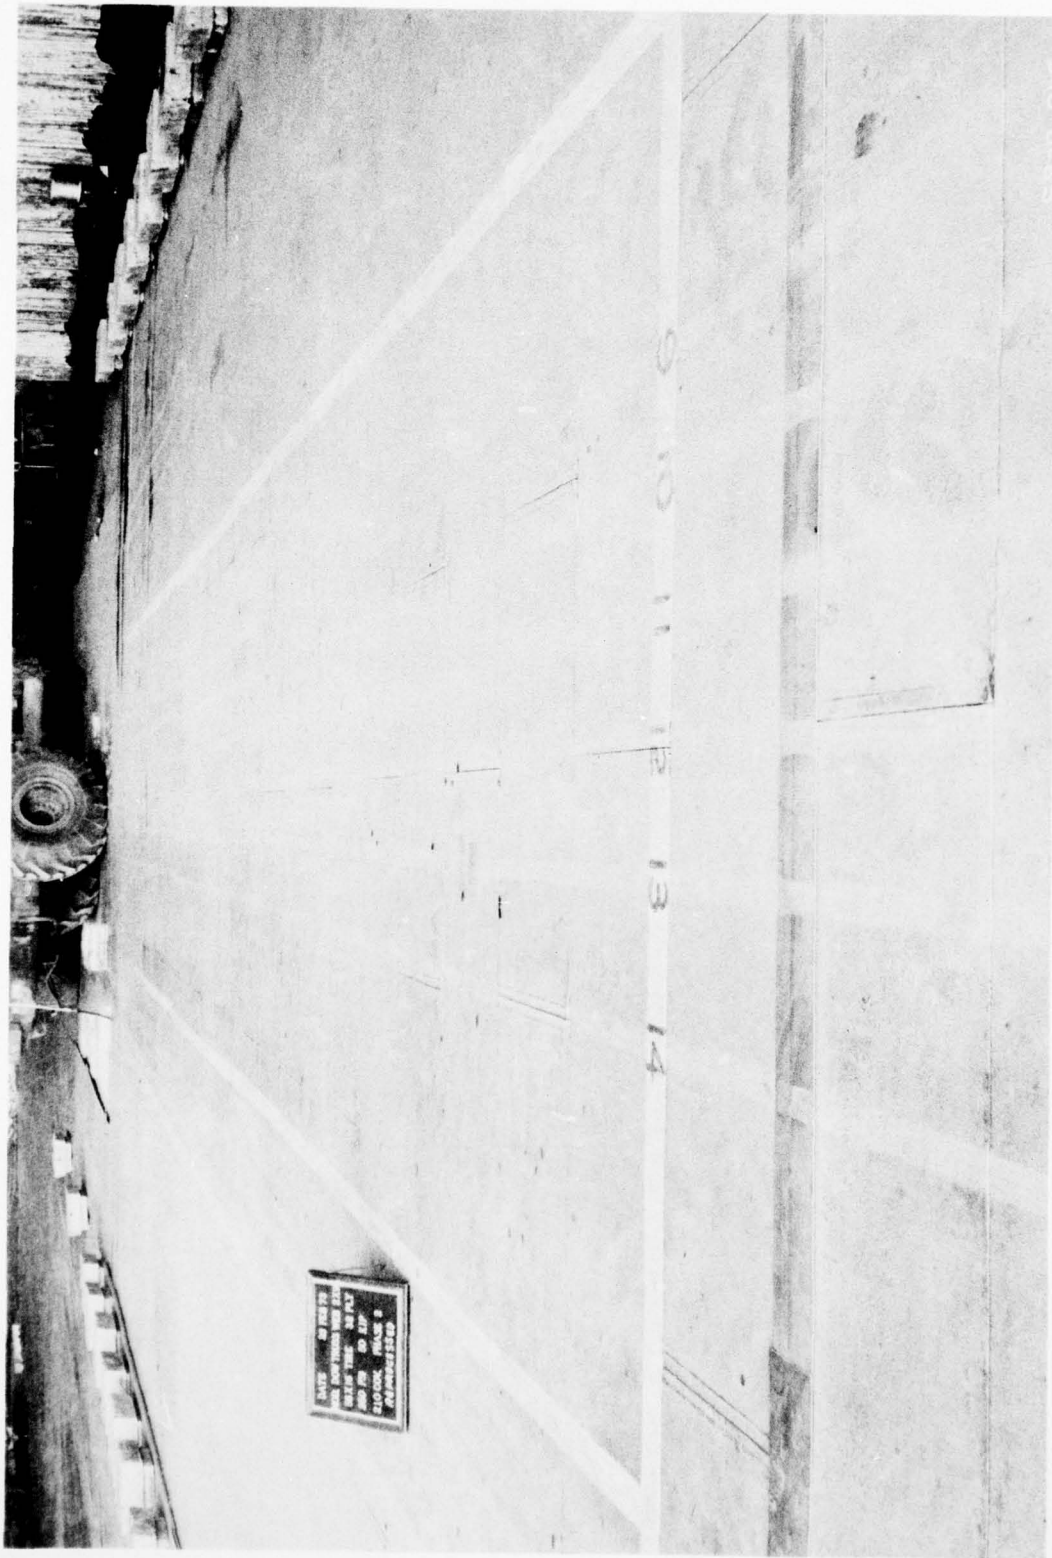
Test section after 210 coverages, Phase 2, subgrade reprocessed

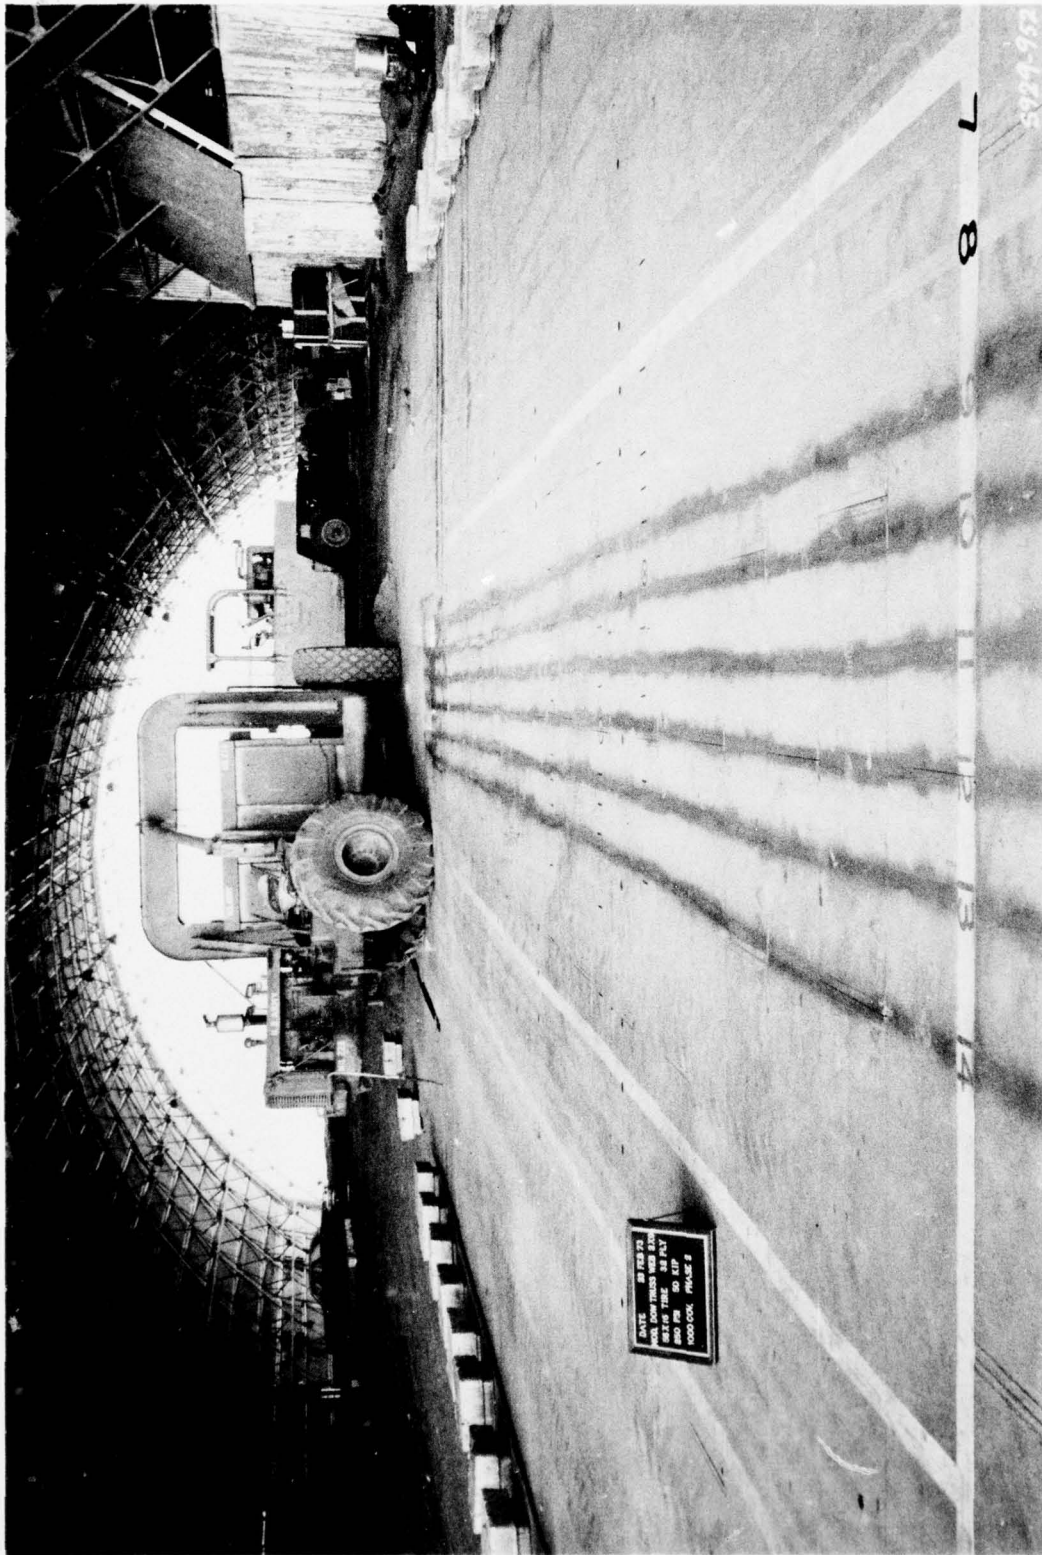
Test section after 1000 coverages, Phase 2, subgrade reprocessed

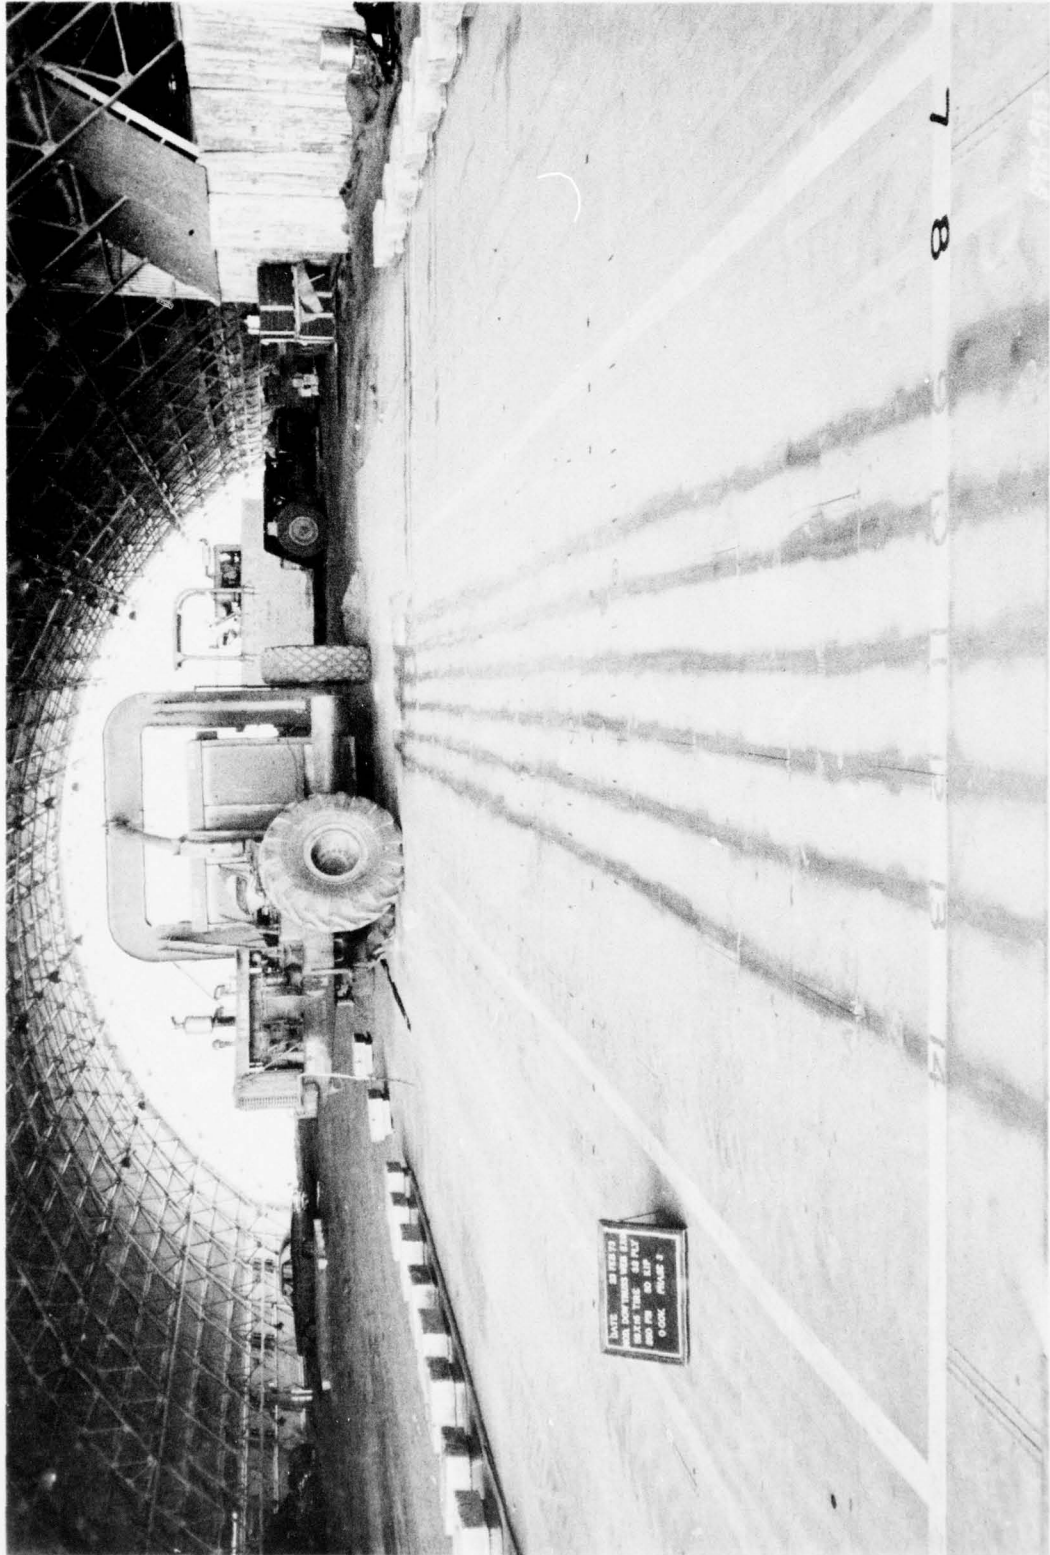
21. The test section at 0 coverage, Phase 3 traffic, is shown on Incl 70. Traffic was continued until 300 coverages were completed (Incl 71). The test section was failed at this coverage level as five additional panels (in addition to the four failed during Phases 1 and 2 traffic) were tire hazards. These panels were 2, 4, 36, 41, and 47, and failure resulted from tire hazards due to splits and sharp edges exposed to the tire. The splits and weld cracks in panels 2, 4, 36, and 41 are shown on Incls 72-76, respectively. Panel 47 was split along the female connector similar to panel 2 (Incl 72). Several panels had areas where the antiskid

Test section at 0 coverages, Phase 3

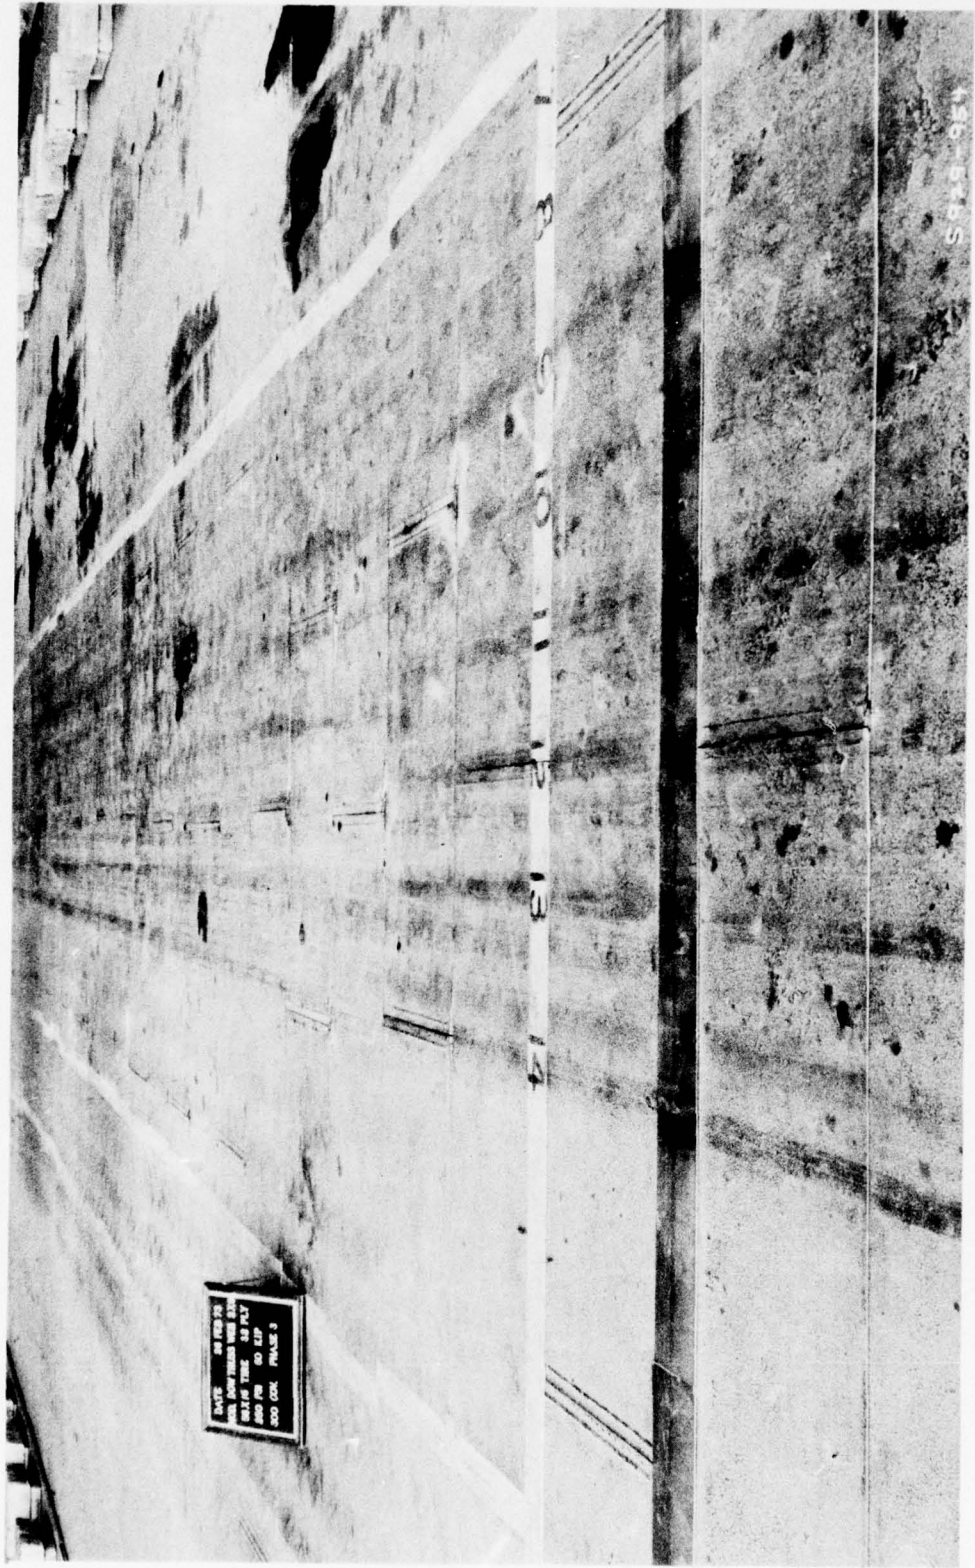
Test section after 300 coverages, Phase 3
