MISCELLANEOUS PAPER S-73-23

CONDITION SURVEY, MINOT AIR FORCE BASE, NORTH DAKOTA

P. J. Vedros

April 1973

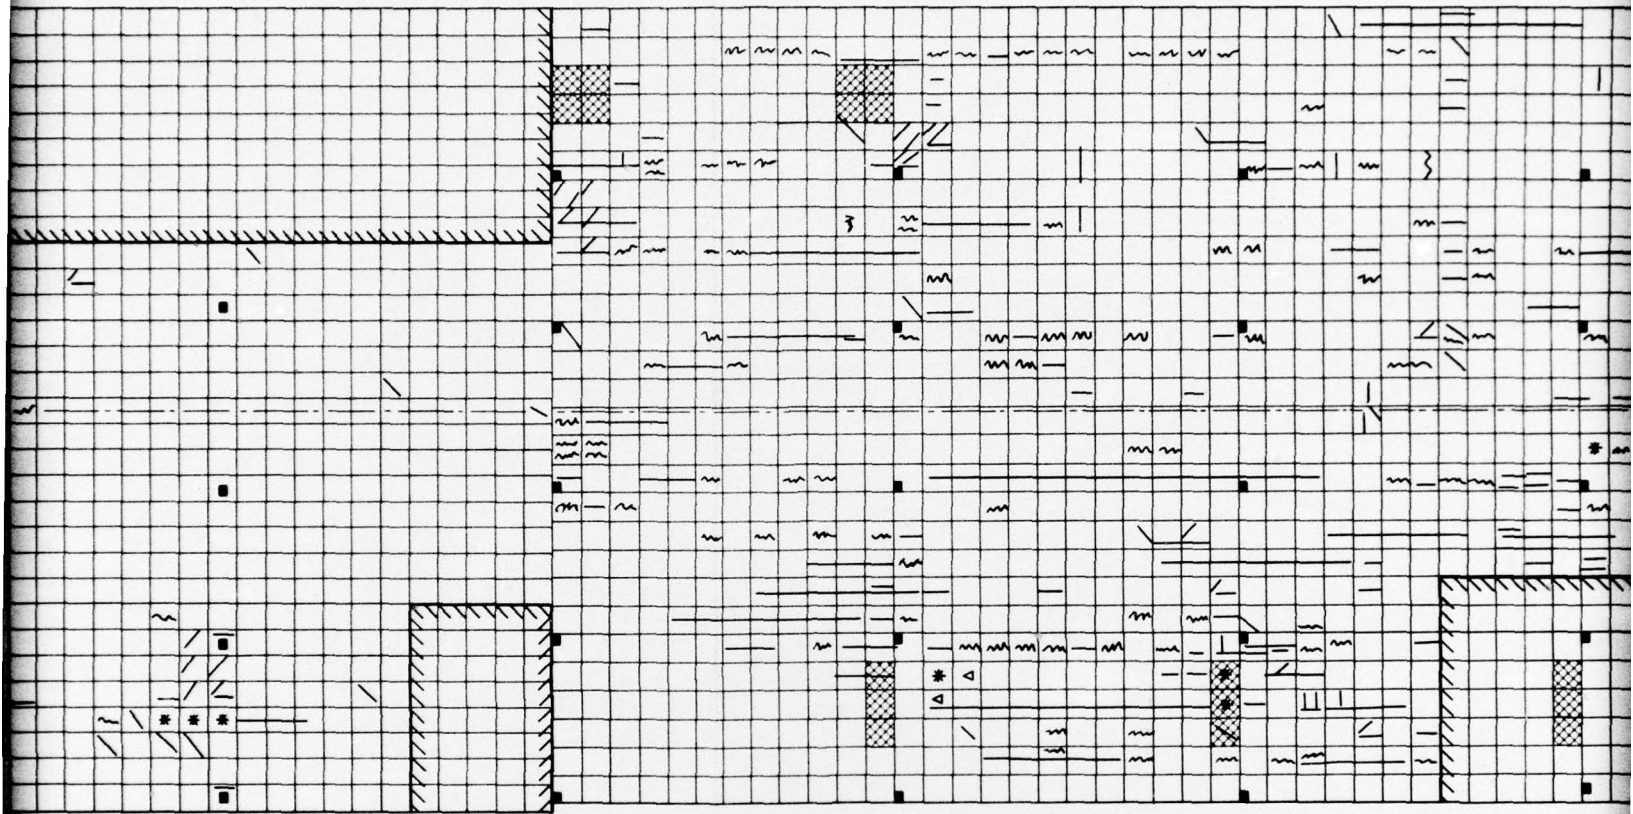
DEFECTS IN SAC
OPERATIONAL APRON
MINOT AFB, NORTH DAKOTA

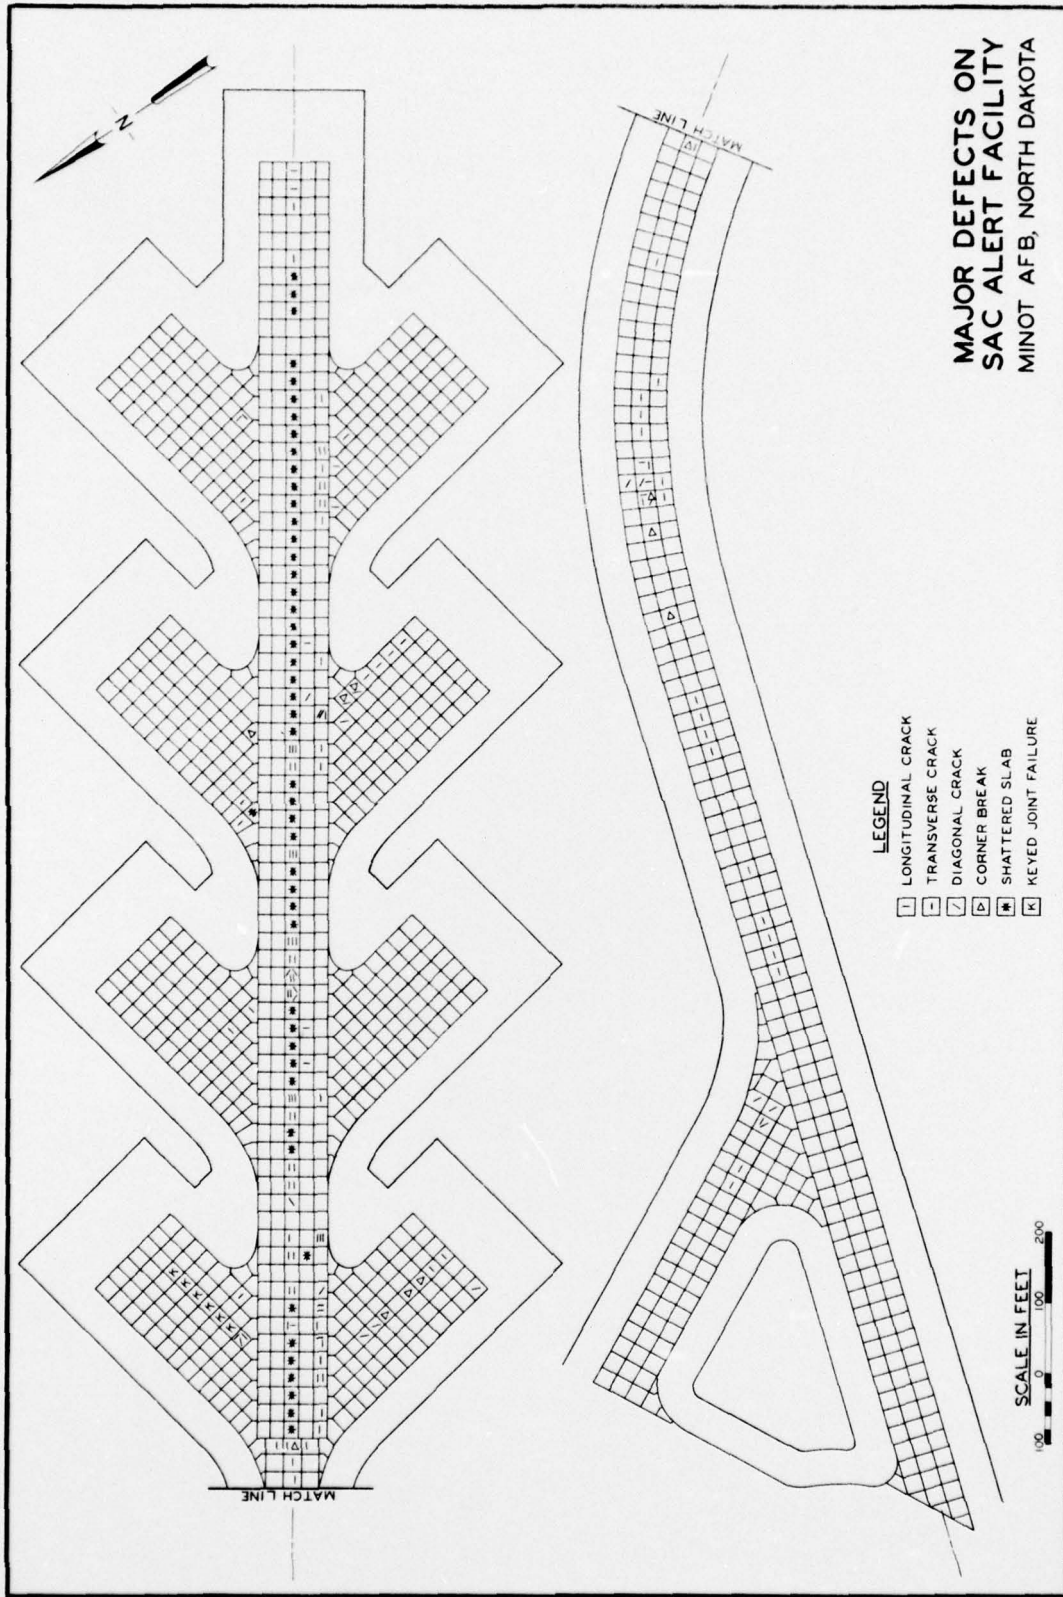
PLATE 5

21. The SAC alert facility consists of a taxiway (feature T13B) and nine parking stubs (feature A8B). The taxiway was in very good condition with about 19 percent of the slabs containing a major structural defect; however, as is shown in plate 5 and table 5, the center taxiing lane was in poor condition in the area adjacent to the parking stubs. Almost every slab in this area was considered to be shattered; i.e., the slabs were cracked into at least six pieces. The alert stubs were in excellent condition, with only about 7 percent of the slabs containing a major structural defect.
