MISCELLANEOUS PAPER S-73-34

# CONDITION SURVEY, PEASE AIR FORCE BASE, NEW HAMPSHIRE

May 1973

Conducted by U. S. Army Engineer Waterways Experiment Station  
Soils and Pavements Laboratory  
Vicksburg, Mississippi

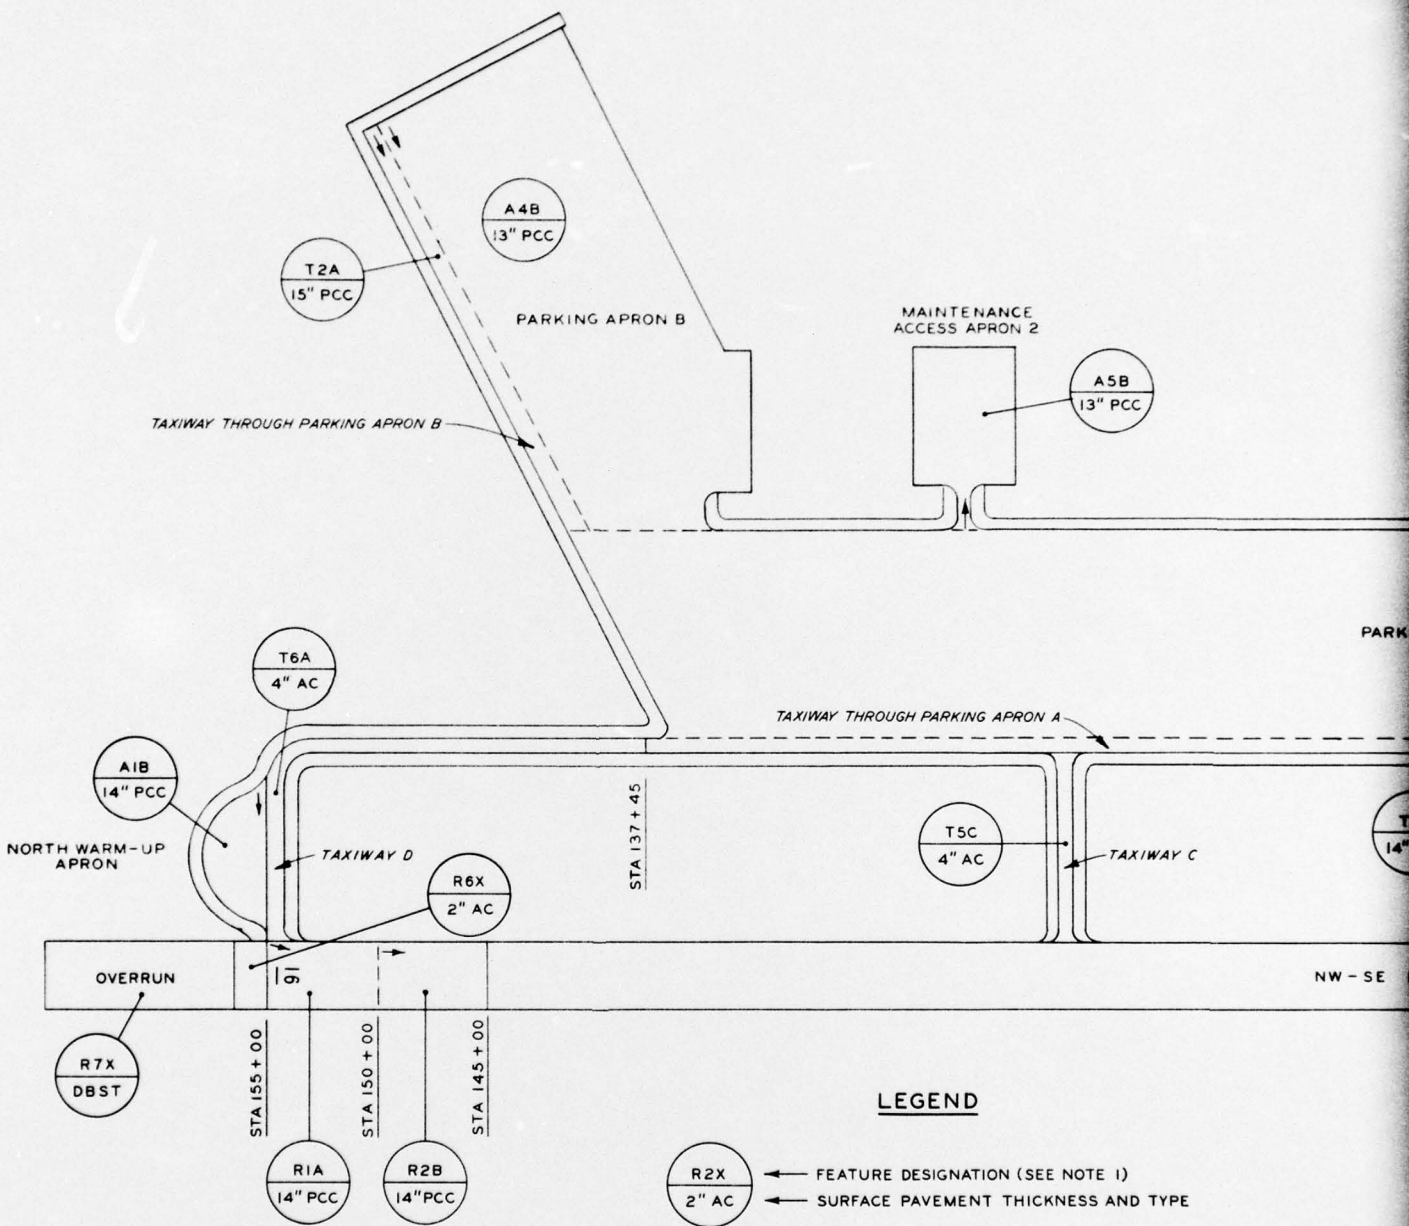
14. The north warm-up apron (feature A1B) was in very good condition based on the percentage of slabs containing no major defects. Jet blast had caused scaling on approximately 10 percent of the slabs. Photo 6 shows some of the scaling in feature A1B. The south warm-up apron (feature A2B) was in fair condition. There were 110 major defects in this feature, of which 100 were longitudinal cracks. Most of the longitudinal cracks were of the type shown in photo 7. They appeared to be caused by the manner in which the pavement had been placed rather than by overloading. Scaling was also prevalent in this feature, with approximately 20 percent of the slabs containing this defect (photo 8). Parking aprons A and B (features A3B and A4B) were in very good condition based on the percentages of slabs containing no major defects. Approximately 10 percent of the slabs in these features contained longitudinal cracks, which were the predominant defect. A large percentage of these longitudinal cracks were of the type shown in photo 9, and they did not appear to be load related. Considerable expansion of these aprons has resulted in upheaval of the shoulder pavements (photo 10) and the removal of the PCC pavement around embedded features, such as the fueling hydrants and drainage structures (photo 11).

Photo 11. AC replacement of PCC pavement  
at drainage structure

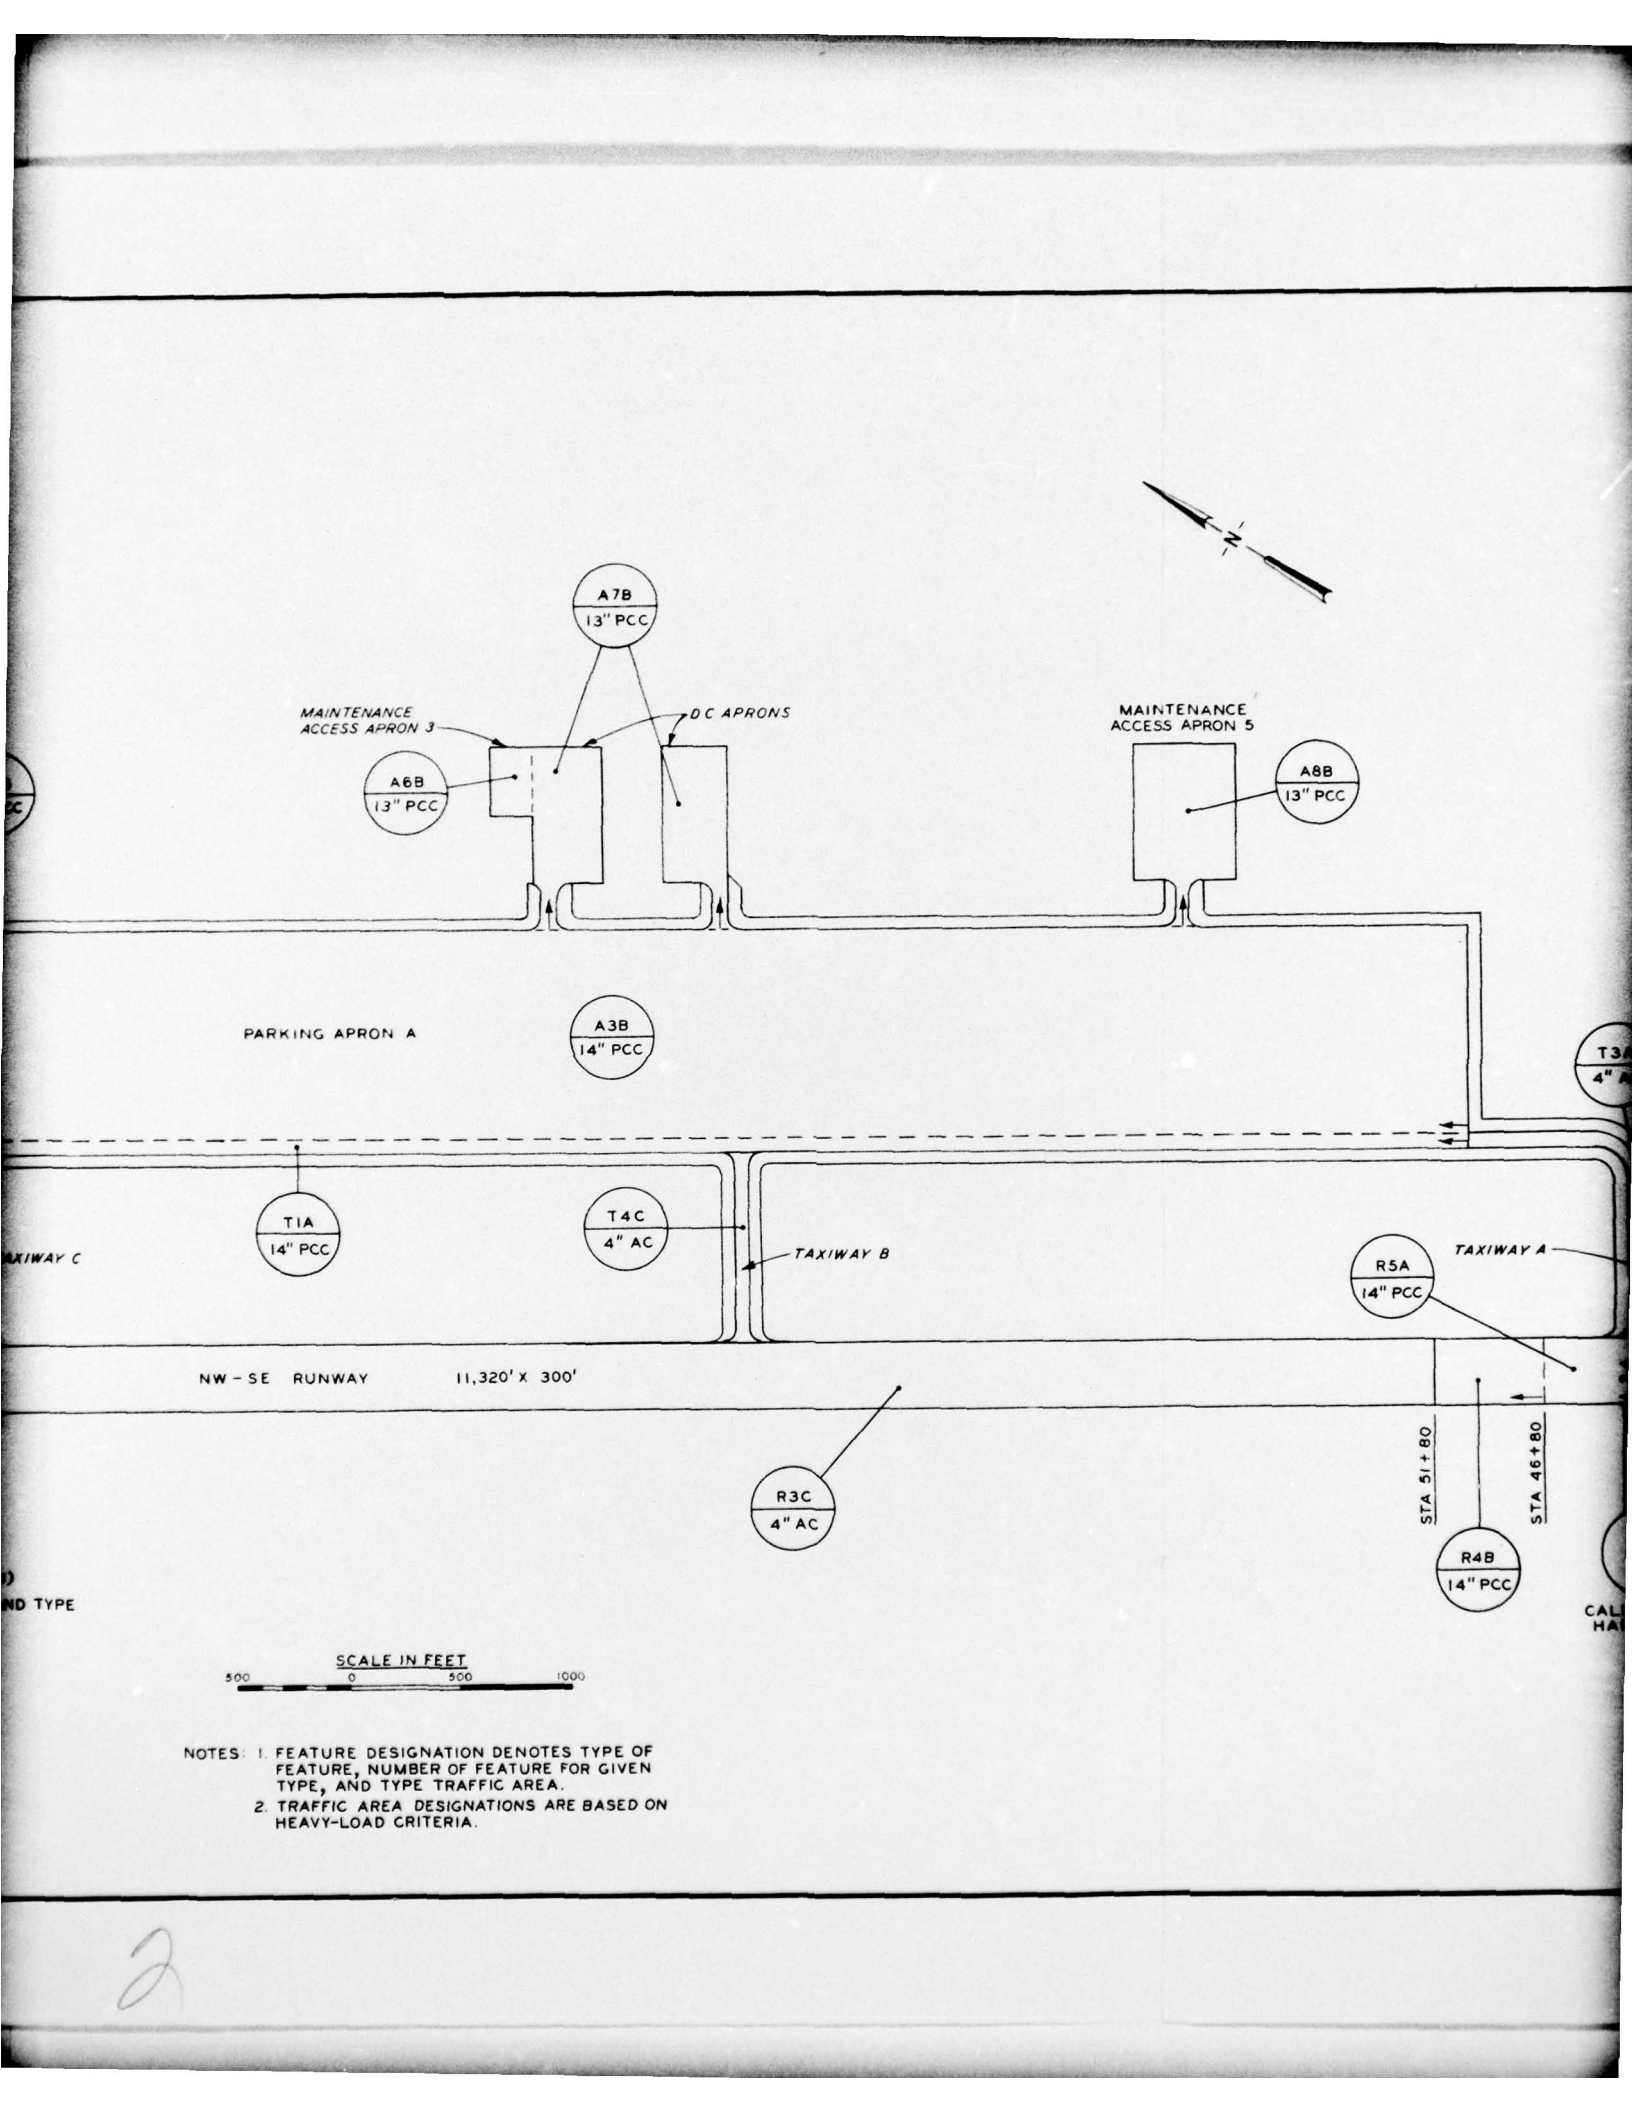
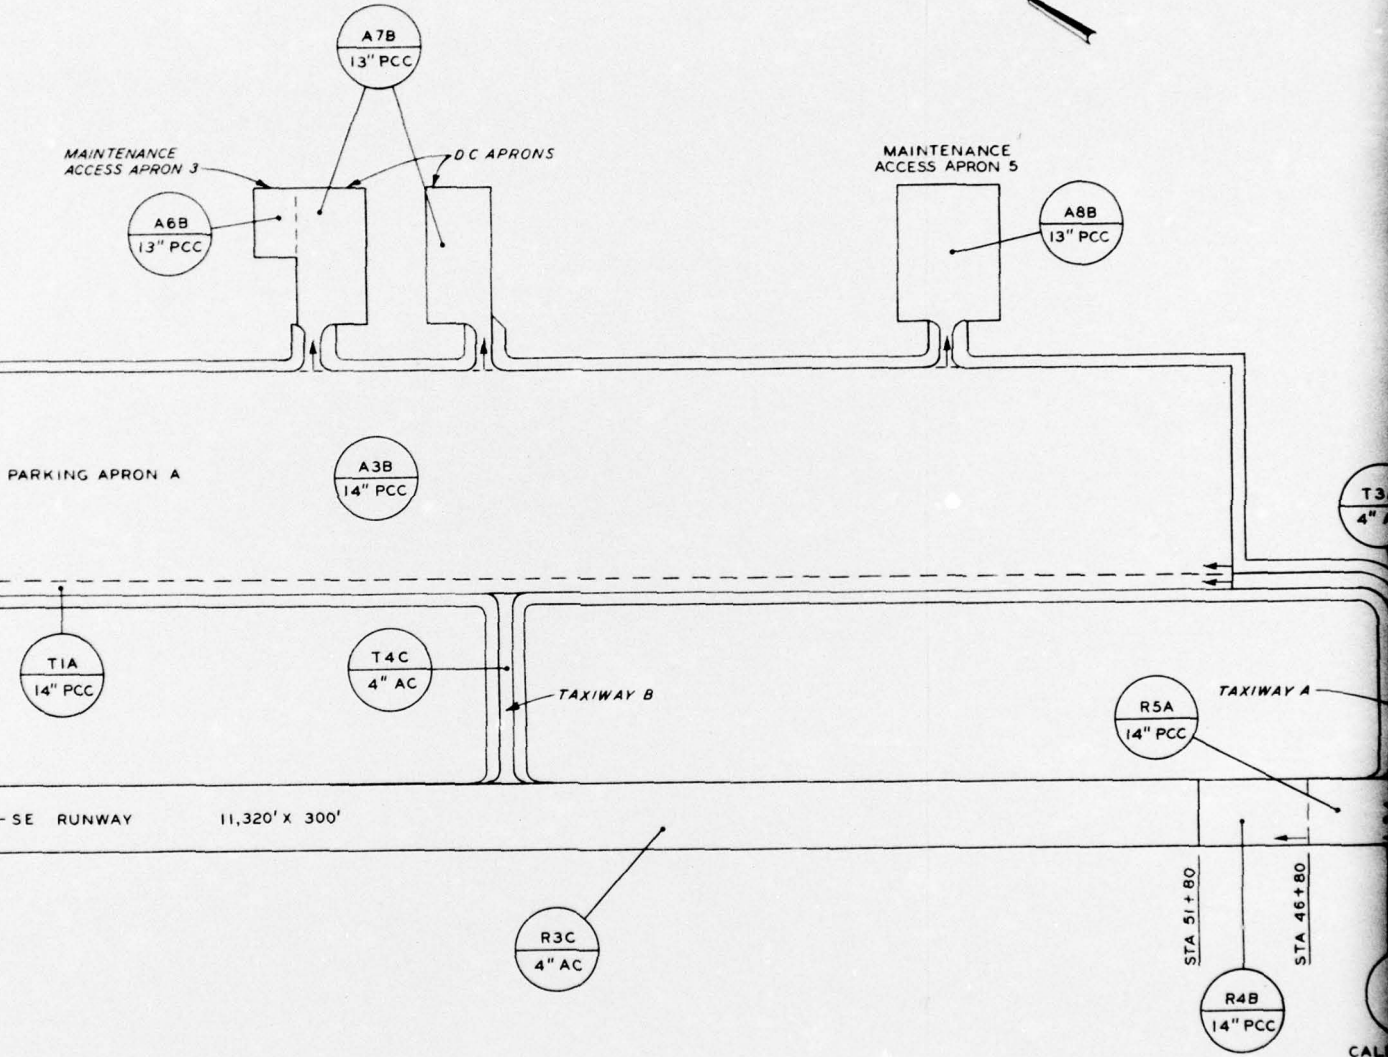
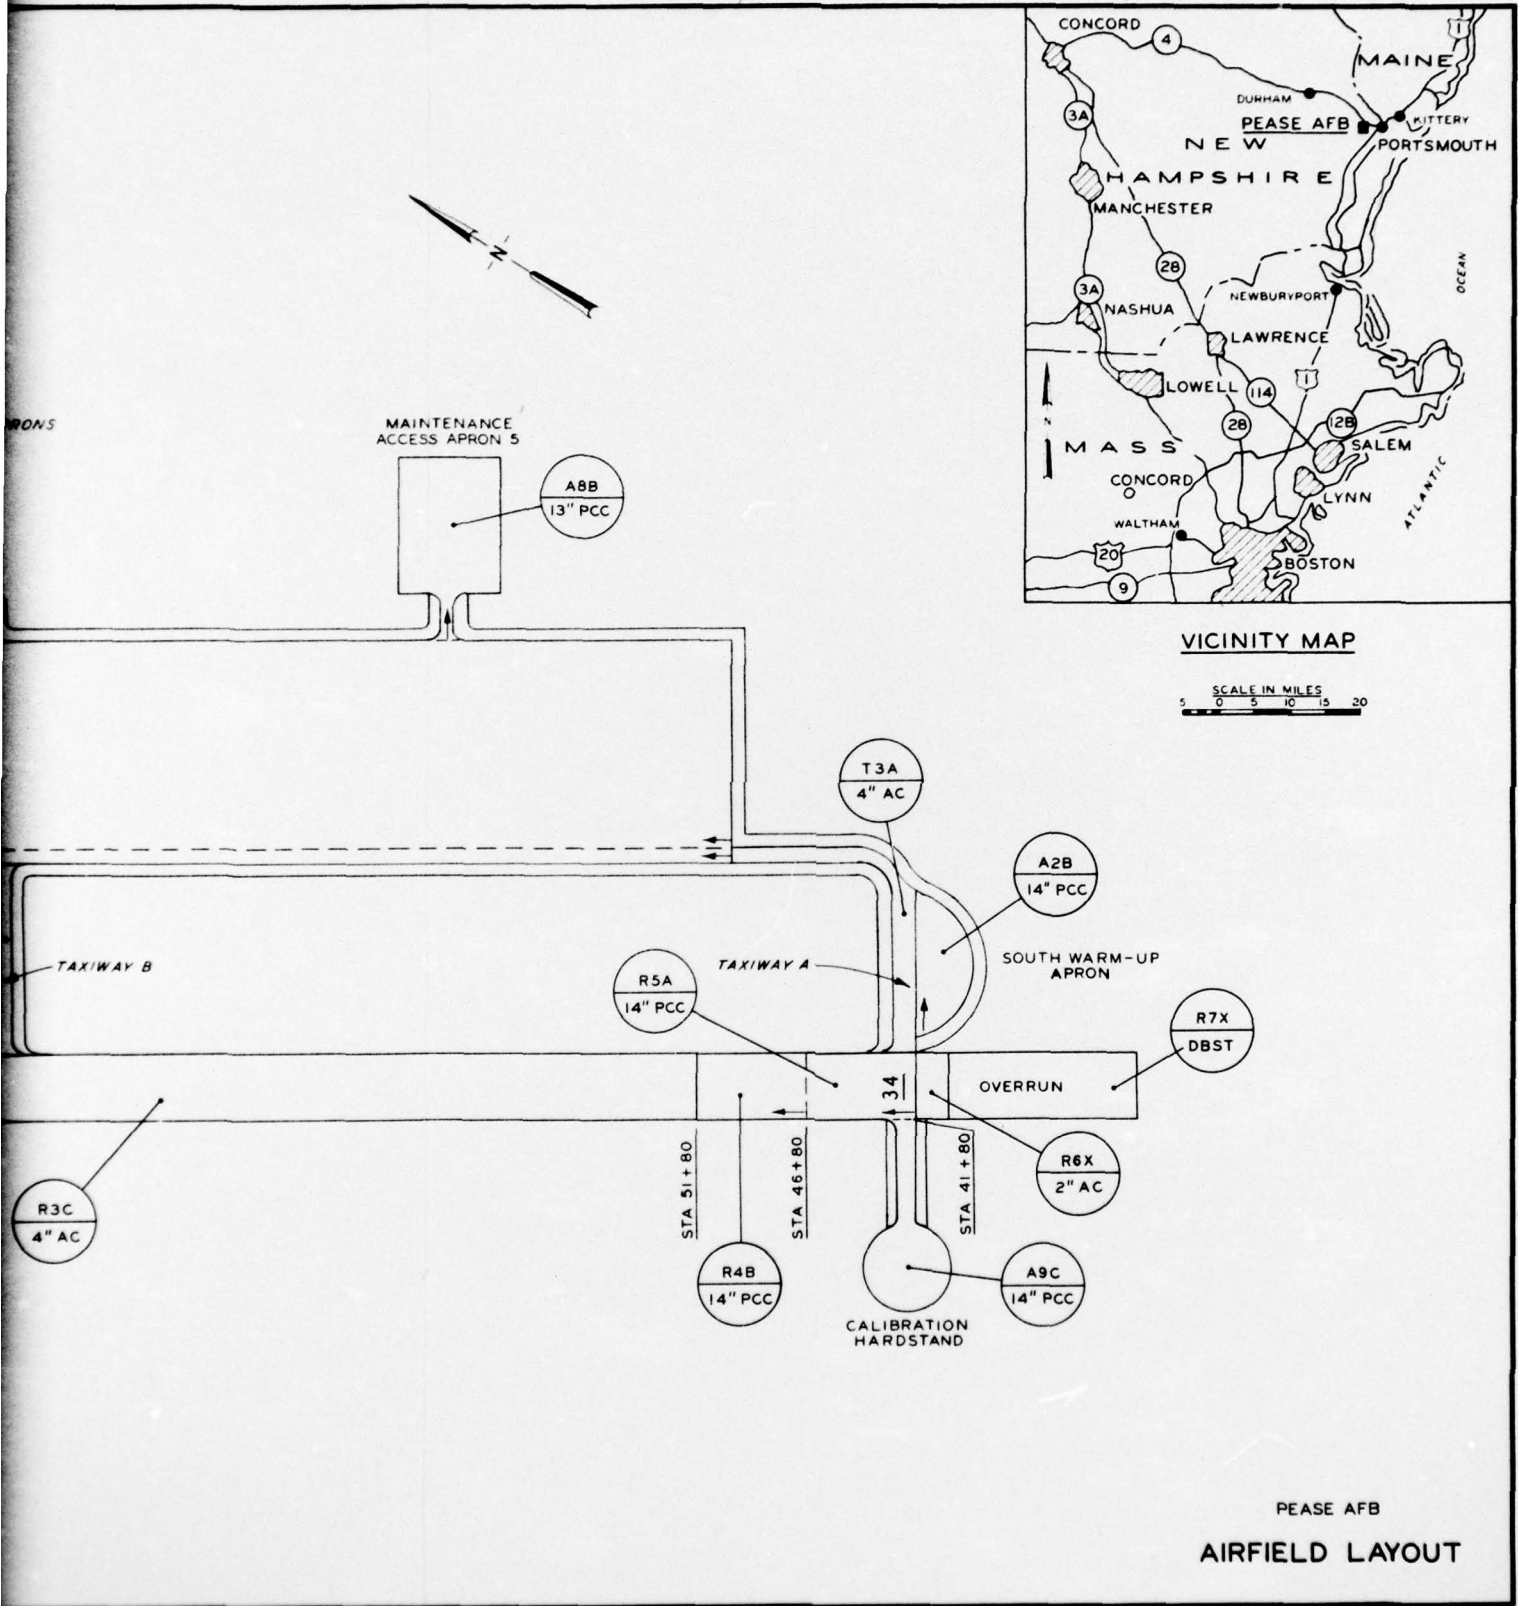
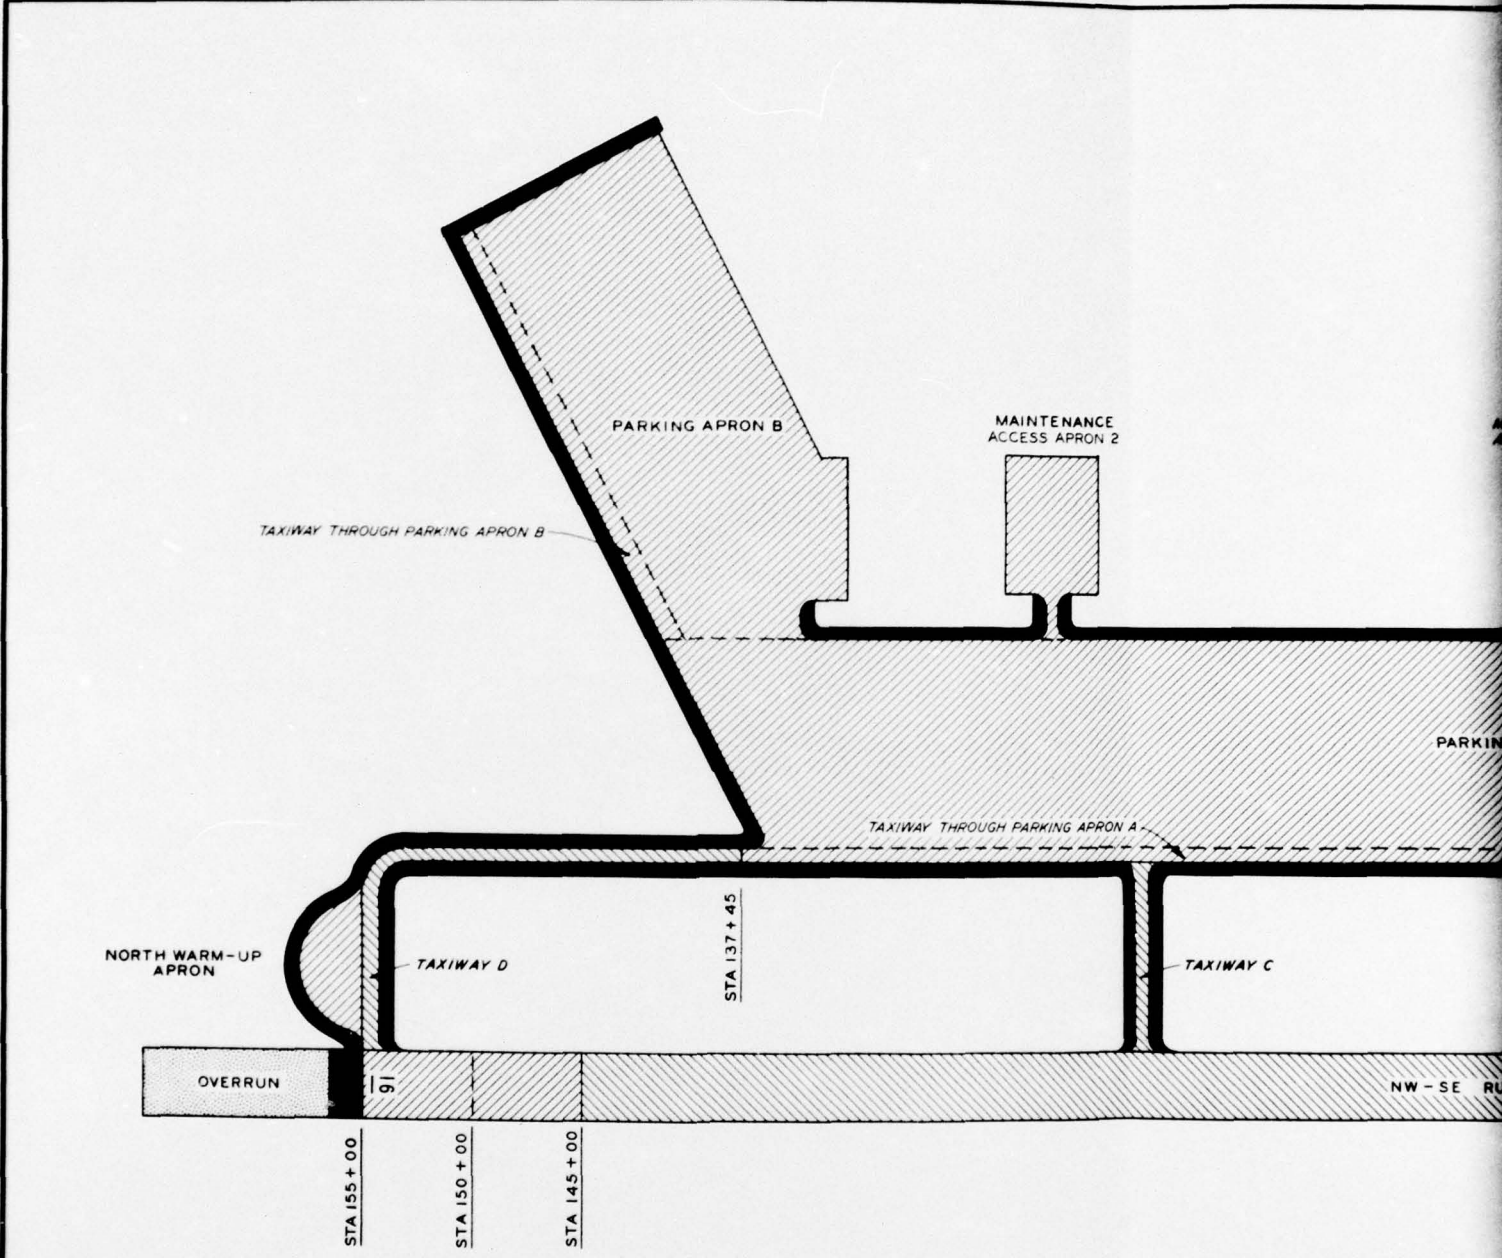
PEASE AFB  
AIRFIELD LAYOUT

the defects were recorded. The locations of the individual pavement features, the inspection starting points, and the directions in which the pavements were inspected (shown by arrows) are indicated in plate 1. The results of the rigid pavement survey for those features that were inspected in detail are presented in table 3. This table shows a quantitative breakdown of the various types of defects and a condition rating for each pavement feature inspected in detail. The procedures used for determining the condition rating of a pavement are given in Appendix III of Department of the Army Technical Manual TM 5-827-3, "Rigid Airfield Pavement Evaluation," dated September 1965.
