CONDITION SURVEY, MARCH AIR FORCE BASE, CALIFORNIA

R. D. Jackson

June 1973

Conducted by U. S. Army Engineer Waterways Experiment Station
Soils and Pavements Laboratory
Vicksburg, Mississippi

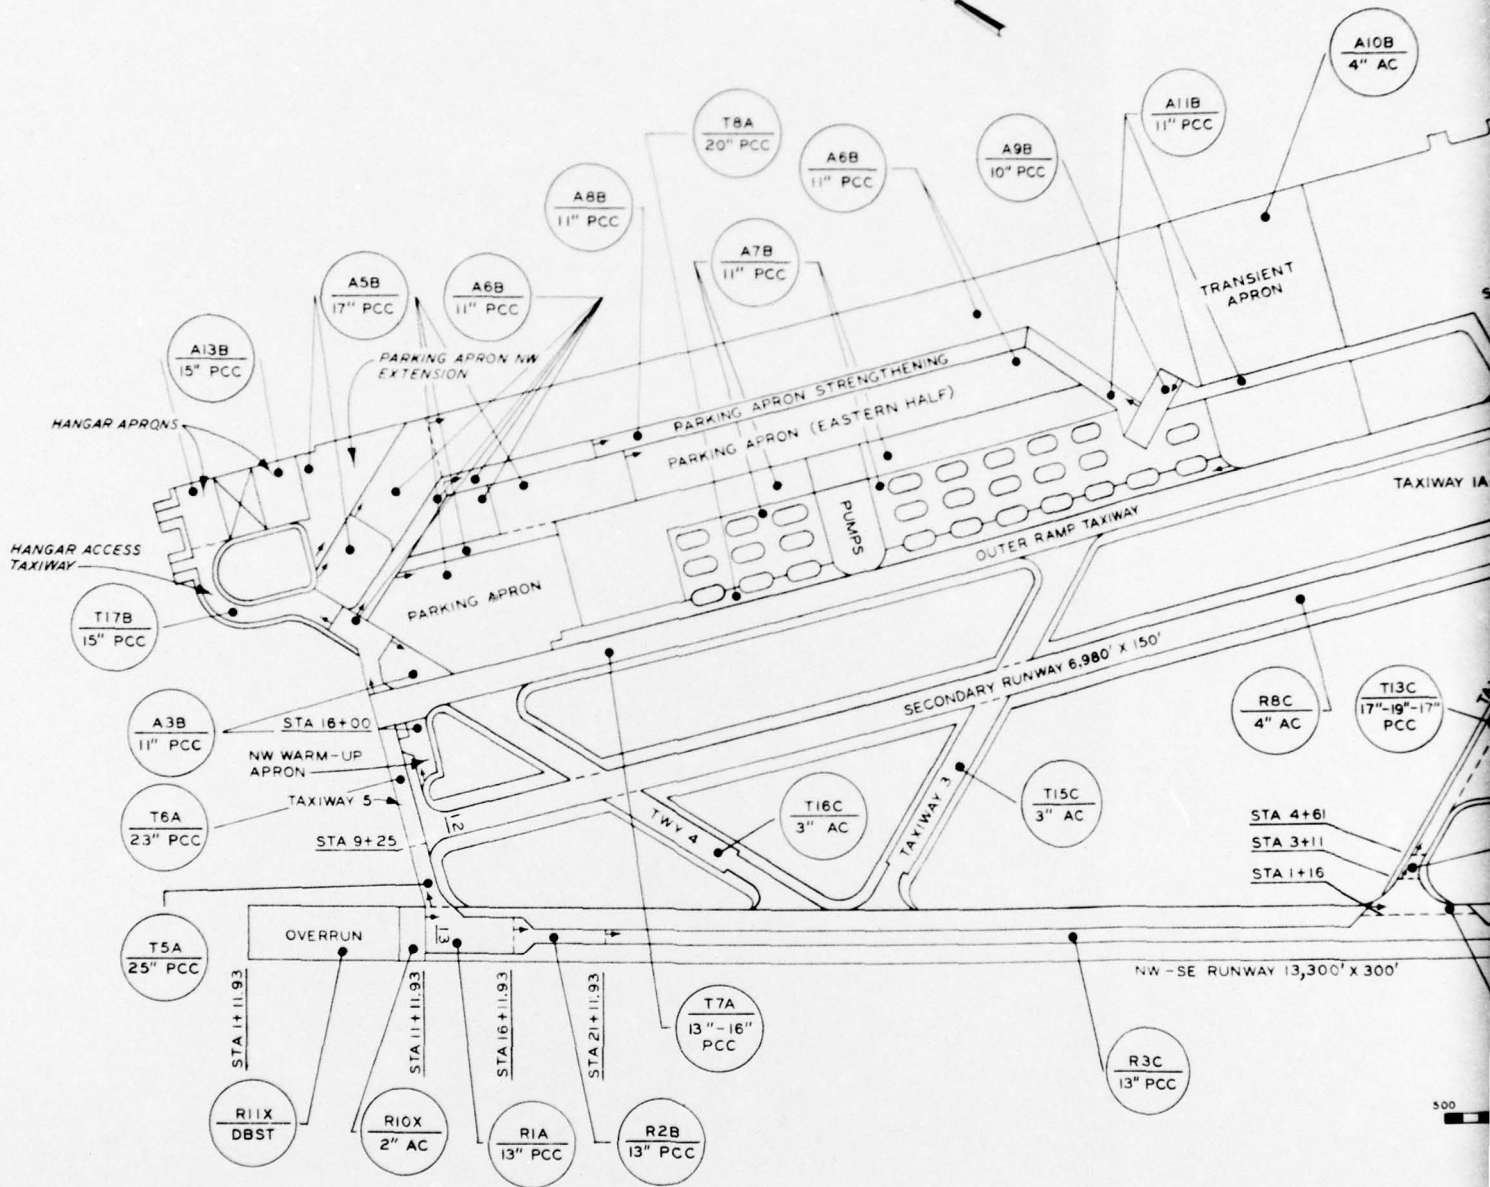
the south and east sides of the south end of the parking apron was noted (photos 5 and 6). Photo 7 shows the upheaval of the shoulder pavement along the east side of the south end of this apron. The shoving and upheaval occurred during 1972 and were apparently caused by expansion of the PCC pavement. Typical cracking of the AC pavement in the refueling area of the apron is shown in photo 8. Photo 9 shows the typically poor condition of the AC pavement on the transient apron.

Photo 9. Typical poor condition of AC of transient apron
