# CONDITION SURVEY, PLATTSBURGH AIR FORCE BASE, NEW YORK

by  
R. D. Jackson

June 1973

Conducted by U. S. Army Engineer Waterways Experiment Station  
Soils and Pavements Laboratory  
Vicksburg, Mississippi

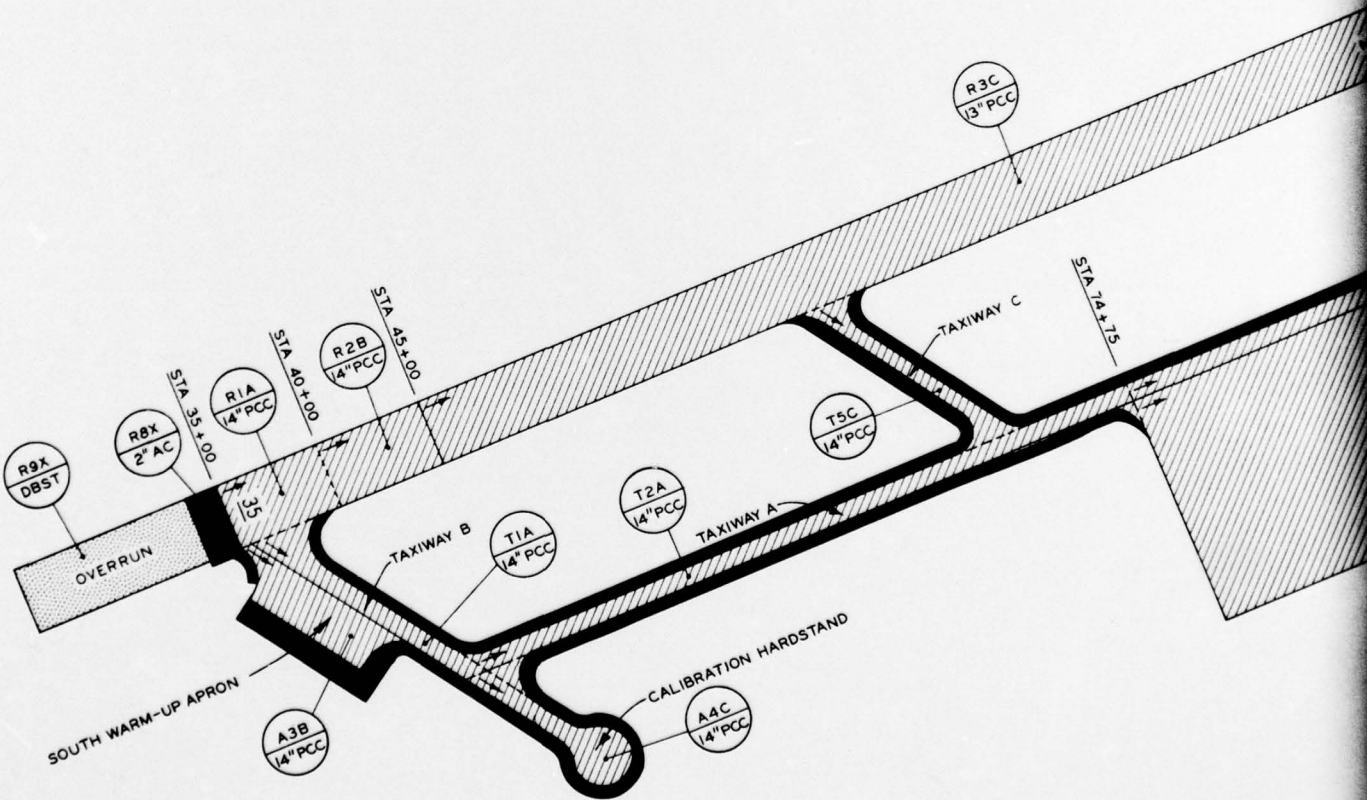
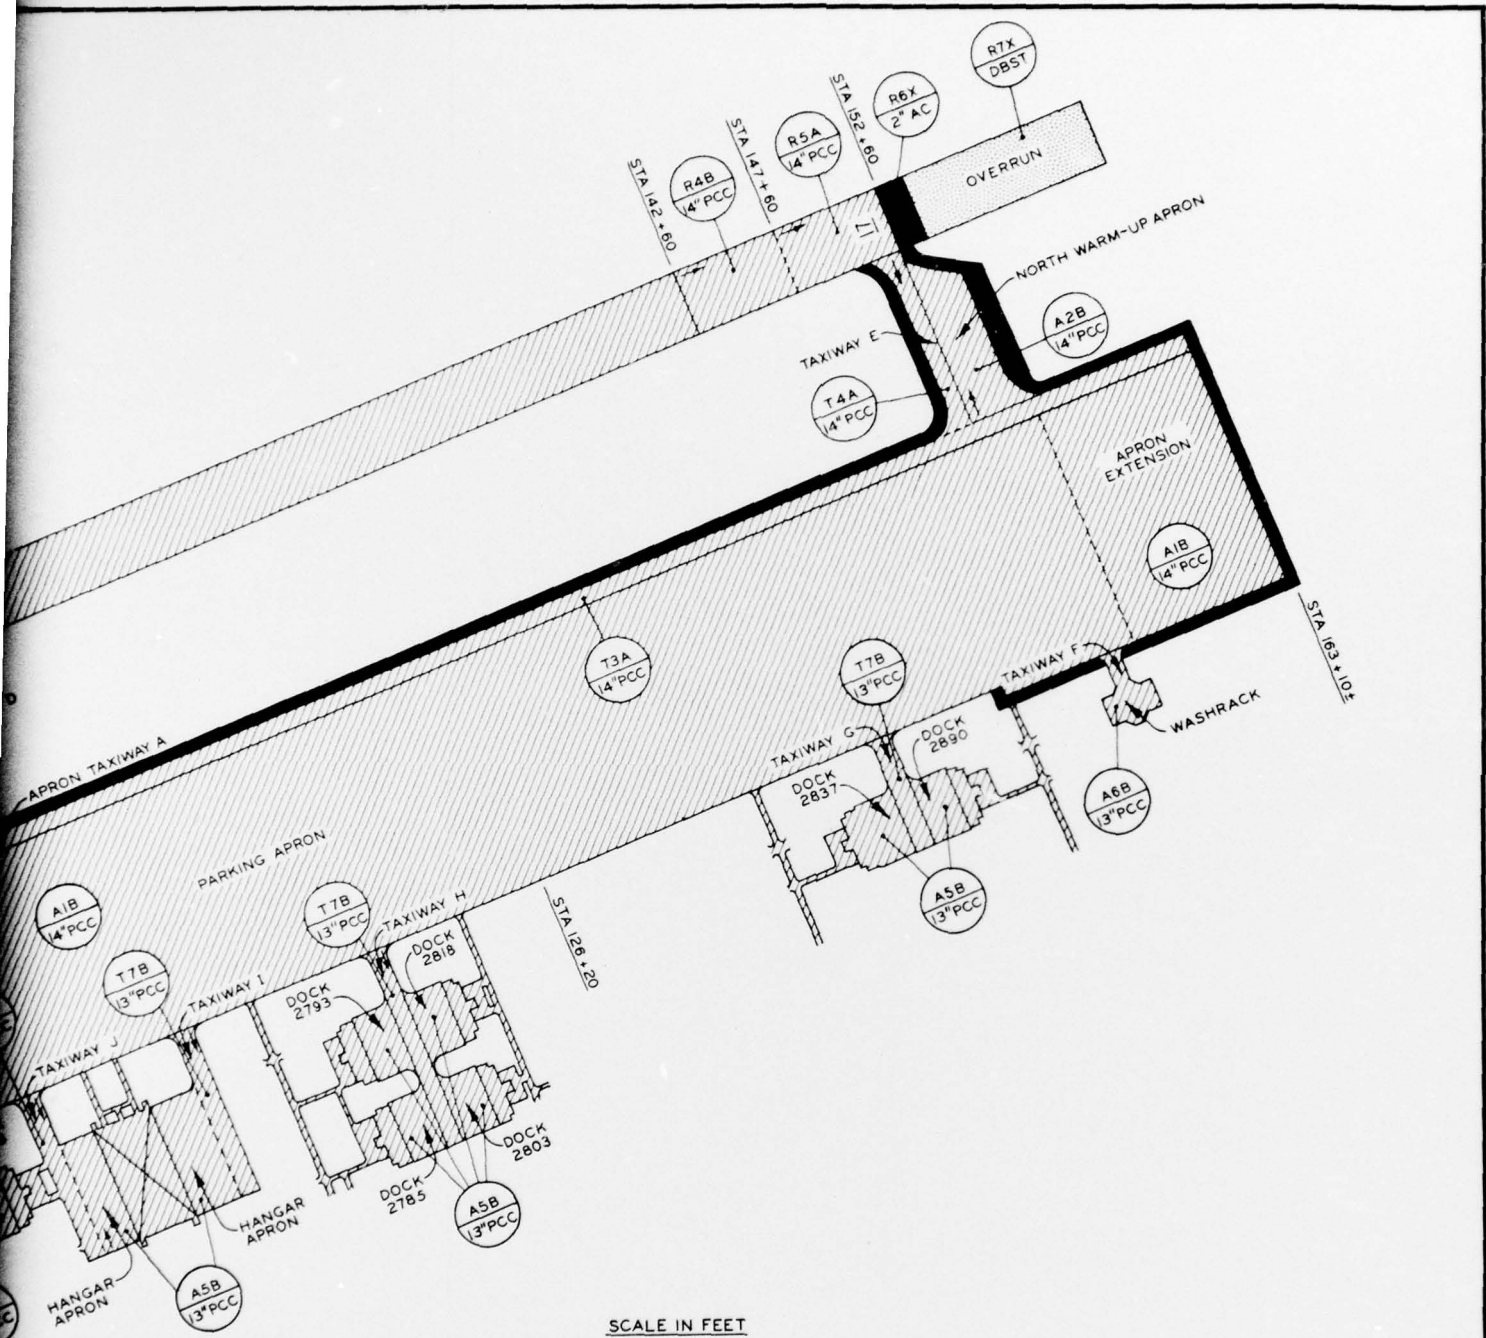
PLATTSBURG AFB  
 AIRFIELD LAYOUT AND PAVEMENT PLAN

9. The following procedure was used in conducting the inspection of the rigid pavements. Representative features were selected for detailed inspection. The features were then inspected slab\*\* by slab, and the defects were recorded. The locations of the individual pavement features, the inspection starting points, and the directions in which the pavements were inspected (shown by arrows) are indicated in plate 1.
