OBSERVATIONS
ALONG THE PIPELINE HAUL ROAD
BETWEEN
LIVENGOOD AND THE YUKON RIVER

R. Berg and N. Smith

October 1976

CORPS OF ENGINEERS, U.S. ARMY
COLD REGIONS RESEARCH AND ENGINEERING LABORATORY
HANOVER, NEW HAMPSHIRE

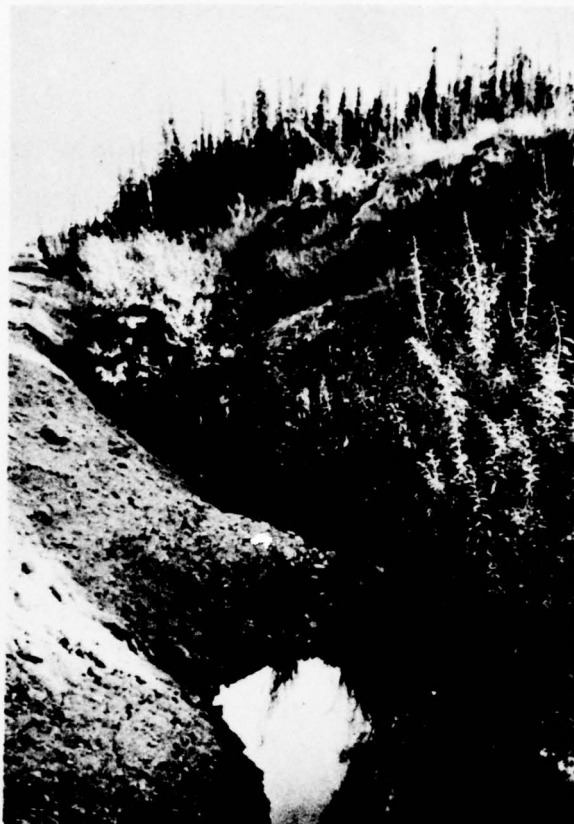
8. Thaw subsidence in ditch at Mile 23.2 Lf.

maintenance by patrol graders while the pipeline is being constructed. The major distress is now occurring in the shoulders and ditches of the roadway. In some locations sizeable "holes" have resulted from subsidence of the shoulder and ditches. Some of these shoulder failures have advanced into the roadway causing a narrower travel surface. Figure 8, a photograph taken at mile 23.2 Lf, is typical of this type of problem. Since the roadway surface is gravel, these types of problems can be repaired by simply hauling in additional granular fill.

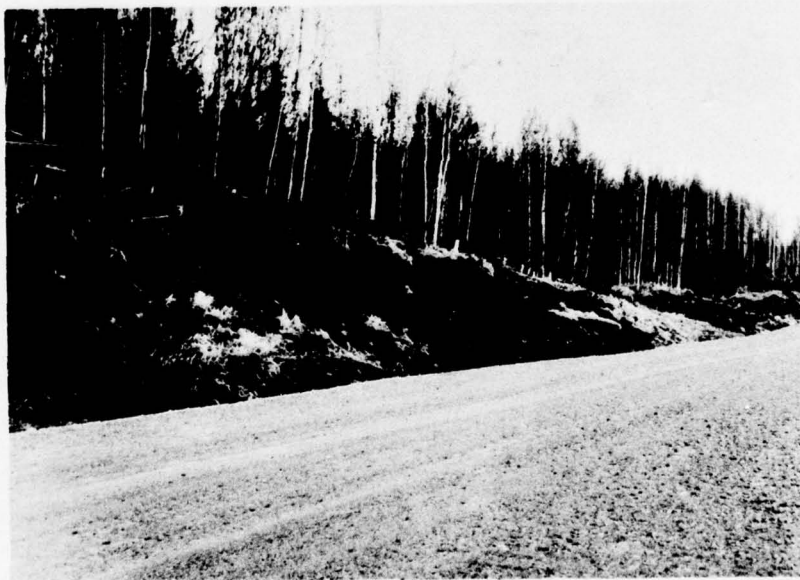
13. Southern end of receding and seeded backslope,
Mile 4.5 Rt, 27 May 1971.

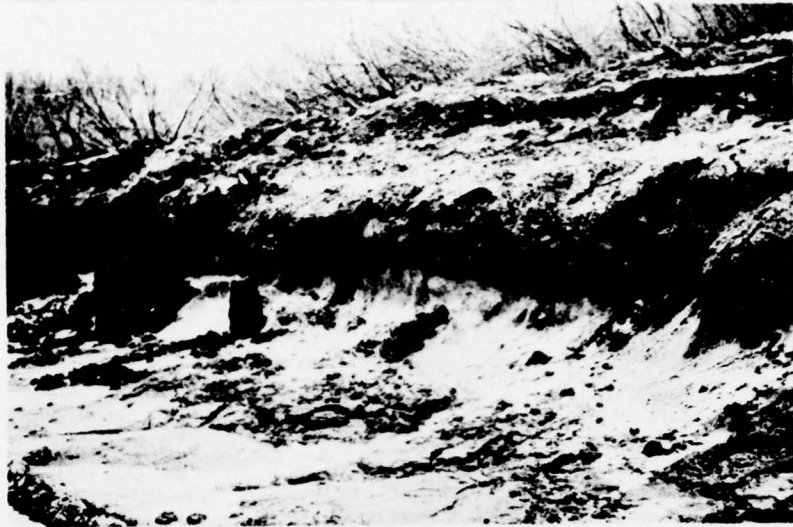
There are actually two slopes involved here, both facing in a southwesterly direction. Figures 22 and 23 illustrate a large mass of ice visible in a shallow cut on 23 April 1970. Figure 24 shows the slope on 11 August 1970. A good growth of grasses had started where the slope was not rapidly degrading. A gravel berm had been placed near the toe of the slope to allow drainage of excess water and to partially

22. Massive ice in shallow cut, Mile 9.85 Rt,
23 April 1970.

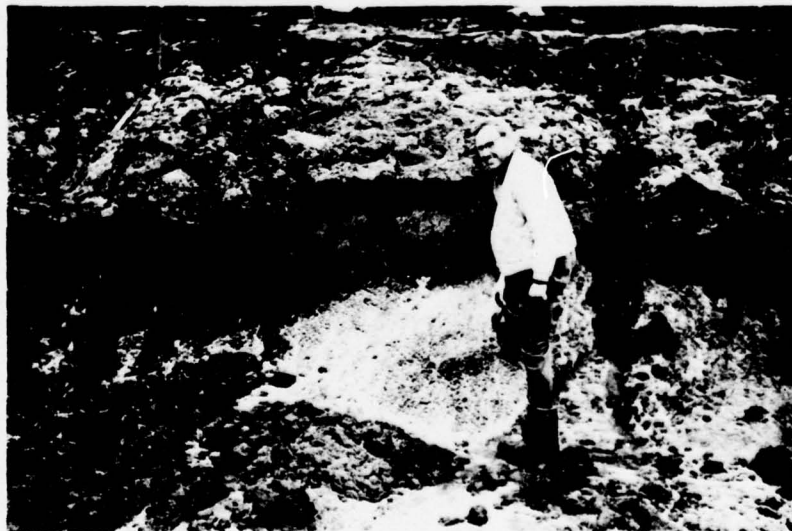
23. Close-up of massive ice in shallow cut,
Mile 9.85 Rt, 23 April 1970.

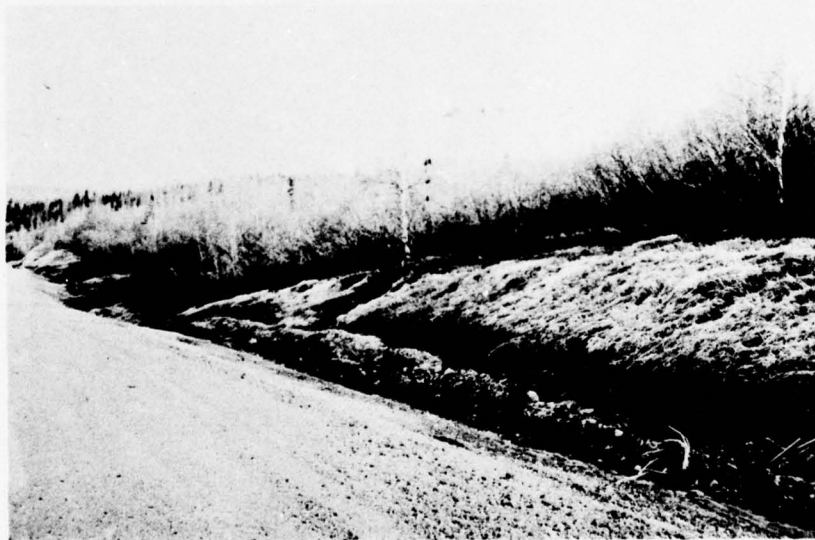
restrain the mineral soil as it fell from the receding ice. On 28 May 1971 the berm was easily observed (Fig. 25 and 26). Most of the slope appeared relatively stable but a small part continued to degrade rapidly (Fig. 26). Figure 27, taken on 27 September 1974, shows the same area as Figure 24 and represents a nearly stable condition on the shallow slope.

The second slope at this site developed stability problems during the second thaw season. It can be seen at the extreme left in Figure 25. It is much higher but the ice-rich soil was not exposed during construction. The photographs taken on 17 August 1971, Figures 28 and 29, show the massive movement and the disruption of the relatively heavy grass cover caused by subsurface thawing. The slope looked quite stable in September 1974 when last photographed. The grass cover had rehealed and some small trees had started to grow (Fig. 30).

25. Relatively stabilized shallow cut,
Mile 9.85 Rt, 28 May 1971.

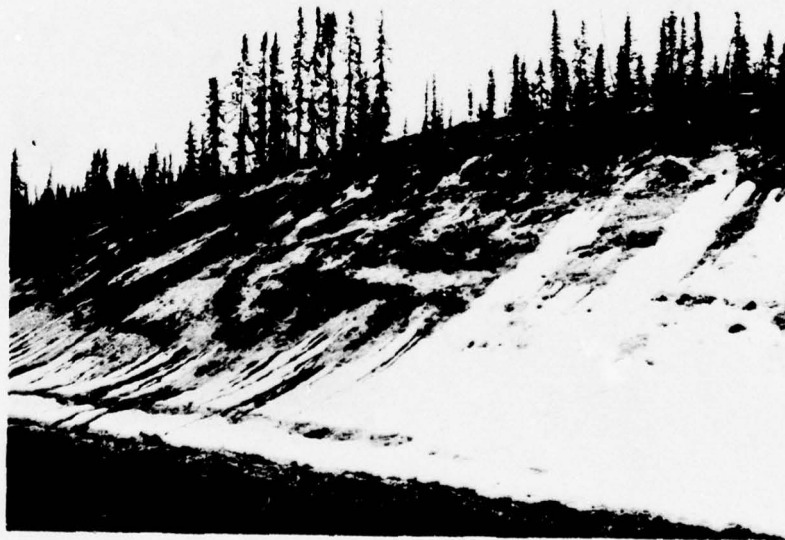
The performance of this slope during the 1970 and 1971 summers is discussed by Smith and Berg (1973). This was the first major ice-rich cut encountered along the road and was the only one made at a nominal 1:1 backslope (Fig. 31). On the remaining deep high ice content cuts, essentially vertical backslopes were made. Figures 32 and 33 show that by 26 June 1970 considerable degradation of the slope had occurred. The ditch was nearly full of wet, muddy soil. Material in the ditch was not sufficiently stable to support a small rock tossed from the roadway shoulder. Between June and August 1970 the ditch was cleaned and a revetment installed (Fig. 34, 35 and 36). The slope had also been hydroseeded but little grass had been established due to rapid degradation of the slope. By May 1971 material in the ditch had dried sufficiently to support a man's weight and the backslope appeared relatively dry (Fig. 37 and 38). Little additional degradation of the slope occurred during the 1971 summer and material in the ditch contained several desiccation cracks on 17 August 1971, as shown in Figures 39 and 40. On 23 June 1972, the slope was in a condition similar to that observed previously (Fig. 41 and 42). This slope was completely snow-covered in April 1973 and was not photographed in 1974. In September 1975 the slope looked quite stable (Fig. 43 and 44). Grasses and willows had established themselves on most of the slope. In the three summers between June 1972 and September 1975 the apparent stability of this slope improved dramatically.

31. Frozen, partially snow-covered 1:1 backslope,
Mile 19.6 Lf, 23 April 1970.

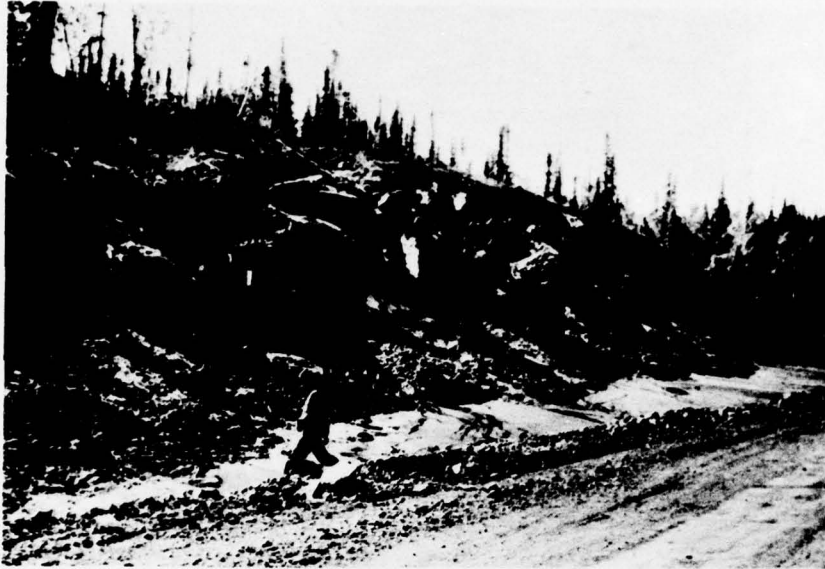
32. Thawing backslope, Mile 19.6 Lf, 26 June 1970.

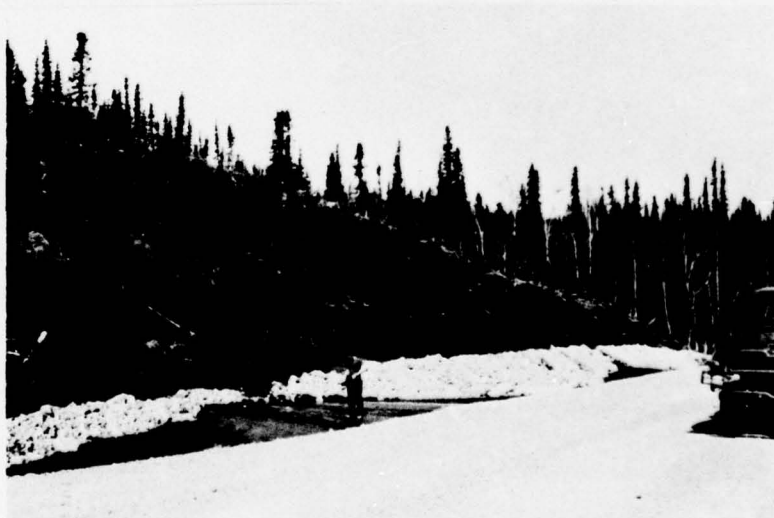
37. Receding backslope and stabilized ditch sediments,
Mile 19.6 Lf, 23 May 1971.

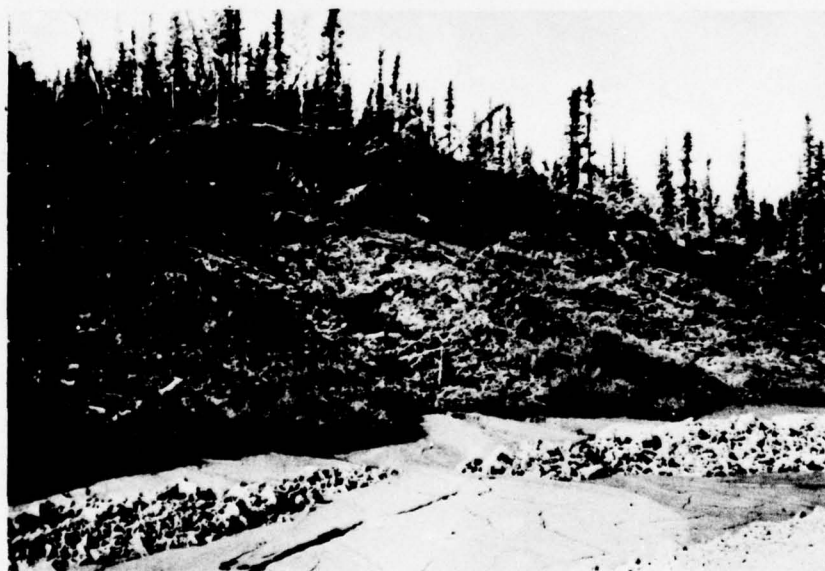
39. Overall view of slope showing desiccation of ditch
sediments and continued slope recession, Mile 19.6 Lf,
17 August 1971.

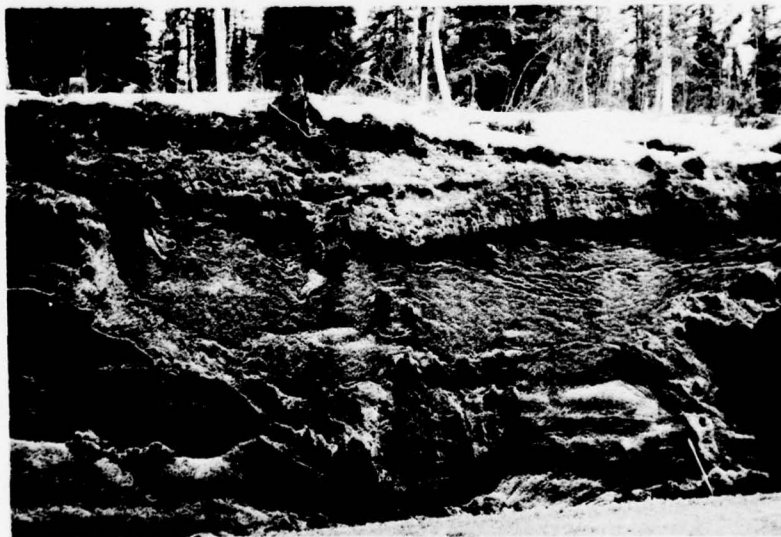
This slope faces the northeast. Figure 45 shows a large mass of ice in the cut on 23 April 1970. This slope degraded rapidly and by September 1970 a shot rock revetment had been installed in the ditch

45. Massive ice in frozen backslope, Mile 19.9 Lf,
23 April 1970.

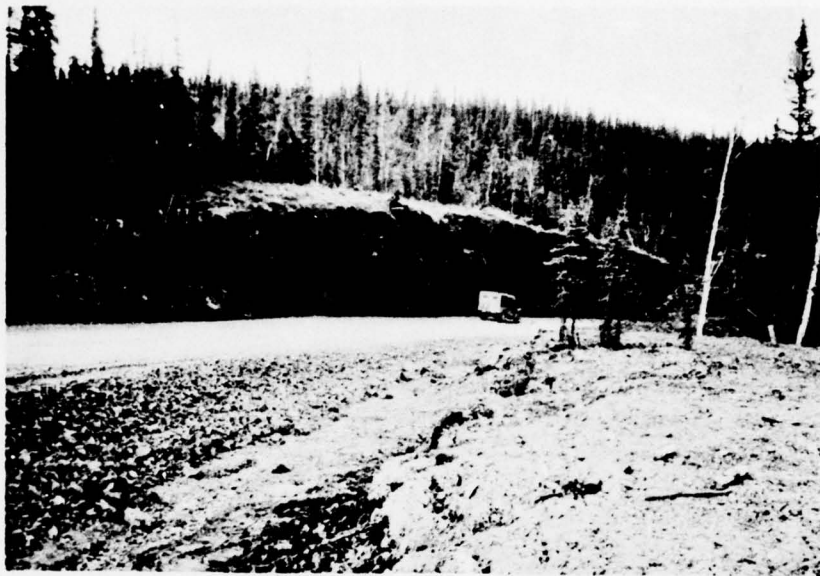
56. Ice face with overhanging mat and clearing atop backslope, Mile 20.25 Lf, 26 June 1970.

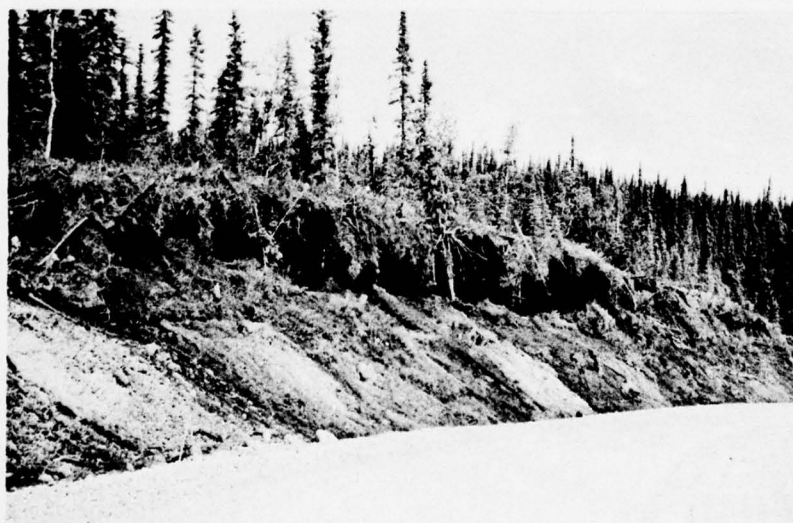
57. Ice face with overhanging mat and hydroseeded lower portion of slope, Mile 20.25 Lf, 11 August 1970.

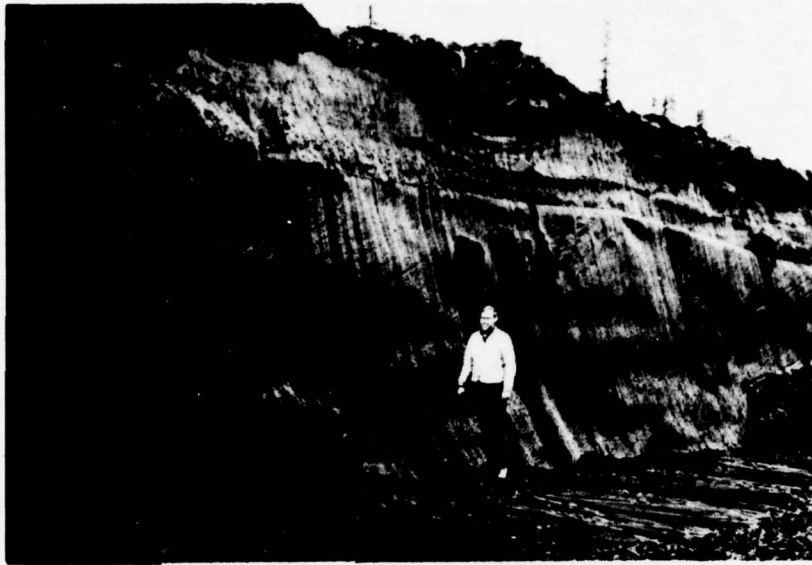
68. Massive ice in frozen backslope, Mile 22.9 Lf, 23 April 1970.

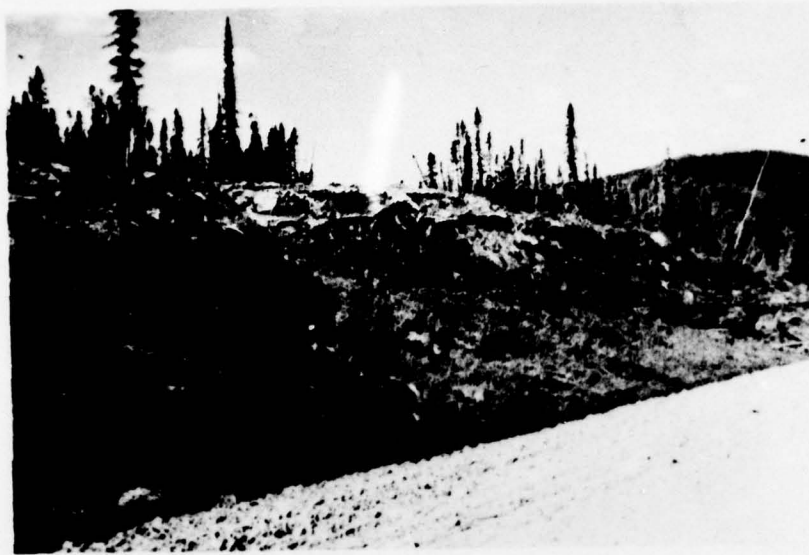
70. Started grasses on portion of slope, Mile 22.9 Lf, 11 August 1970.

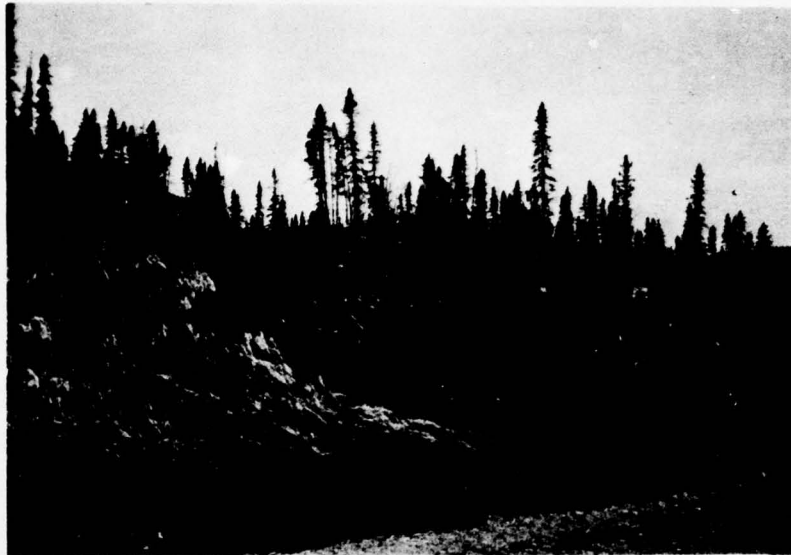
72. Unstable portion of backslope, Mile 22.9 Lf, 28 May 1971.

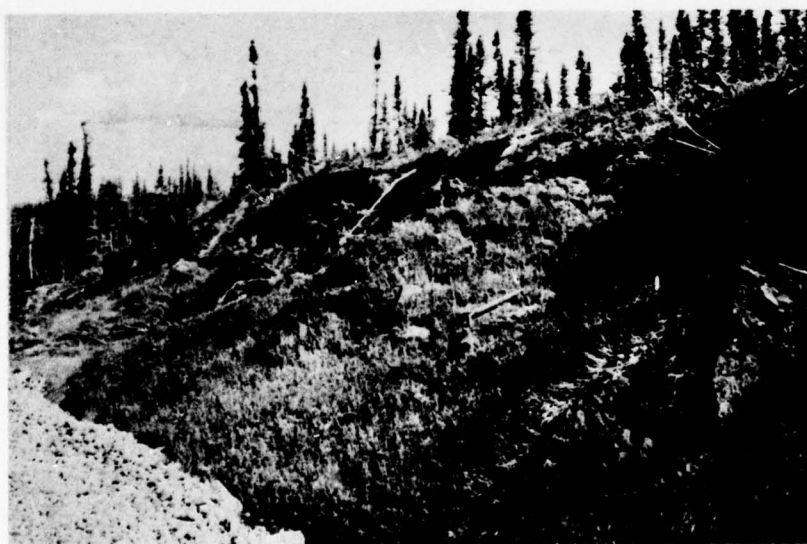
77. Parts of backslope stabilized and other sections receding, Mile 22.9 Rt, 11 August 1970.

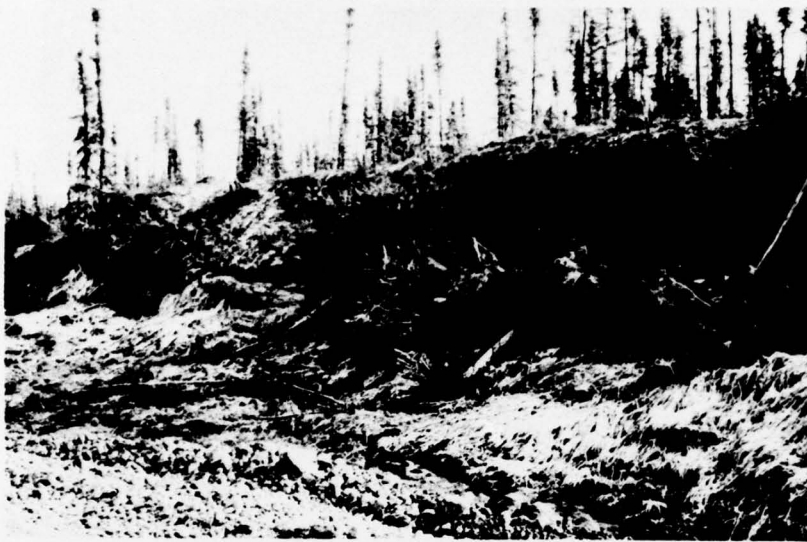
78. Center portion of slope, Mile 22.9 Rt, 28 May 1971.

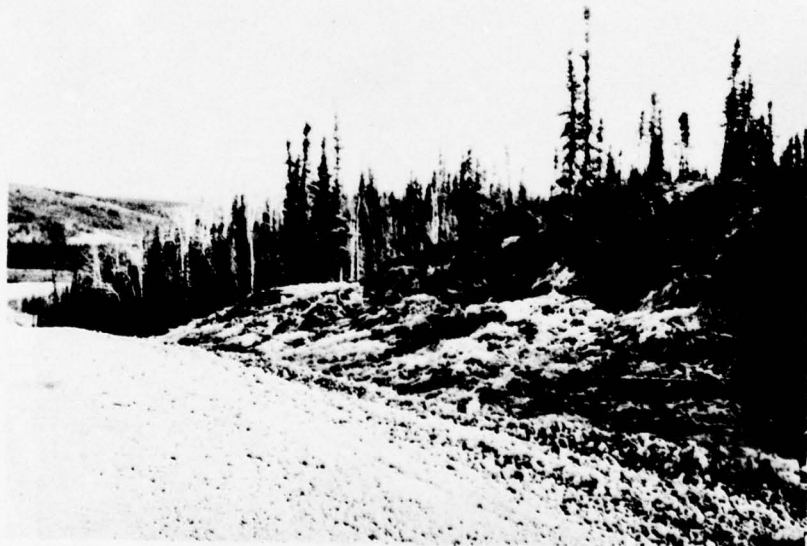
79. Northern portion of slope, Mile 22.9 Rt, 23 June 1972.

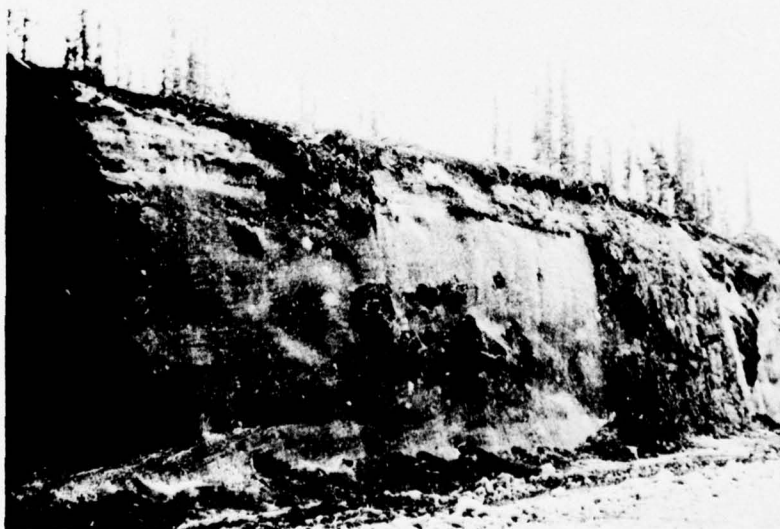
83. Massive ice in frozen backslope, Mile 23.2 Lf, 23 April 1970.

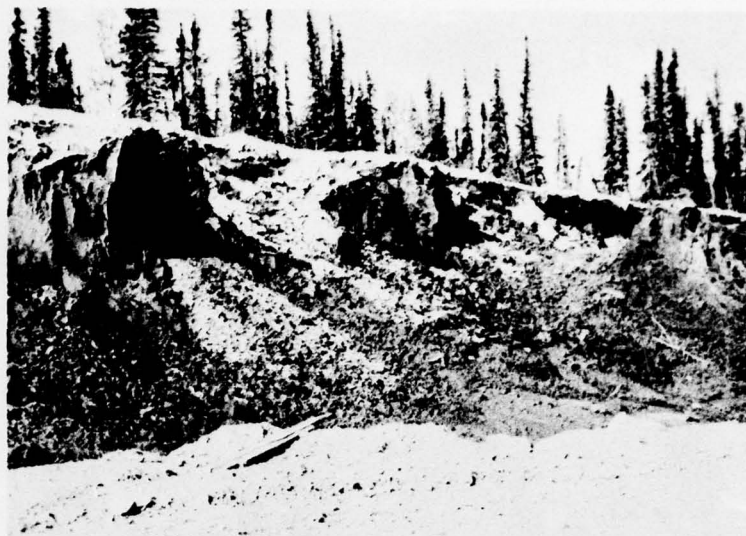
84. Center portion of slope showing fibrous insulation on cleared top of backslope, Mile 23.2 Lf, 11 August 1970.

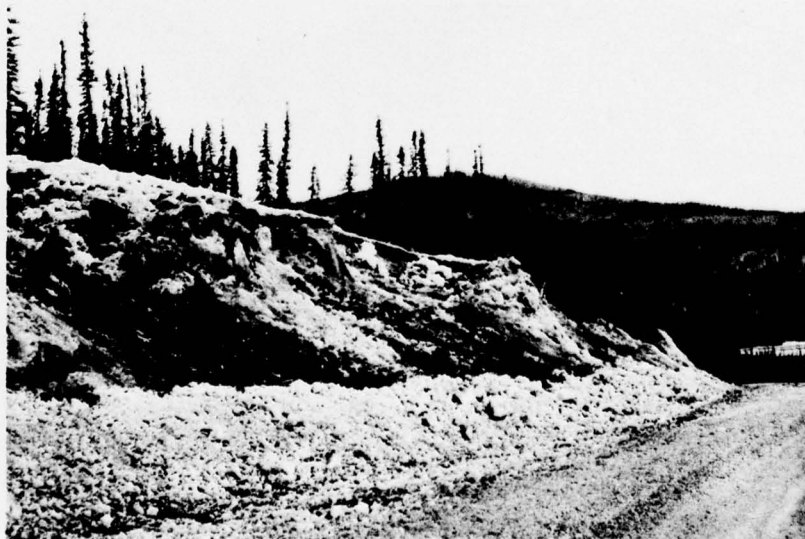
85. Gravel berm near base of backslope, Mile 23.2 Lf, 28 May 1971.

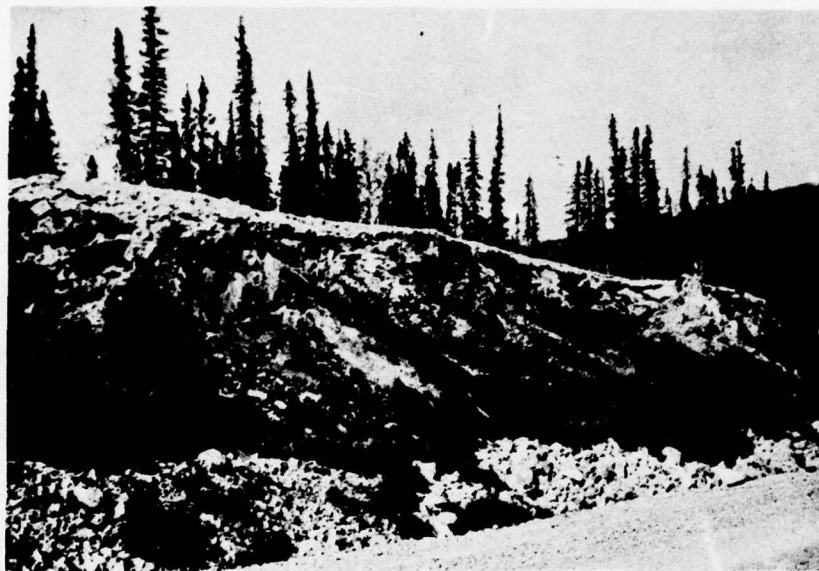
86. View of slope showing grass growth and continued slumping, Mile 23.2 Lf, 17 August 1971.

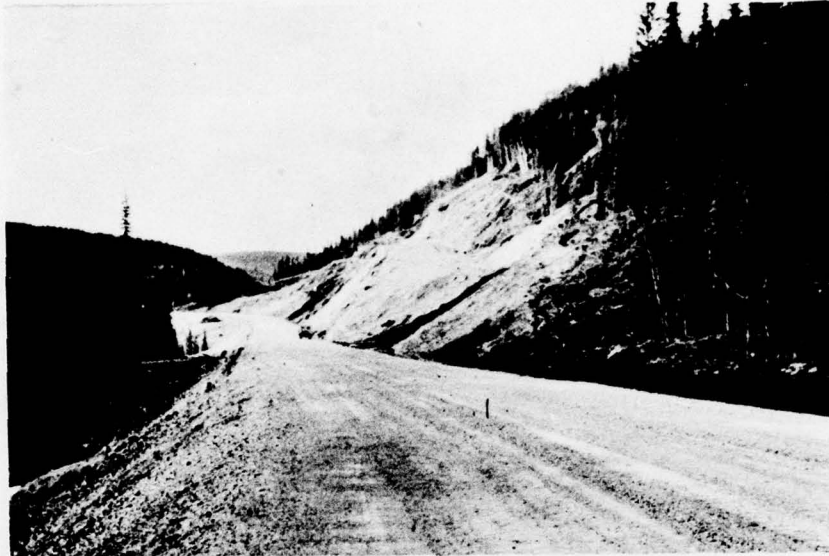
90. Overall view of backslopes, Mile 33.1 Rt in foreground and Mile 33.3 Rt in background, 26 June 1970.

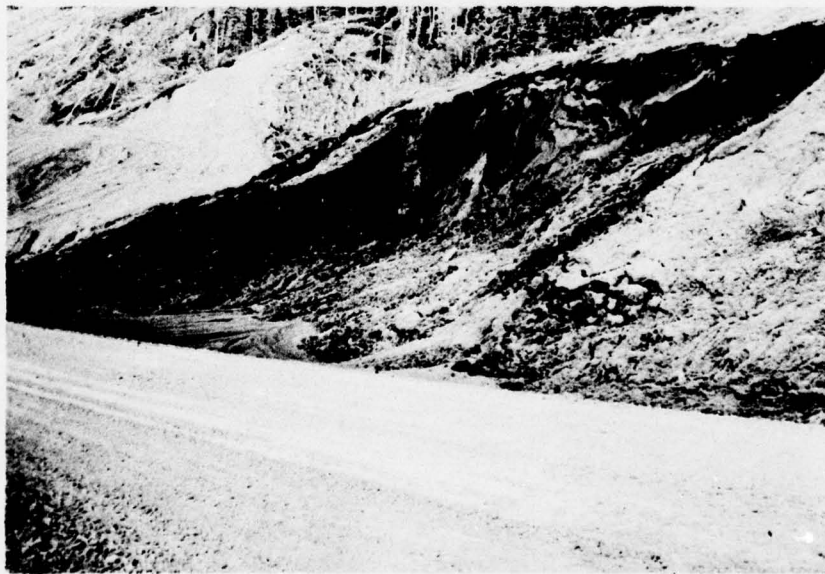
91. Close-up of start of sloughing, Mile 33.1 Rt, 26 June 1970.

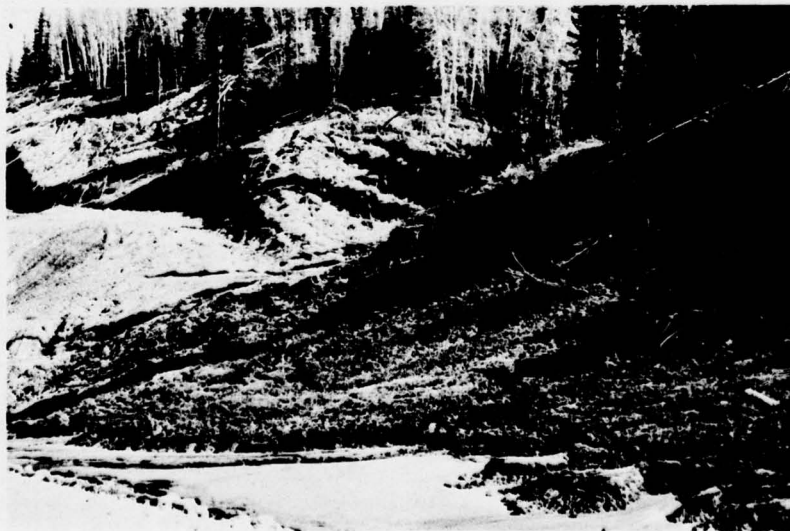
95. Northern end of slope, Mile 33.1 Rt, 28 May 1971.

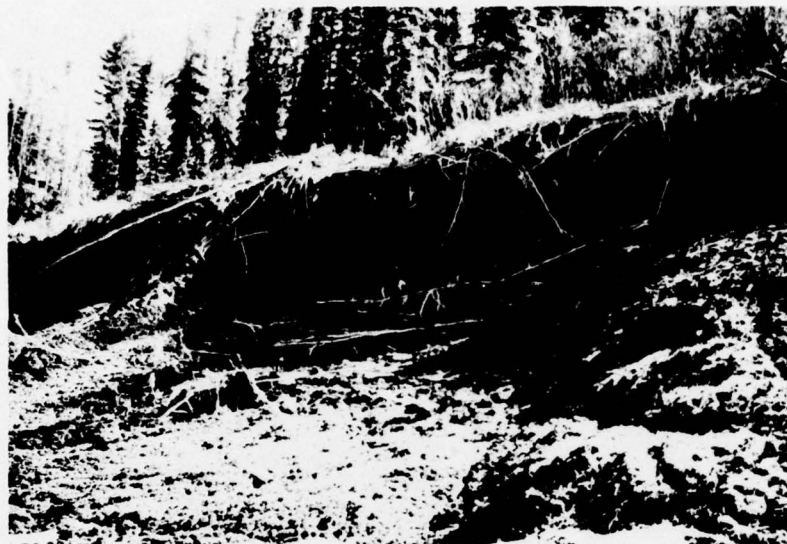
96. Center portion of slope with mat overhanging ice face, Mile 33.1 Rt, 28 May 1971.

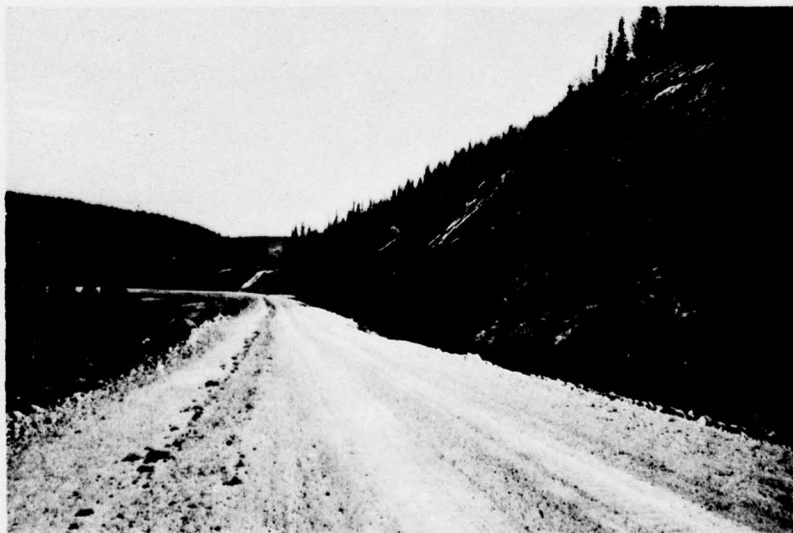
97. Benched slope, Mile 33.3 Rt, 28 May 1971.

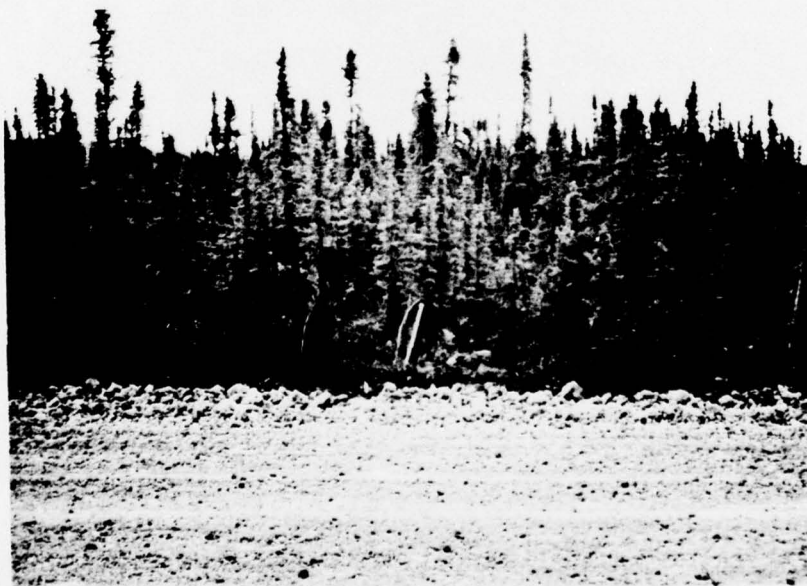
Figures 110 and 111 illustrate the conditions at the second cross-section site on 27 June 1970. This site is at station 2710+00 at about mile 50.7 (81.6 km). The finished grade elevation was 1177.5 ft (358.8 m) and the width of the roadway surface was about 28 ft (8.5 m). The section is located in a relatively flat area with very little vertical grade on the road which runs in a northwesterly direction. At this site the trees and vegetation had been disturbed for a width of only about 20 ft (6.1 m) beyond the toe of the slope on each side of the road. Figure 112 illustrates changes in cross-section levels for this section from 27 June 1970 through September 1975. The roadway centerline has subsided about 1.25 ft (0.38 m) since it was constructed. Reasons for the settlement can be inferred from exploratory borings for the pipeline in that vicinity (Fig. 113). The boring logs were taken from Alyaska (1971) and the locations were within 500 ft (150 m) of the cross-section site. Occasional to considerable amounts of visible ice were encountered in the top 3 to 6 ft (1 to 2 m) of overburden. This would easily account for the recorded settlements.

111. Right side of road, Mile 50.7, 27 June 1970.
