**6 AIRFIELD PAVEMENT EVALUATION,
BUTTS ARMY AIRFIELD,
FORT CARSON, COLORADO.**

AIRFIELD PAVEMENT EVALUATION

BUTTS ARMY AIRFIELD

FORT CARSON, COLORADO

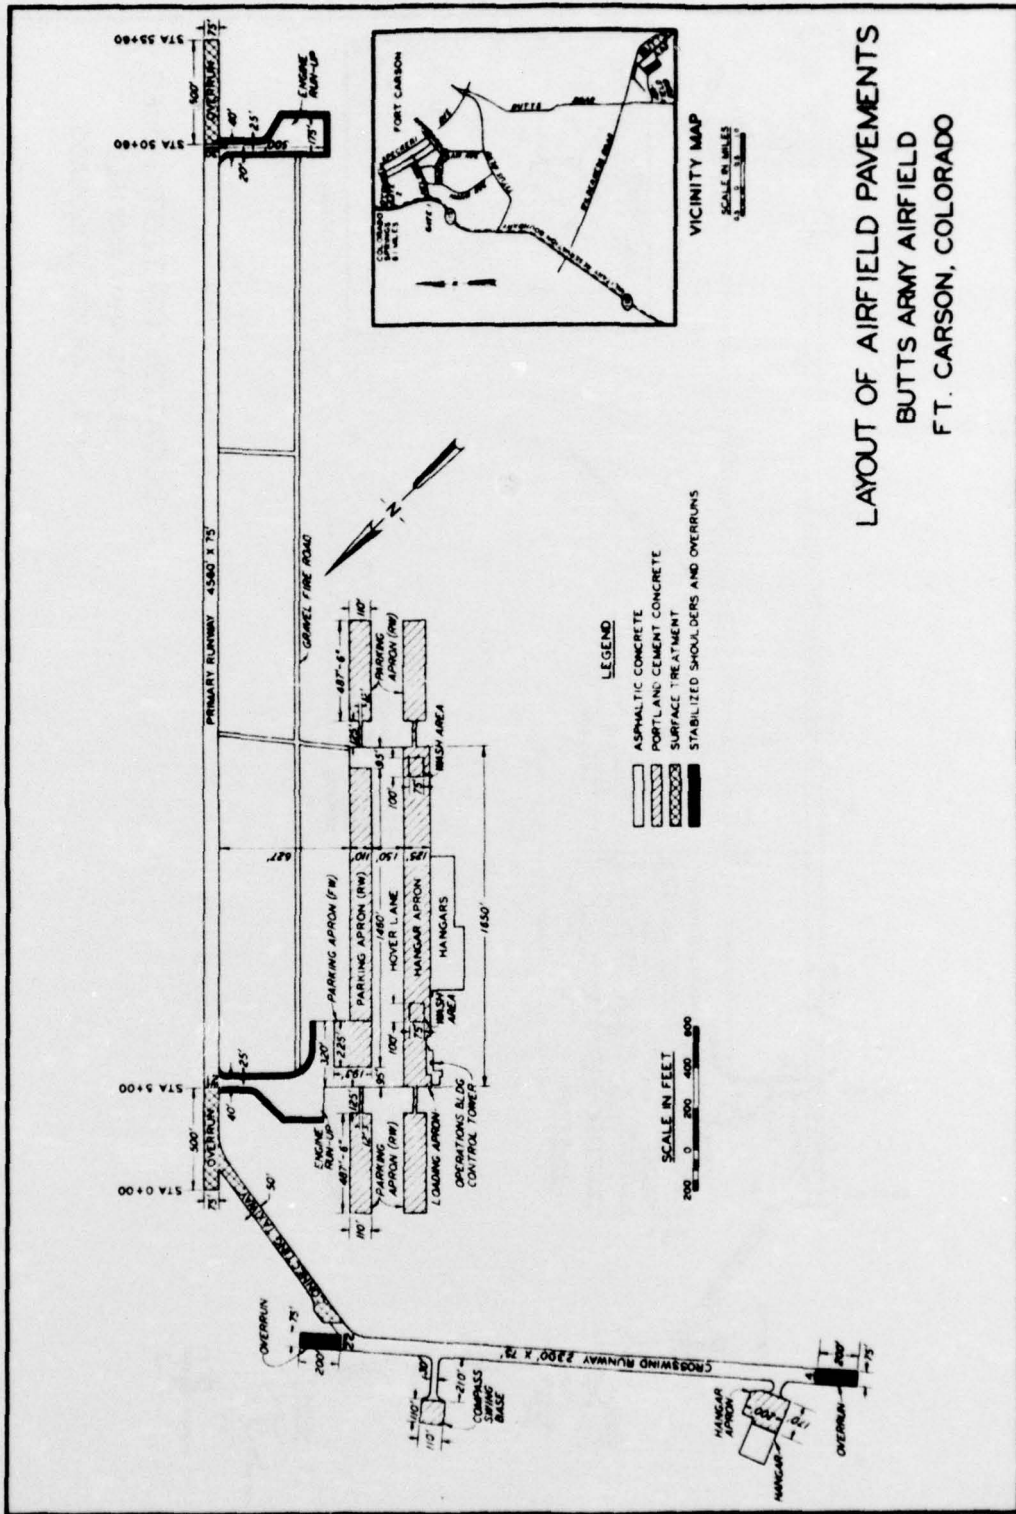
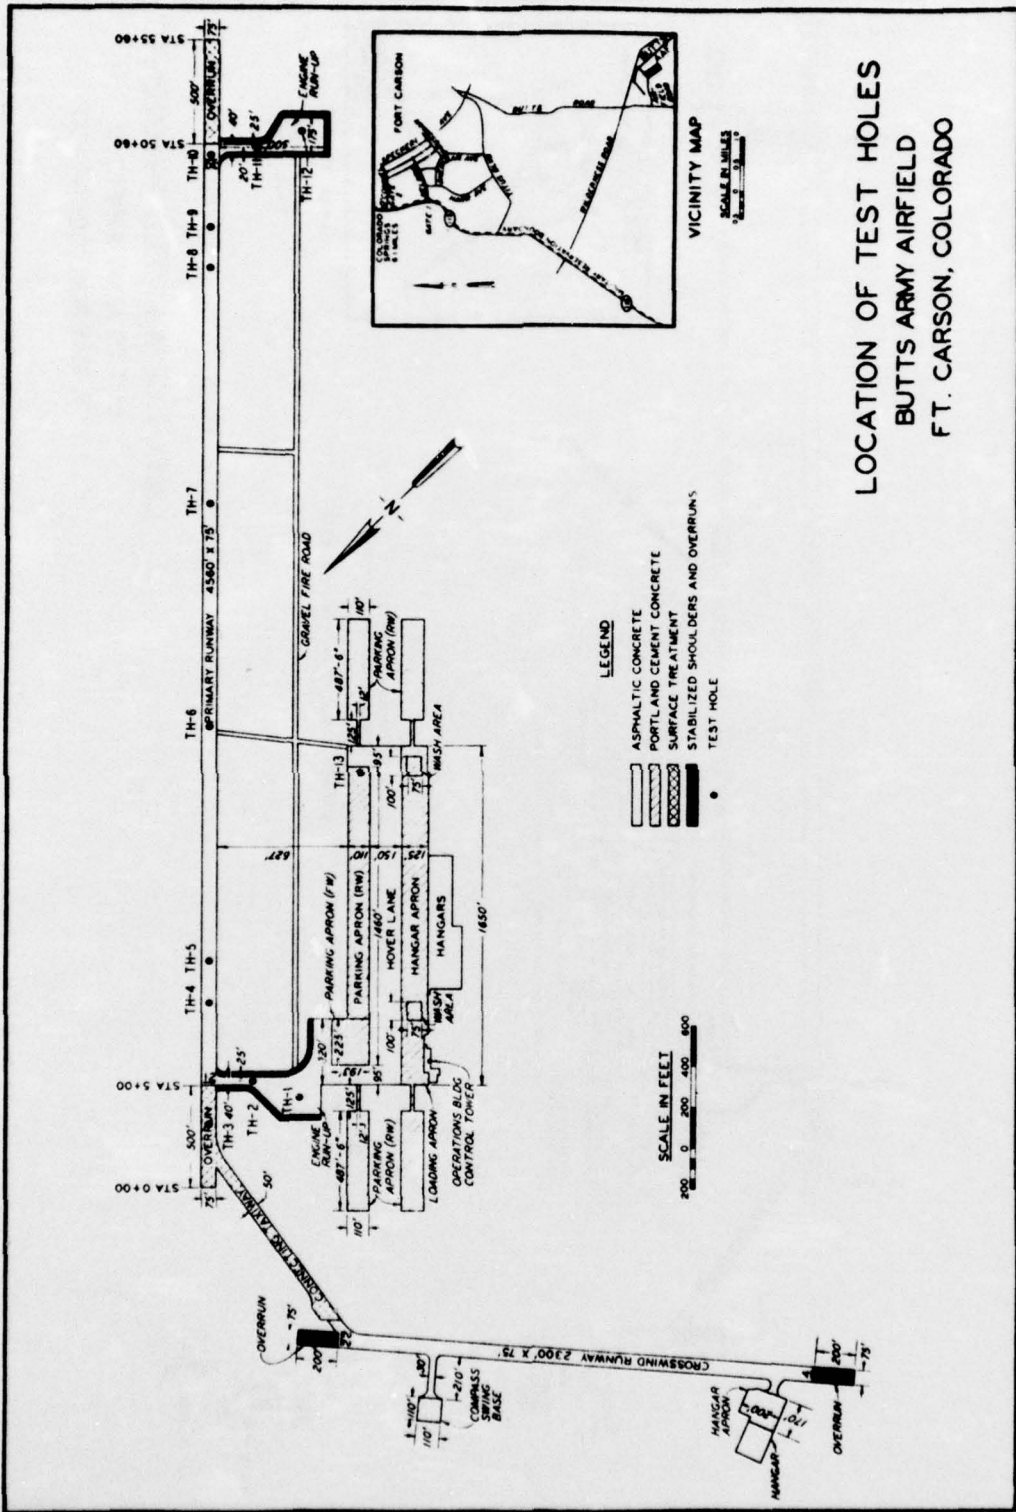
PLATE 2

10. Tests were performed at 13 locations by the Lincoln DeVore Testing Laboratory in January 1976. Locations of the tests are shown in Plate 2 and tests are described below. Results of the tests are given in Tables 1-4.
