GROUND SUPPORT EQUIPMENT DEPARTMENT
NAEC-GSED-106 SEPT 1976
CODE IDENT. NO. 28638

CONTROL OF CORROSION
IN
GROUND SUPPORT EQUIPMENT

INTERIM REPORT

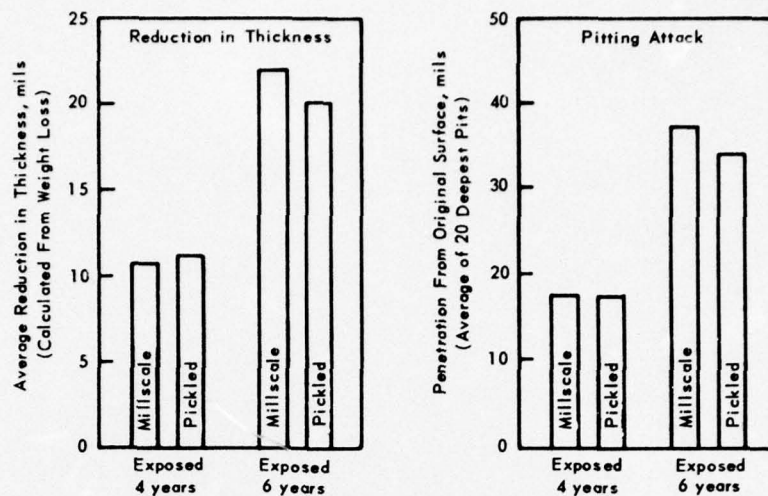
5.5.12. Another factor affecting the steel's performance in the marine atmosphere is the condition of the surface as exposed. For example, when hot-rolled steel is used for construction, the mill scale is sometimes left on. The rate of penetration, based on weight loss, and the depth of pitting are greater for a mill-scaled surface than for, say, a pickled surface. This point is illustrated by the results of 8 years' exposure of steel panels at Cristobal, Panama Canal Zone (see Figure 5-1(10)). When the surface is wet with salt spray, the mill scale will serve as a relatively large cathode to the small anodes formed at breaks in the scale, and this will result in intense local attack.

Figure 5-1. Comparison of Effects of Mill Scale and Pickled Subsurfaces on the Corrosion Resistance of Unalloyed Low-Carbon Steel Exposed to the Tropical Marine Atmosphere at Cristobal, Canal Zone (10).

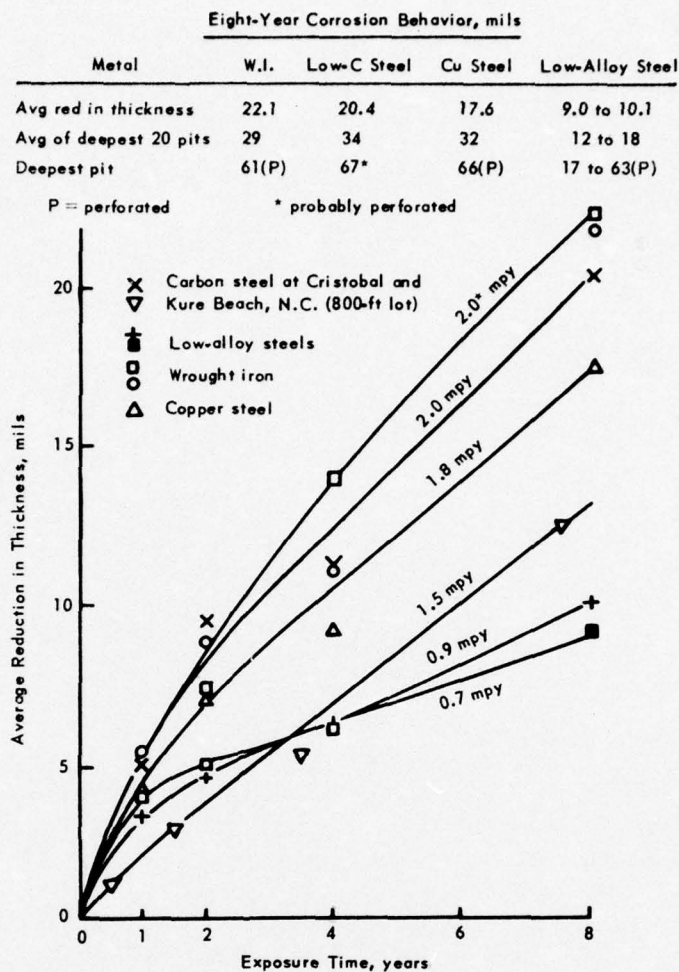
5.5.13. Wrought Iron. As made in this country in recent years, wrought iron is essentially a dead mild steel to which an oxide-silicate slag has been added, while still molten. As is the case with carbon steel, unprotected wrought iron is rapidly attacked by exposure to marine atmospheres. A comparison of the behavior of wrought iron and steel is shown in Figure 5-2 for the first 8 years of the 16-year Navy exposure program at Cristobal, Canal Zone (10). Carbon-steel behavior at the 800-foot lot, Kure Beach, N. C., is also shown for comparison. It is to be noted that the rate of penetration for steel and wrought iron after 8 years' exposure is quite similar. Both materials showed considerable pitting. The environments of these two locations are typical of many Navy sites where GSE is used and stored.

Figure 5-2. Corrosion Results for Wrought Iron and Steels after Eight Year's Atmospheric Exposure at Cristobal, Canal Zone (10).

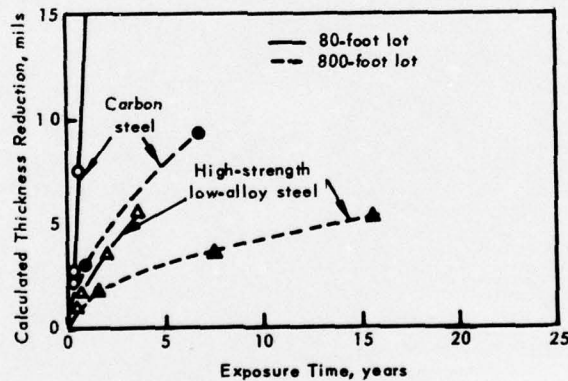
Figure 5-3. Comparison of Corrosion Results for Various Steels in Marine Atmosphere, Kure Beach, N. C. (11).

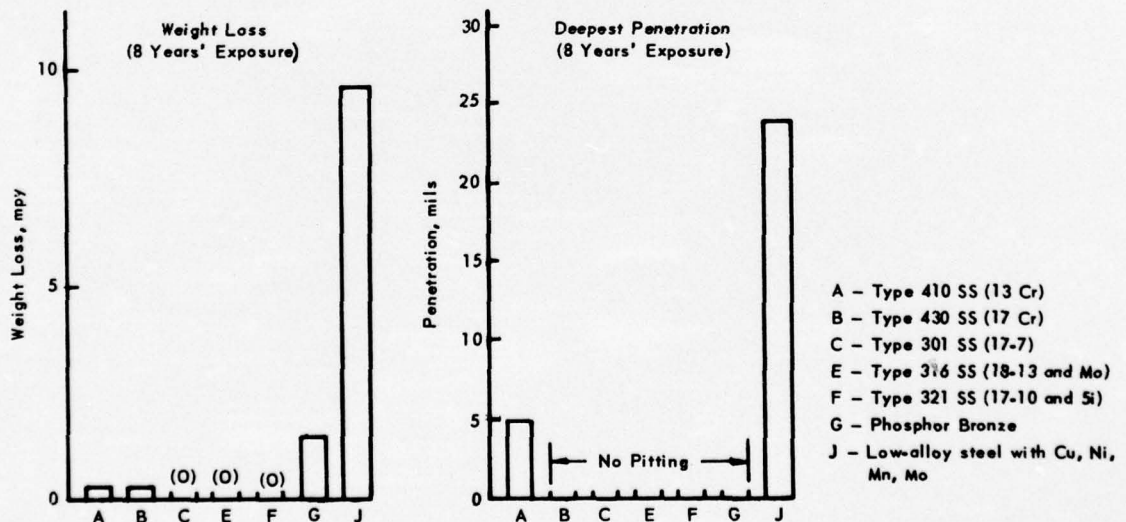
5.5.15.3. A Type 304 panel exposed at the 800-foot lot at Kure Beach, N. C., corroded at a rate of less than 0.1 mpy. At the 80-foot lot, Type 304 panels showed somewhat more staining but negligible attack after 11 years. Type 316 panels have a higher order of resistance than Type 304 under the same exposure conditions. The results of 8-year atmospheric exposures at Cristobal, Canal Zone, for these stainless steels are compared in Figure 5-4. Note that the austenitic grades were free from pitting or weight loss (12).

Figure 5-4. Comparison of Corrosion Damage of Stainless Steel, Phosphor Bronze, and Low-Alloy Structural Steel in Tropical Marine Atmosphere at Cristobal, Canal Zone (12).

5.5.15.4. The martensitic stainless steels, as typified by Type 410, may experience rust after only a few months of exposure to the marine atmosphere. Type 410 has the minimum chromium content (12 percent) required for passivity, and local breakdown may be experienced. The deepest pit on a panel exposed at Cristobal for 8 years was 5 mils (see Figure 5-4); however, the weight-loss penetration was only 0.007 mpy.

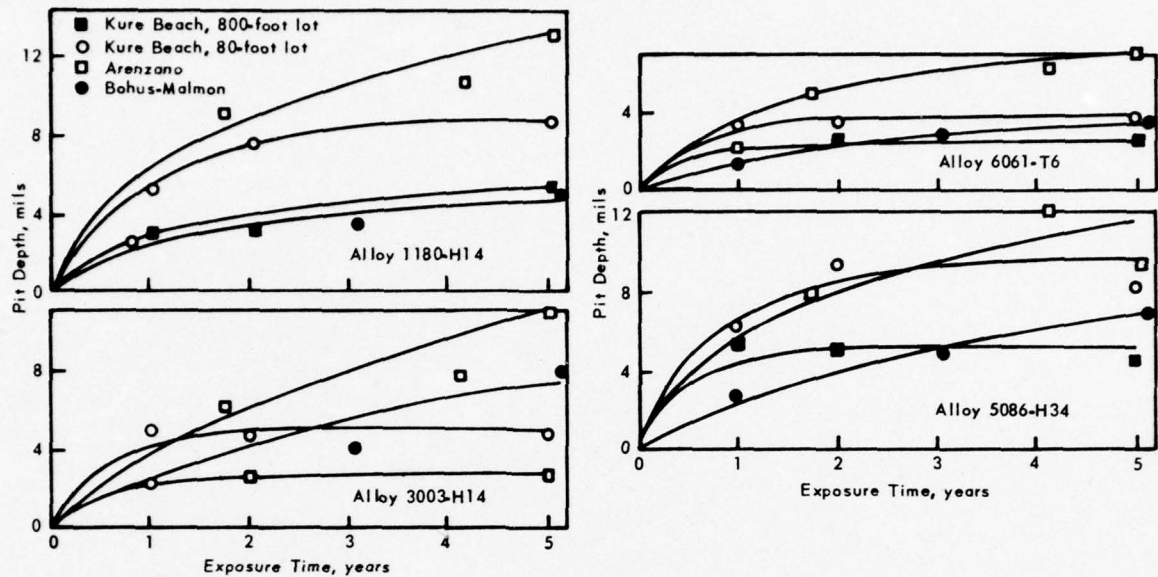
5.5.17.5. Pitting, which has its own unique type of attack pattern on aluminum alloys, frequently is found in GSE where surfaces are left exposed or where the surface coating has been broken. Since many aluminum alloys tend to pit in marine atmospheres, the extent measured at a number of sites for four different aluminum alloys by AILOK, reference (19), are presented in Figure 5-5. In this comparison, Alloy 6061 showed the best performance with maximum pitting ranging from 3 to 7 mils. Since the rate of pitting tends to taper off with time, designers can allow for it in applications where penetration would mean failure, e.g., tanks. In marine service, pits are observed both on the skyward and groundward faces of exposed surfaces. Evidence of this type corrosion attack was found in GSE at NAS/MCAS sites on both the East and West Coasts.

Figure 5-5. Maximum Measured Pit Depths for Aluminum Alloys in Selected Marine Atmospheres (19).
