NWC-TP-5812

Baseline Data From an A-4 Cockpit in Simulated Carrier Deck Fire

by
Anthony San Miguel
Systems Development Department

AUGUST 1976

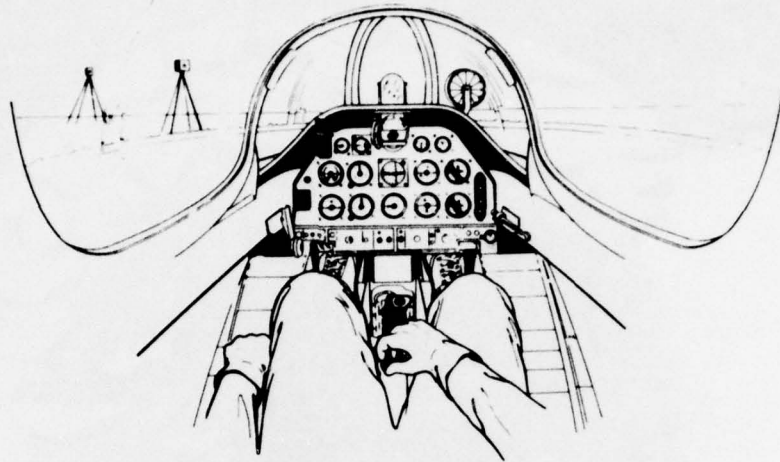
FIGURE 1(a). Conditions That Would Be Seen by Pilot at Ignition ($t = 0$).

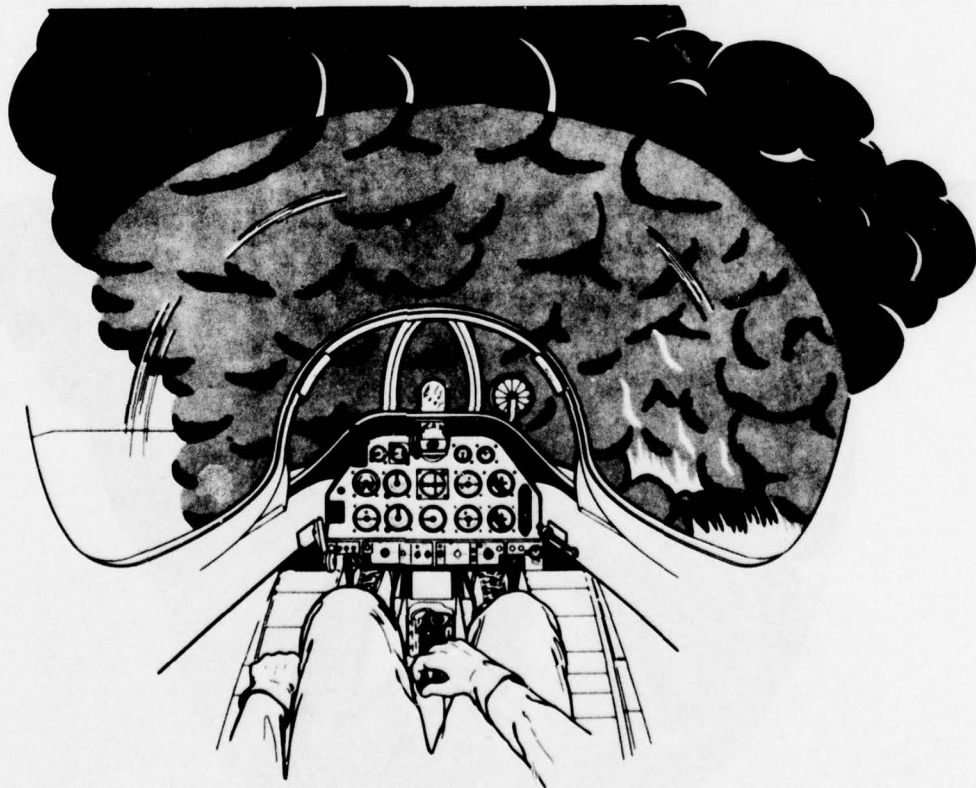
FIGURE 1(b). Eleven Seconds After Ignition ($t = 11$ Seconds).

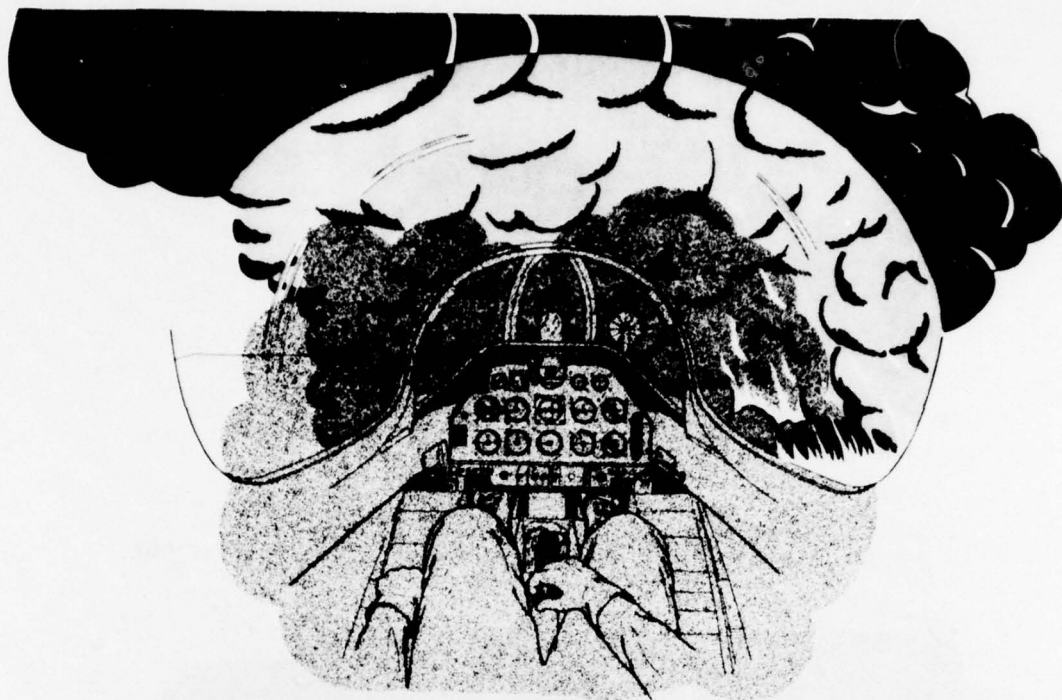
FIGURE 1(c). After 71 Seconds ($t = 71$ Seconds).

The activity of the cockpit mouse was recorded on movie film until it could no longer be observed at 71 seconds.¹ (See Figure 1(c), p. 8.) By the time the firefighters reached the cockpit after the fire, the mouse had died in the fire.

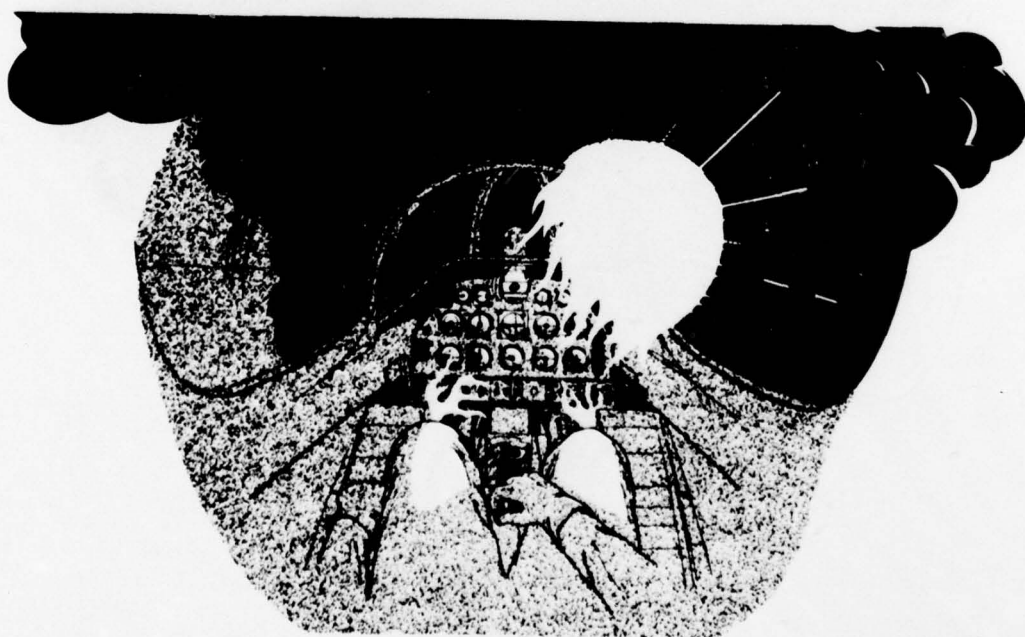
The cockpit heated faster on the starboard side due to the prevailing wind direction. First flicks of flame were seen in the cockpit at about 192 seconds. By about 222 seconds, the canopy had completely failed, and flames engulfed the cockpit. Calorimeter data indicated that the first significant heating in the cockpit came from the direction of the canopy at about 203 seconds (Appendix E). Next, a relatively hot burst came from below at 208 seconds. The entire region where the directional calorimeter was located was heated between 213 and 232 seconds. By 232 seconds, light water applied by firemen had cooled the interior of the cockpit.

FIGURE 1(d). Between 192 and 232 Seconds ($t = 192-232$ Seconds).

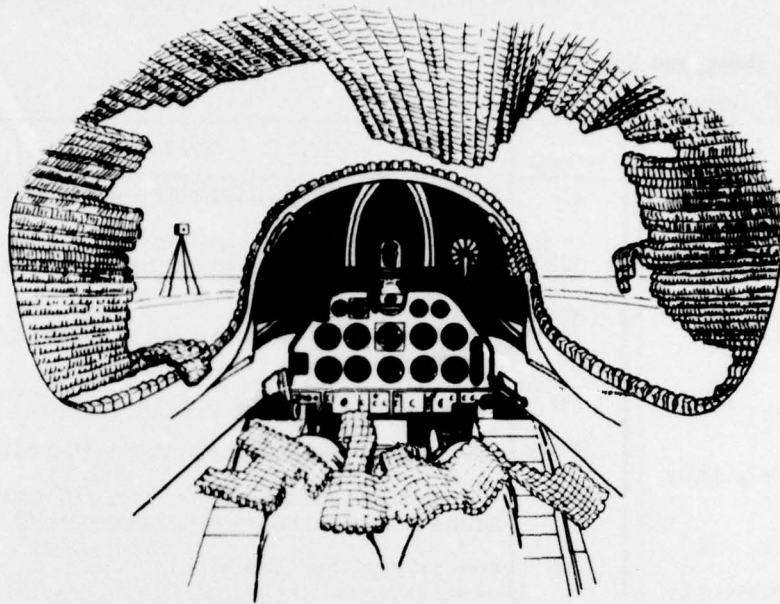
FIGURE 1(e). After Fire was Extinguished (t = 243 Seconds).

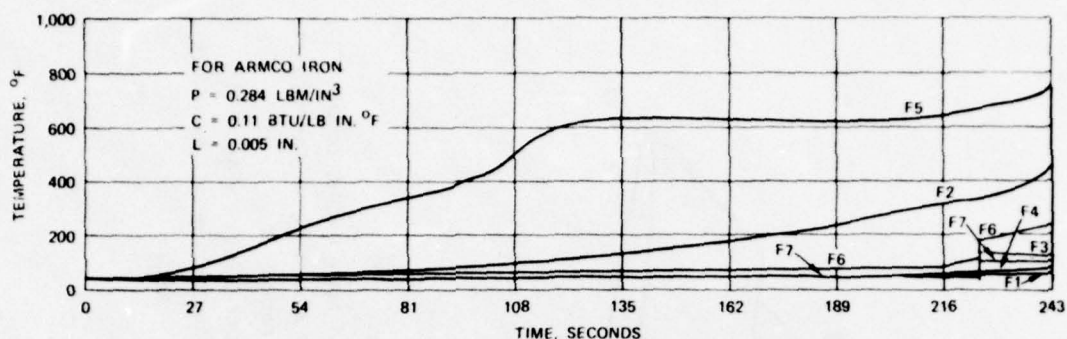
FIGURE E-4. Mean Temperature Change of Slug Calorimeters.

An overview of Figure E-4 shows that the interior of the cockpit was not being significantly heated during the test, with the exception of F5. The maximum heating-- $q < 0.15 \text{ BTU/ft}^2\text{-sec}$ (1702 W/m^2)--occurred on the starboard side of the aircraft as shown by transducer F5. That the heating of the cockpit was not symmetric is demonstrated in that F2 heated more slowly-- $q < 0.05 \text{ BTU/ft}^2\text{-sec}$ (567 W/m^2)--than F5. F2 sensed initial heating at 59 seconds. At about 185 seconds the heating rate increased to that initially experienced by F5. F5 sensed heat at 11 seconds and was saturated at 123 seconds. The saturation time suggests steady-state heating of the starboard interior side of the cockpit between 123 and 210 seconds. The increase in cockpit heating after 210 seconds is due to heat entering the cockpit via cracks in the cockpit and not because of the fire getting hotter.

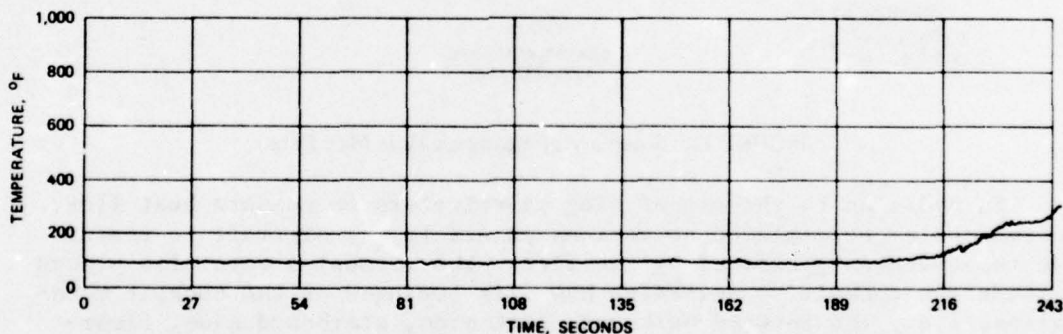
The typical response of a thermocouple sensing the temperature rise of all slugs in the three-dimensional transducer is shown in Figure E-5. The essential feature is that no significant heat is observed until about 205 seconds. The face of the transducer viewing the forward instrument panel sensed a heat rate of 0.46 BTU/ft²-sec (5221 W/m²) between 213 and 222 seconds. The port and starboard faces recorded only about 0.022 BTU/ft²-sec (250 W/m²) between 211 and 231 seconds. The bottom face measured about 0.94 BTU/ft²-sec (10,700 W/m²) between 208 and 232 seconds and the top face measured about 0.32 BTU/ft²-sec (3600 W/m²) between 203 and 232 seconds. These data are summarized in Figure E-6. They suggest that initial significant heating came from the canopy region first (203 seconds). Next a relatively hot burst came from below at 208 seconds. The entire region where the three-dimensional transducer was located was heated during the period from 213 to 232 seconds. By 232 seconds, light water from the firefighting equipment had cooled the interior of the cockpit.

FIGURE E-5. Typical Response of Thermocouple Sensing Temperature Rise of Slugs in Three-Dimensional Transducer.

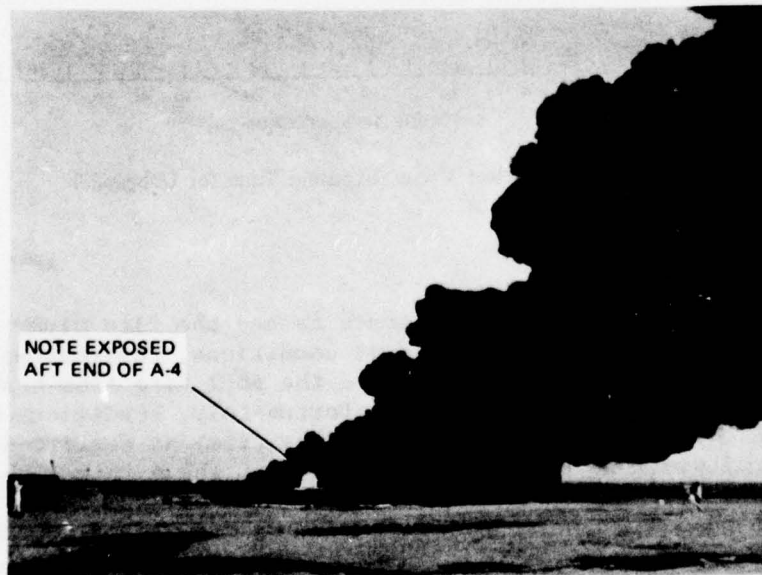
As discussed earlier, wind and gusts caused the fire plume to be deflected as shown in Figure E-9. These conditions, together with the protective effect of the wings, prevented the pool fire from heating the insulated aft portion of the aircraft. Fortunately, conditions were such that the cockpit section was engulfed by fire, as confirmed by the movie camera within the manikin. Unfortunately, the external thermocouple data was lost (due to recorder power failure), and hence flame characterization could not be evaluated since there was no telemetry backup.

FIGURE E-9. A-4 Pool Fire Deflected by Prevailing Wind. (Neg. LHL 187354)

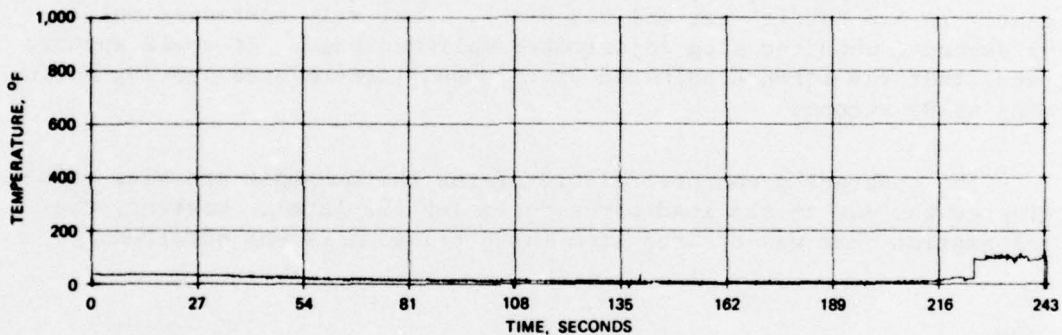
A slug calorimeter was placed on the back of the seat facing aft to detect potential heating from the fuselage fuel tank. Its output is shown in Figure E-10. No appreciable heating was recorded before the canopy failed.

FIGURE E-10. Output of Slug Calorimeter Placed on Back of Pilot's Seat, Facing Aft.

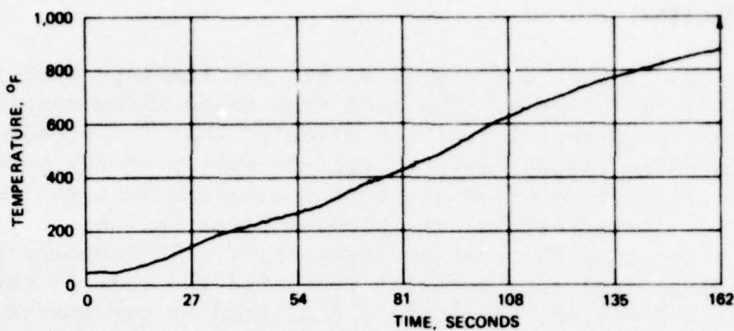
The response of the thermocouple is shown in Figure E-11. Initial heating was detected at 7.4 seconds after ignition. Heating remained relatively uniform until 162 seconds, at which time the thermocouple failed, perhaps suggesting that the nose cone was destroyed by fire or mechanically detached.

FIGURE E-11. Output of Thermocouple Located 1 Foot (0.3 m) in Front of Bulkhead Hinge in Nose Cone.

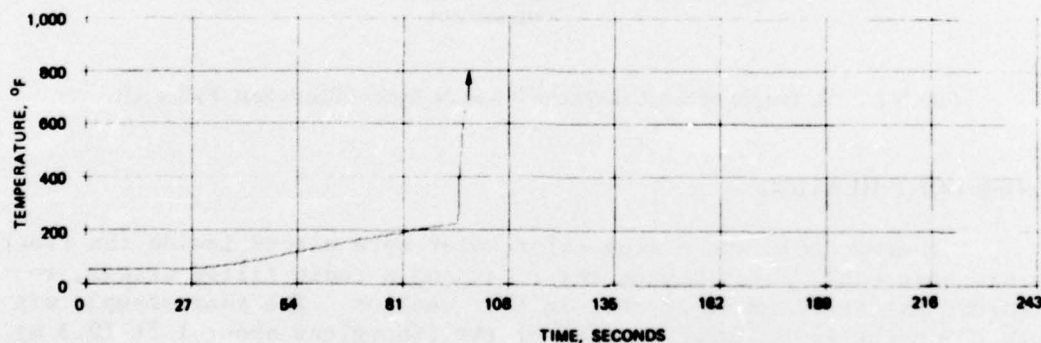
The slug calorimeter response is shown in Figure E-12. Initial heating was detected at 21 seconds. The heating rate was about 0.05 BTU/ft²-sec (567 W/m²). At 95 seconds the heating rate increased significantly to 4.5 BTU/ft²-sec (51,048 W/m²). That rate continued until 99 seconds, when the slug calorimeter malfunctioned. It would appear, then, that the forward bulkhead experienced fire-related heating beginning at 95 seconds.

The apparent premature failure of the thermocouple and slug calorimeter was due to the lead wires not being insulated. However, the information that was desired from these transducers was obtained.

FIGURE E-12. Output of Slug Calorimeter Placed on Radio Access Filter Screen in Nose Cone.

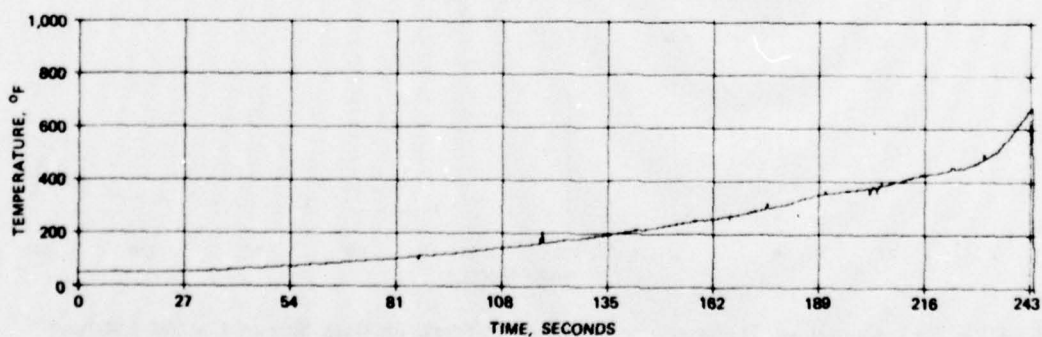
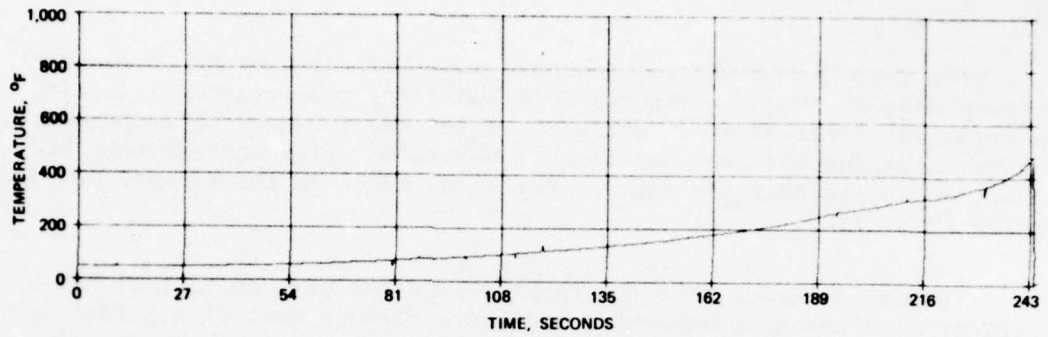
FIGURE E-16. Response of Thermocouple on Port Access Door.

FIGURE E-17. Response of Slug Calorimeter on Port Access Door.

The response of the thermocouple and slug calorimeter on the port access door is shown in Figures E-16 and E-17, respectively. Initial heating was detected at 27 seconds. Note that the melting temperature of the aluminum skin was not reached before the fire was extinguished. Also, no appreciable cooling was detected, although the firemen had just put out the fire.

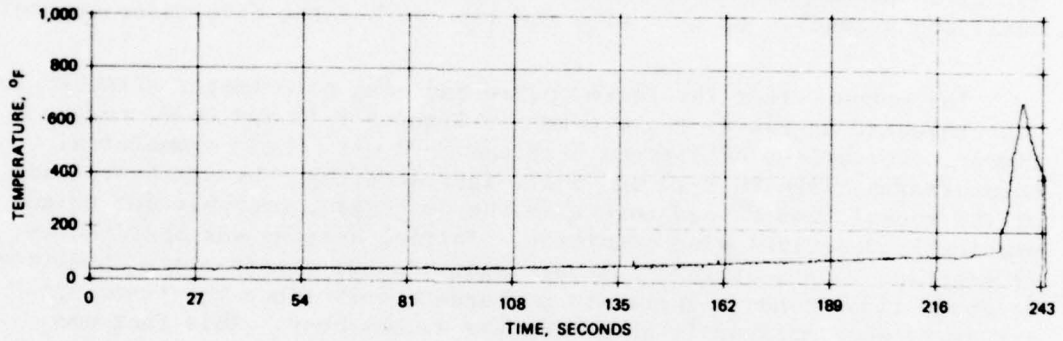
FIGURE E-18. Response of Thermocouple About 20 Inches (51 cm) Above Cockpit Floorboard in Upper Interior Corner Formed by Forward Bulkhead and Port Side.

Further evidence that the forward interior port section of the cockpit remained near ambient temperature through most of the fire is suggested by a thermocouple located in the upper corner between the forward bulkhead and the port side approximately 20 inches (508 mm) above the floorboard. The response of that thermocouple is shown in Figure E-18. Modest heating is shown up to 232 seconds, at which time hot effluent gas caused a dramatic temperature rise that continued until 238 seconds. At this time the firemen had the fire under control.

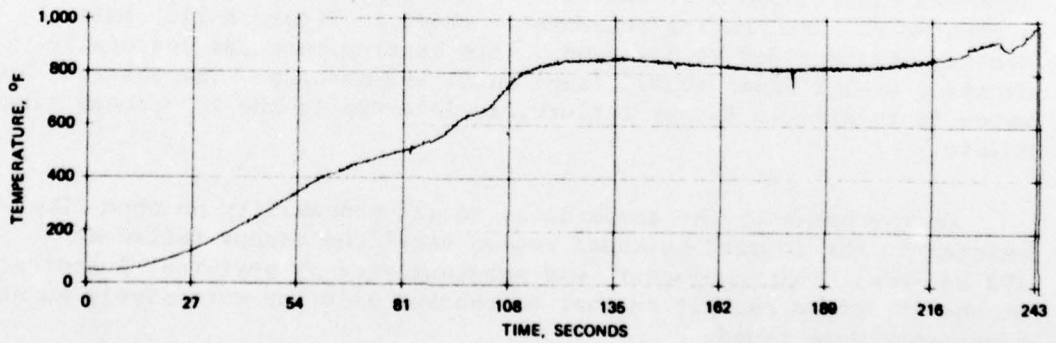
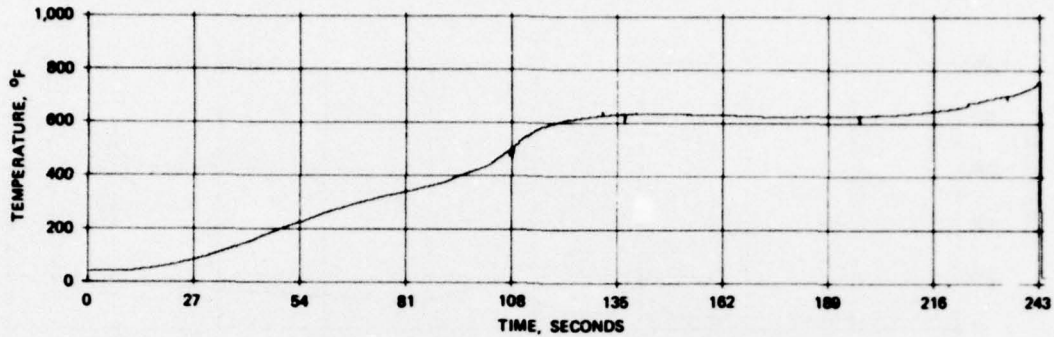
FIGURE E-19. Response of Thermocouple Attached to Starboard Access Door.

The outputs from the thermocouple and slug calorimeter attached to the starboard access door are shown in Figures E-19 and E-20, respectively. Comparison of Figures E-19 and E-20 with their symmetrical counterparts, Figures E-16 and E-17, indicates that the starboard side of the cockpit was heated more than the port side, probably due to the previously described wind condition. Initial heating was observed at 11 seconds. The starboard fuselage skin reached steady-state conditions at about 113 seconds. There was no burn-through since the frame and stringers were apparently absorbing the excess heat. This fact was confirmed by post-test inspection. The heat flux impinging on the starboard side of the cockpit was about $0.1 \text{ BTU/ft}^2\text{-sec}$ (1134 W/m^2) compared with about $0.01 \text{ BTU/ft}^2\text{-sec}$ (113 W/m^2) on the port side.

FIGURE E-20. Response of Slug Calorimeter Attached to Starboard Access Door.

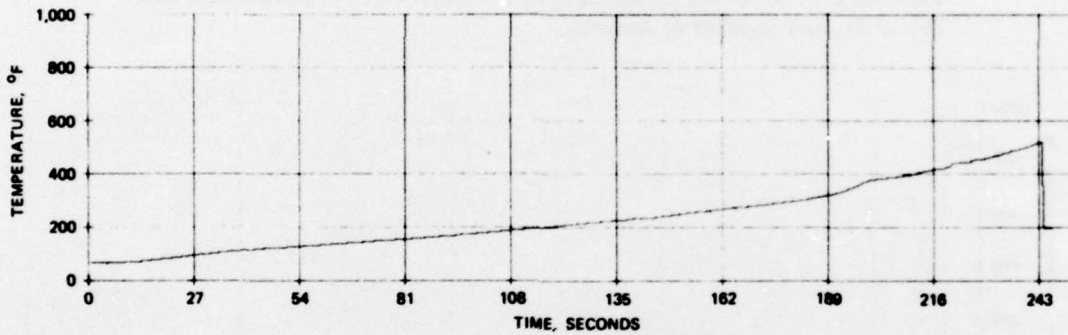
A thermocouple was placed behind the instrument panel in the forward bulkhead region with a direct view of the sky through the glareshield access hole. Its heating response is shown in Figure E-21. Initial heating was recorded at 8 seconds. Its heating rate was reasonably constant at 1.2°F/sec (0.67°C/sec) until 162 seconds. The observed hump, which is related to canopy failure, is detected in the 195-second time domain.

On the basis of the above data, in all probability no open fire existed in the forward bulkhead region until the canopy failed at 192 seconds. This conjecture was substantiated by post-test inspection of the dissected cockpit in that no charred paint or extensively burned components were found.

FIGURE E-21. Response of Thermocouple Placed Behind Instrument Panel Near Forward Bulkhead and With Direct View of Sky Through Glareshield Access Hole.

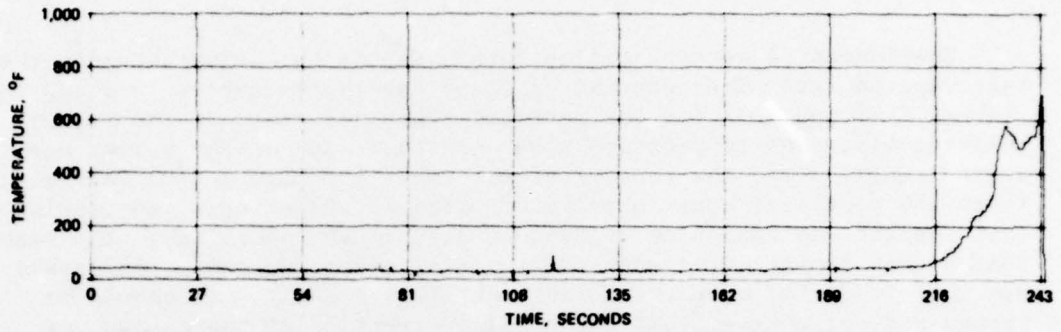
A thermocouple was attached above the glareshield alongside the exposed glass ferris wheel containing the cockpit mouse. The response of this thermocouple is given in Figure E-29. Heating in this location began at 211 seconds. Further confirmation of the relative coolness above the glareshield was provided by the thermocouple placed near the port and starboard panels as shown in Figures E-30 and E-31. The region above the glareshield apparently remained cool until after the canopy failed. This conjecture was confirmed by post-test inspection of the glareshield. Hence, it is probable that the cockpit mouse expired after the canopy failed.

FIGURE E-29. Response of Thermocouple Attached Alongside Glass Ferris Wheel Above Glareshield.

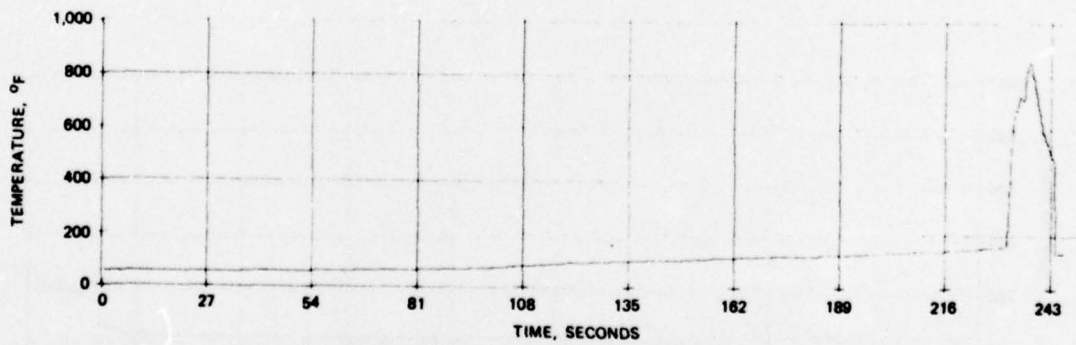
A thermocouple was also placed aft of the pilot's helmet. Its response is shown in Figure E-35. This thermocouple recorded a definite steady rise in temperature from about 27 seconds. At the time of canopy failure it had reached 127°F (51°C). This temperature rise is greater than that of other thermocouples in the vicinity, probably because it was in the air rather than being attached to the helmet. The temperature rise may be due primarily to free convection and not to fire radiation.

FIGURE E-35. Response of Thermocouple Placed Behind Pilot's Helmet.

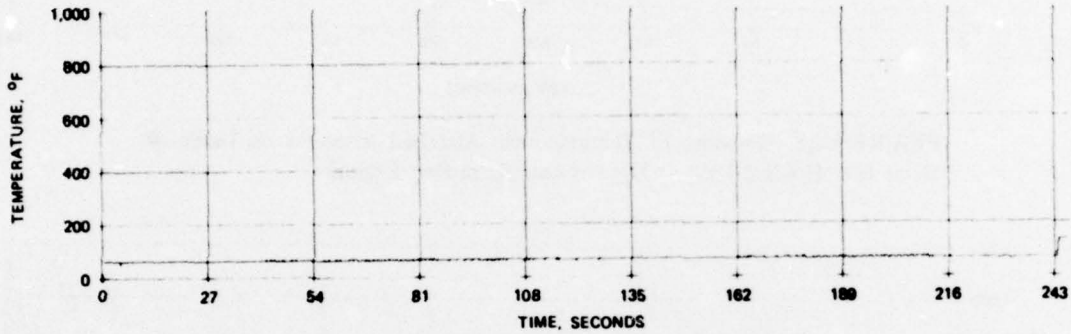
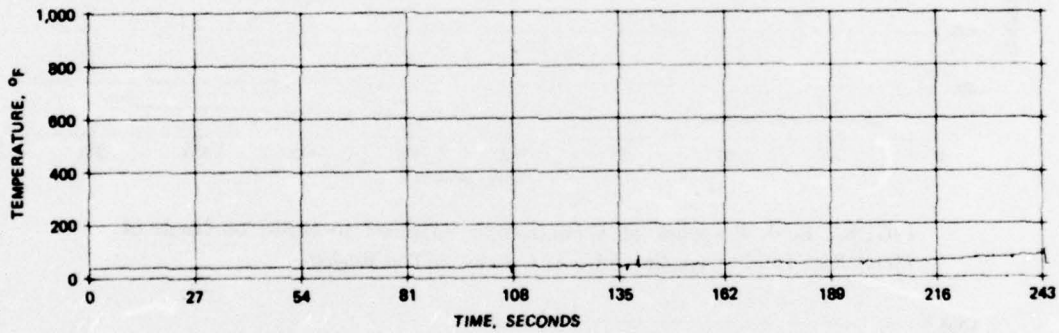
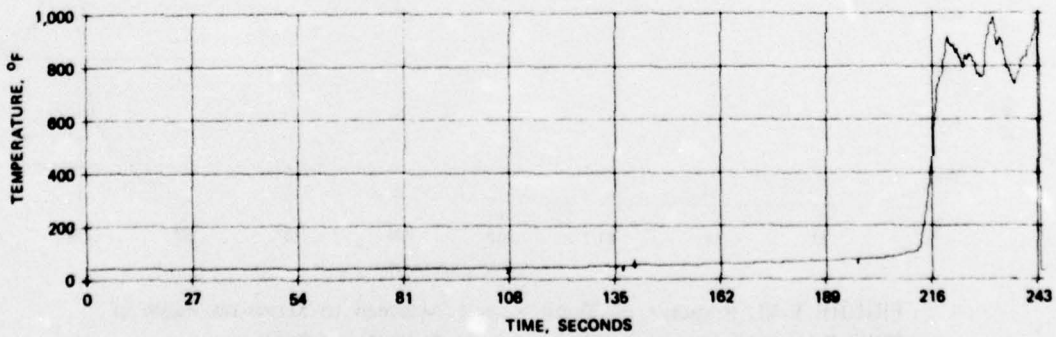
Thermocouples were also placed inside the canopy along the periphery; one on the port side, one on the starboard, and one at the top. The response of these thermocouples is shown in Figures E-41, E-42, and E-43. It is apparent that little heat transmits through the canopy to the pilot before the canopy fails. Again, evidence is found that the canopy failure occurred in the top starboard quadrant of the canopy.

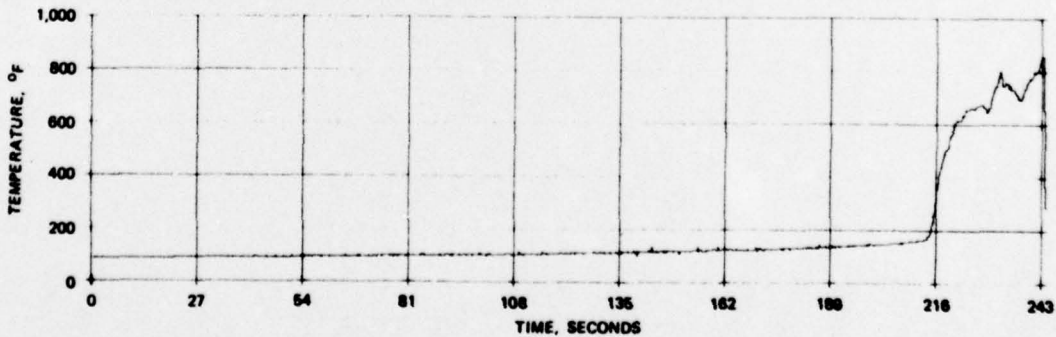
A thermocouple was placed on the pilot's seat above the aft floorboard. The response of this thermocouple is shown in Figure E-45. The heating begins at 59 seconds. The heating is due to fire in the wheel well eventually penetrating the floorboard and heating the seat from below. Post-test inspection revealed that the floorboard under the seat had melted and burned through. It is possible that this event contributed to or caused the anomaly in the development of toxic gases between 120 and 150 seconds that is discussed in Appendix F.

FIGURE E-45. Response of Thermocouple Placed on Pilot's Seat Above Aft Floorboard.

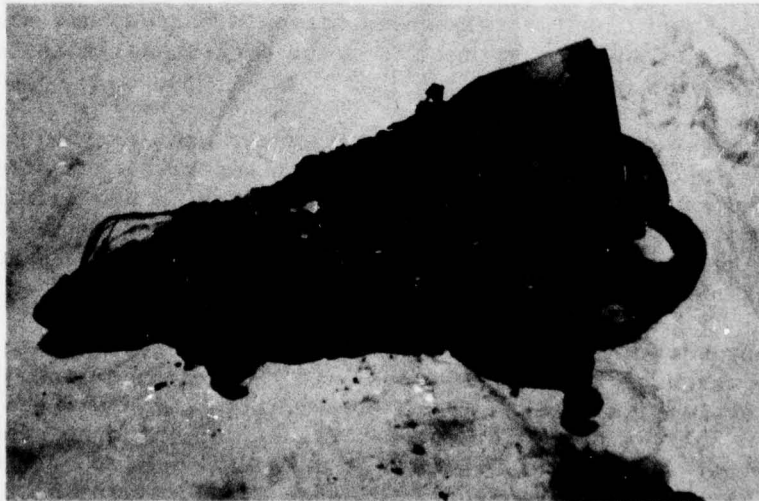
FIGURE G-8. Cockpit Rat After Fire. (Neg. LHL 187326)

Immediately after the fire was extinguished, the cockpit rat was examined by Dr. Steve Packham of the UUFRC. He found the rat to be alive, but with third-degree burns over the head, shoulders, forelimbs, and on the sides of hind limbs (see Figure G-8). Wires leading from the physiological monitoring electrodes were burned free of insulation, and

the externally exposed parts of the cannula on the rat were missing. A pinkish colored fluid was exuding from the nose, and the mouth and tongue were swollen shut and were dry.

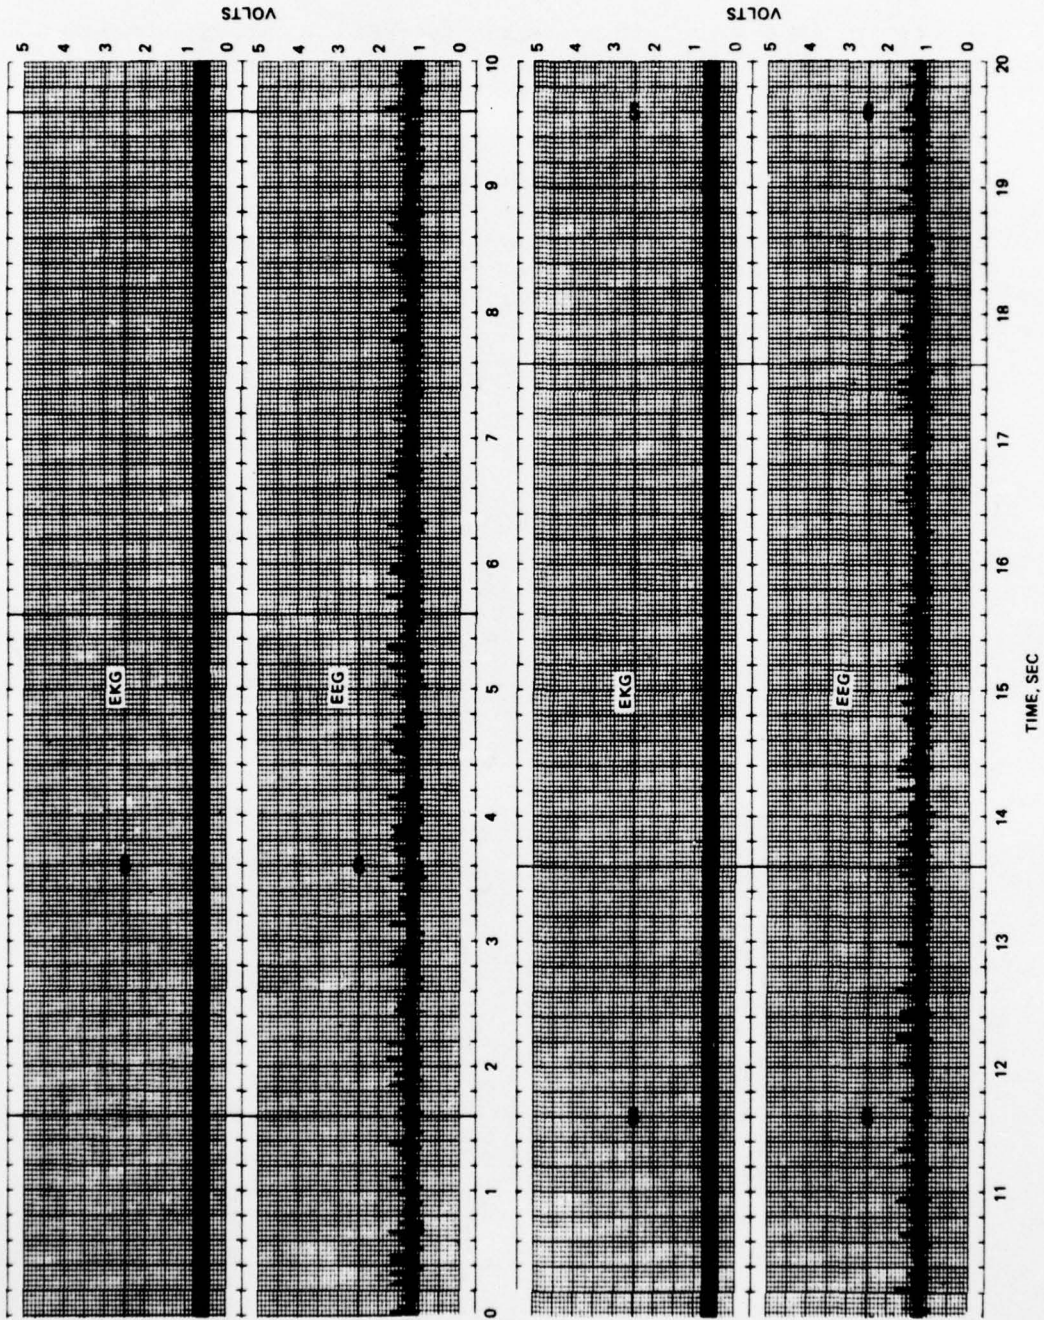
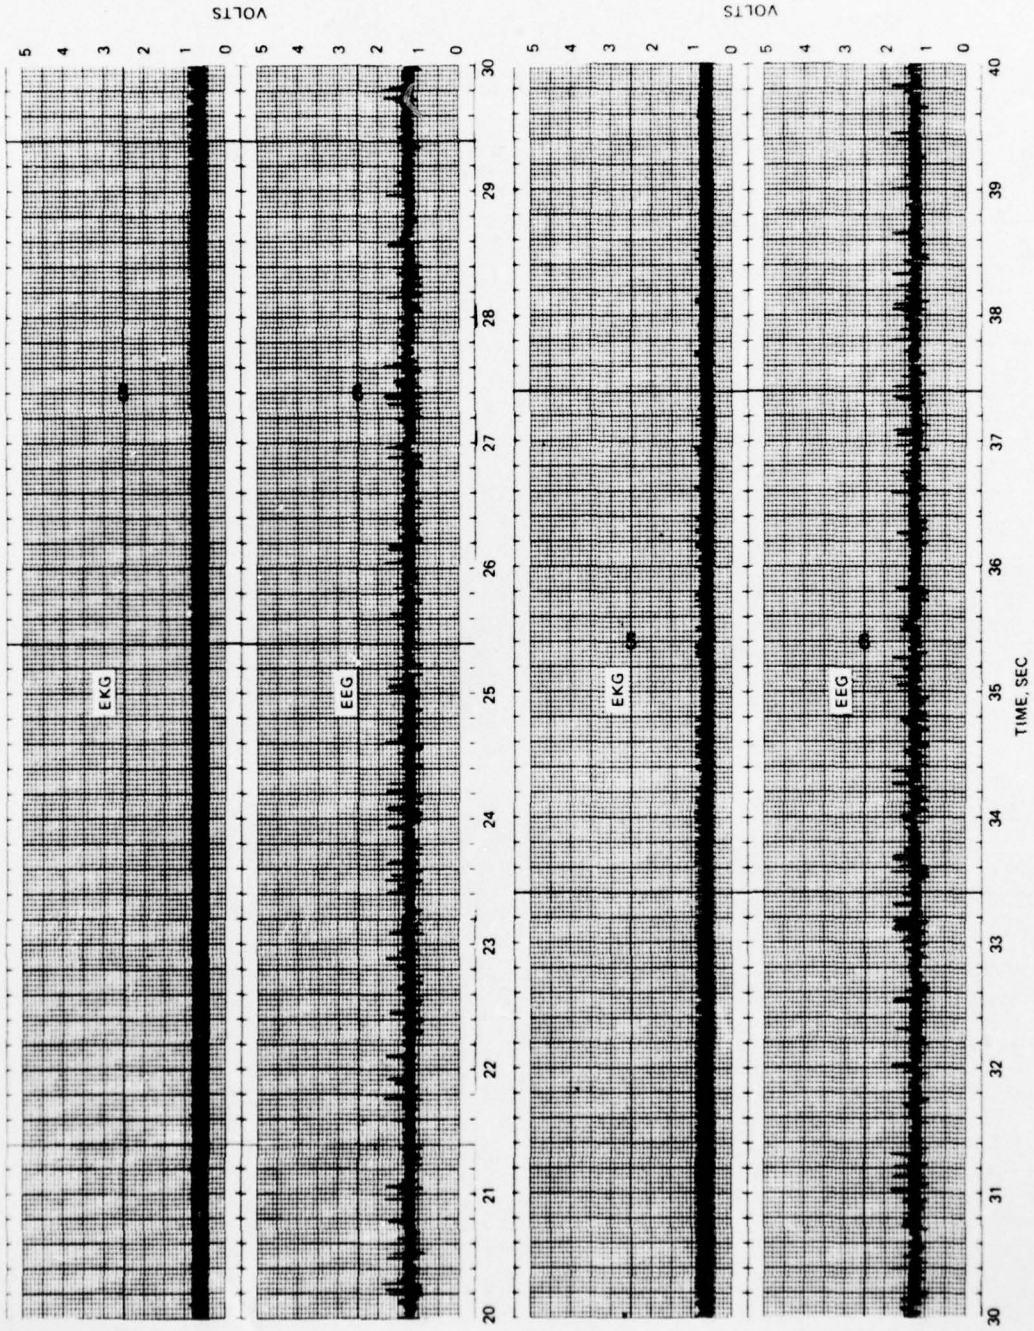
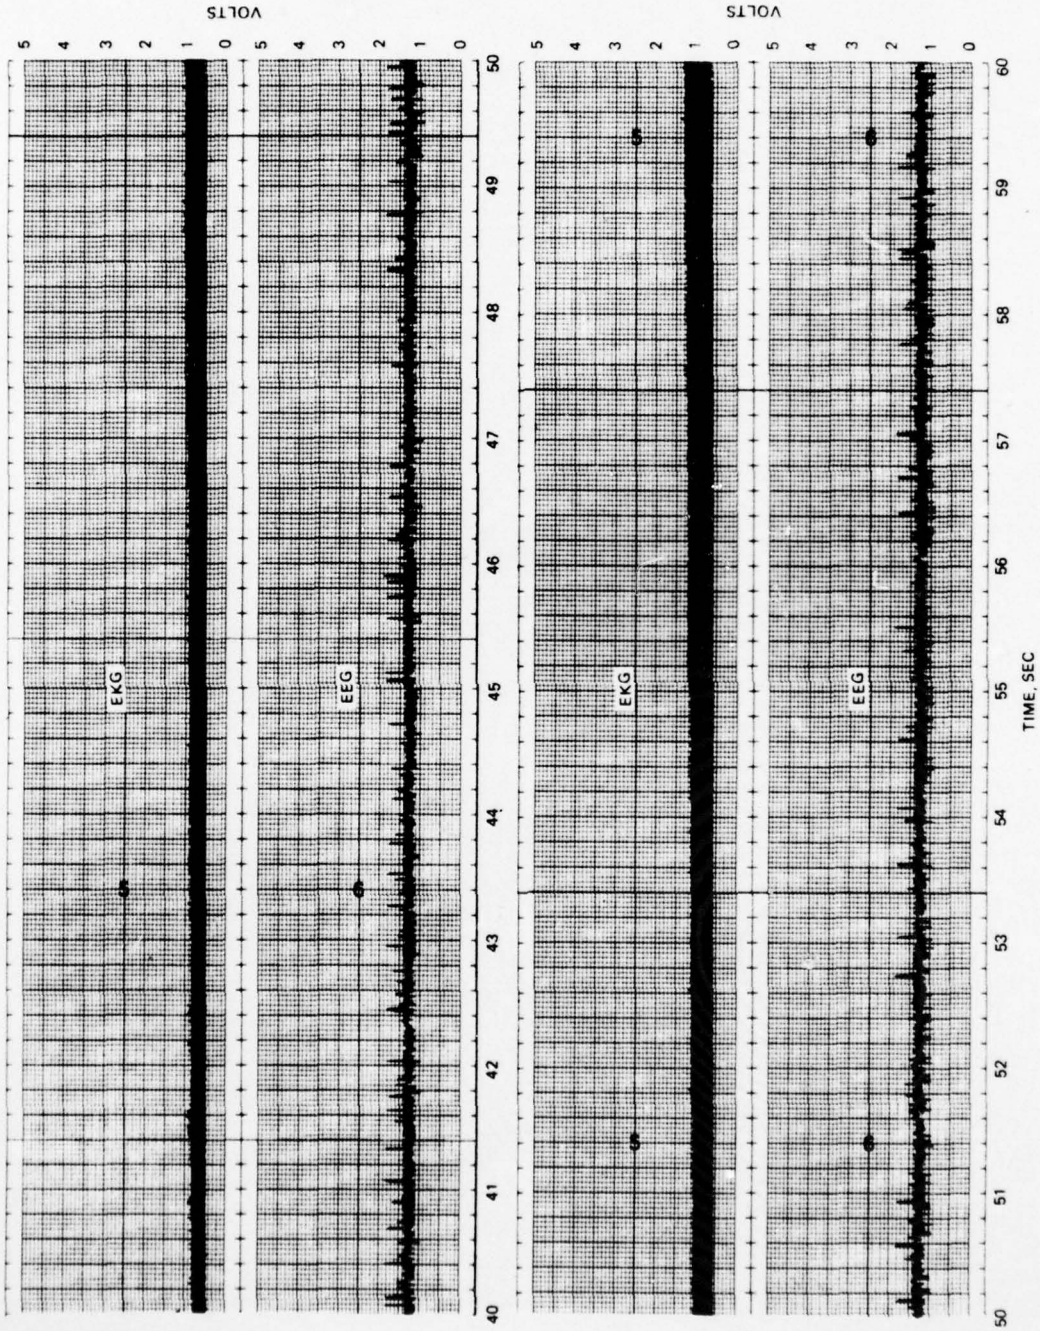
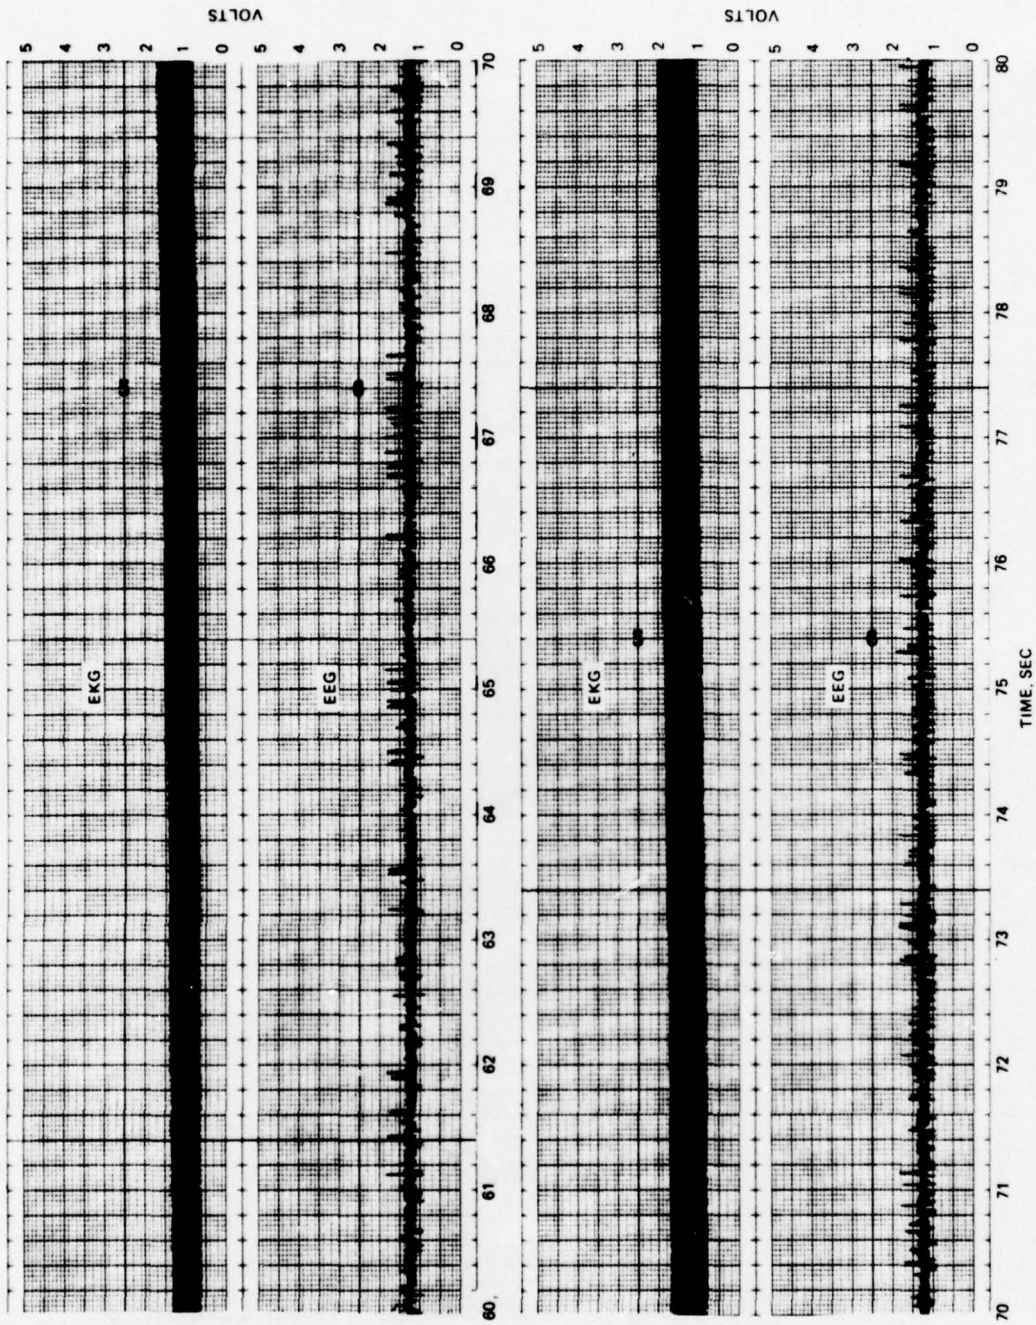
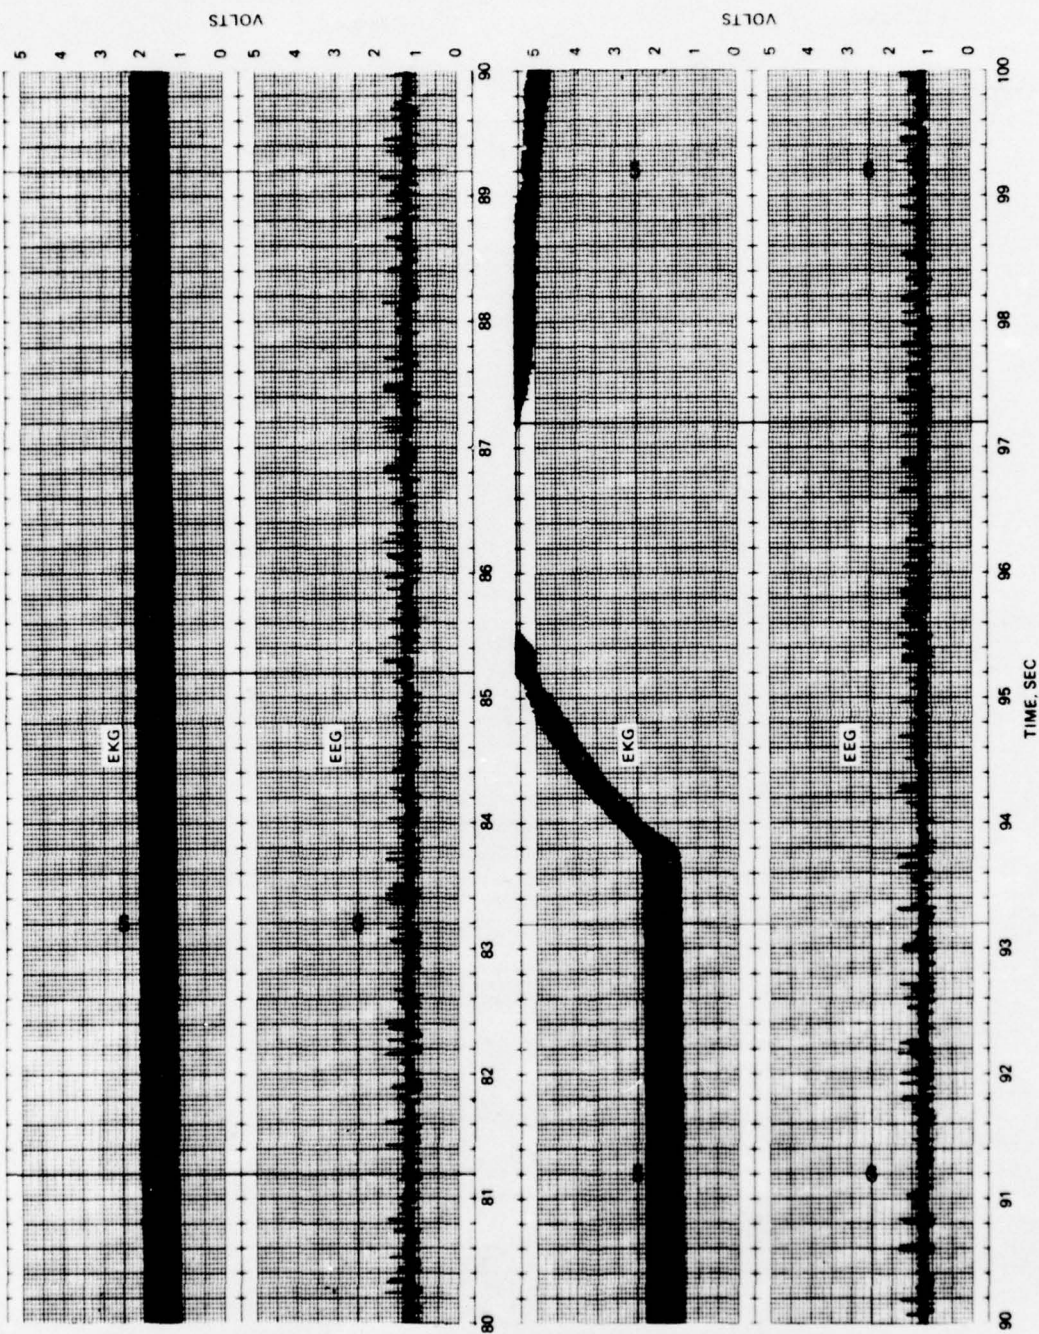
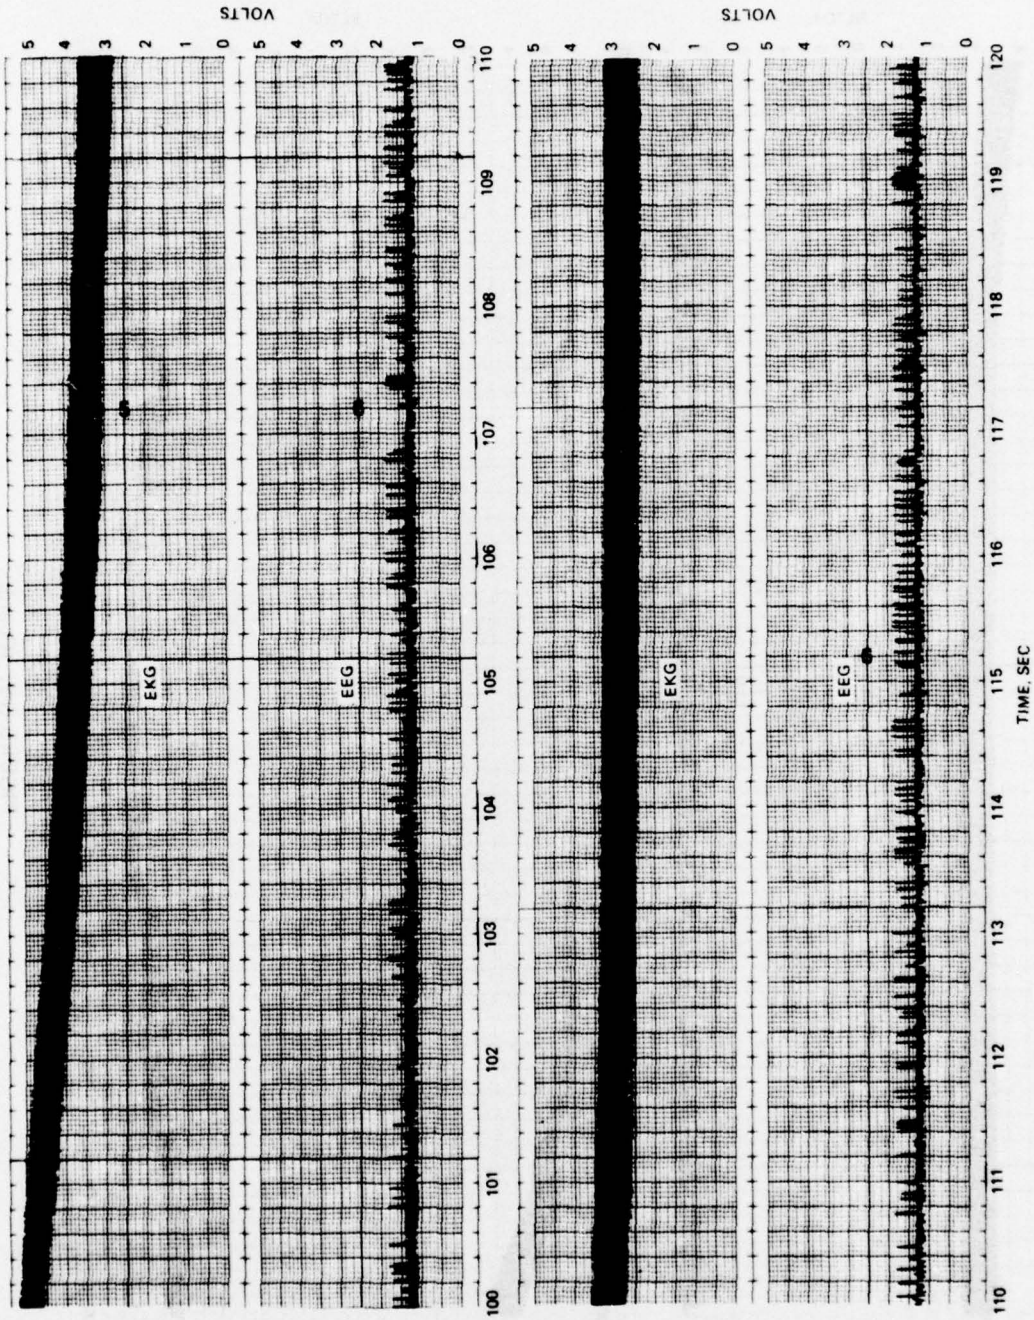
FIGURE G-9. EKG and EEG of Cockpit Rat.

The EEG and EKG recorded from the cockpit rat are given in Figure G-9. These data cover the entire test time of 243 seconds. Data at $t = -10$ seconds were similar to those at $t = +10$ seconds. In the opinion of FRC personnel who examined them, these records are not of physiological origin. That opinion was based on the fact that frequency of the EKG signal is about 36 waves/second instead of 8. The EEG record was rejected by them on the same basis. According to the FRC personnel, any correlations of EKG and EEG records with those of other transducers was probably due to the thermal destruction of wire, leads, etc. That opinion is not shared by the author. However, it is prudent to warn other investigators of the conflicting opinions and to caution them to use the data in proper context.

The significant EEG events occurred at about 41 seconds, when both amplitude and spindle incidence decreased. At about 93 seconds, the signal amplitude and spindle incidence increased. At about 133 seconds, apparent activity of the kind that follows a sudden attack or seizure was indicated by low voltage amplitude. At about 150 seconds, animal revival was indicated. At about 161 seconds, animal hyperexcitability ended with the signal moving off scale. At about 238 seconds, EEG activity returned, suggesting that the animal was still alive.

It must be pointed out that the "apparent" EKG and EEG response in Figure G-9 is subjective. There is always the possibility of error due to the voltage amplification conditioning electronics, etc. It is possible that wires were connected incorrectly. On the other hand, the "apparent" response of the two independent signals corresponds very favorably with the events occurring within the cockpit as indicated by all the other transducers.

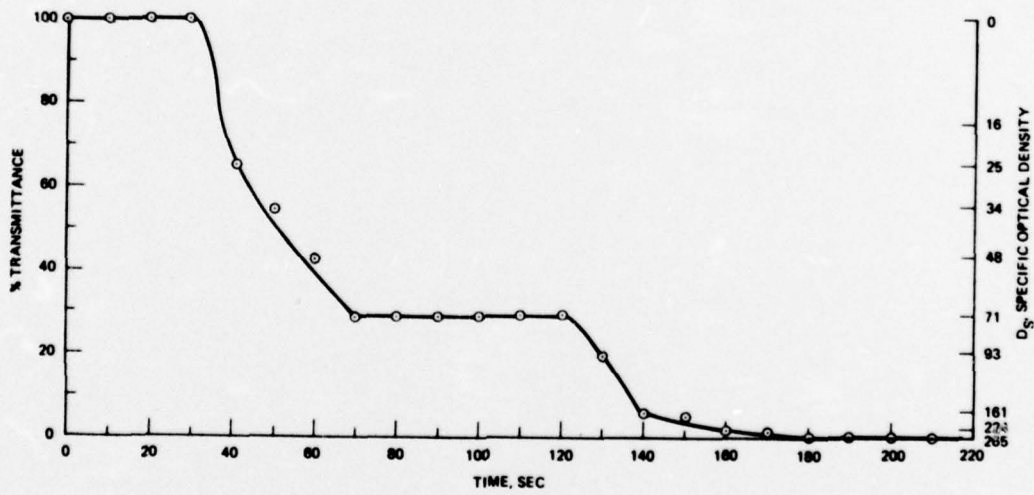
FIGURE H-7. Smoke Transducer Data Produced During Burn Test.

The output of the transducer during the A-4 burn test is shown in Figure H-7. No smoke was recorded until after 30 seconds into the test. At that time the transmittance began to decrease uniformly from 100 to 29% (from $D_s = 0$ to $D_s = 71$) at 70 seconds. The materials producing this smoke apparently were then expended, because the smoke transducer output remained uniform between 70 and 120 seconds. New smoke generation began at 120 seconds, causing the transducer output to decrease to $D_s = 161$ at 140 seconds. Complete smoke obscuration ($D_s = 200$) was measured by 155 seconds.

The transducer suffered fire damage before the fire was completely extinguished. However, because of its design, a few electronic components can be readily replaced to render the transducer operable again.
