NWC-TP-5812

Baseline Data From an A-4 Cockpit in Simulated Carrier Deck Fire

by
Anthony San Miguel
Systems Development Department

AUGUST 1976

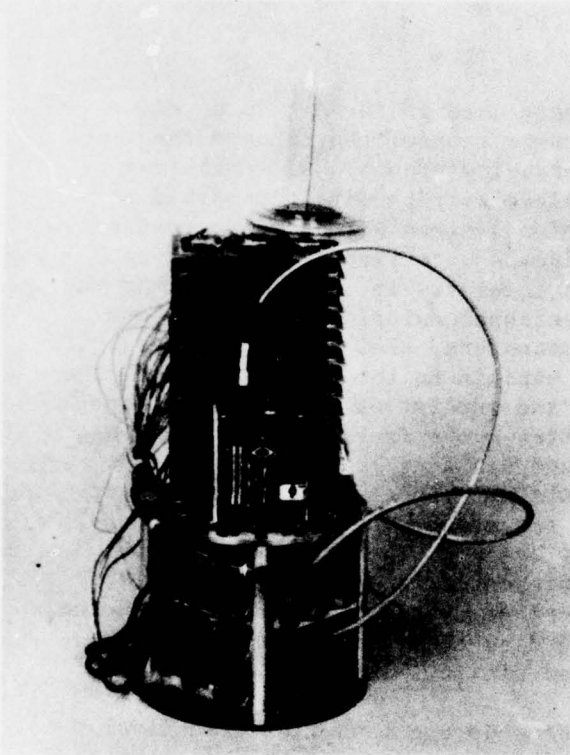
FIGURE J-1. RF Telemetry Transmitter. Item in glass cover atop the transmitter is the antenna, which was placed atop the fuselage behind the cockpit when the system was installed in the A-4. (Neg. LHL 186351)

As a final note, the entire telemetry system except for the RF antenna (which may be seen on top of the transmitter in Figure J-1) was recovered after the test. It is thought that the antenna was broken by the force of the stream of light water used to extinguish the fire, rather than by the fire itself.
