TECHNICAL REPORT NO. 76-8

SEMIANNUAL REPORT, PROJECT T/4703  
SPECIAL DATA COLLECTION SYSTEMS

JANUARY THROUGH JUNE 1976 .

**TELEDYNE  
GEOTECH**

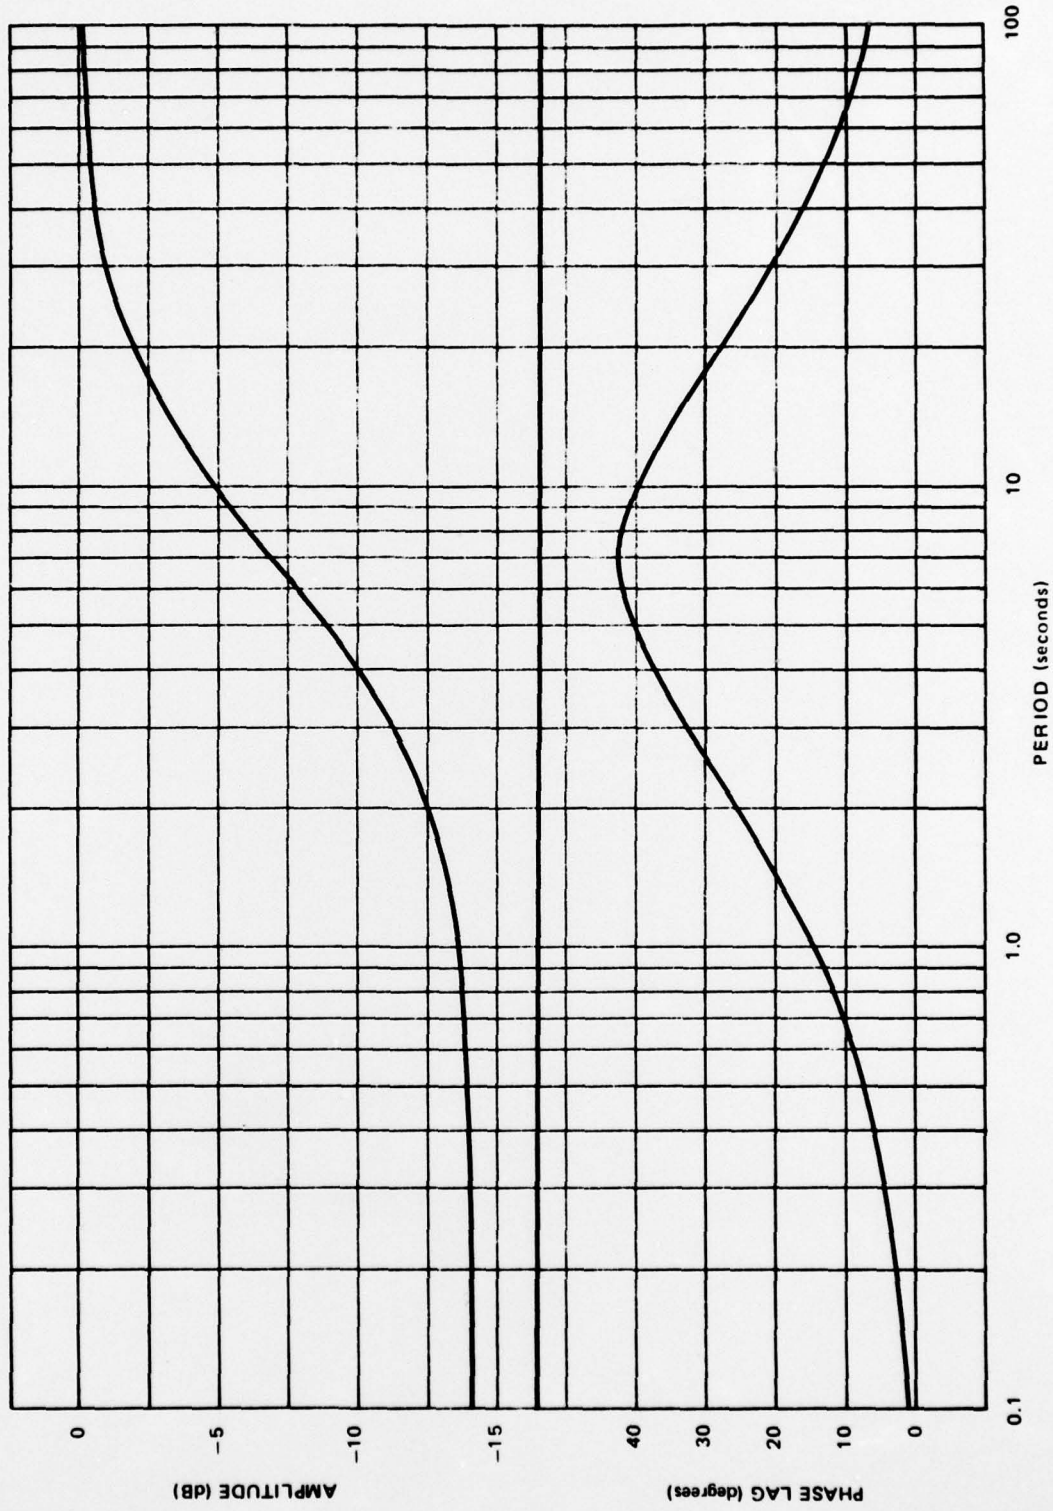
The modification consists of replacing two resistors and one capacitor in each of the three line drivers in the KS electronics. Figure 2 shows the amplitude and phase response of this filter. The overall effect of this modification is to shift the normalized LP frequency response slightly toward the longer periods. The SP response is attenuated 12 to 14 dB and has slightly more gain at the longer periods. The appendix shows the total system amplitude and phase responses in tabular form for both the original and the modified cases.

Figure 2. Amplitude and phase responses of the modified Model 36000 line driver filter G 9135
