ADHESIVE BONDED AEROSPACE STRUCTURES STANDARDIZED REPAIR HANDBOOK

*BOEING COMMERCIAL AIRPLANE COMPANY
P.O. BOX 3707
SEATTLE, WASHINGTON 98124*

MAY 1976

PHASE III REPORT FOR PERIOD 1 JANUARY 1975 THROUGH 30 SEPTEMBER 1975

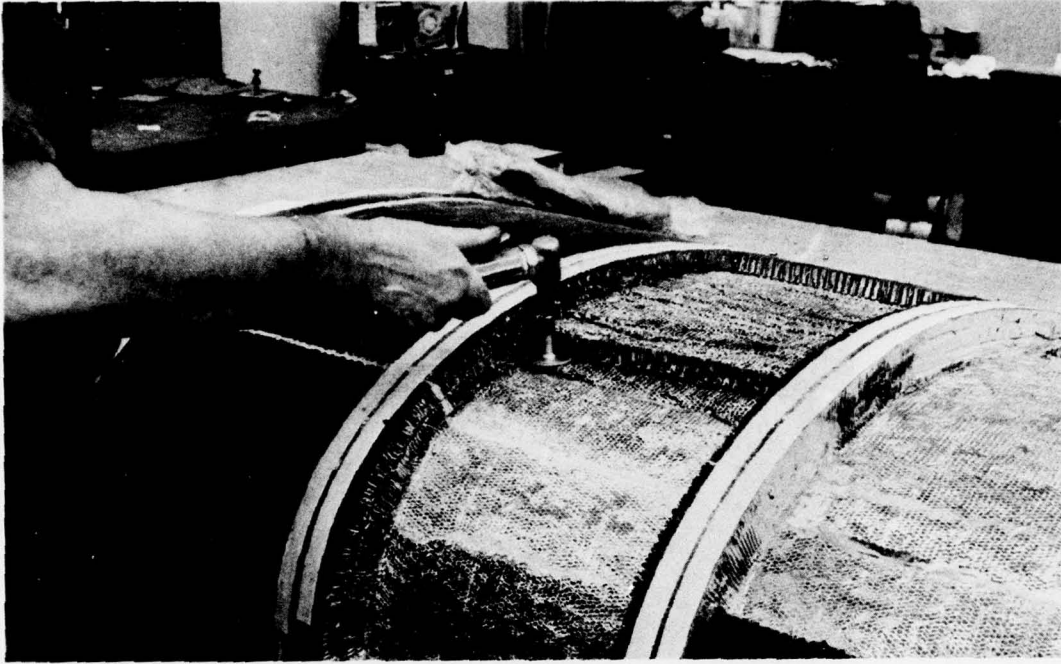
In the procedure, dry ice was used to chill the outer skin to lower the adhesive peel strength. The outer skin was then peeled and removed from the edge members and core. The undensified core sections were subsequently removed using an abrasive disk mounted in a high-speed drill motor. The process is shown in figure 18. The densified core sections at the panel periphery and those used to form the two radial ribs were left intact. These densified sections are not usually part of the corrosion problem.

Figure 18.—Removing Core With the High Speed Cutter

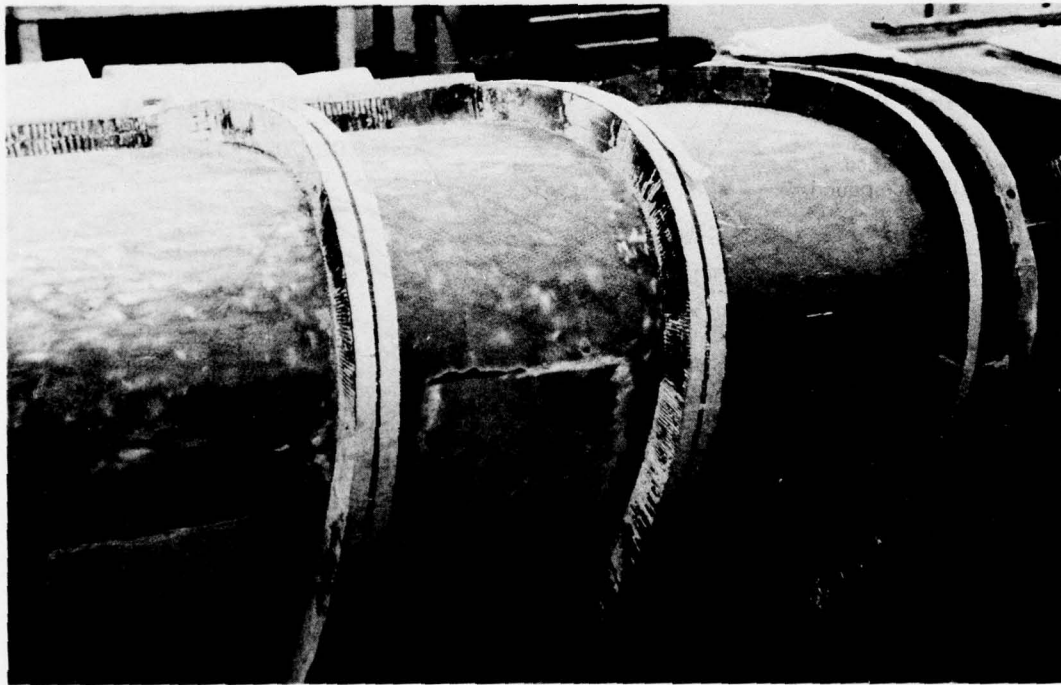
Figure 19.—Core Removed With Bare Metal Areas to Demonstrate Surface Preparation Techniques

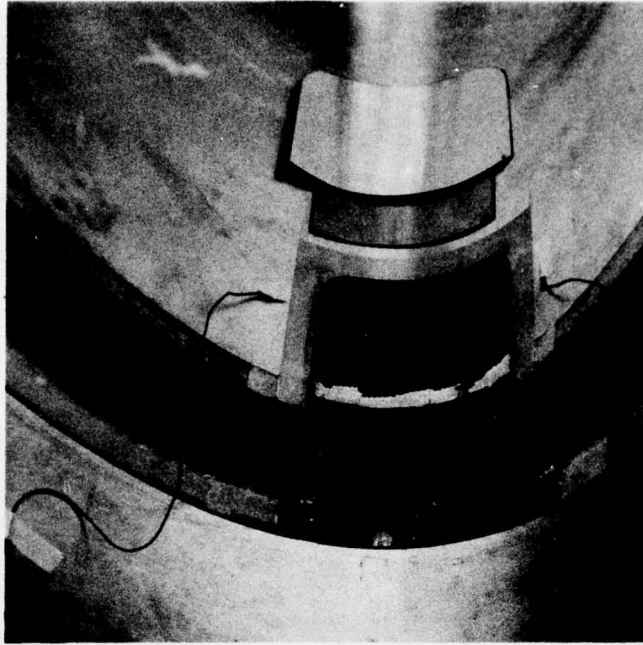
The first-stage cure procedure consisted of covering the assembly with parting film. The outer skin was placed over the core to act as a caul plate. The part was then placed in the bonding tool for cure. The cure was at 250°F for 60 minutes. The autoclave pressure was 35 psi. The part is shown bagged and in the bonding tool in figure 32. After cure, the part was debagged, the core splice material was inspected for adhesion to the core edges, and the surface of the core was examined for proper contour.

Figure 32.—Repaired C-141 Wing Leading Edge Ready for the First-Stage Cure

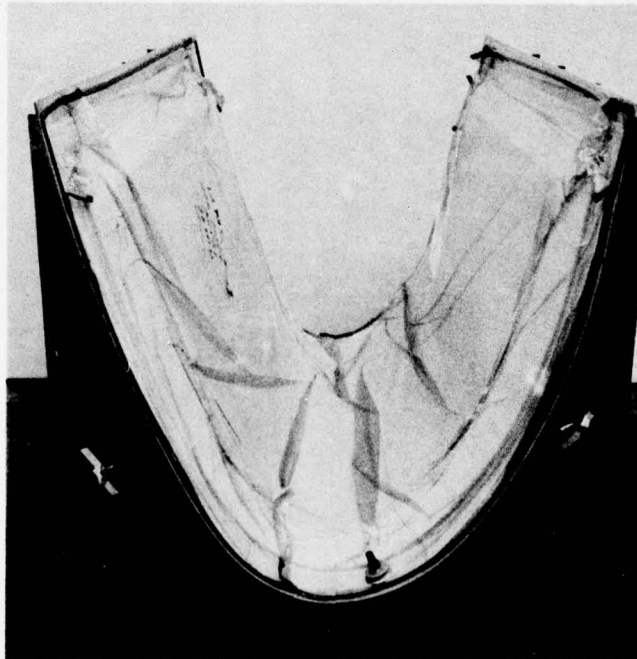
After removal from the bonding tool, the part was ultrasonically inspected. As a result, a void was found between the inner skin and core next to the edge at the radius apex. This measured approximately 4 in. long radially and was about 3 in. wide. It was caused during the first-stage repair bond. The female production bond tool had been used (see fig. 16). The core was positioned next to the tool surface and then covered by the inner skin. The inner skin had been preformed but using the same tool that was used for forming the outer skin. Reliance was on the bonding pressure to push the skin to the tighter inner radius. The bonding pressure used was not sufficient to do this and hence the void.

Figure 33.—Details for Repair of a Void in the Leading Edge Assembly

The part was repaired by removing the skin in the delaminated area and patching. The repair details and the finished patch are shown in figures 33 and 34. The completed part after painting is shown in figure 35.

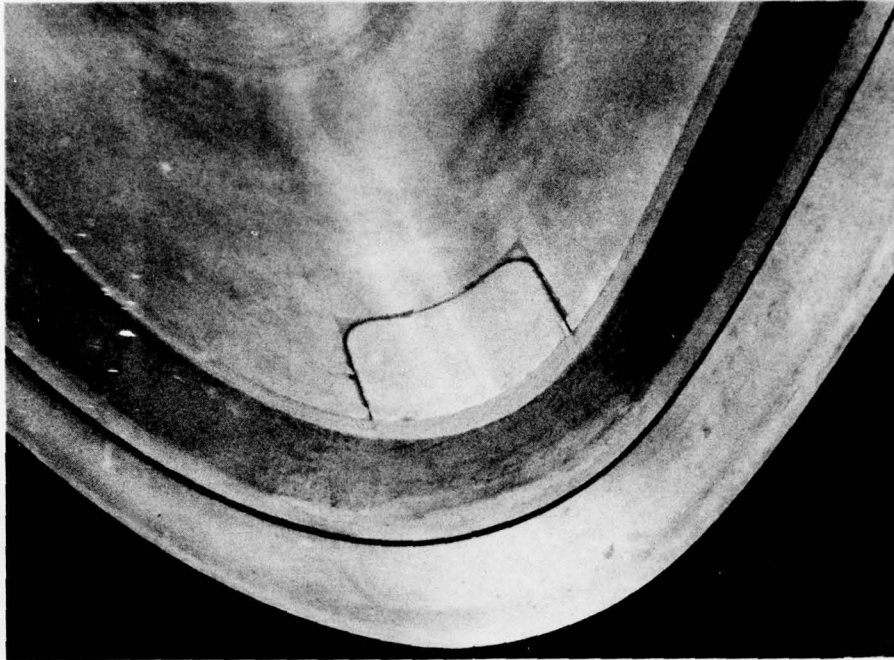
Figure 34.—Completed Repair of Void Area

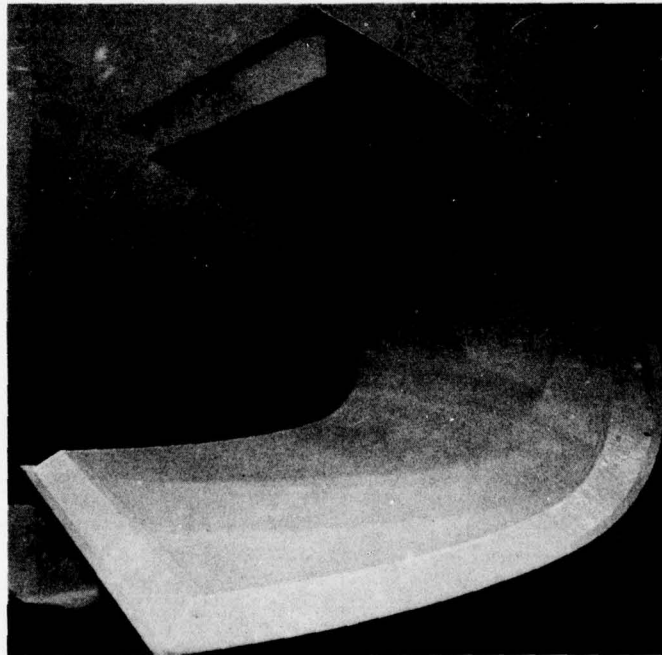
Figure 35.—C-141 Wing Leading Edge After Rebuild

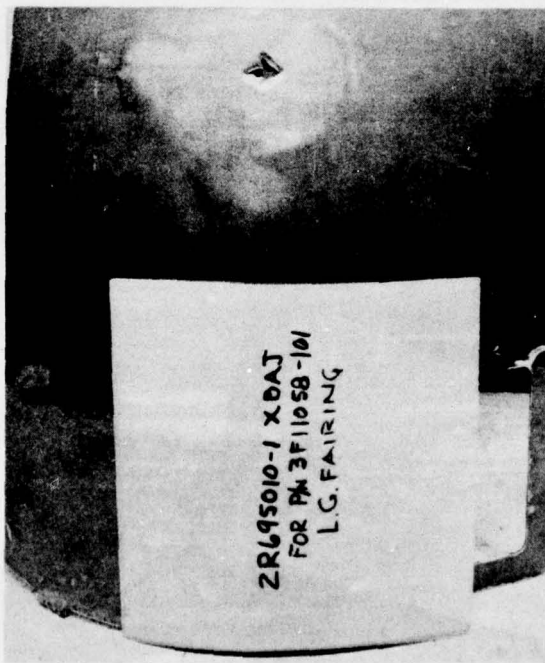
Figure 37.—Damaged Access Panel and Molded Fiberglass Bond Assembly Jig (BAJ)

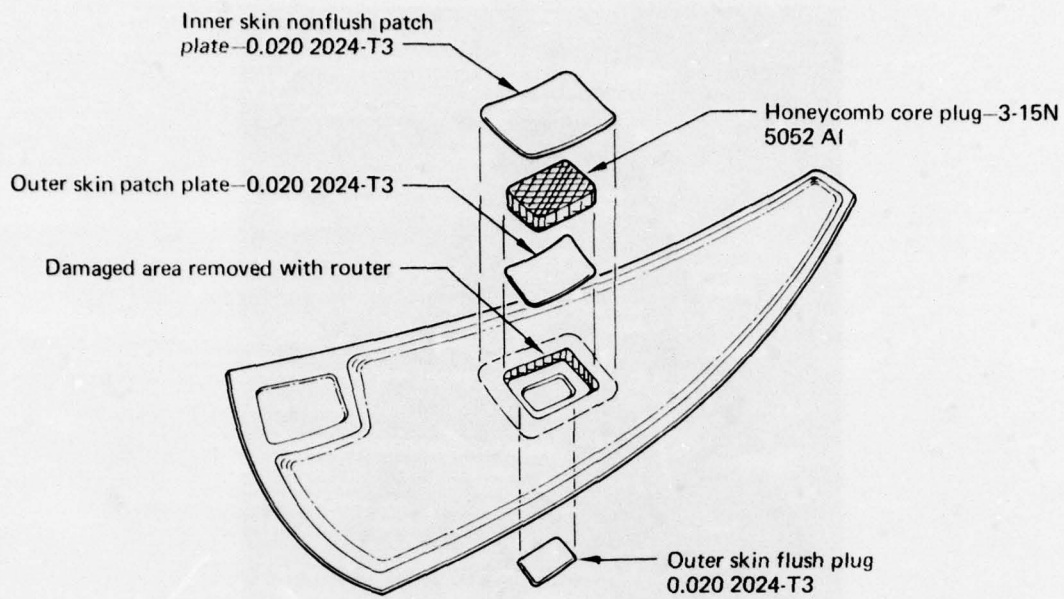
Figure 38.—Exploded View of Repair Details for the C-141 APU Access panel

After fabricating the fiberglass BAJ, the damaged area was cutout using a high-speed router. An exploded view of the repair is shown in the sketch in figure 38. The details consisted of the flush filler plate, the internal patch plate providing for a minimum 1.00-in. bonded overlap around its edges, the core, and the nonflush patch plate for the inner concave surface. The metal skin patch details were cut to size using standard shop practice. The core detail was surface machined to proper thickness. A mylar template was made and used to define the core shape. These pieces are shown in figure 39. The materials for the repair matched those of the part. The skins were 0.020 2024-T3 aluminum. These were formed to proper contour using a Roto-Peen technique. The plastic BAJ was used to define the proper shape. This process is shown in figure 40. The core was 3-15N 5052 aluminum. Preforming the core was not required.

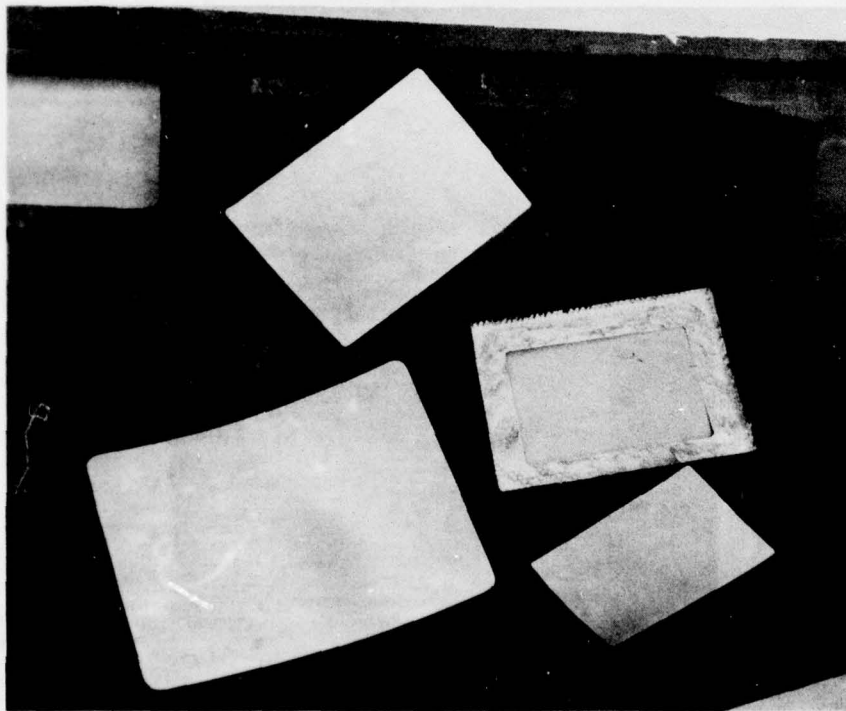
Figure 39.—Damaged Removed and the Repair Details Shown

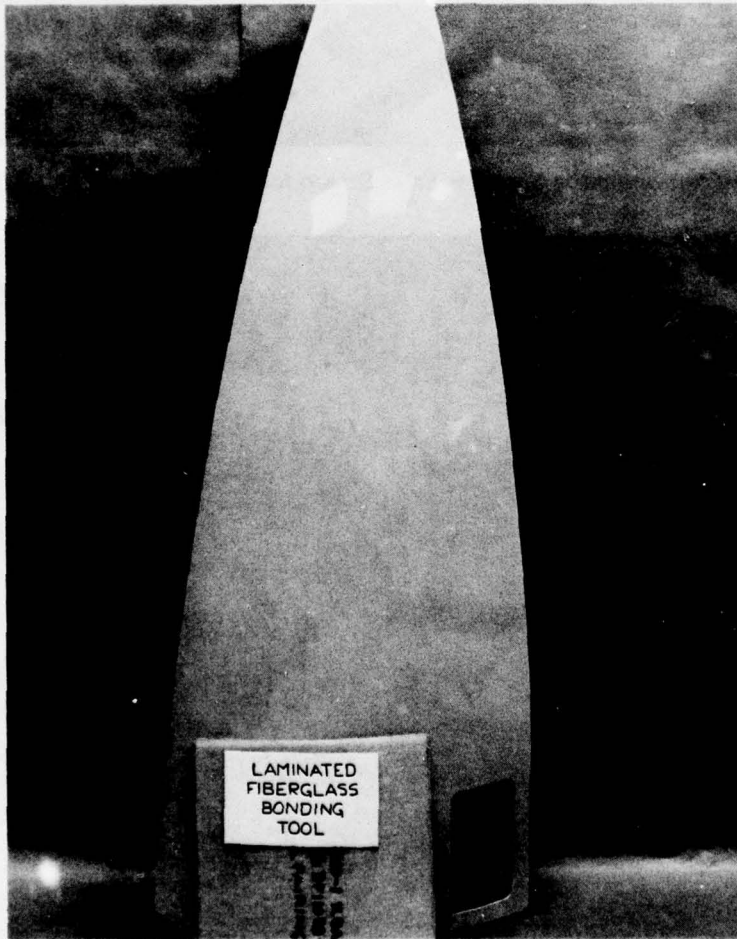
Figure 47.—C-141 APU Access Panel—Repaired Panel

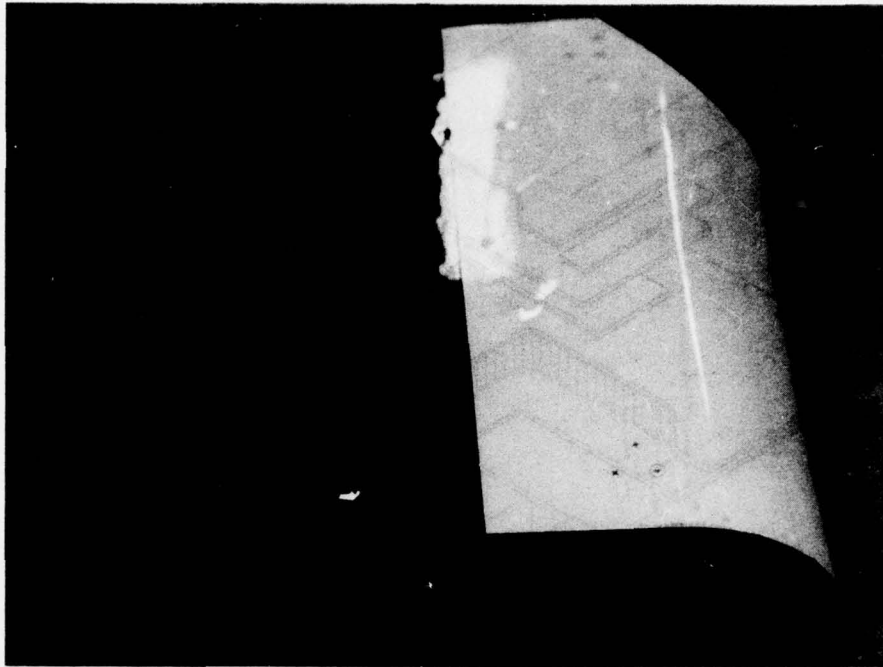
Figure 48.—T-38 Main Landing Gear Door Received From Nellis AFB

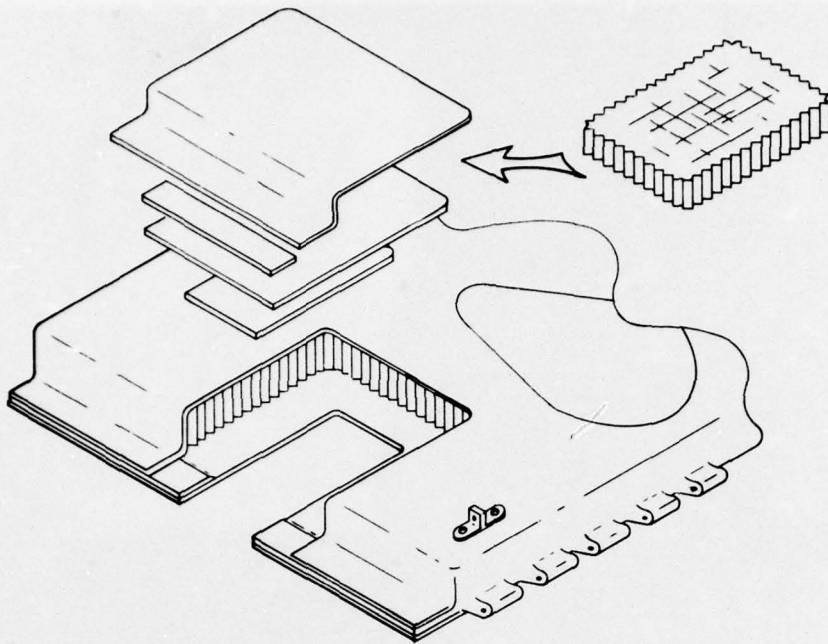
Figure 50.—Exploded View of Repair Details for the T-38 Main Landing Gear Door

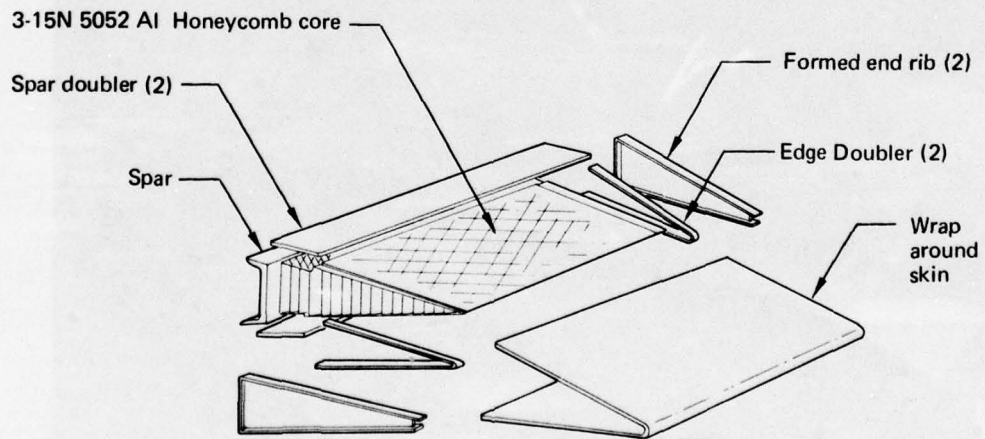
Figure 65.—C5-A Aileron Trailing Edge Part Breakdown

A breakdown sketch of the component is shown in figure 65. Work consisted of repairing the core and replacing the skin and the longitudinal and side doublers. The skin and doublers were 0.025 and 0.020 2024-T3 aluminum, respectively. The core was 3-15N 5052 Al.

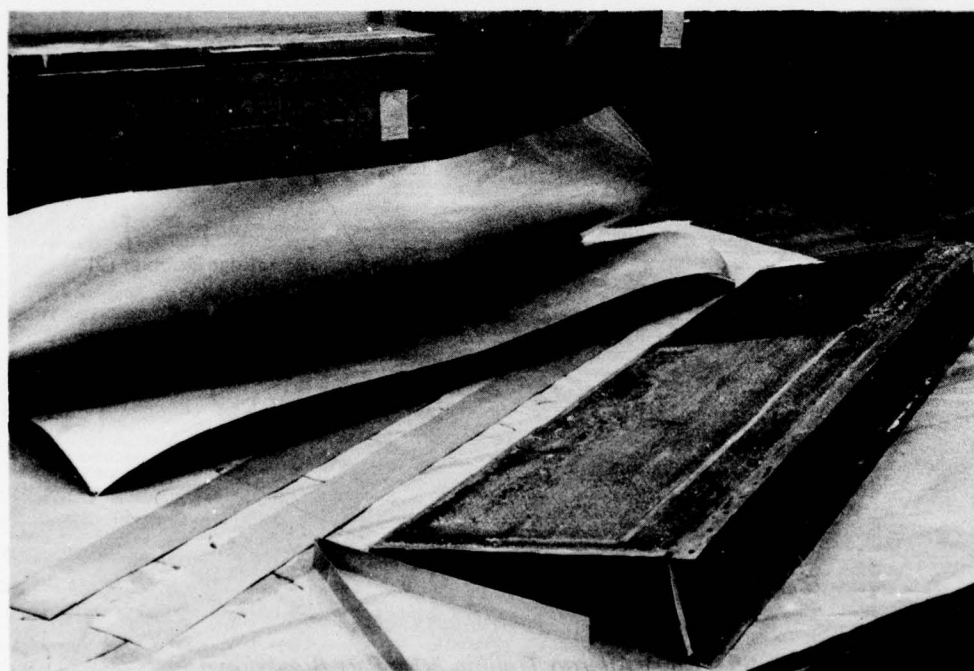
Figure 67.—C5-A Aileron Trailing Edge Repair Details Ready for Bonding

The bond areas on the part had a coating of the original adhesive. This was lightly sanded and wiped with MEK. The details were then primed and the part assembled for bonding. The primer was EC3921, and the adhesive was AF127-3. The part details are shown ready for assembly in figure 67.

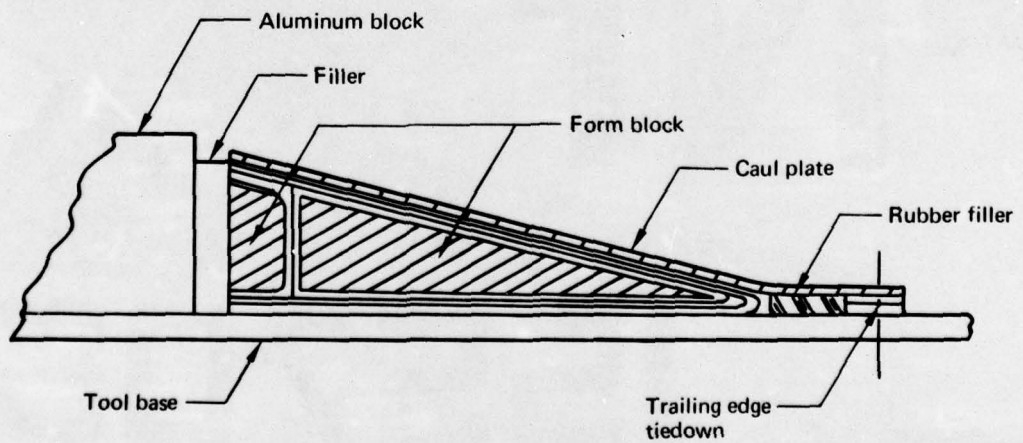
Figure 69.—Tooling Concept to Support the Trailing Edge Panel During the Rebuilding Cure

In both bond stages, the edges of the core were fully supported by form blocks fixed to the tool base to prevent lateral movement. The downward pressure on the core was evenly distributed by use of a caul plate. The tooling concept is illustrated by sketch in figure 69.

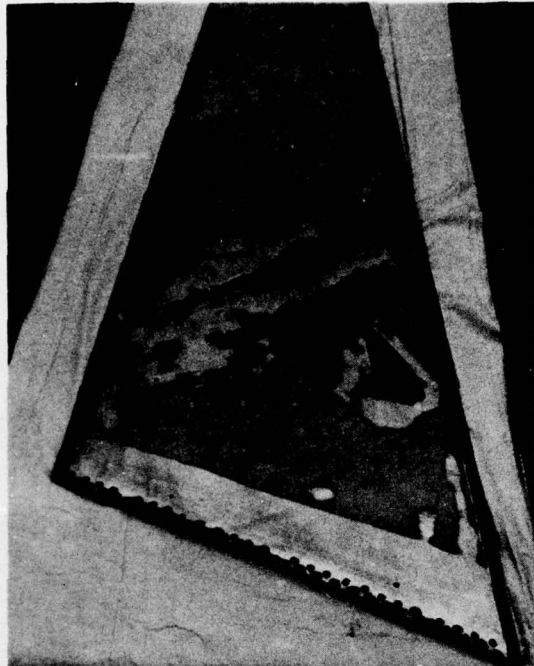
Figure 74.—Cosmetically Filled Fin Panel to be Used as Base for Molding the Fiberglass Bond Assembly Jig

The surface of the panel was curved in the fore and aft direction. Because of this, fabrication of the BAJ was required to achieve proper contour during bonding. The contour for the BAJ was obtained by filling and smoothing the damaged panel surface. Filling was done with Corfil 615. The restored panel surface is shown in figure 74.

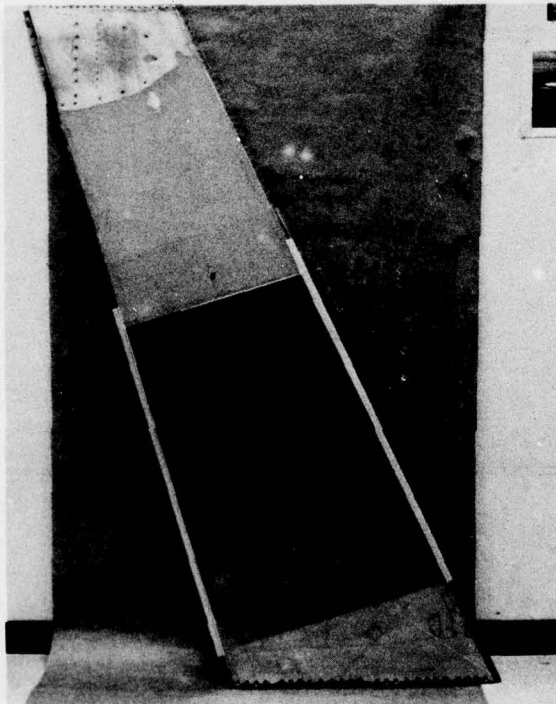
Figure 75.—Metal Contour Sheet Placed Over the Panel to Provide a Surface for Molding the Fiberglass Bond Assembly Jig

After the cosmetic treatment of the panel surface, a metal contour sheet was attached to the panel with double-backed tape. This is shown in figure 75. This sheet was used as a base for forming the fiberglass laminate BAJ. Parting film, followed by a multilayered prepreg laminate, was layed up on the metal sheet surface. The entire assembly was then vacuum bagged. The assembly is shown at a point where it is ready for closure and sealing of the vacuum bag in figure 76. The vacuum bagging material included the following:

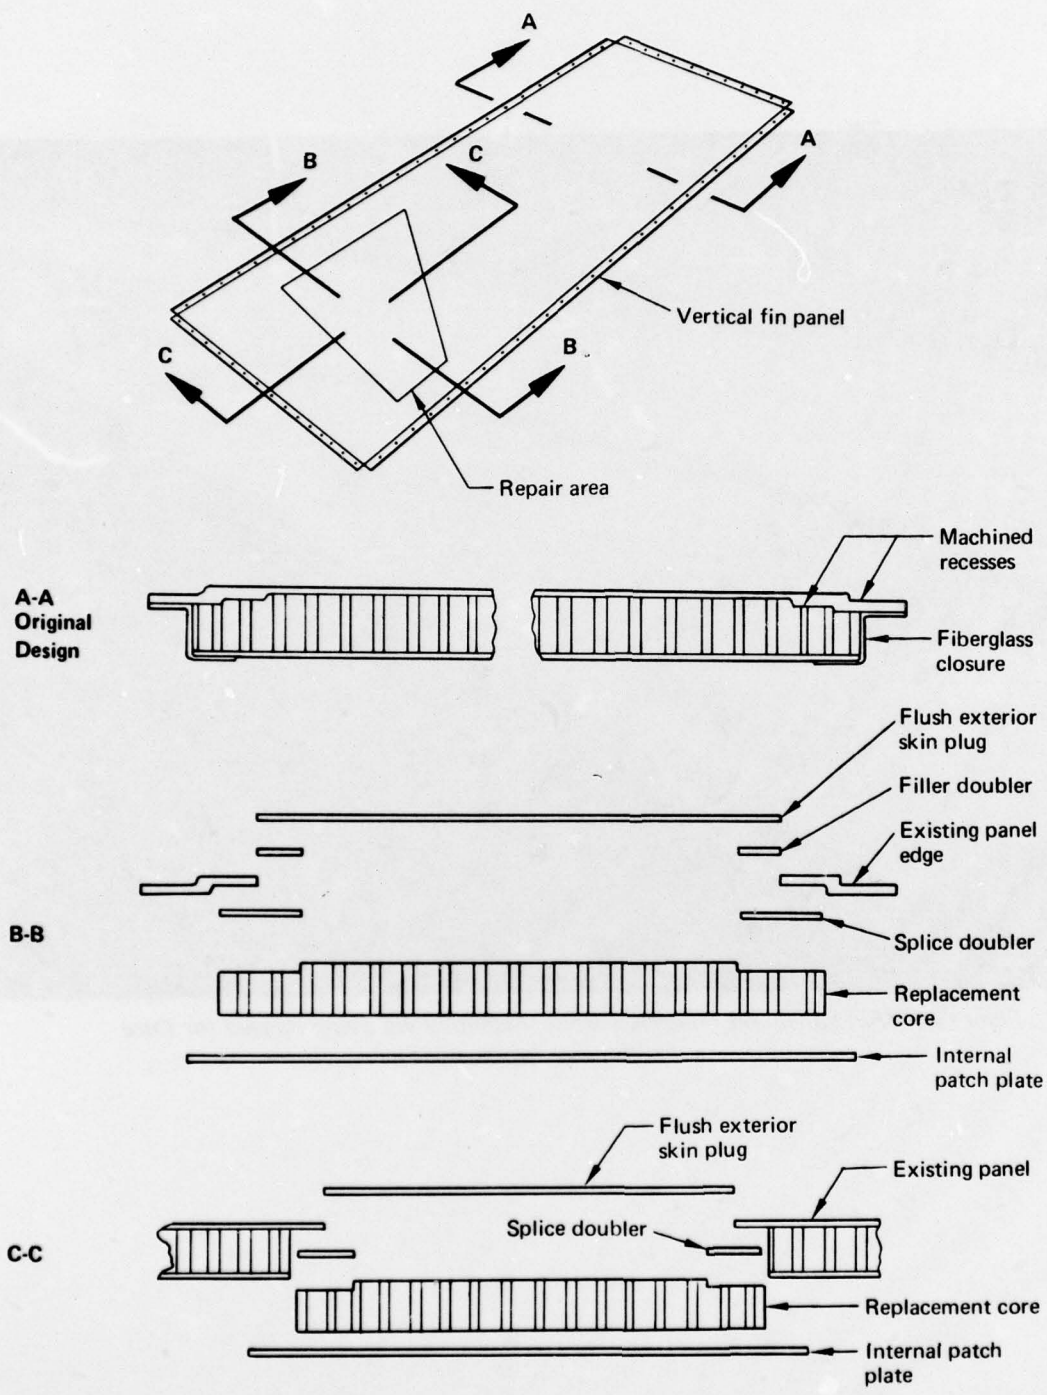
Figure 77.—Detail Cross-Sections of the A-6 Fin Panel Repair

Cross sections of the panel and the repair design are shown in figure 77. A trapezoidal area was cut from the panel to remove the damage. A sheet of mylar film was placed over the cutout area and marked. This was used as a template for cutting the core outline and edge recesses. The template is shown in figure 78. Machining with the high-speed core surfacing machine is shown in figure 79.

The sequence can be noted from figure 77 view B-B starting from the top with the flush skin plug, a layer of adhesive film, the filler doublers, covering adhesive strips, and the splice doublers. The core splice adhesive was then installed, and the adhesive strips were placed over the splice doublers. The core was then slid into place; the adhesive film and finally the covering internal splice plate were added. The splice plate was secured in position with polyester tape.

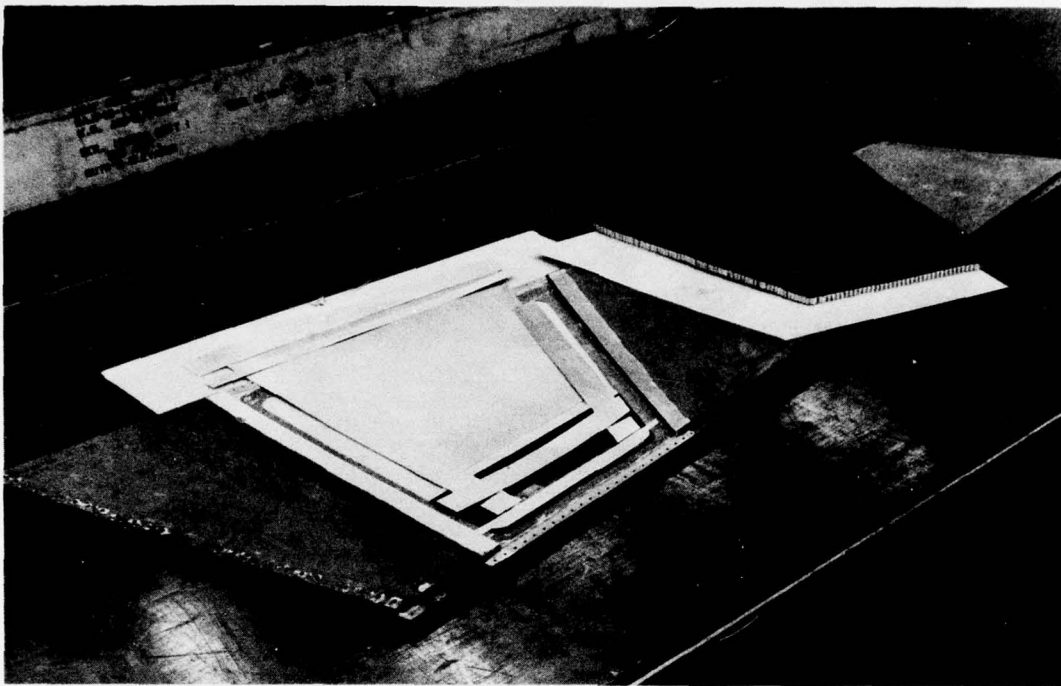
Figure 80.—A-6 Fin Repair Details Ready for Assembly

The repair details are shown ready for assembly in figure 80. Surface preparation for bonding consisted of *hand phosphoric acid anodizing the sheet details and the surface of the panel interior skin that received the inner bonded patch*. The panel bond surfaces with

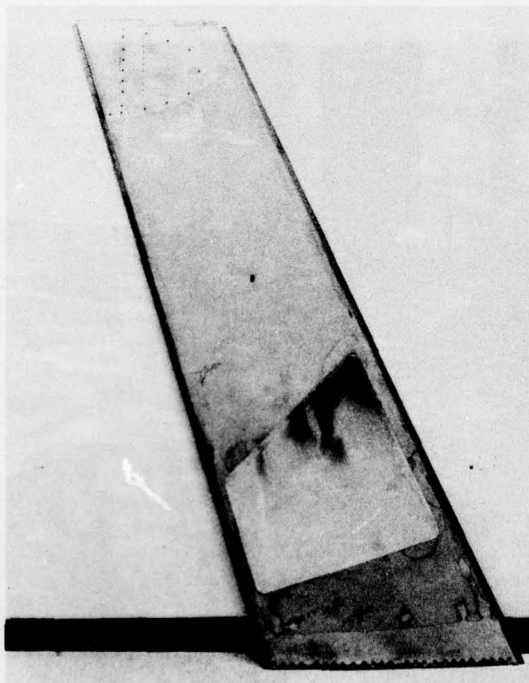
Figure 81.—Exterior Surface of the Fin Panel After Bonding

Nondestructive inspection (NDI) after the cure indicated that the repair was satisfactory. The exterior and interior repair surfaces are shown in figures 81 and 82, respectively. The finished panel after painting is shown in figure 83.

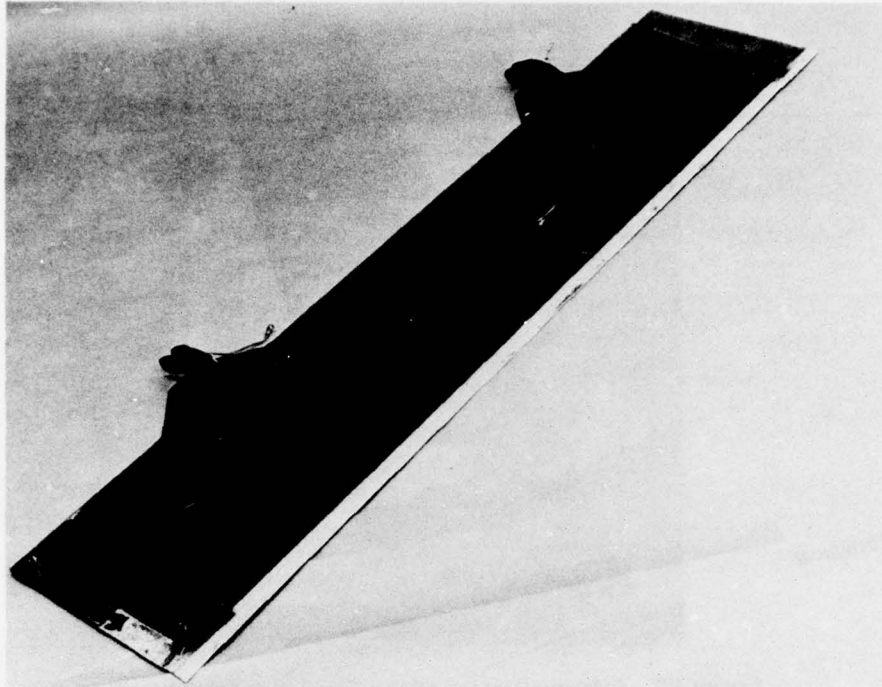
Figure 84.—F-111 Outboard Spoiler Received From Sacramento ALC

Work scheduled for Phase IV consists primarily of demonstrating repair procedures on an F-111 outboard spoiler and writing the handbook sections. The spoiler is shown in figure 84. The damage will be to the trailing edge starting in line with the outboard hinge fitting and extending inboard approximately 2 ft. It will extend in from the trailing edge to about 40% of the chord.
