BOEING VERTOL CO PHILADELPHIA PA

SMALL HARDWARE DESIGN FOR EASE OF MAINTENANCE AND INSPECTION.(U)

USAAMRDL-TR-76-31

March 1977

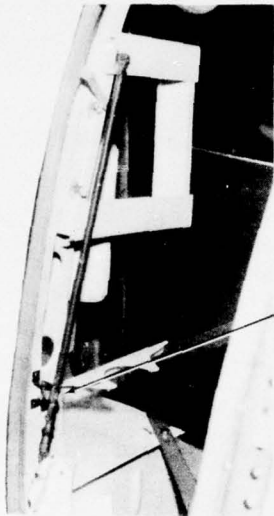
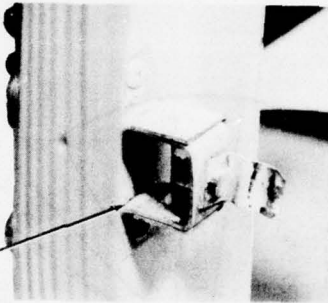
FAN HEAD SCREW

STAY ROD CLIP FAILS

DRIVE RECESS FAILS

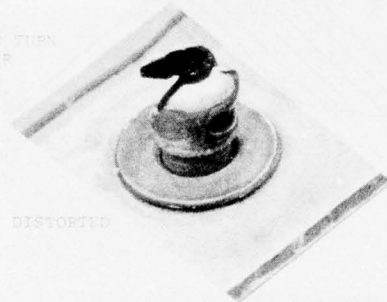
QUARTER TURN FASTENER

WASHER LOOSENS, FRILLS OUT, FASTENER IS LOST

SEVERELY DISTORTED STUD

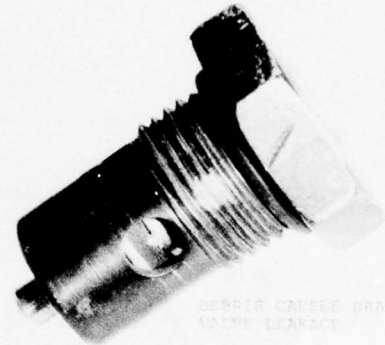
FUEL DRAIN VALVE

GERRIS CAUSES DRAIN VALVE LEAKAGE

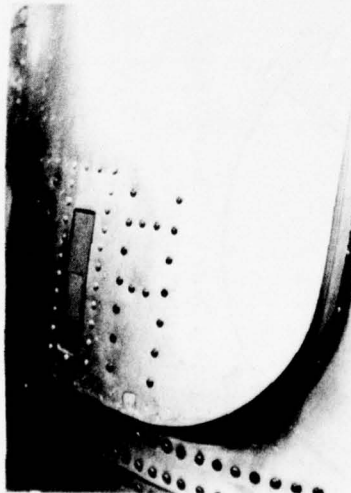
ACCESS PANEL LATCH

PANEL IS LATCHED BUT NOT SAFE FOR FLIGHT

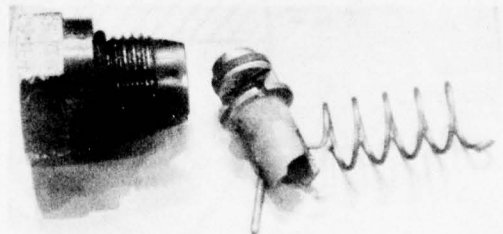
VALVE FAILS AFTER CONTINUED USE

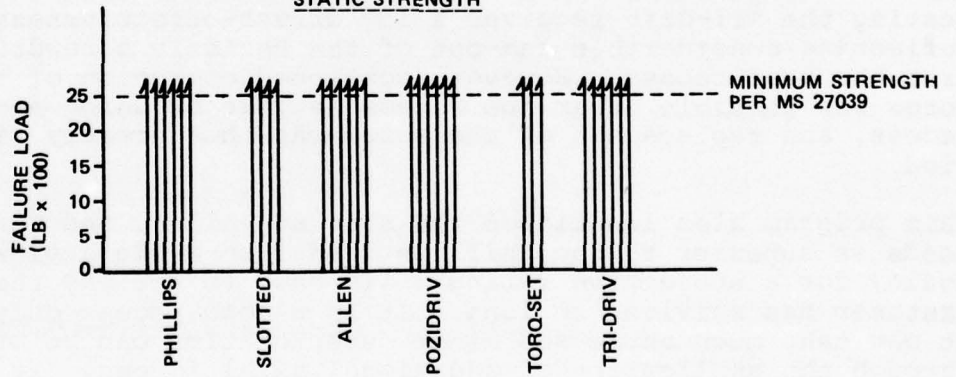
Figure 4C. Drive-Recess Performance

NOTE: DUE TO ALLEN HEAD RECESS DESIGN, FAILURES OCCURRED AT HEAD-SHANK ATTACHMENT AND FAILURE LOADS WERE CONSISTENTLY 10 PERCENT LOWER THAN THE OTHER SCREW FAILURE LOADS.

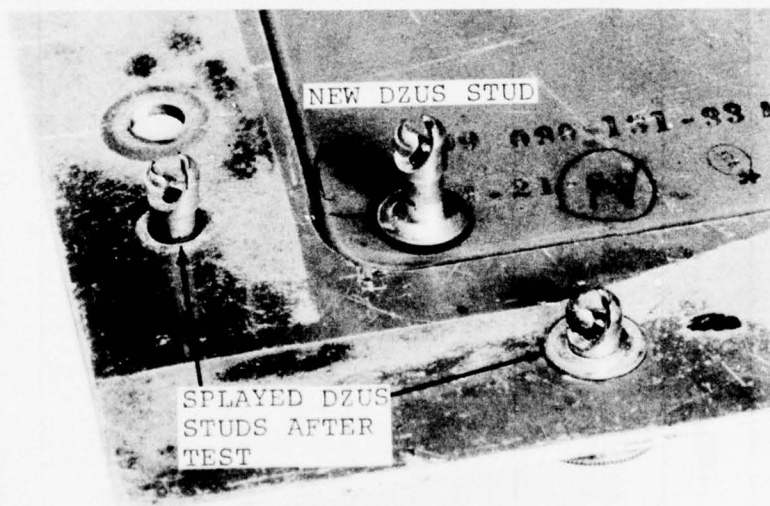
Figure 14. Splayed Fastener From Over-Grip Test

- A fastener that is too short can frequently be deformed to fit the installation. It may appear similar to the one in Figure 14 but will usually engage in the receptacle. The consequences of using such a fastener are unknown.
 - In verification of the maintenance error theory, a used right-hand AH-1G panel supplied to Boeing for test after considerable helicopter use was found to have incorrect length fasteners, apparently from field replacement. This is discussed under "Panel Application," on page 49.
2. The current fastener stud is not self-ejecting and tends to remain in the receptacle when unscrewed. If the fastener is installed in a panel, the friction forces between the stud and receptacle may interfere with panel removal. Damage occurred to the soft aluminum stud retaining washer during a test when the panel had to be pried off, duplicating the condition shown in Figure 7.

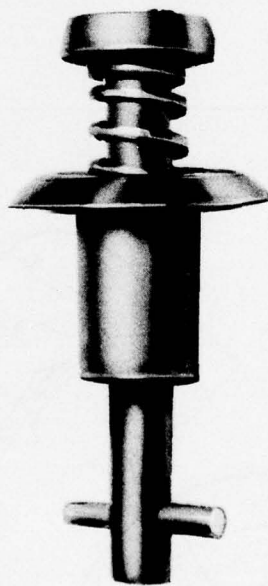
Figure 27. Shearing of Cross Pin

SHEARED
CROSS PIN

BENT
CROSS PIN

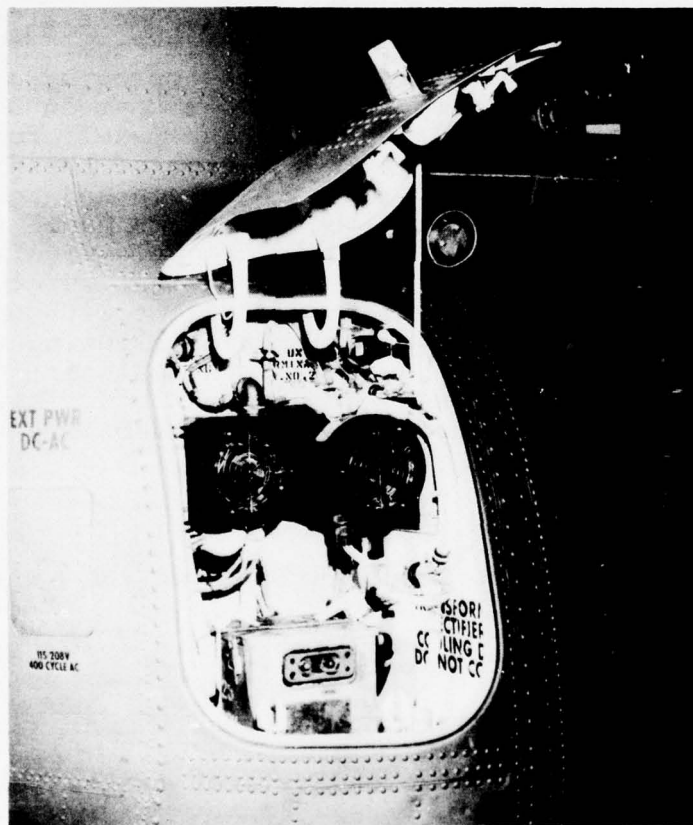
Figure 30. Battery Access Panel Installation

1. Frequency of use - twice daily operation in order to connect and disconnect battery.
2. Compound door curvature - lack of panel hinge rigidity and an inclination of the hinge axis to the latch axis cause alignment problems.

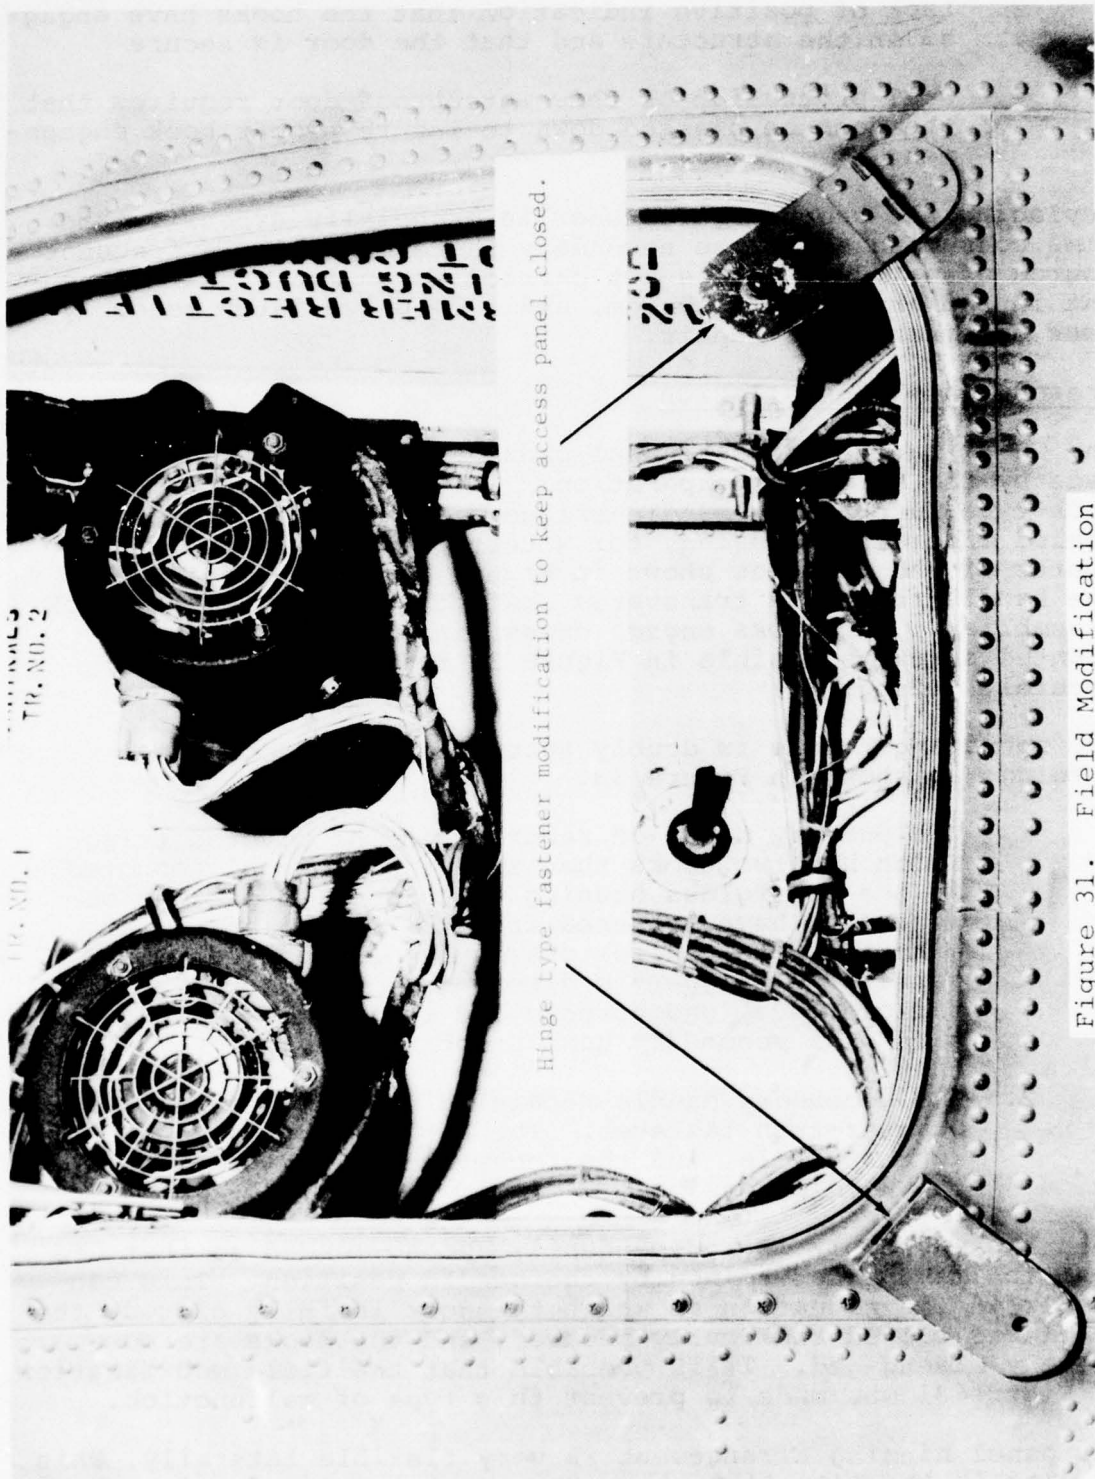
FIG. NO. 1
TR. NO. 2

Hinge type fastener modification to keep access panel closed.

Each hook assembly is independently spring-loaded so that its position is not determined by the handle position. This can result in the situation in which the door is fully closed, the handle is closed and doubly secured, and the hooks are completely disengaged. It is probable that the field modification of Figure 31 was made to prevent this type of malfunction.

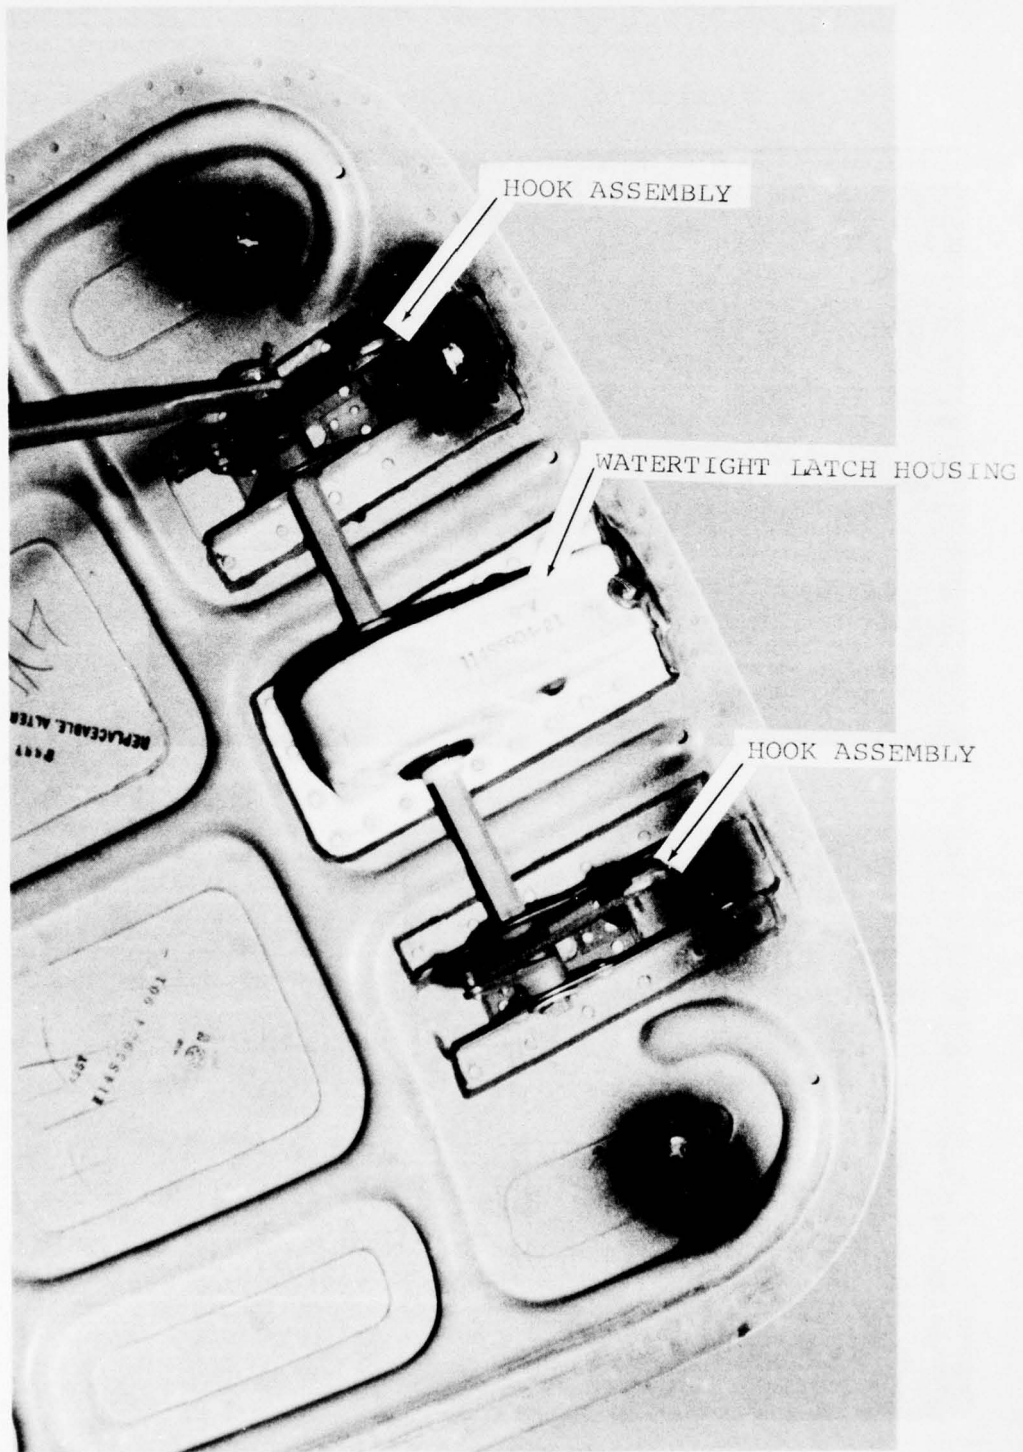
Figure 32. Latch Details

The CH-47 battery access panel presently uses latch components made by the Hartwell Corporation. This is a trigger-action, hook-type latch. The handle-trigger assembly is mounted in a sealed fiberglass housing, for watertightness, in the lower center of the panel as shown in Figure 32. The operation of the handle rotates a transverse shaft to actuate the two hook assemblies. The hooks engage cross pins in the structure-mounted brackets visible in Figure 30 to keep the panel securely closed.

The panel hinging arrangement is very flexible laterally. This results in the situation where the panel is closed and the retention hooks entirely miss the cross pin, resulting in the situation described above.

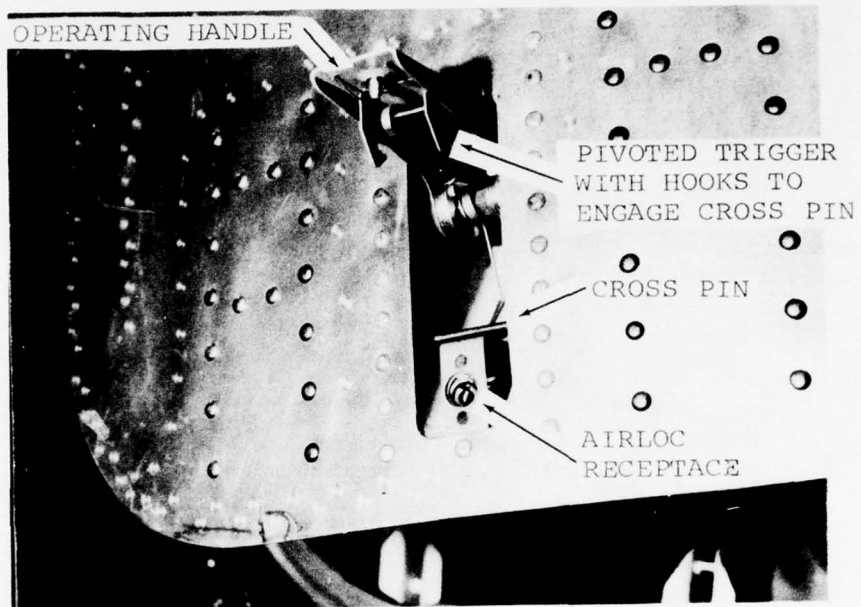
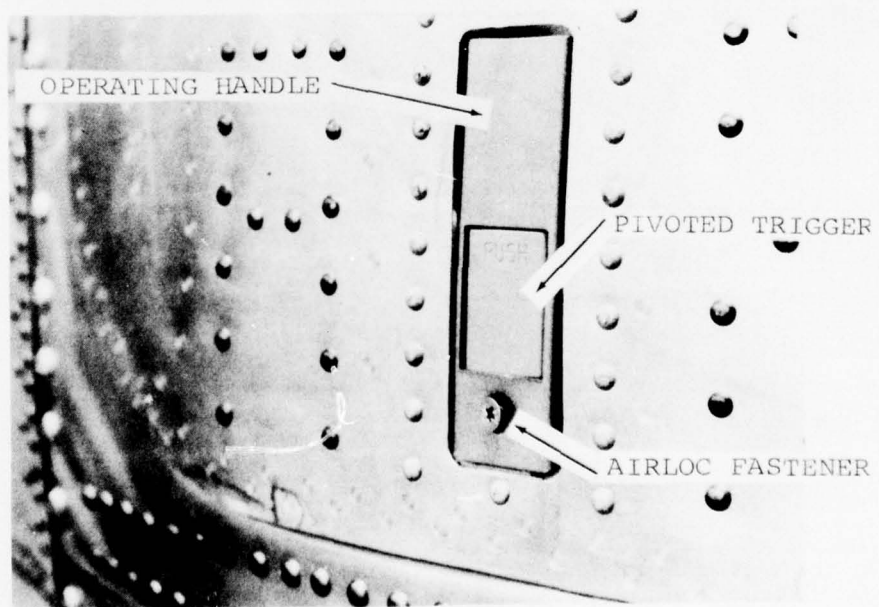
Figure 33. The Double Securing Operating Handle

The operating handle is doubly secured against accidental opening, as shown in Figure 33.

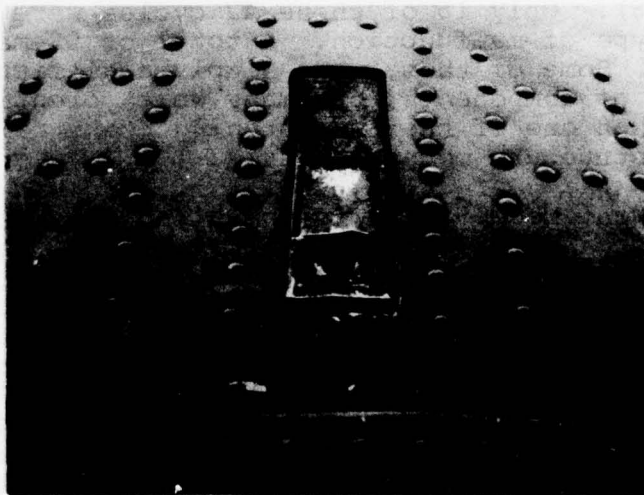
Figure 37. Trigger Release Operation

7. The trigger mechanism forces are affected by latch tension forces. If latch forces are high, it is difficult to engage and disengage the trigger. The trigger is released by pressing with one's thumb or finger. If the release forces are high, the trigger has a tendency to snap "in", and one's thumb gets scraped by the edge of the handle (Figure 37).

AT LEAST YOUR FINGER DOESN'T GET SCRAPED

TO AVOID SCRAPING YOUR FINGER WHEN THE TRIGGER SNAPS IN -
USE A SCREWDRIVER

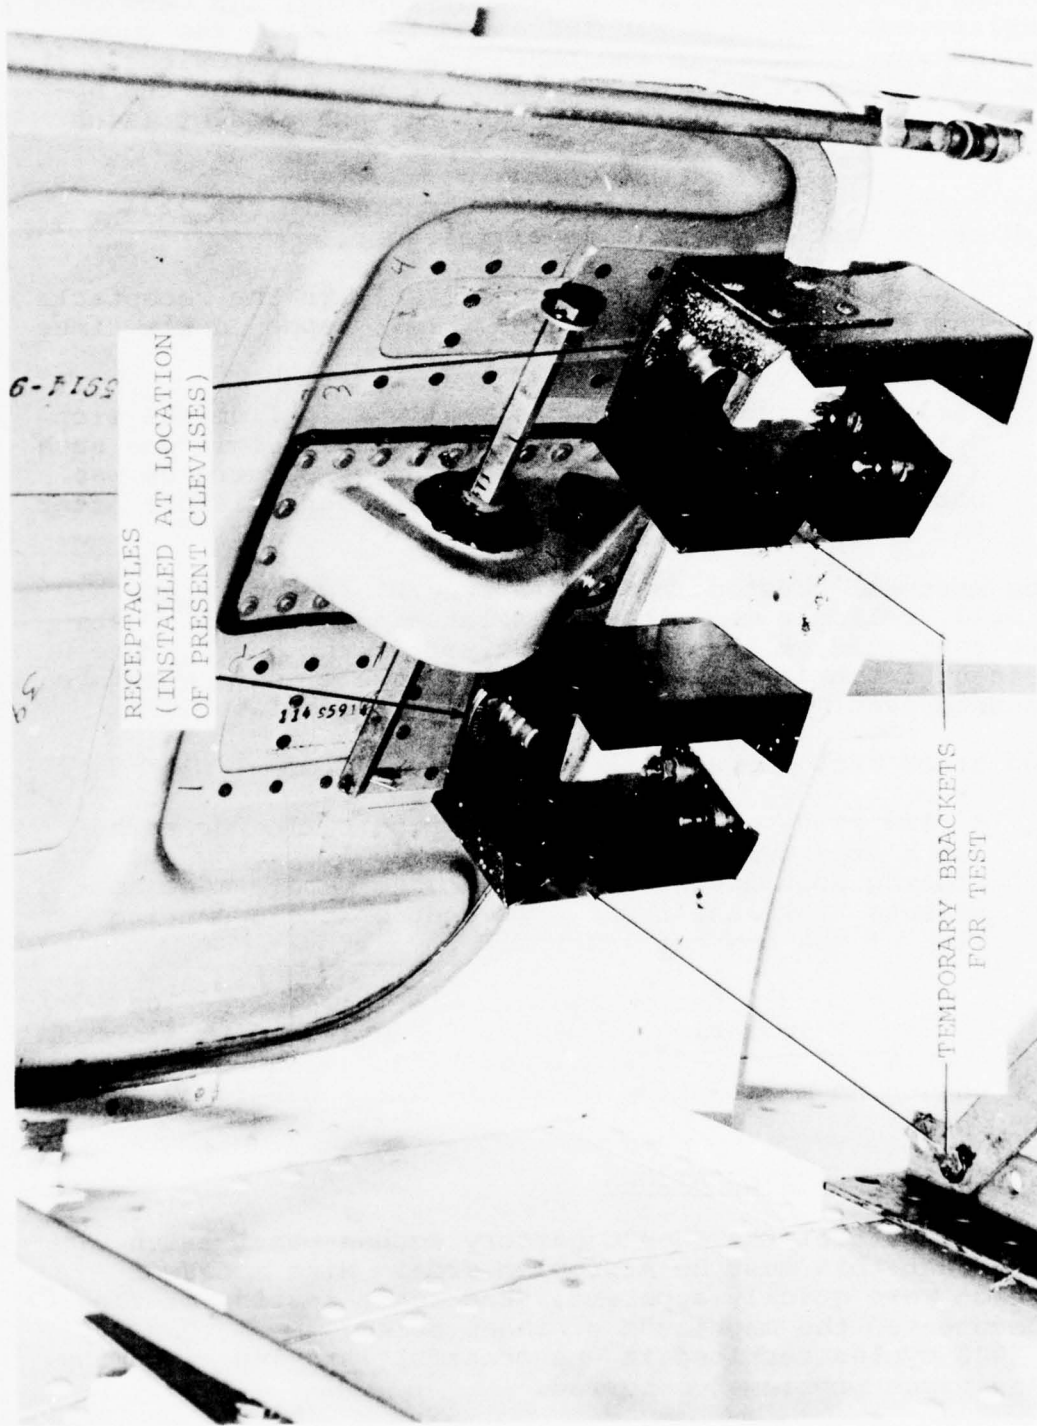
Figure 39. Candidate Replacement Latch Receptacle Installation

At the completion of 3000 cycles of testing, the candidate replacement component was installed for test. The upper bodies were mounted in the panel used in the previous test. The lower bodies were mounted in test brackets at the approximate location of the brackets for the present latch (Figure 39).

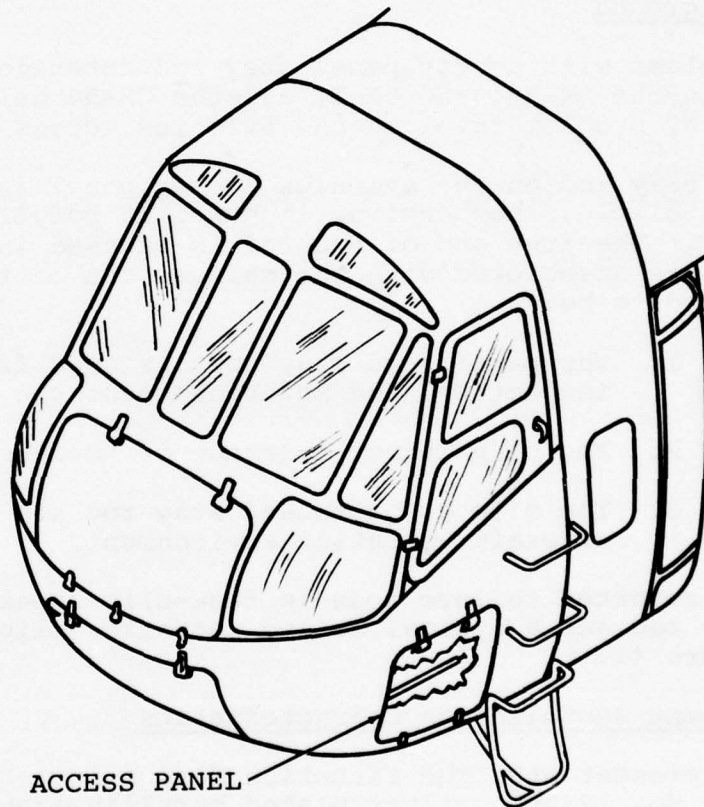
Figure 40. CH-54 Avionics Access Panel Location

Problems with access panel stay rod retention have been reported on the OH-58, the UH-1, and the CH-54 helicopters. The latter problem involved the avionics access panel (Figure 40).

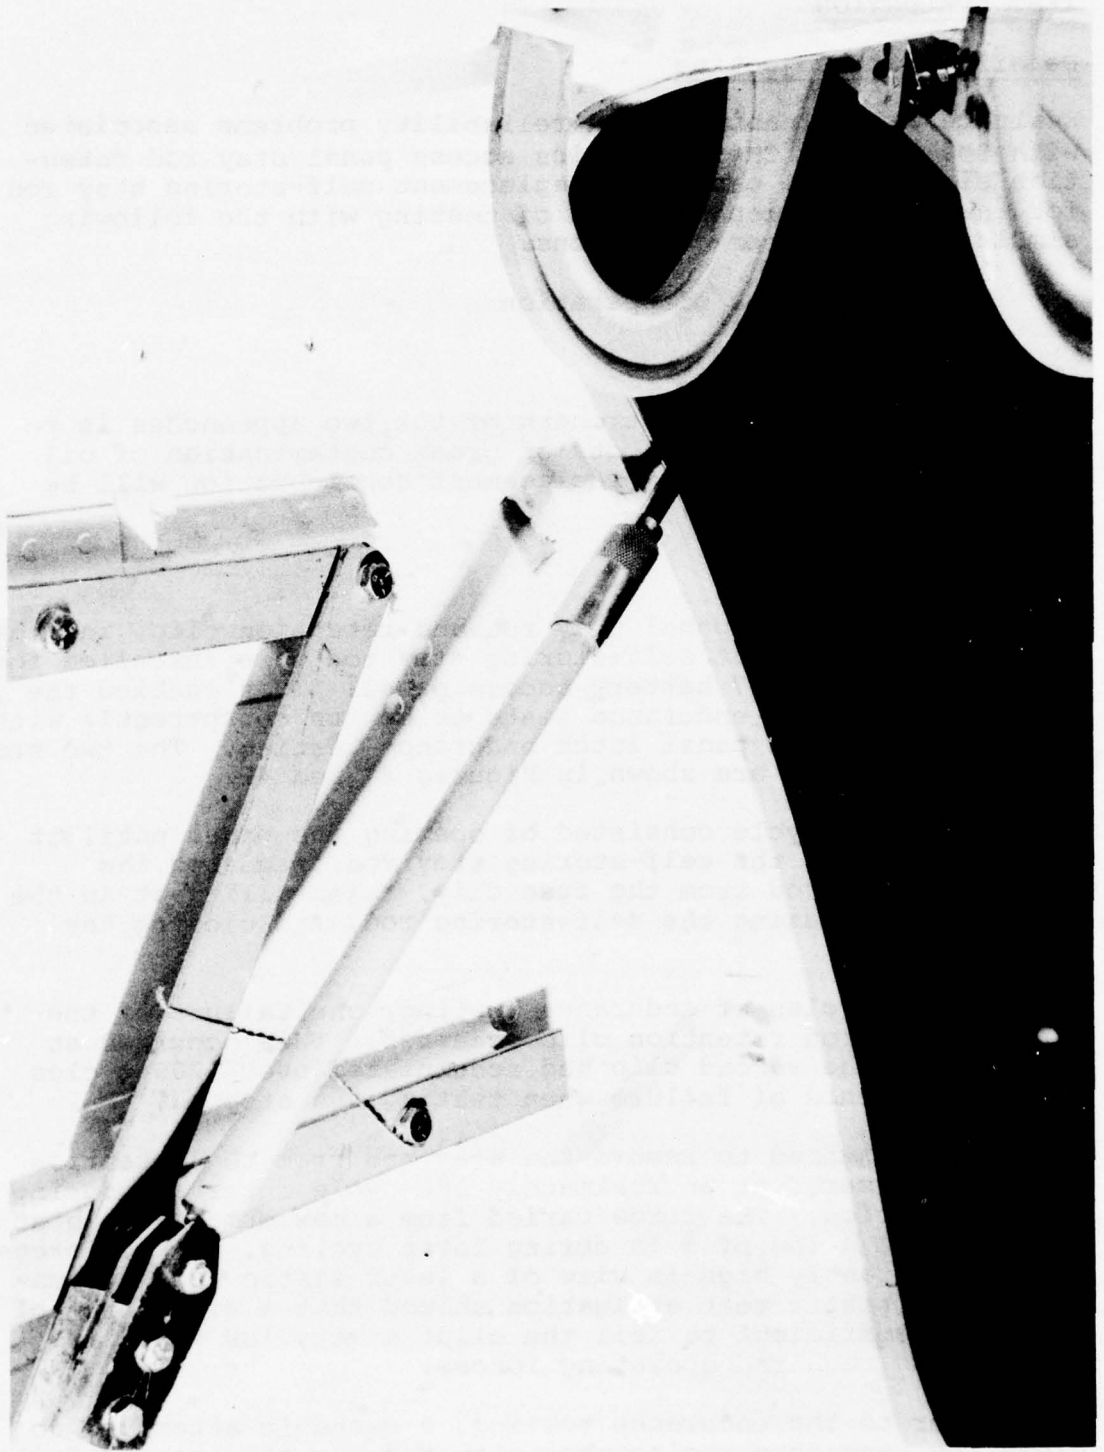
Figure 42. Candidate Replacement Stay Rod Installed for Test

Just prior to the endurance testing, a mechanic attempted to close the candidate replacement stay rod for storage and failed the release assembly. He explained that he did not understand

the method of operation of the rod and that he pushed, pulled and twisted the release sleeve until the rod failed.

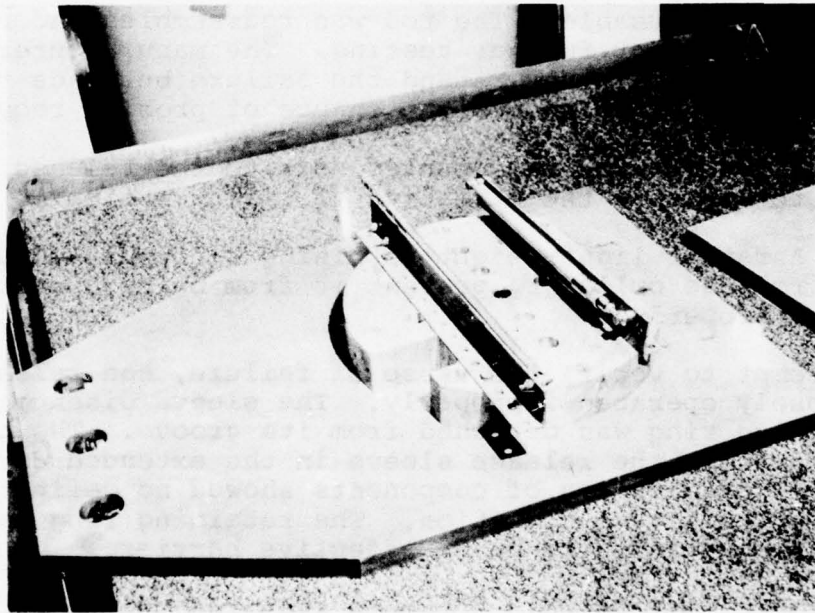
Figure 43. Stay Rods Installed for Vibration Test

A vibration search of the present stay rod system and the candidate replacement rod was conducted in all 3 axes to determine natural frequencies. The two test components were mounted on a slip table as shown in Figure 43, and resonance searches were made over the range of 5 to 500 Hz. A half-hour dwell was made at 250 Hz for the lateral axis and at 350 Hz for the longitudinal axis. Frequency sweeps were made over the range from 5 to 500 Hz until three hours of testing had been accumulated on each of the three axes. The vibration accelerations were 2 g at the peak, except at the very low frequencies, where the double amplitude was limited to 0.4 in. Testing was in general accordance with MIL-STD-810, Method 514.1.

This process had been repeated for 131 cycles when the locking detents failed to hold the door in the extended position, and further testing was discontinued. This is a very severe test in view of the intended use. Although the test demonstrated that this stay rod is susceptible to gross contamination, the durability demonstrated in this abnormal environment does not appear to justify adding seals to the mechanism.

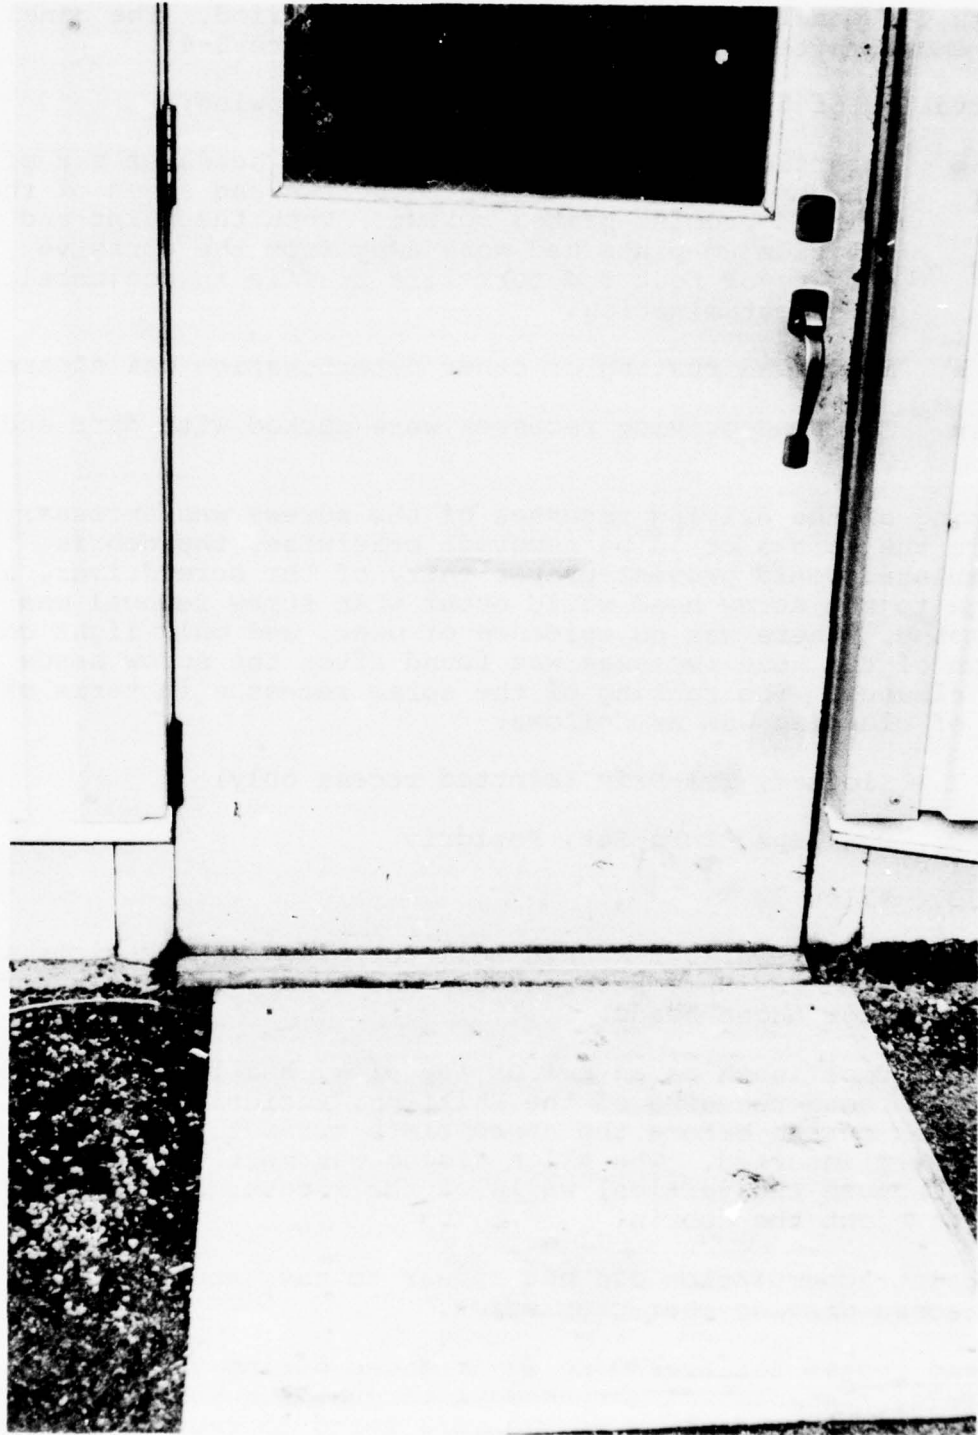
Figure B-3. Floor Panel Installation

The panel installation is shown in Figure B-3. After one month of exposure, the panel was rotated 180 degrees to equalize the exposure of the various screws to abrasive wear. A 4,000-lb fork lift truck was deliberately driven

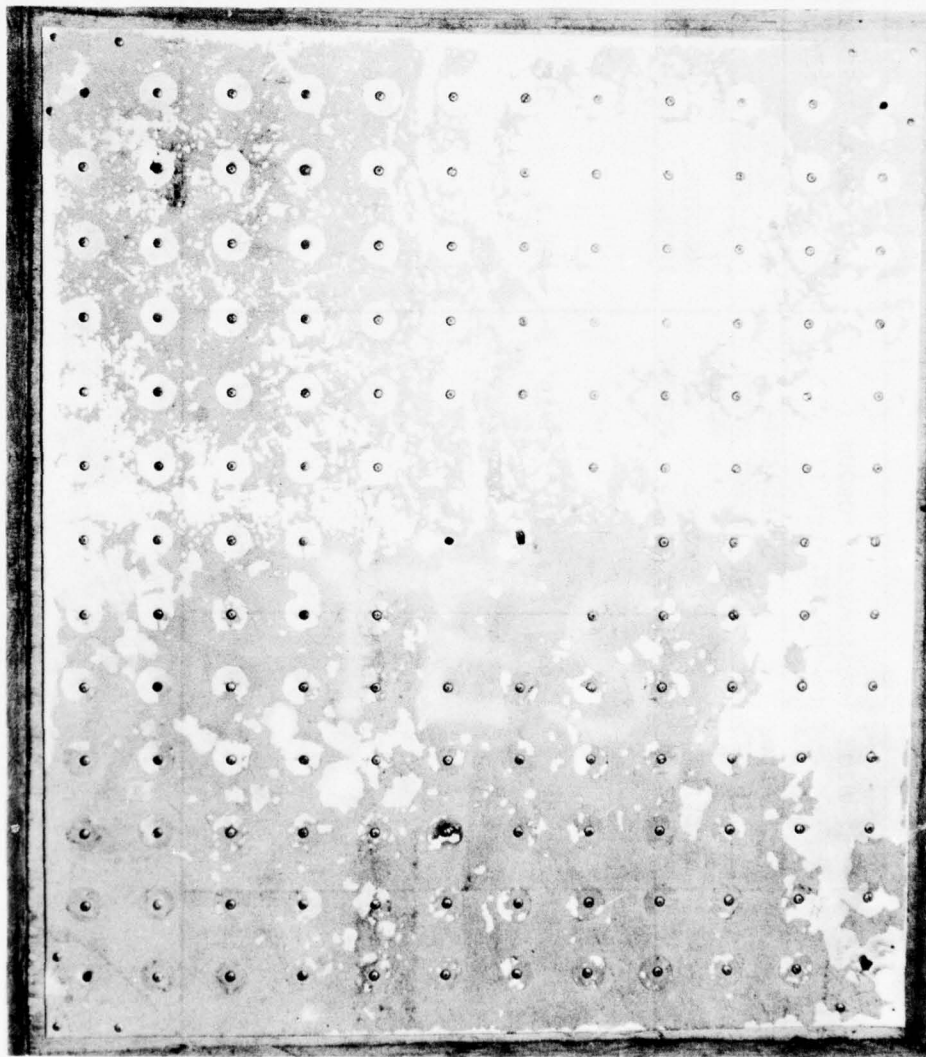
Figure B-4. Floor Panel After Removal

The paint accumulation did not appear to have any effect on the recess driving characteristics.

No head recess failures were experienced during the screw removals. The removal (breakaway) torques are summarized in Table B-3. The alloy screws were found to require approximately 25 percent more breakaway torque than the corrosion-resistant screws for a given level of installation torque. After the environmental exposure, the values of breakaway

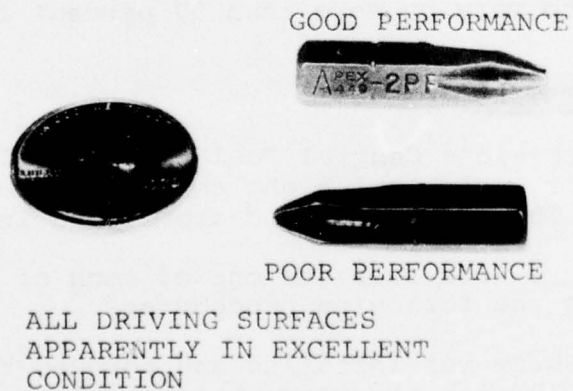
Figure B-9. Two Phillips Screwdriver Bits in Seemingly Good Condition
