TECHNICAL REPORT M-207  
March 1977

COATINGS AND CATHODIC PROTECTION OF PILINGS IN SEAWATER:  
RESULTS OF 5-YEAR EXPOSURE

| REPORT DOCUMENTATION PAGE | | READ INSTRUCTIONS<br>BEFORE COMPLETING FORM | |
|---|--|---|--|
| 20. ABSTRACT (Continue on reverse side if necessary and identify by block number)<br>This report presents the results of the inspection of test pilings extracted after 5 years of exposure to seawater at LaCosta Island, FL. The effectiveness of various coating systems and sacrificial anodes in preventing corrosion of H- and steel pipe pilings in seawater is assessed. Six of the coating systems were found to perform excellently, as was a coating/cathodic protection combination. Sacrificial anodes of zinc and aluminum were also found to effectively reduce corrosion in the immersed zone. → over | | | |

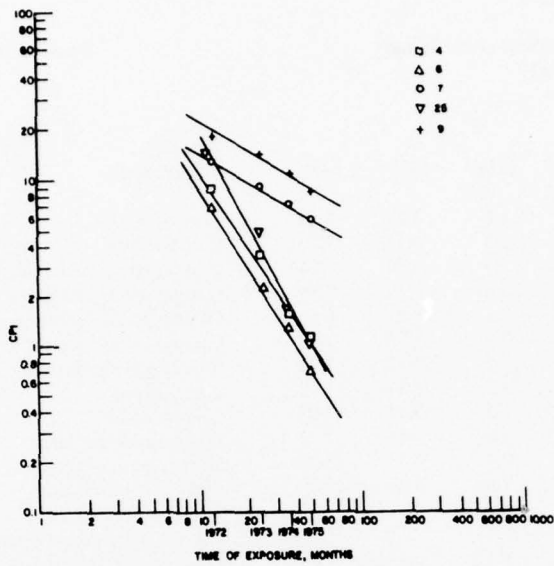
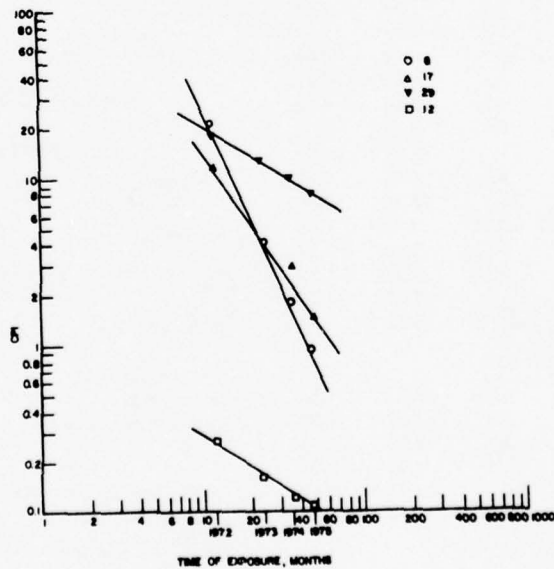
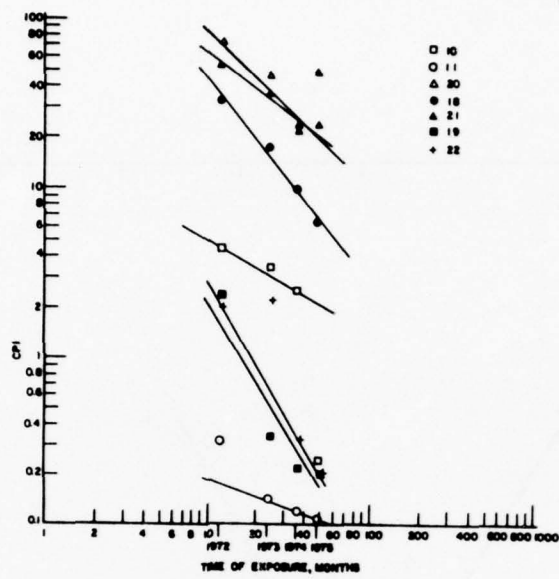
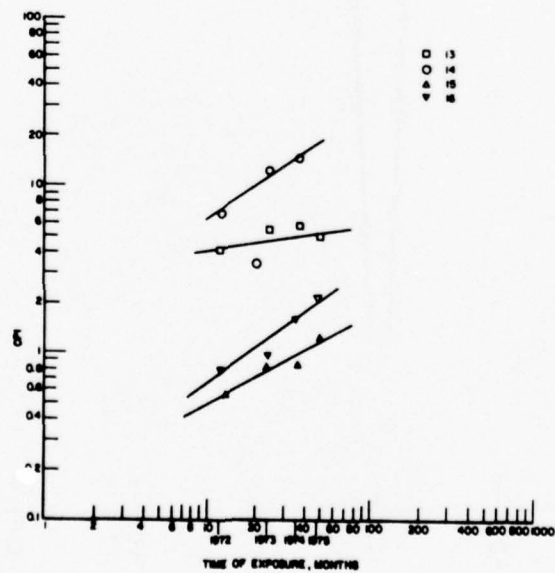
Plotting the cathodic protection indices vs. time durations on log-log plots (Figures 8 through 11) permits prediction of the deterioration of the coatings over a long period of time. Deterioration of the coatings generally resulted in a drop in CPI, as demonstrated by a negative slope averaging approximately -0.65 for all coatings (Figures 8 through 10). However, some coatings, such as flame-sprayed metalics, have a completely flat slope or a slightly positive one, indicating formation of protective corrosion products, such as aluminum oxide or zinc oxide, in the porous flame-sprayed metal. All other systems show negative logarithmic behavior, with decay of index  $m$  depending

Comparison of Table 6 and Figures 8 through 11 shows a very strong correlation between the rank of the effectiveness of protection and CPI for all independent generic systems. Only in the category of organic over metal-filled coatings is the correlation weakened, possibly because of the difference in conductivity of the various metal-filled undercoats.

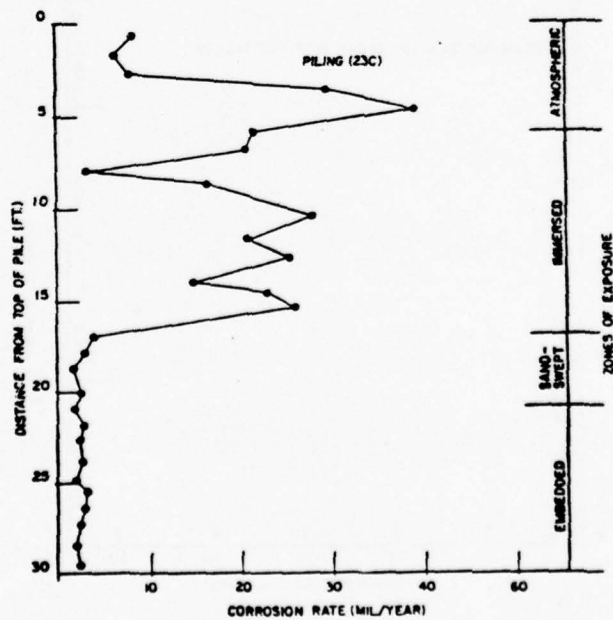
Figure 16. Corrosion profile of bare mariner steel. SI conversion factors: 1 ft = 0.3048 m; 1 mil = 0.0254 mm.

Figures 15 through 19 give the corrosion rate profiles for pilings of bare carbon steel, bare mariner steel, cathodically protected bare carbon steel, coal-tar epoxy with cathodic protection, and coal-tar epoxy over an organic zinc-rich primer exposed at LaCosta Island. The corrosion profiles are very similar for all systems in the embedded zone, since all pilings were bare in this zone. The average corrosion rate for the embedded zone was found to be 1.1 mil/year (0.03 mm/year), which is comparable to the value of 1.4 mil/year (0.04 mm/year) found by Hunter and Horton<sup>9</sup> to be the corrosion rate of steel embedded in sand.

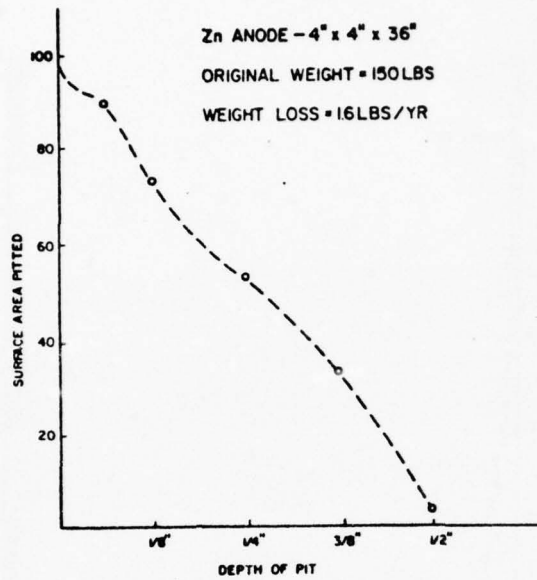
Figure 20. Pit distribution for zinc anodes. SI conversion factors: 1 in. = 2.54 cm; 1 lb = 0.4536 kg.

The rate of consumption of the zinc and aluminum anodes applied to the bare pilings at LaCosta Island was found to be 1.6 and 0.8 lb/year (0.7 and 0.4 kg/year), respectively. Figures 20 and 21 show the pit distribution for the respective anodes; the average pit depth was on the order of 0.25 in. (6.4 mm) for both anodes.

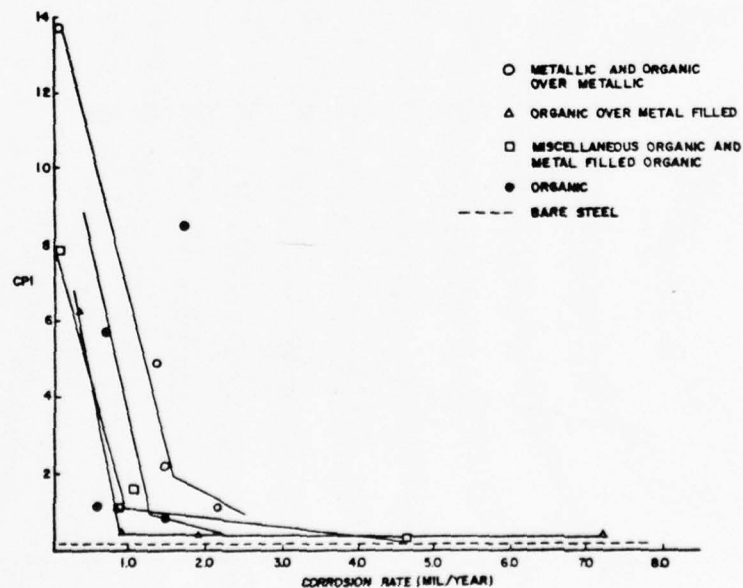
Figure 22. Cathodic protection index as a function of corrosion rate for LaCosta Island pilings. SI conversion factor: 1 mil = 0.0254 mm.

Figures 22 and 23 show the cathodic protection index<sup>11</sup> as a function of corrosion rate for the LaCosta Island and Dam Neck pilings, respectively. The data from both sites reveal sharp declines in CPI with increasing corrosion rate for each independent generic system. At low corrosion rates, the CPI appears to depend on the specific generic system, while high corrosion rates are associated with low CPI, regardless of the generic system. The bare steel baseline was included to indicate the low CPI coupled with the high corrosion rates generated by the bare steel, in comparison to any of the coating systems. The correlation between CPI and corrosion rate was determined by computer analysis to be 80 percent for all systems.

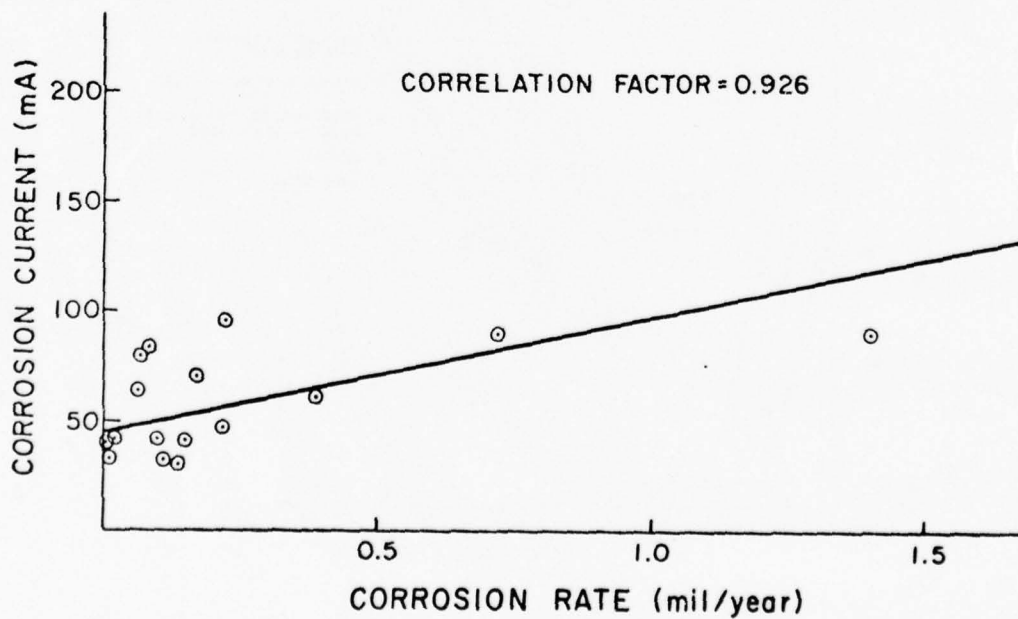
Figure 24. Corrosion rate vs. corrosion current. SI conversion factor: 1 mil = 0.0254 mm.

24. A computer analysis was conducted to determine the degree of correlation between corrosion current and corrosion rate. A strong correlation of 0.9 was found to exist. Since the corrosion current is determined by polarization measurements, this method provides a nondestructive testing technique of monitoring corrosion of steel immersed in water.
