USAAMRDL-TR-73-98F

**3000-HP ROLLER GEAR TRANSMISSION DEVELOPMENT PROGRAM  
Volume VI - Reliability and Maintainability Report**

Sikorsky Aircraft  
Division of United Technologies  
Stratford, Conn. 06602

January 1977

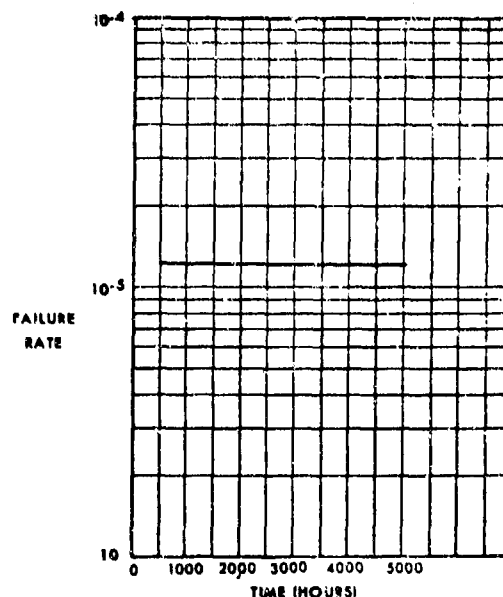
Figure 19. Safety-of-Flight Hazard Function.

The first hazard function analysis was performed for the roller gear transmission on the basis of safety-of-flight failure modes alone. The results of this analysis are presented in Figure 19. The size and shape parameters of the various safety-of-flight failure modes are tabularized in Table E-5 of Appendix E. As can be seen from Figure 19, the safety-of-flight failure rate is essentially constant with time. Any

Table E-4 lists the main transmission generic components that are common to the roller gear and baseline transmissions and their associated hazard function parameters. Combining the parameters from Table E-3 with those of E-4 resulted in main transmission computed MTBR's of 394 and 657 hours, at 50 percent and 95 percent confidence levels respectively. The safety-of-flight hazard function parameters used to compute the failure rate depicted in Figure 19 are given in Table E-5. As a result of the constant failure rate shown in Figure 19, on-condition maintenance would appear feasible for a fully developed roller gear main transmission.

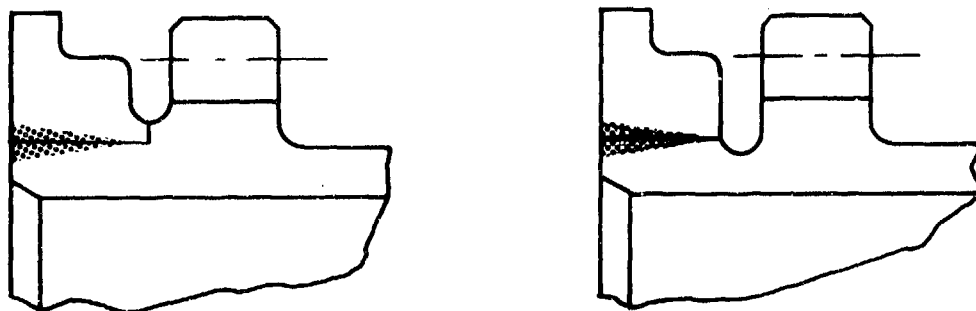
Figure A-4. Initial and Modified Weld Root Relief.

The initial weld configuration incorporated an undercut between the roller and gear shaft to accommodate weld splatter. However, when the weld did not fully penetrate into the undercut, voids remained at the root of the weld, lending incomplete fusion of the joint. To eliminate the stress risers that this induced, the root area of the weld was removed as shown in the modified configuration (Figure A-4).

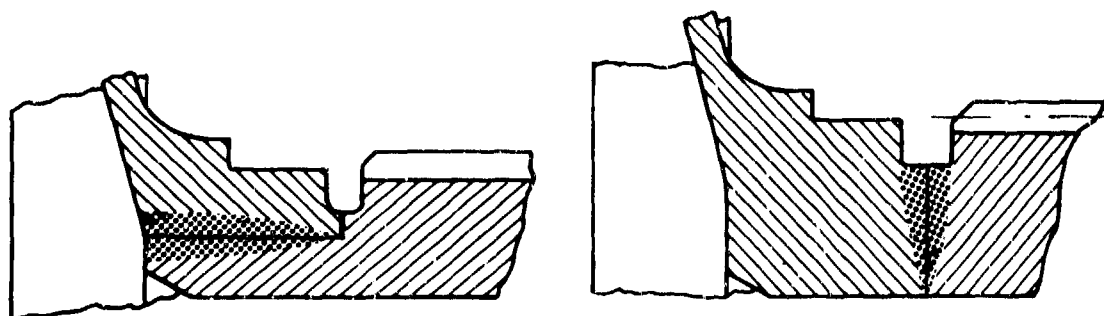
Figure A-7. Weld Configurations, First-Row Pinion.

The initial design of the first-row pinion was configured with a longitudinal weld to join the outer gears to the inner gear (Figure A-7). However, initial development testing resulted in fracture of the small diameter roller, and it became apparent that the weld was too deep for the constraints imposed. To increase the depth of weld penetration would induce too much heat and temper the case-hardened surface of the roller, thereby reducing the required  $R_c$  58-64 surface hardness. A butt-welded joint was designed which eliminated the problem.

The outer roller weld was modified to remove root weld porosity. This was accomplished by machining the root area of the weld similar to that accomplished on the sun gear.

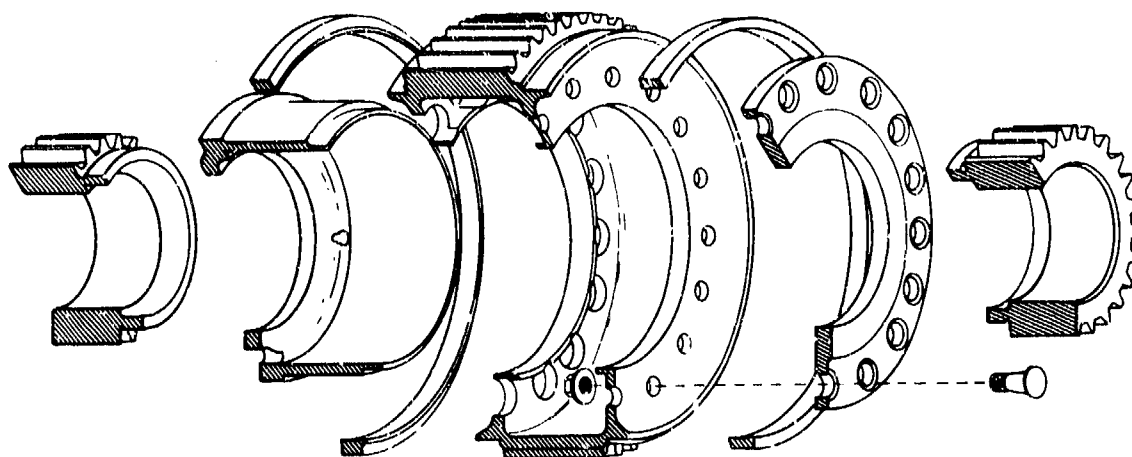
Figure A-9. Second-Row Pinion Initial Design, Exploded View.

The initial pinion design, shown in Figure A-9, consisted of an assembly of seven fabricated parts: two identical ex.3 gears, two rollers, a central shaft, a center gear, and an end flange bolted to the center gear web by taper-shank bolts. Fracture at the root of the weld between the central shaft and gear flange during bench testing, (8) necessitated the redesign of this gear.

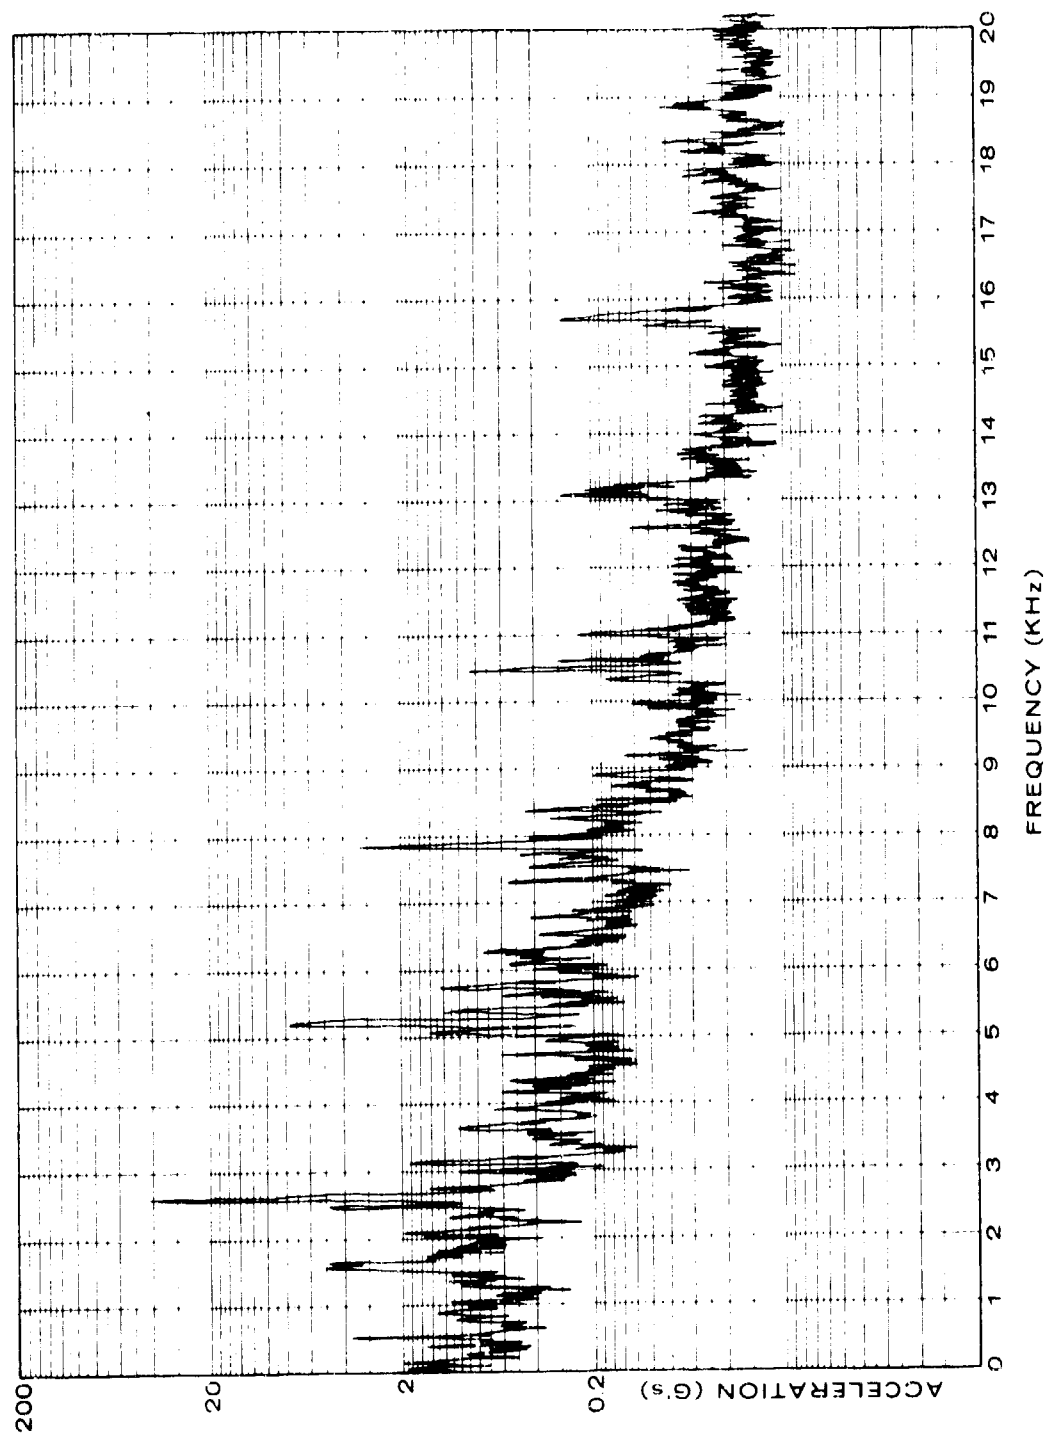
Figure C-14. Vibration Sweep, 10 Test Hours.

Evident in the first recording are  $\pm 130$  Hz sidebands at the first, second, third and fourth harmonics of the first-/second-row mesh frequencies. On the 260-hour recording, the sidebands at the third harmonic correspond to the speed of the sun gear, 67 Hz. It would appear that run-out of the sun gear and/or driveshaft is imparting additional dynamic loads on the gear teeth and, consequently, the bearings. The importance of this type of force has yet to be assessed, but, during the running of the R&M test, three quill shafts driving the upper roller gear unit fractured. Run-out of the sun gear could have been a contributory cause.

The sideband amplitudes are of a relatively low magnitude when compared to the gear clash frequency values. Sidebands generally indicate a discontinuity in the normally smooth sequential operation of gear teeth meshing. Thus, when the recordings were obtained, the roller gear units were operating satisfactorily.

The 50 g's peak amplitude at 2636 Hz remained constant throughout the test program. This acceleration corresponds to a displacement of the pinion of  $\pm 0.00003$  inch occurring at a velocity of .42 inch/second. These very low values attest to the smoothness of the roller gear unit.

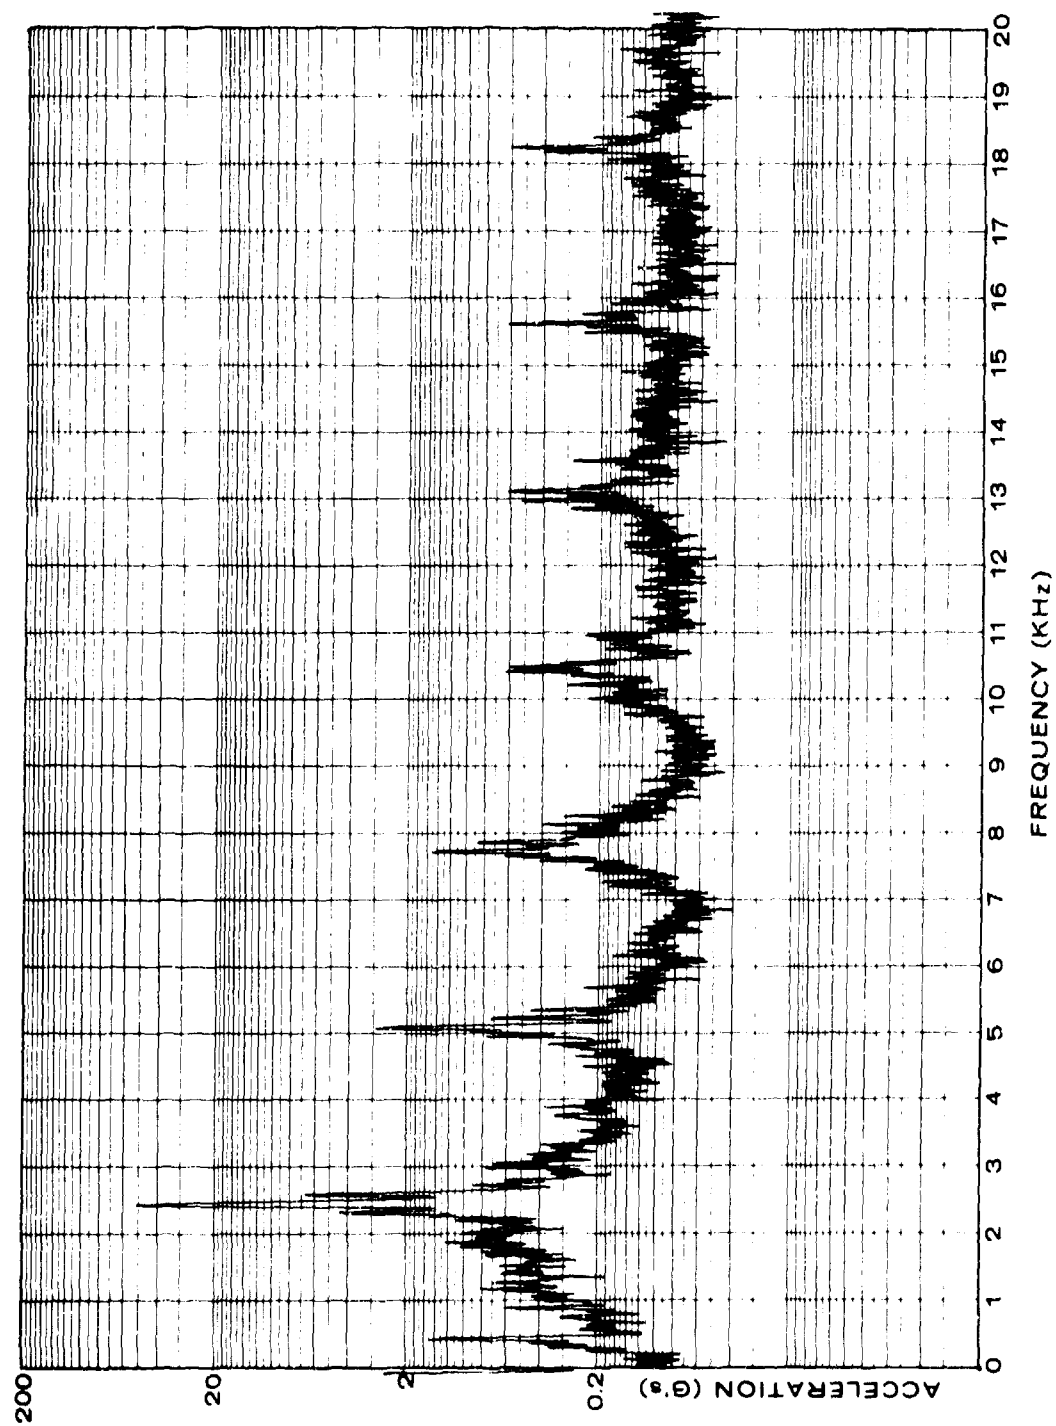
Figure C-15. Vibration Sweep, 260 Test Hours.

Comparison of the two frequency sweeps shows a smoothing out of the ring gear harmonics with time. This is normal to expect as the minor discrepant errors incurred during manufacture are worn away and the unit becomes "run in."
