title: REFLECTIVE FLOOR FINISHES FOR AIRCRAFT MAINTENANCE HANGARS

author: Robert L. Alumbaugh, Ph D, and David Gurganus

date: May 1977

CIVIL ENGINEERING LABORATORY

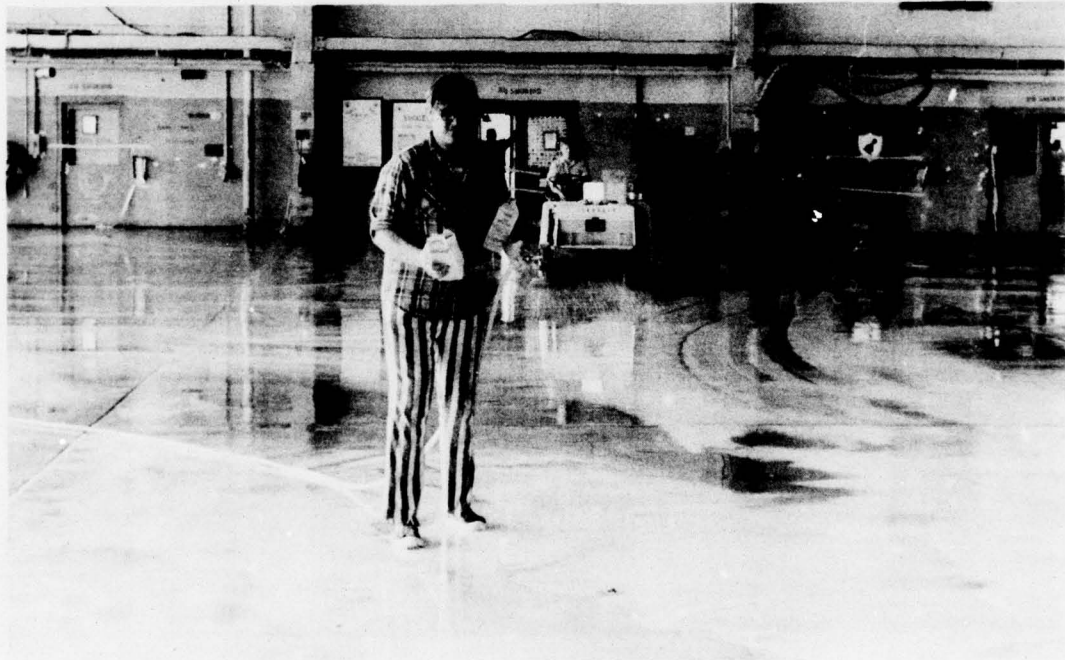
Figure 3. Application of water and industrial grease remover to hangar deck.

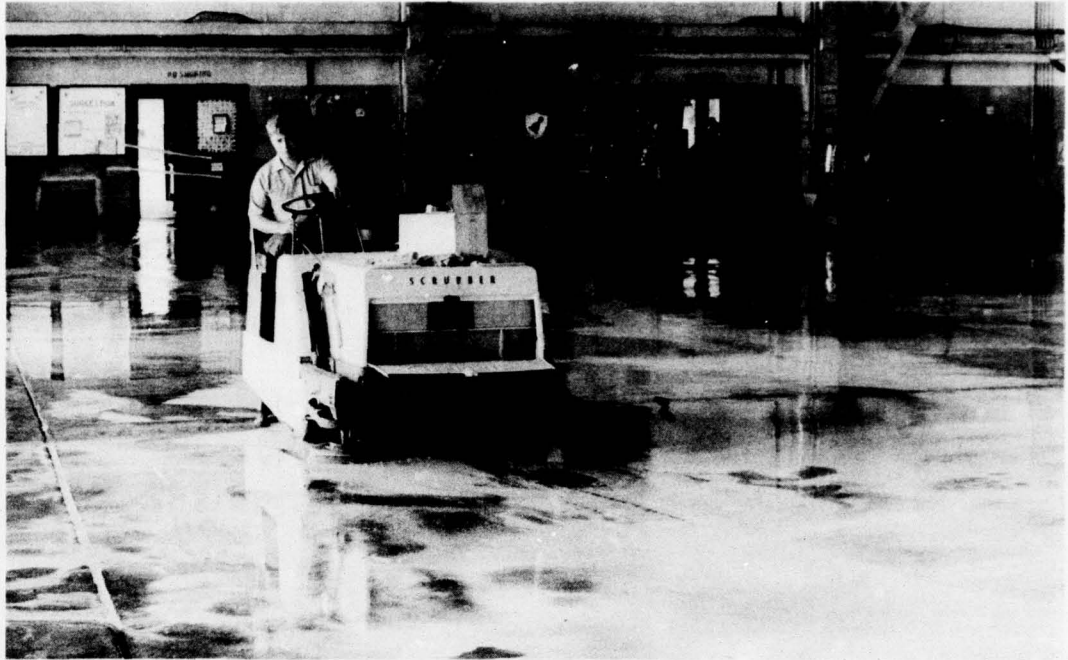
Figure 4. Hangar deck thoroughly scrubbed during the grease removal phase.

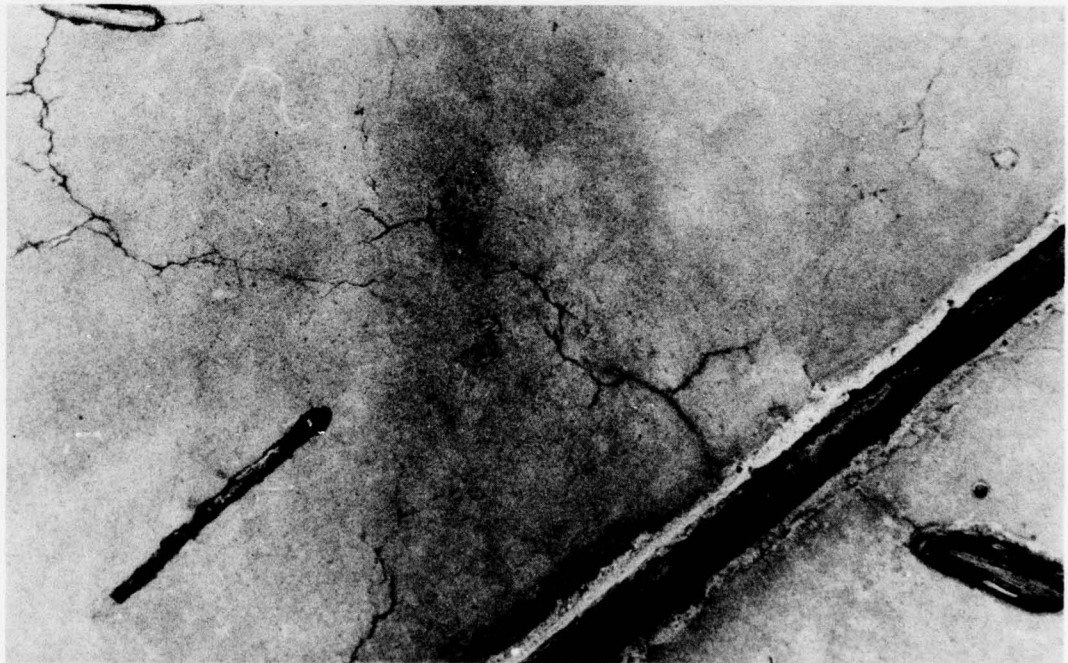
The following morning, the deck appeared to be dry and, for a 16-year old, previously oil-soaked deck, appeared to be exceptionally clean (Figure 5). The deck was given a final power brooming and was ready to be primed.

Figure 5. Condition of cleaned deck ready for priming.

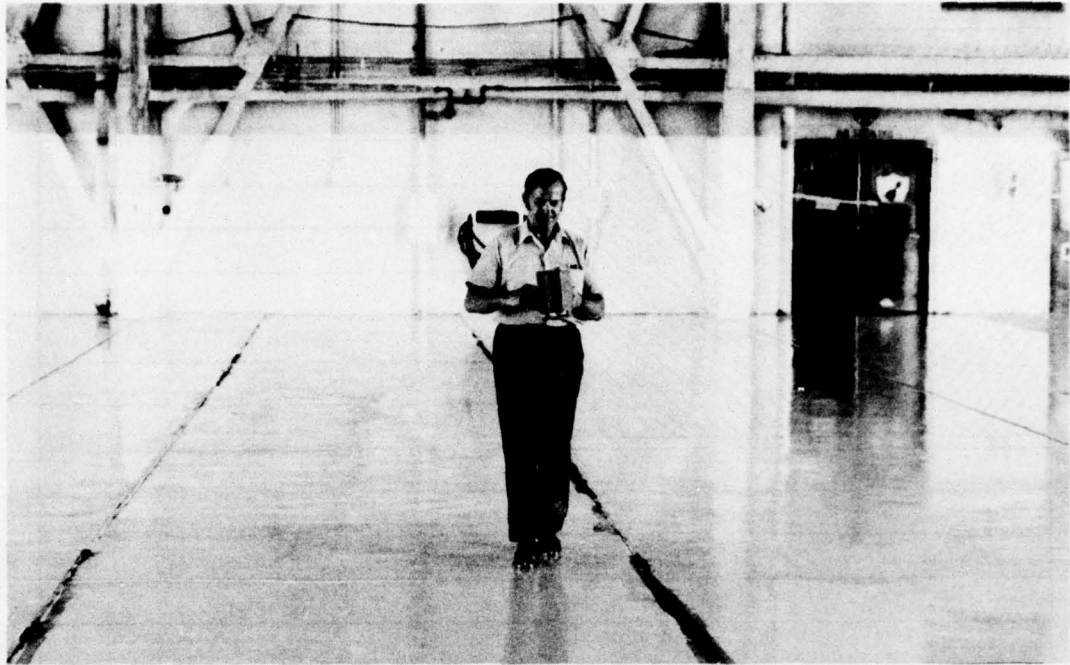
Figure 7. Applicator wearing golf shoes broadcasts grit into first wet finish coat using a grass seeder.

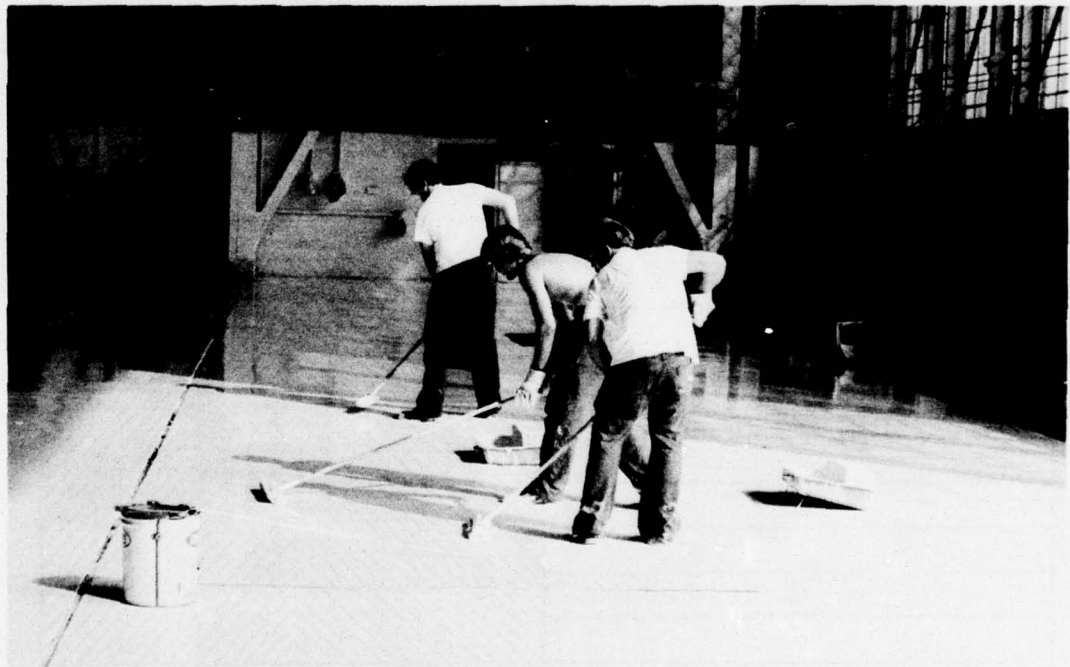
As soon as the primer was dry (in approximately 2 to 3 hours), the first finish coat of TT-C-542, thinned one to one with the manufacturer's recommended thinner, was applied by lamb's wool applicators (see Figure 8). While the first finish coat was still wet, grit was again broadcast onto the deck. However, at the suggestion of the Naval Safety Center, grit was sprinkled onto only one-half of the area of System A. Since urethane coatings have an inherent slip resistance, the grit was omitted from half of the area to determine if it was actually required for nonskid purposes (see Figure 6 for location).

Figure 8. Application of System A with lamb's wool applicators.

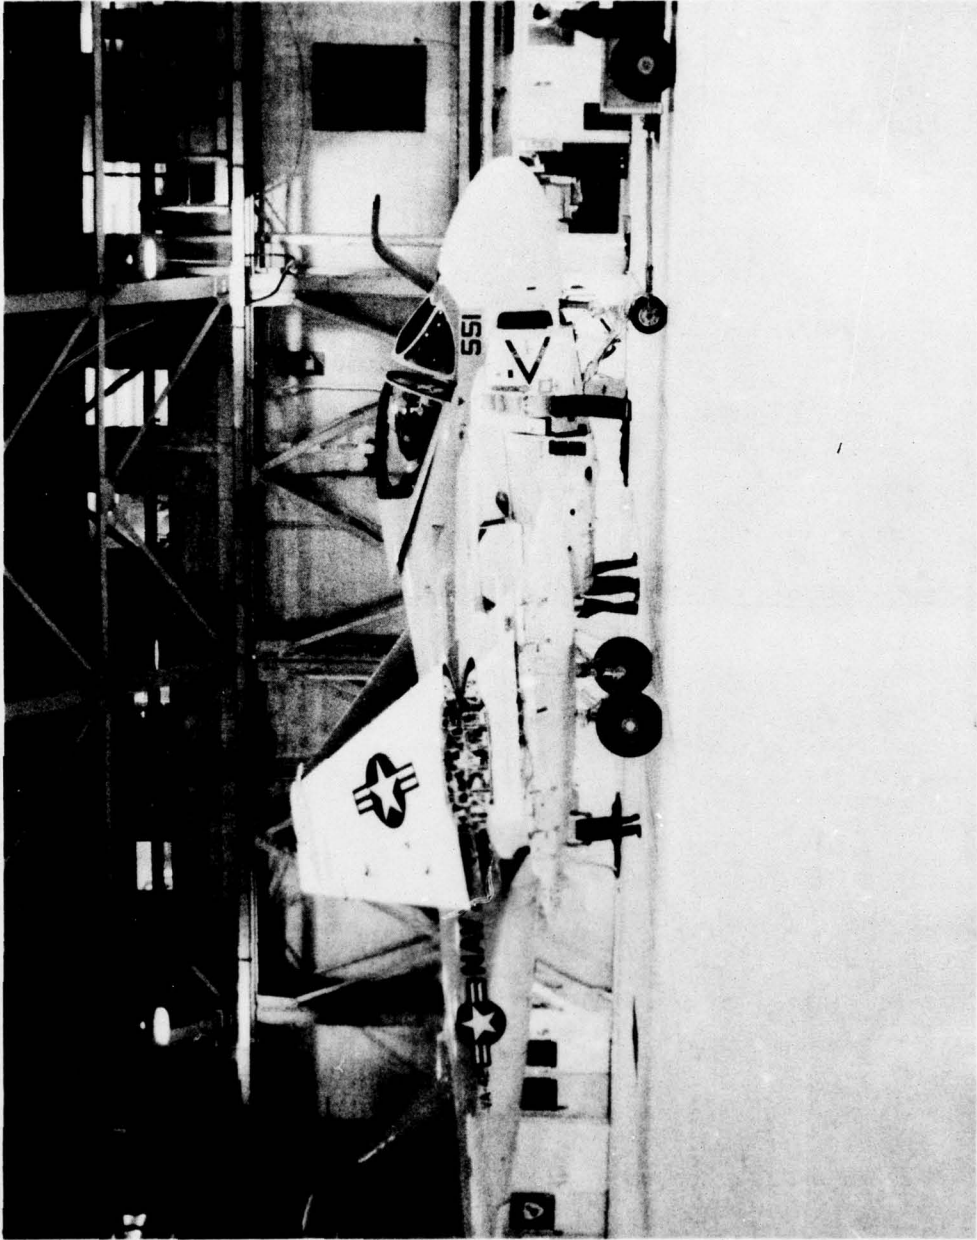
Figure 12. Reflective finish coated hangar completed except for line markings.
