USAAMRDL-TR -77-9

INVESTIGATION OF FACTORS CONTROLLING ENGINE SCHEDULED OVERHAUL - T53/T55

Avco Lycoming Engine Group
Stratford Division
Stratford, Conn. 06497

May 1977

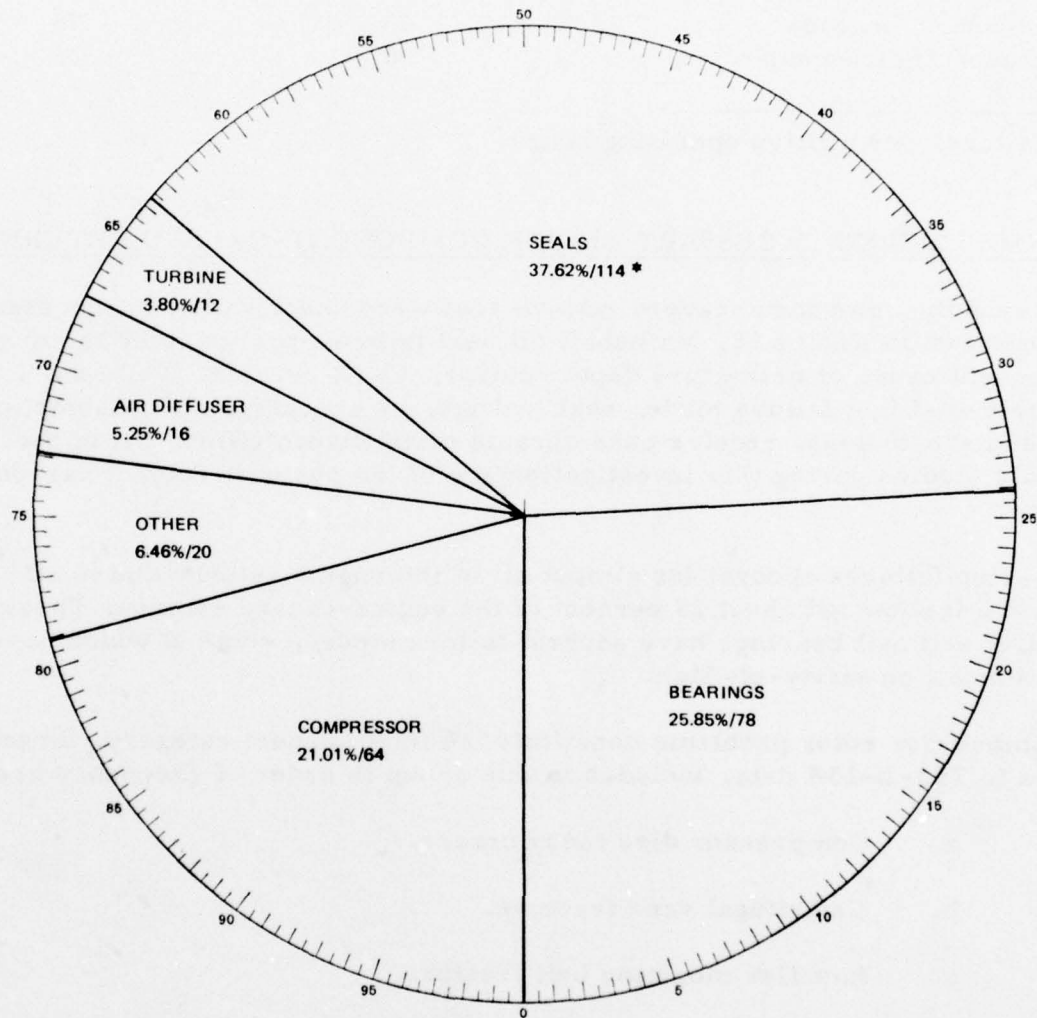
Figure 18. Composite Engine - Engine-Caused Returns

The engine component-caused returns that were unscheduled but necessary are shown in Figure 18. Mainshaft oil seal failures proved to be the most frequent cause of premature depot returns, 37.62 percent. While not a safety-of-flight failure mode, seal leakage, or excessive oil consumption does nevertheless, require considerable maintenance effort. All of the seals studied during this investigation are of the positive-contact carbon-type.

The "other" category, shown in Figure 18, represent a group of engine returns (approximately 6 percent or about 20 per million operating hours) that are returned for various engine problems; but either the reason could not be confirmed or the records were incomplete, and they could not be properly classified.

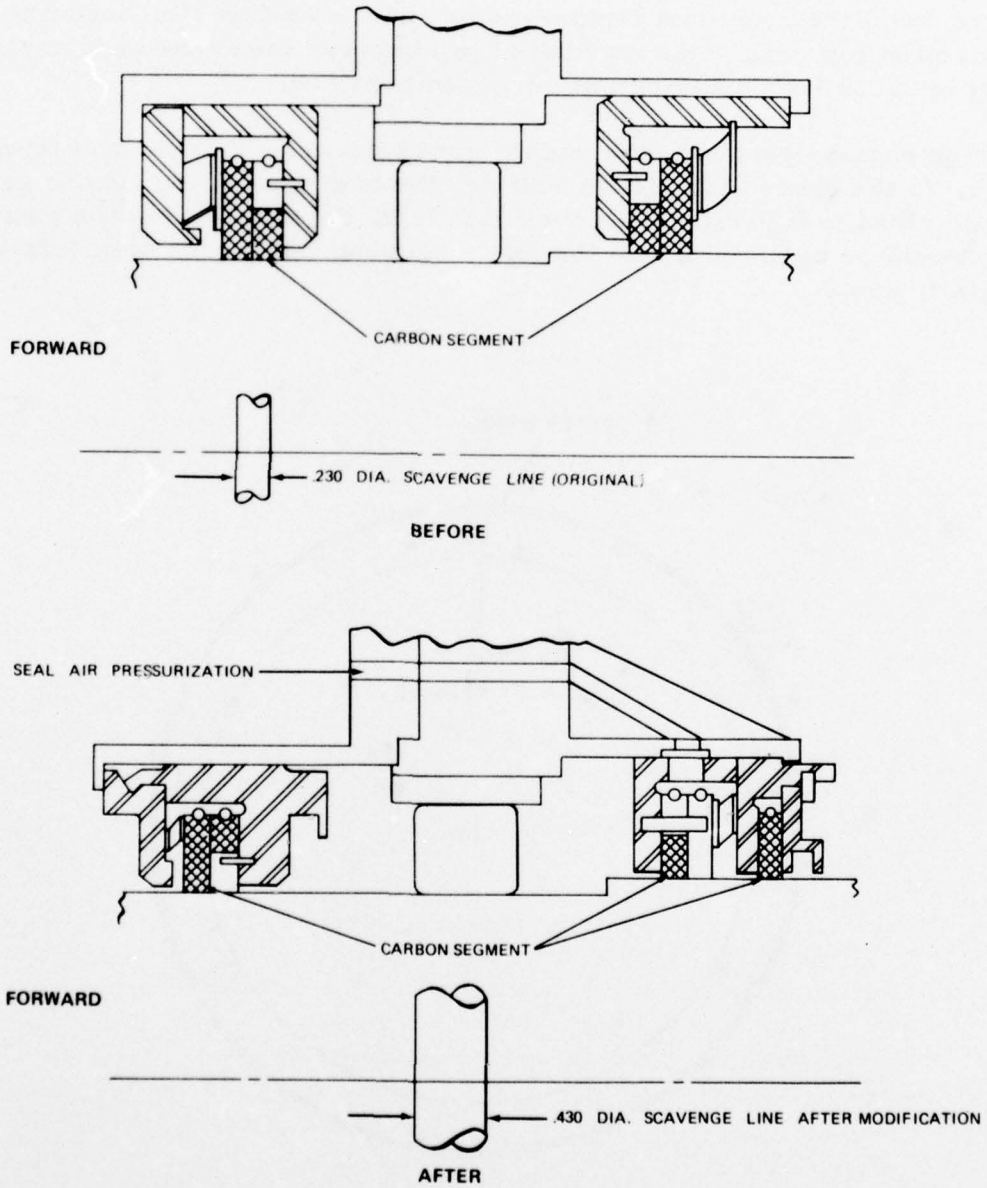
Figure 22. T53-L-13 Number 2 Bearing Package Schematic

The original Number 2 bearing package (Figure 22) in the T53-L-13 experienced a high-speed oil leakage problem because of a pressure differential across the package. This pressure differential of 10 psi across the bearing cavity caused oil to leak out of the forward seal. The problem was solved by connecting the forward air cavity to the center of the aft seal, creating a zero-pressure differential across the cavity. An oil leakage problem remained at low speeds due to insufficient air-to-oil pressure differential. This was eliminated by increasing the scavenge

line cross-sectional area from 0.230 to 0.430 inch diameter as shown in Figure 22. Increased oil scavenging reduced the bearing cavity pressure, which increased the air-to-oil pressure differential.

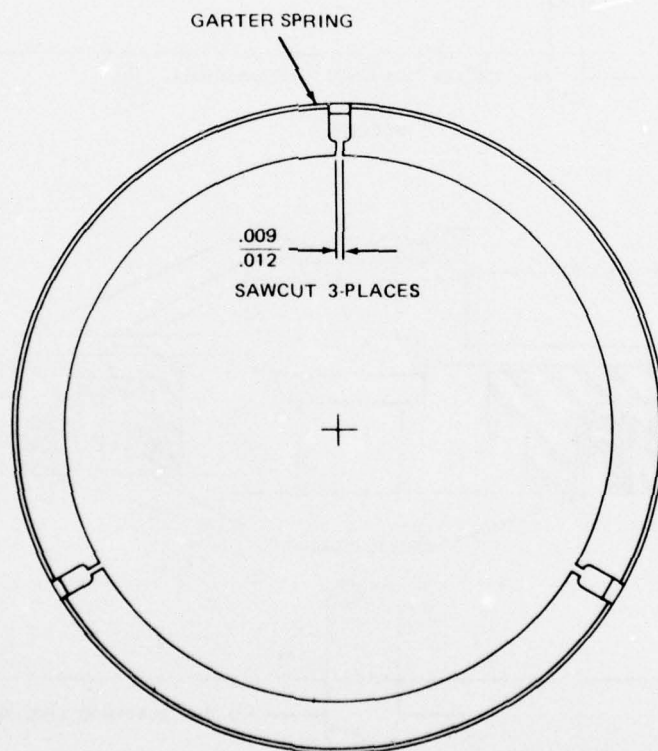
Figure 23. Number 2 Seal for Improved Scavenging Airflow Sawcut Seal Design

The sawcut seal design (Figure 23) is a positive-contact, single carbon ring cut into three equal segments for sealing. Three sawcuts or joints are from 0.0009 to 0.012 inch wide when installed on the runner. The total orifice area was 0.0001 square inch.

When the bore of the carbon sealing segments wears in the sawcut seal design, the sawcuts close. As the bore of the segments wears, the sawcuts close completely at room temperature, and the carbon ring becomes a controlled gap seal. This controlled gap between the runner and carbon ring is 0.005 inch maximum at room temperature.

During engine operation, the runner grows because of speed and temperature. At the ground idle power setting, the average carbon runner gap would close to 0.002 inch. Above flight idle, the average carbon runner gap would be negligible, and the joints between the carbon elements would begin to open.

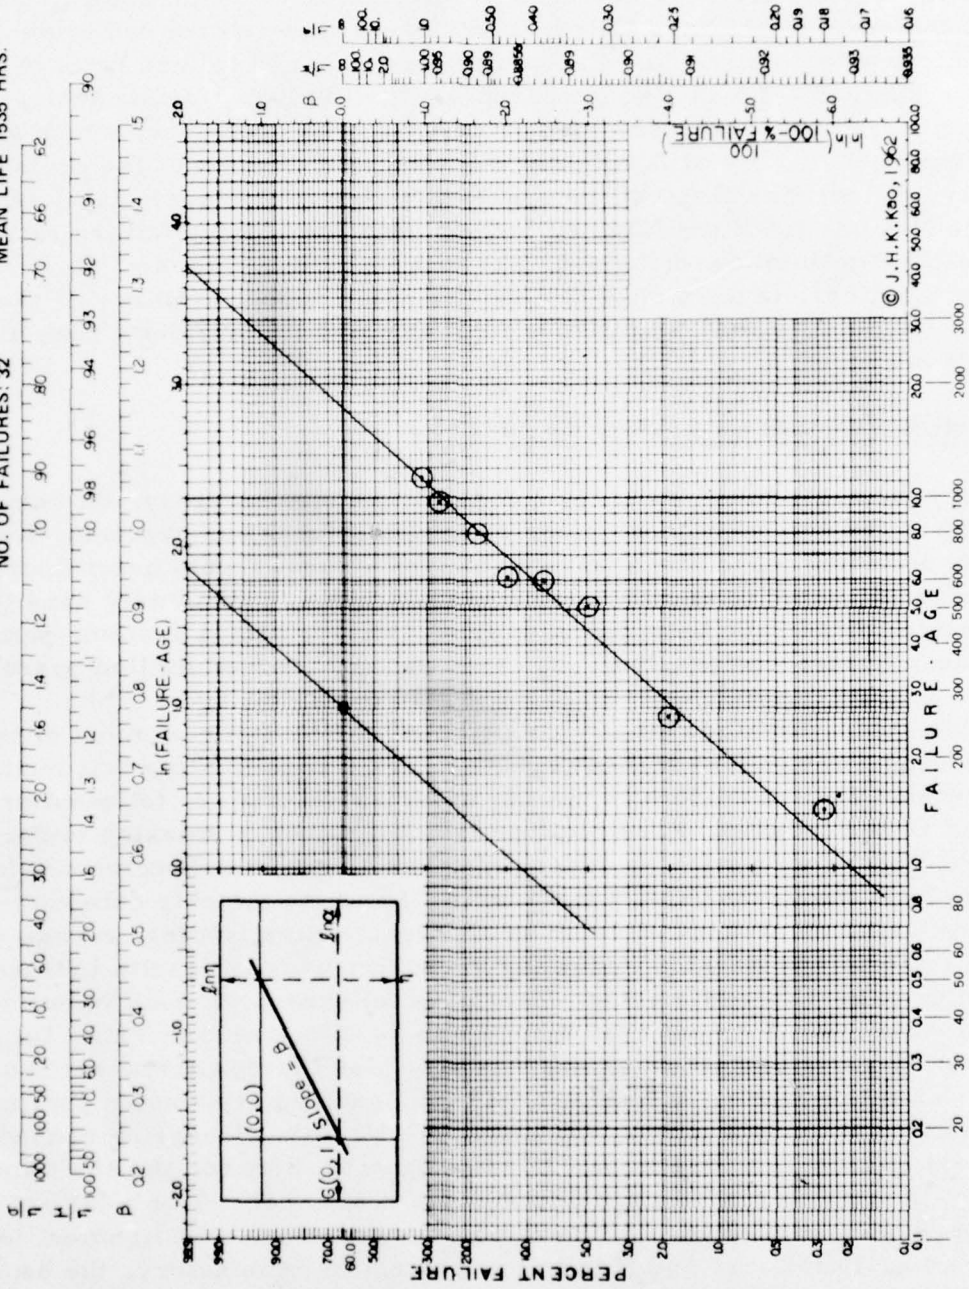
Figure 26. Weibull Plot - Number 2 Forward Seal

A Weibull plot (Figure 26) was made for the Number 2 forward seal from a sample of 300 engine returns, including 32 seal leakage events. A characteristic life of 1,748 hours was established, at which point 63 percent of the seals would have failed. The slope β was determined to be 2.16, indicating a positive correlation between time and failure rate. A Weibull plot (Figure 27) was also prepared for the Number 1 seal. Again, 300 engine returns were used with 20 seal failures occurring, which gives a characteristic life of 2,980 hours at which 63 percent of the seals would have failed. The slope of the regression line in this case was 1.60. Both the Number 1 and the Number 2 seals show increasing failure rates with respect to time; nevertheless, wearout was not the prime failure mechanism. Rather, buildup of coke deposits with respect to time was the most likely cause, accumulating to a point at which the segment froze and leakage occurred.

ENG. MOD. T53-L-13A $\beta = 2.16$
 SPECIMEN SIZE: 300 $\theta = 1748$ HRS.
 TIME PERIOD: 2/69 - 12/70 % FAILED AT MEAN 53.7
 NO. OF FAILURES: 32 MEAN LIFE 1535 HRS.

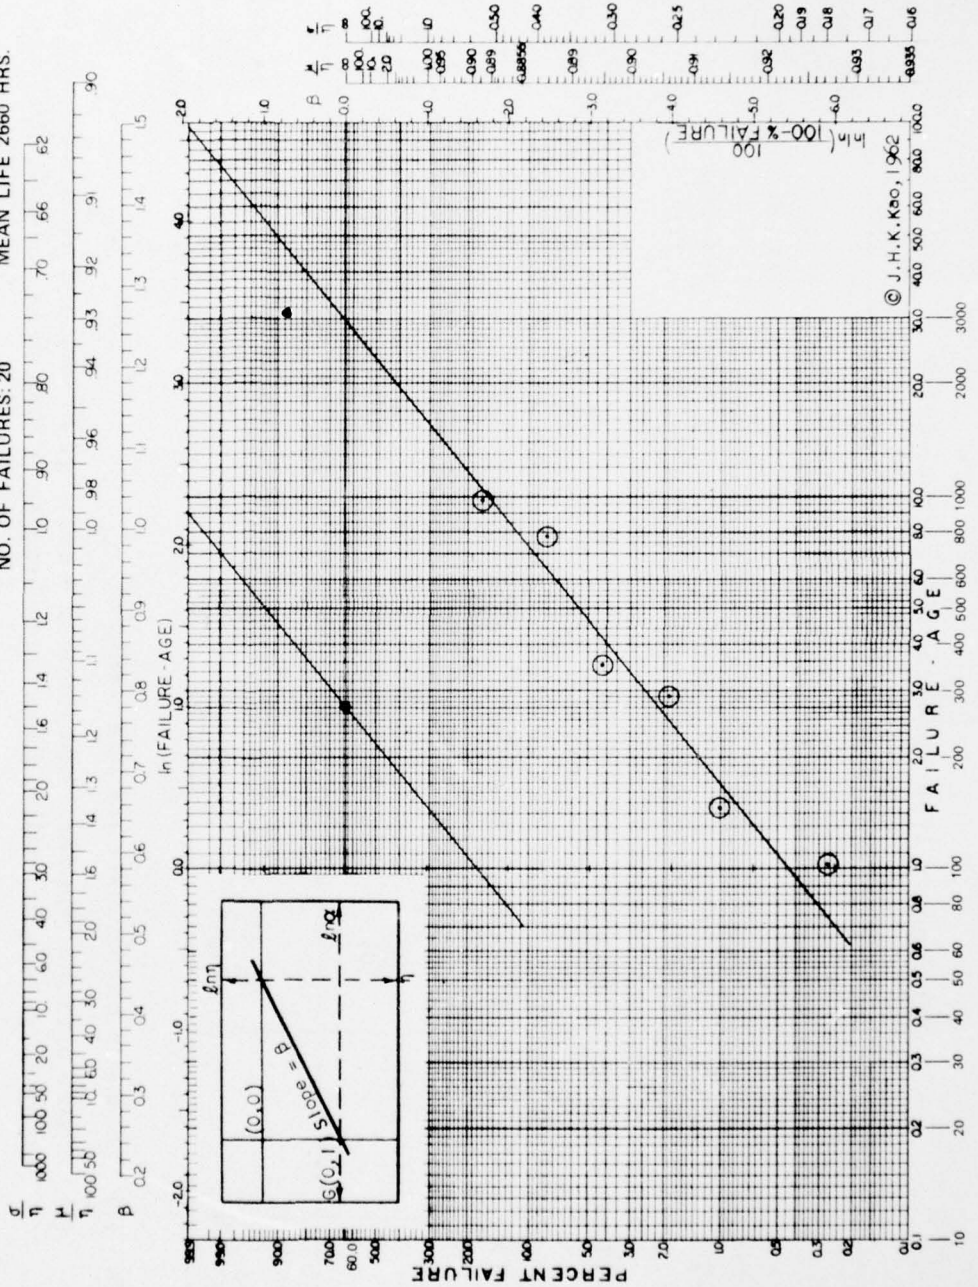
Figure 27. Weibull Plot - Number 1 Seal

ENG. MOD. T53-L-13A $\beta = 1.60$
 SPECIMEN SIZE: 300 $\theta = 2980$ HRS.
 TIME PERIOD: 2/69 - 12/70 % FAILED AT MEAN 57.0
 NO. OF FAILURES: 20 MEAN LIFE 2660 HRS.

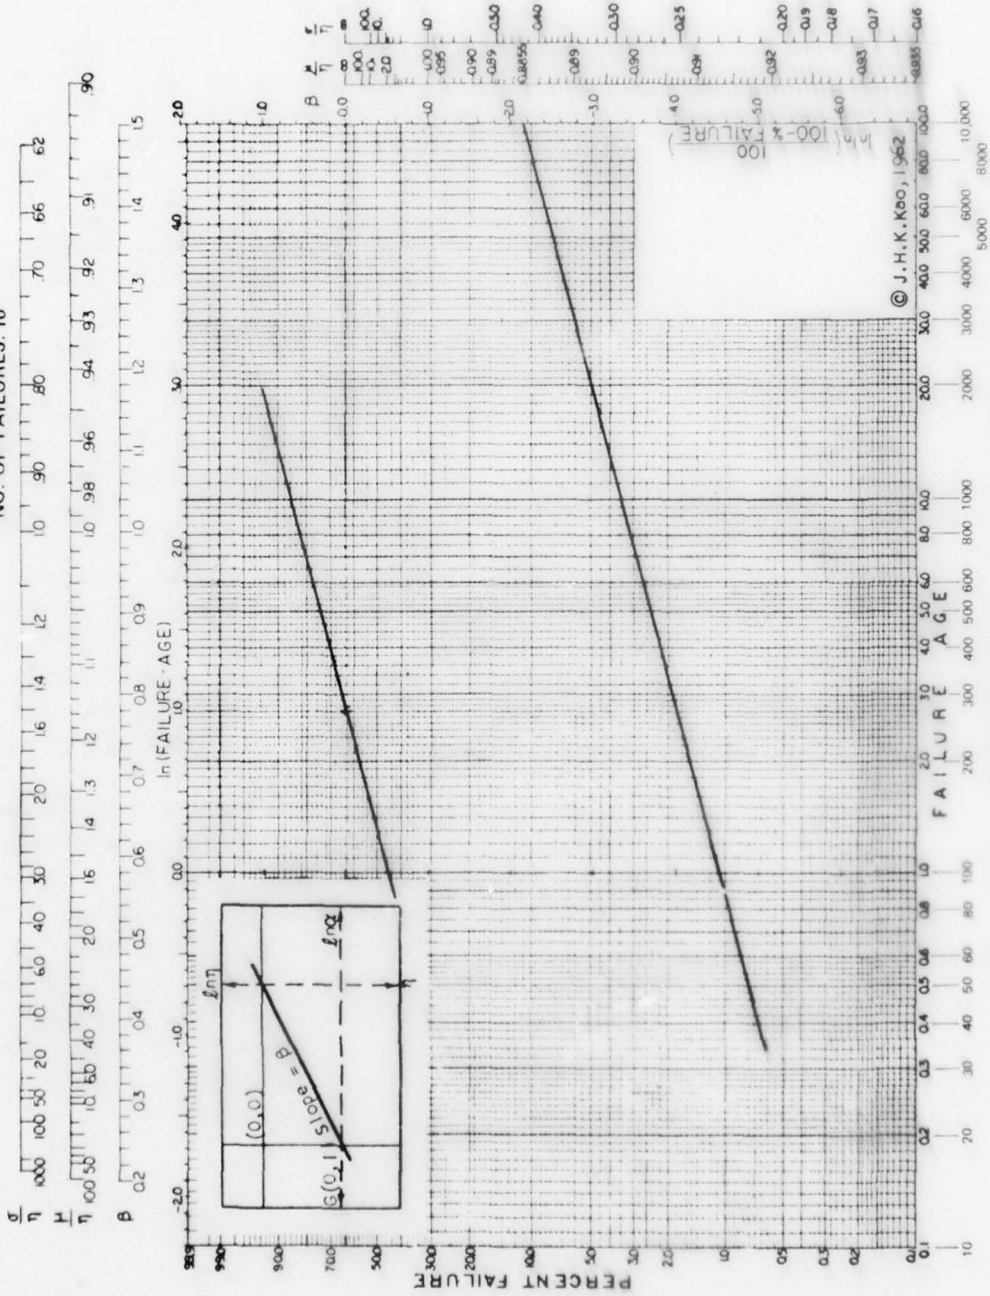
Figure 28. Weibull Plot - Number 21 Bearing

ENG. MOD. T53-L-13A $\beta = 49$
 SPECIMEN SIZE: 300 $\theta = 636,508$ HRS.
 TIME PERIOD: 2/69 - 12/70
 NO. OF FAILURES: 10

Number 21 Bearing - The problems observed in this position resulted from forced roller skewing. In particular, the function of the bearing is to support the power turbine shaft at a forward engine position. During operation, the bearing position shares support of the shaft with the power turbine bearing assembly and the power shaft power-transmitting sun gear. This redundancy in support gives rise to misalignments at the Number 21 bearing location, and consequently to forced roller skewing. The roller skewing problems were manifested as retainer breakage in the T53-L-11 and roller end wear in the T53-L-13 engine. The retainer breakage problem was resolved on the T53-L-11 by strengthening the retainer design. The T53-L-13 roller end wear problem was virtually eliminated by incorporating improved controls in the skew restraint.

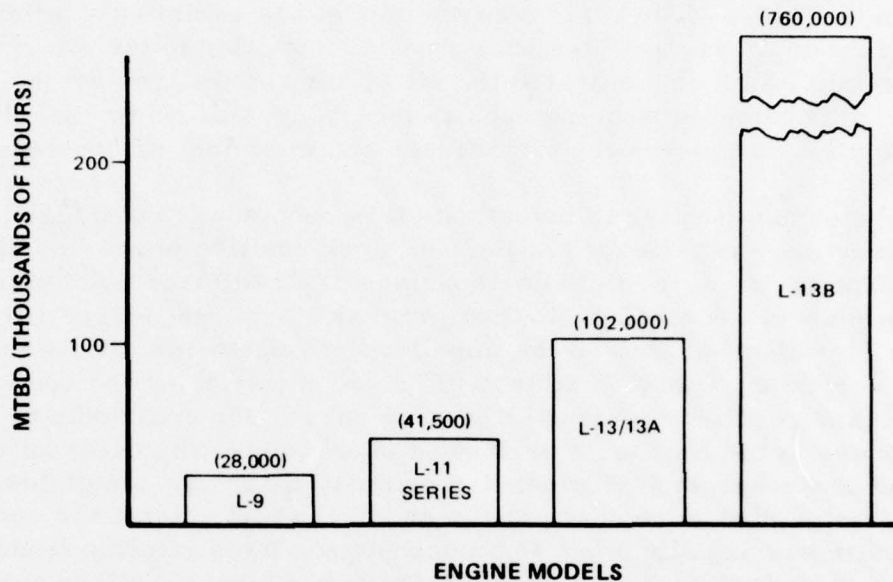
Figure 29. MTBD for T53 Number 2 Bearing Cage Failures

Also contributing to the increased bearing reliability were changes made to the Number 2 bearing package which increased the oil scavenge flow for the T53-L-13 engines. The following tabulation shows the effect of these changes on the mean-time-between-bearing cage-failures. Figure 29 shows the improvement in mean-time-between-depot (MTBD), due to the reduction in bearing cage failures, for the T53-L-9, L-11, L-13/13A/13B engines.

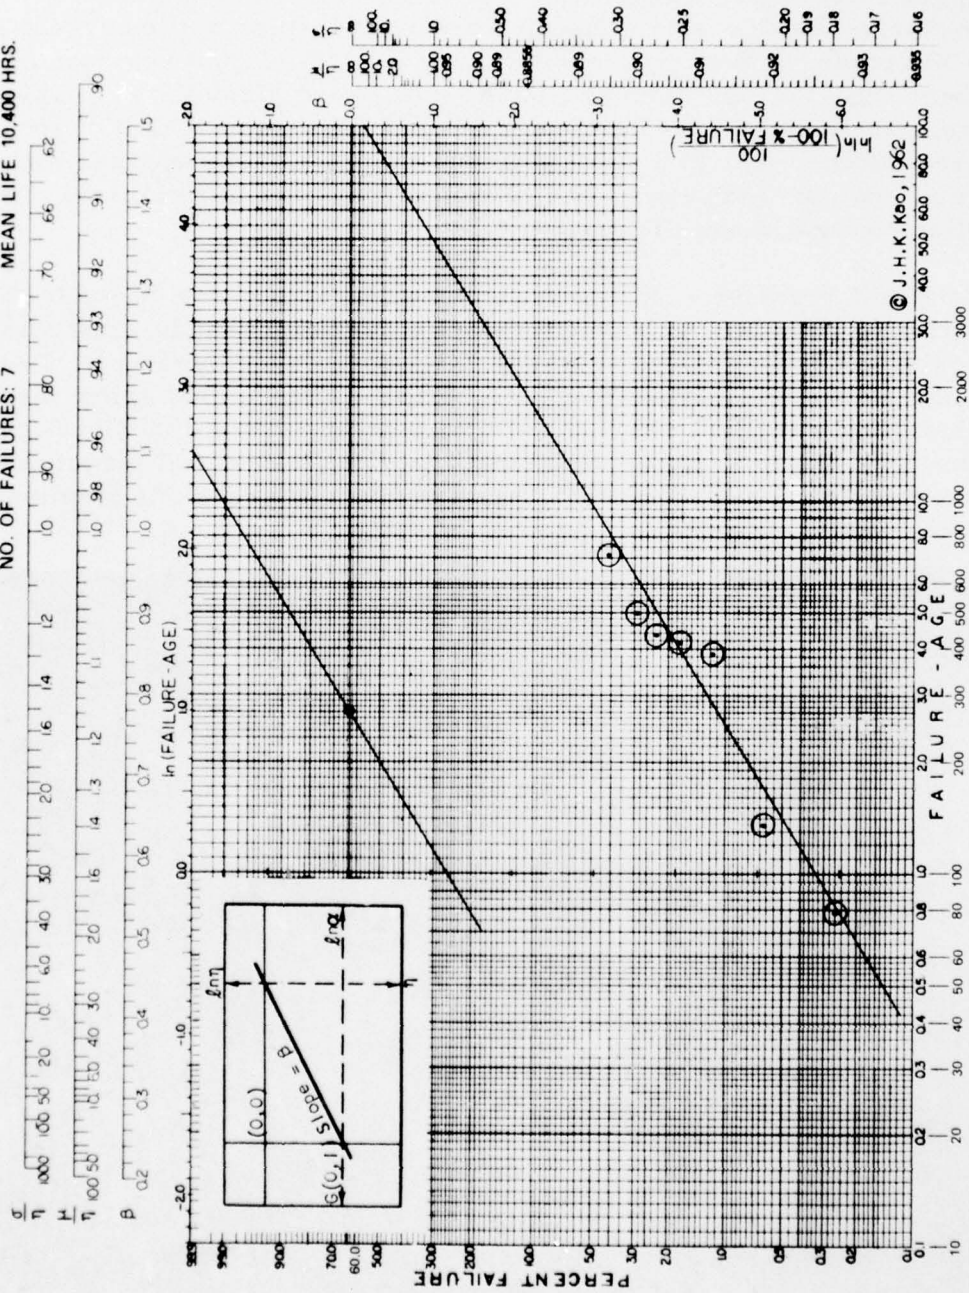
Figure 35. Weibull Plot of Compressor Fourth-Stage Aluminum Disc

Figures 30 through 34 show the compressor rotor with the damaged fourth-stage disc together with surface fracture in the tenon area. Figure 35, a Weibull plot of the fourth-stage disc failures, indicates a slope of 1.20 or an increasing failure rate with respect to time.

ENG. MOD. T53-L-13A $\beta = 1.20$
 SPECIMEN SIZE: 300 $\theta = 11,066$ HRS.
 TIME PERIOD: 2/69 - 12/70 % FAILED AT MEAN 60.5
 NO. OF FAILURES: 7 MEAN LIFE 10,400 HRS.

The T53-L-13/13A field experience had shown that the second-generation type of gas turbine engine needed a stronger, more durable type of compressor rotor disc arrangement. Hence the titanium compressor discs were further developed and became the main feature of the current T53-L-13B engine. The change from aluminum to titanium discs resulted in a design strength improvement from 47,200 psi to 113,000 psi at operating temperatures. The T53-L-13A engine experienced an MTBD of 16,000 hours with the aluminum discs whereas the T53-L-13B engine, with titanium compressor discs (one-piece design), has accumulated over 3.8 million hours without a failure.

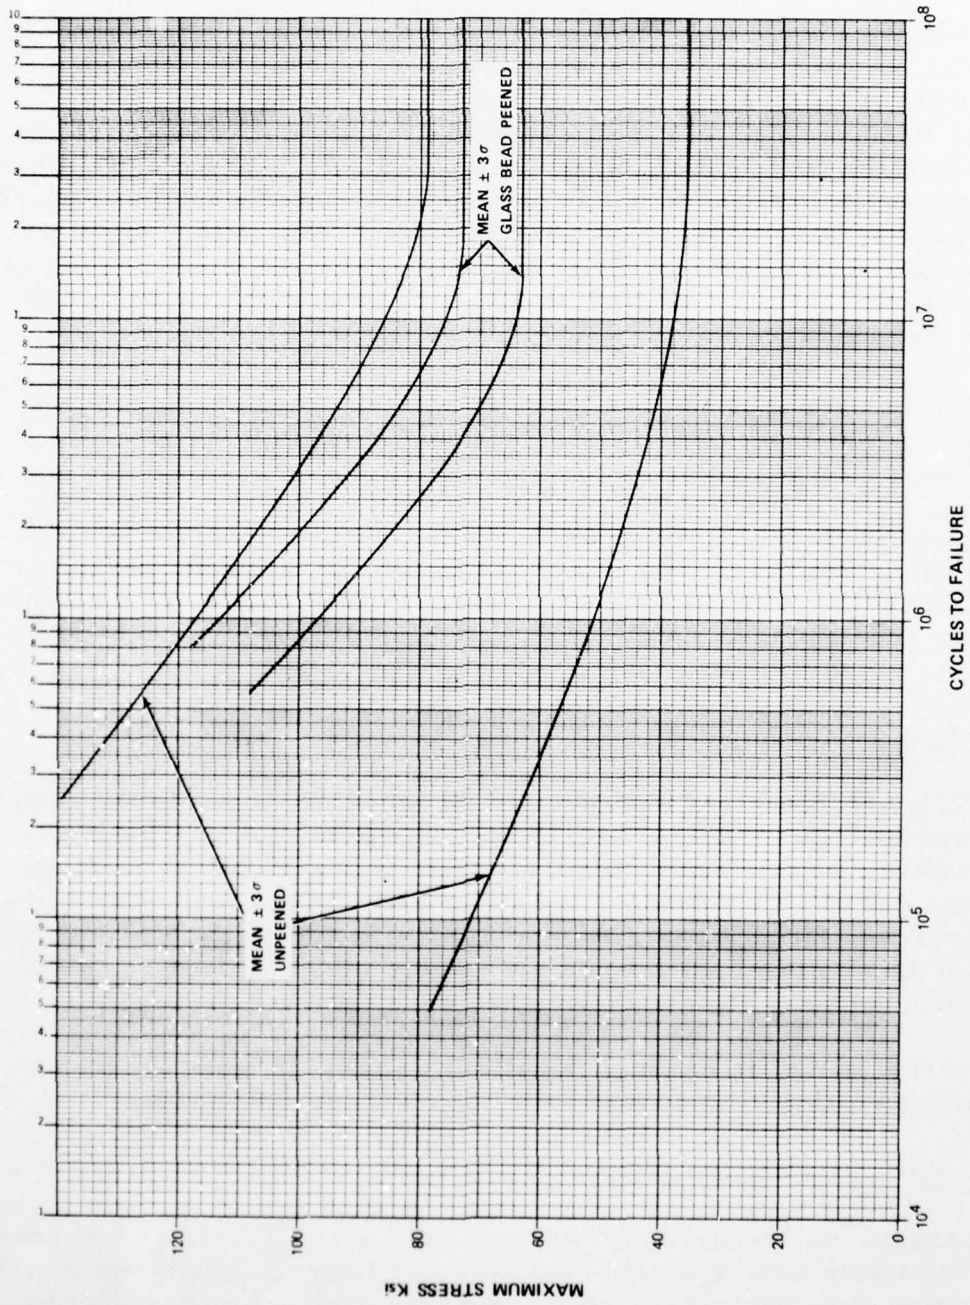
Figure 37. Centrifugal Compressor Fatigue Life

Centrifugal Impeller - During 1971, vane fracture of the T53-L-13B centrifugal impeller became a problem. The failure mode constituted cracking and/or complete breakout of a vane section by fatigue. Fracture origin was observed at approximately vane midspan, just above the fillet radius, at the concave surface of the vane (see Figure 36). Crack propagation took place along the vane length in both fore and aft directions. When complete section breakout was experienced, cracking terminated at the vane outer edge.

thickness and glass-bead shot-peening was approved. Because of the long lead time required for castings, shot-peened thin-vane impellers were incorporated into the overhaul system in February 1972, and thick vane impellers were introduced into the system in May 1972. Figure 37 shows the improved fatigue life with glass-bead shot peening.

Although there were over 360 engines with vane fractures reported on the original thin-vaned impeller, there have been only five shot-peened thin-vaned impeller fractures reported and there have been no failures reported on the thick-vane impeller.

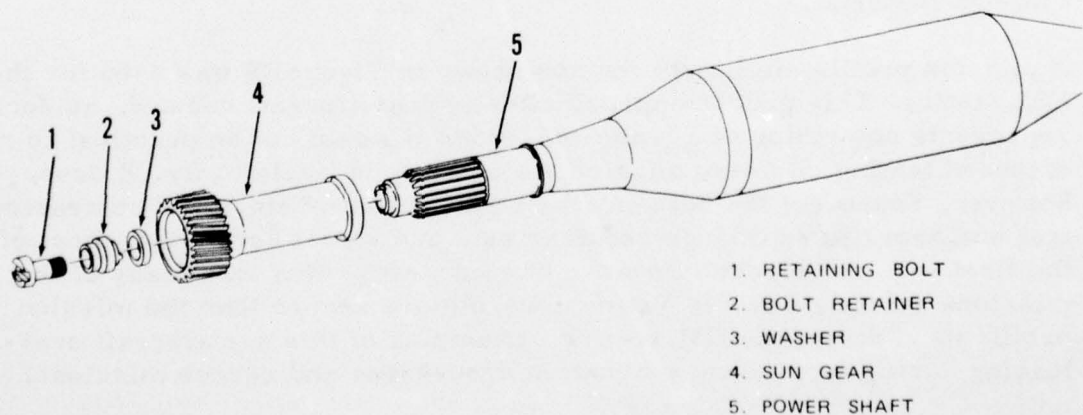
Figure 38. Sun Gear Retaining Bolt and Power Shaft Installation

Sun Gear Retaining Bolt and Washer - The planetary gear system used in the T53 reduction gear train incorporates a sun gear splined to the power shaft (see Figure 38). The sun gear is retained by a combination of spherical bolt and washer. If worn, this bolt and washer will allow the sun gear to move axially, thereby causing internal spline wear between the sun gear and the power shaft. Wear of the bolt and retainer was caused by inadequate lubrication and, to some degree, by mismatch between the two spherical surfaces. A revised lubrication system was incorporated by adding oil lubrication holes in the bolt and a nylon washer that replaced the previous bronze washer. Since incorporation of these changes, the sun gear spline wear problems have been eliminated.

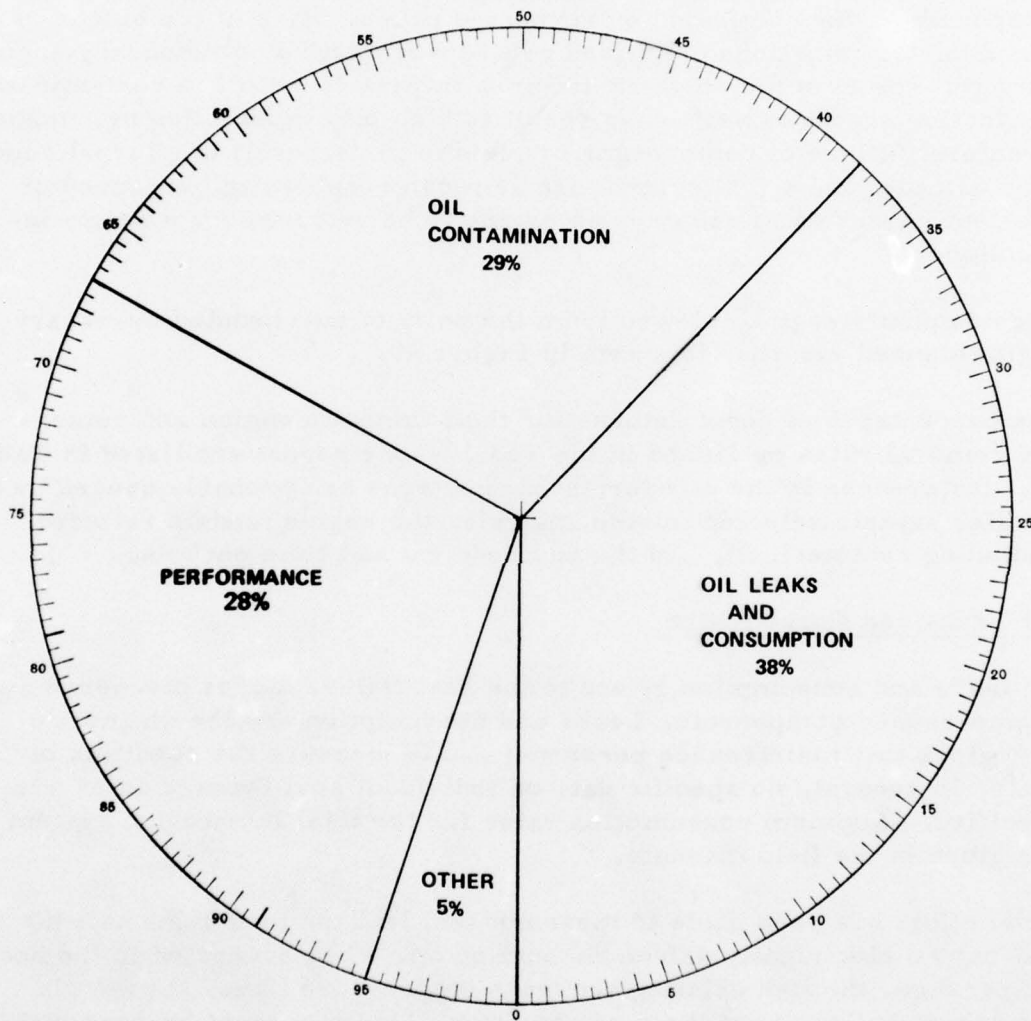
Figure 40. Composite Unscheduled, Necessary Engine-Caused Symptomatic Inspection Returns

The composite engine, viewed from the point of unscheduled necessary engine-caused returns, is shown in Figure 40.

Oil contamination is caused by metal particles in the lubricating oil system and is usually the result of abnormal wear on an oil-wetted component. In the case of the engines reviewed in this study, the component affected the most was the bearings, although gears and spline wear did account for a few returns. It is generally recognized that the Spectrometric Oil

- (2) Blades
 - (3) Bearing cages.
5. An average of 29 percent of engine-caused returns to depot were for oil contamination by metallic particles. In most cases it was not apparent in the field, what caused the contamination or if field maintenance could have been performed to correct the problem (see Figure 40).

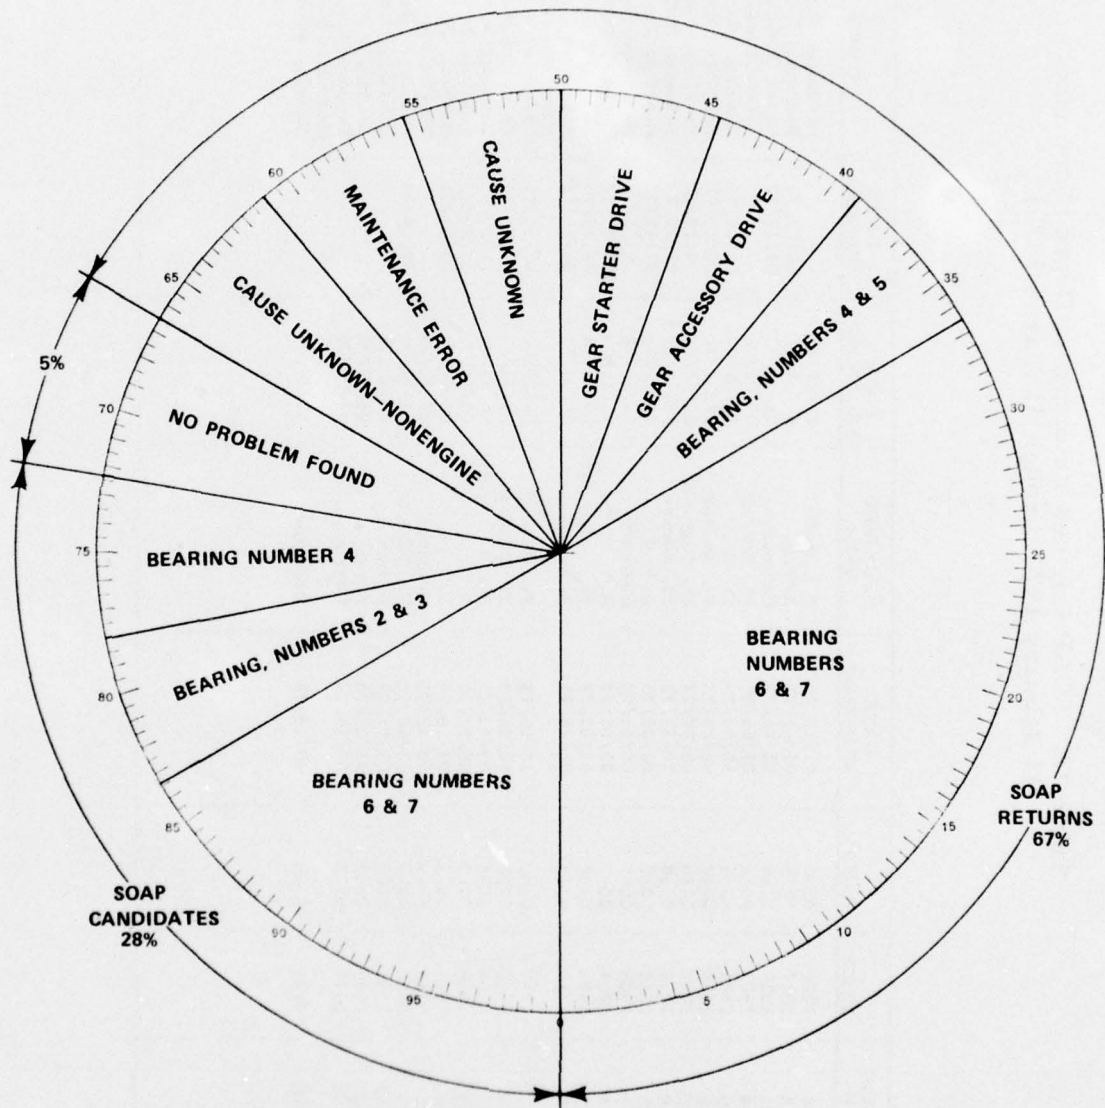
Figure 41. SOAP Returns or Candidates - Causes Found, T55 Engines (1 April 1975 through 31 December 1975)

Since 1 January 1972, 51 T55 engines were removed from aircraft for depot returns as a result of SOAP (see Table 12). All of these engines have been analyzed at the Corpus Christi Army Depot (CCAD), as of 31 March 1975. Beginning 1 April 1975, Lycoming Reliability/Maintainability (R&M) overhaul personnel, who were on site, began identifying those engines considered to be SOAP candidates. An engine is classified as a SOAP candidate when teardown analysis at the depot reveals any discrepancy that should have been detected through SOAP oil analysis, even though the engine was not reported as being returned to the depot because of SOAP. For the nine months ending 31 December 1975, 18 T55 engines shipped to the depot were SOAP returns or candidates. Figure 41 illustrates the component causes found on these 18 engines.

- a. The SOAP Program has shown itself to be 67 percent effective in identifying actual problem engines in the field (see Figure 41).
- b. 28 percent of the engines that SOAP should have identified in the field were returned to overhaul depot for other reasons (see Figure 41).
- c. 89 percent of those engines returned to depot for exceeding SOAP limits were found to have oil system discrepancies which justified their return to depot (see Figure 42).

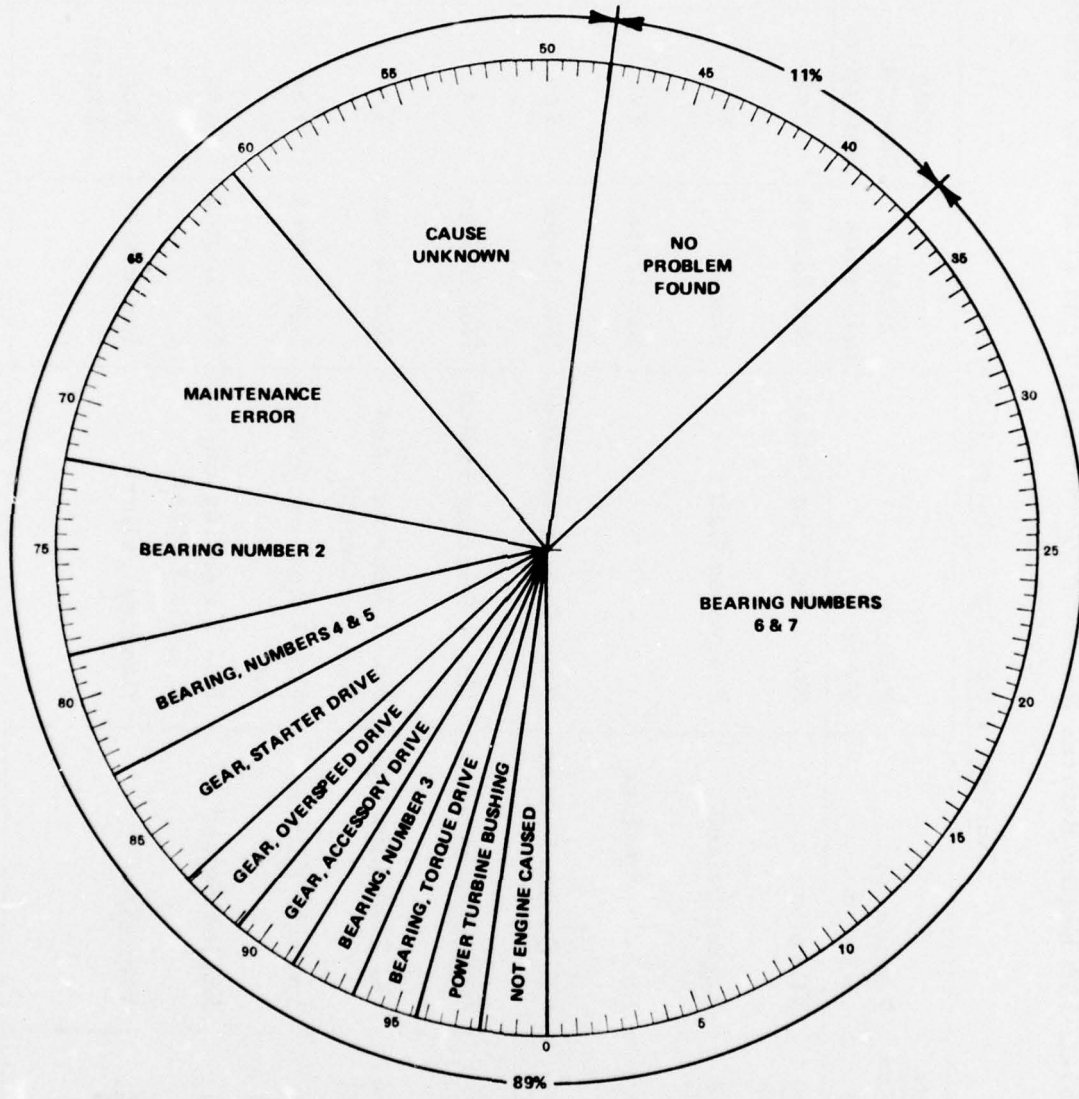
Figure 42. SOAP Engine Returns - Causes Found
 (1 January 1972 Through 31 March 1976)

Table 13 identifies those five engines that were classified as SOAP candidates. Figure 42 graphically portrays the causes found by onsite R&M personnel for these same 51 SOAP engines. Figure 42 shows that over 49 percent of all returns analyzed were the result of main shaft and Numbers 6 and 7 bearing failures. The data shown in Table 12 indicates that bearings were the most common problem, particularly rotation of the Numbers 6 and 7 bearing race. As discussed earlier, this duplex bearing supports the output shaft. This bearing's outer race is allowed to move axially to accommodate the differential thermal growth of the engine and power shaft.
