INVESTIGATION OF SLUMPING FAILURE IN AN EARTH DAM ABUTMENT AT KOTZEBUE, ALASKA

Charles M. Collins and Terry T. McFadden

July 1977

Prepared for
U.S. PUBLIC HEALTH SERVICE
By
CORPS OF ENGINEERS, U.S. ARMY
COLD REGIONS RESEARCH AND ENGINEERING LABORATORY
HANOVER, NEW HAMPSHIRE

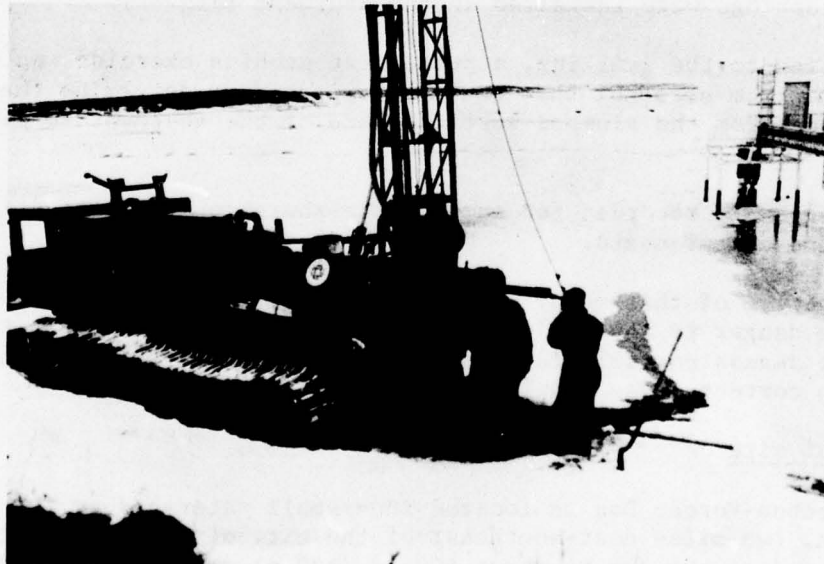
In May 1976 authorization to proceed with the study was given. An emergency contract was immediately issued to Jim Thrasher and Associates for the drilling of four thermocouple probe holes. The drill rig was

Figure 1. Drill rig on the ice behind the dam.

placed on the ice behind the dam and holes were sunk into the upstream base of the dam (Fig. 1). Later in the summer, seven additional holes and thermocouple strings were installed in the abutment (Fig. 2).

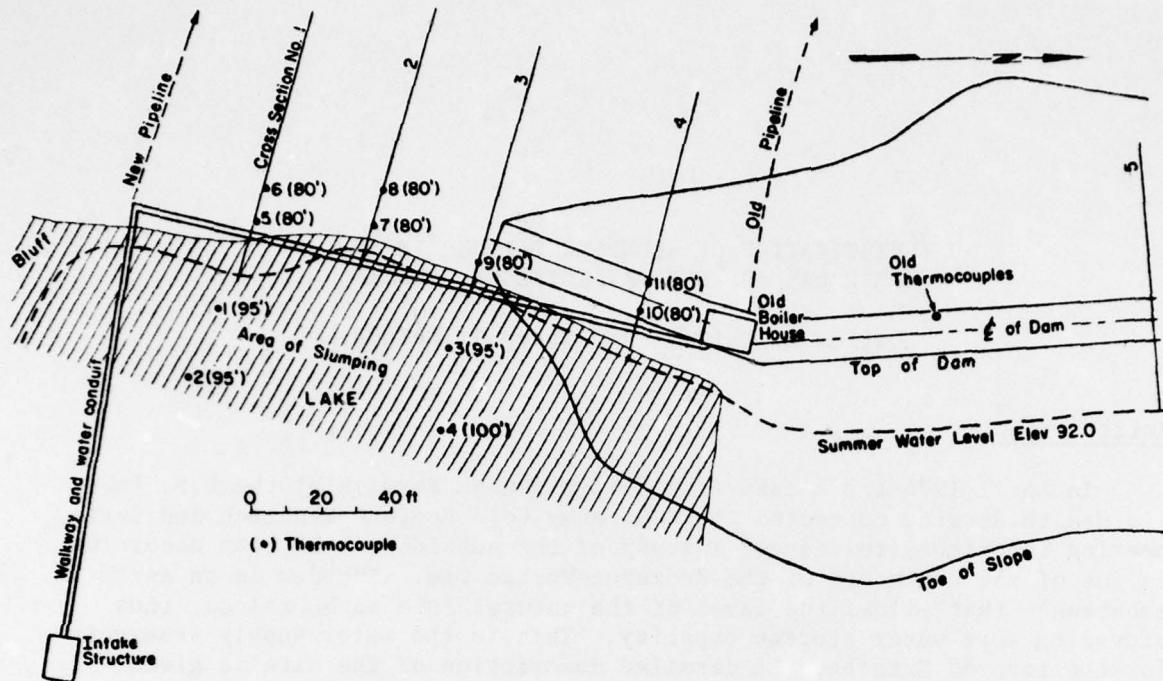
Figure 2: Location of drill holes with thermocouple assemblies and cross sections, Vortac Dam, Kotzebue, Alaska.

Slumping and collapse are occurring along the steep bank facing the water from approximately the boiler plant to the southern end of the dam where it joins the bluffs (Fig. 2). Slumping from these bluffs is also visible along the southwest side of the lake (Fig. 5).

In August 1976, Jim Thrasher and Associates drilled seven 80-ft holes (Fig. 6) on the dam crest adjacent to and through the southern abutment (Fig. 2, holes 5-11). Thermocouple assemblies were installed with thermocouples at 10-ft (3-m) intervals to a depth of 80 ft (24 m).

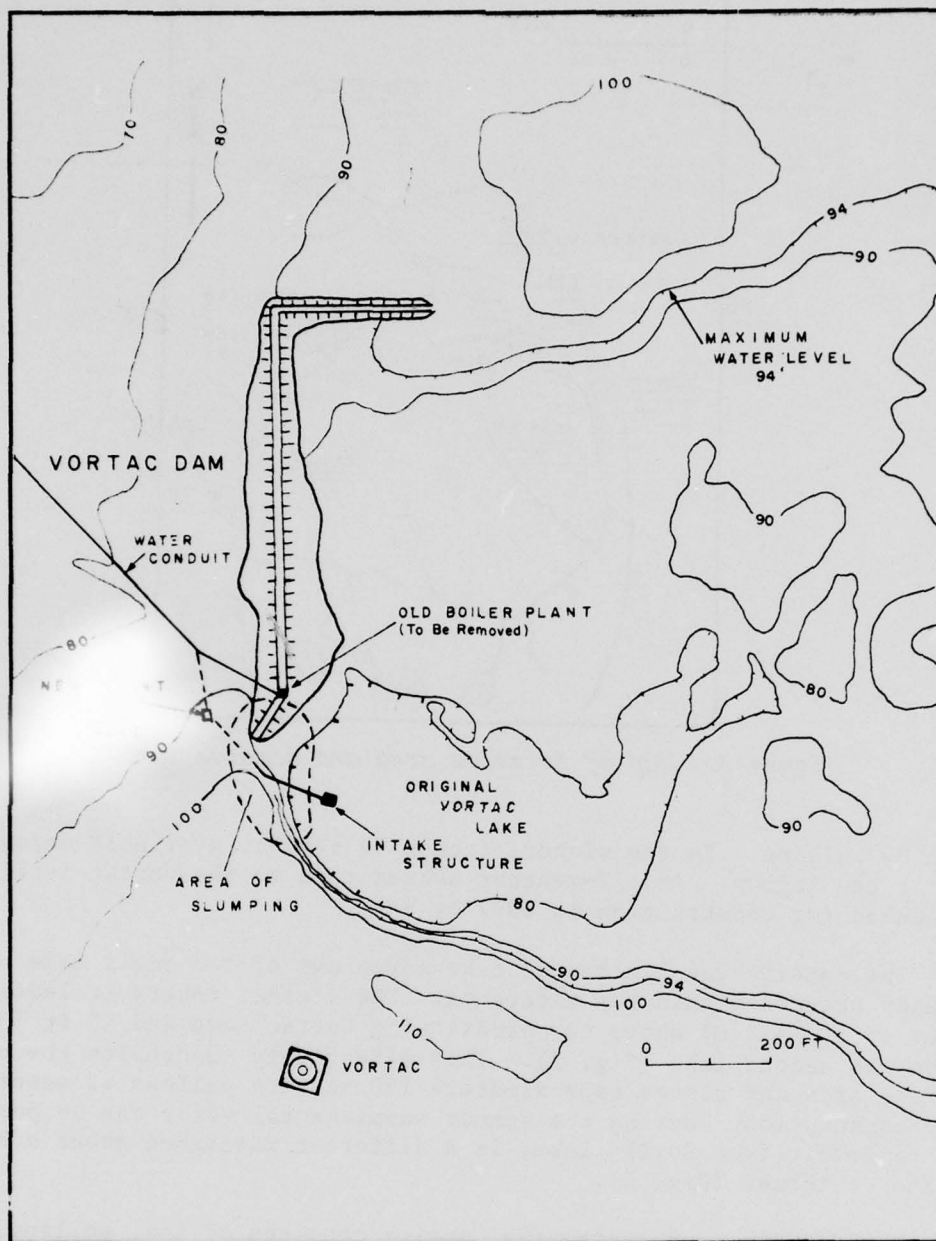
Figure 4. Enlarged map of damsite.

north-northeast. This portion of the dam is adjacent to the slope failure. At the old boiler plant the dam makes a dogleg and runs almost due north for 650 ft (198.3 m) before it makes a second turn to the east and runs for another 250 ft (76.3 m) (Fig. 4). The maximum height of reservoir water surface is within 2 ft (0.6 m) of the crest of the dam when the lake is full in the fall.

A water intake structure is located in the lake, near the south end of the dam, about 100 ft (30 m) from shore. A walkway and water conduit extends from this structure to the dam abutment at the southern end. The conduit originally ran along the crest of the dam to a boiler plant [a 12-by 16-ft (3.7- by 4.9-m) wood frame structure located at the first turn in the dam, 70 ft (21.3 m) from the south end]. From the boiler plant, the conduit ran west down the face of the dam toward the town. In the fall of 1976 a new, larger-capacity boiler plant was constructed off the dam, toward the southwest, eliminating two 90° turns of the conduit and removing the conduit and the boiler plant from the crest of the dam (Fig. 4).

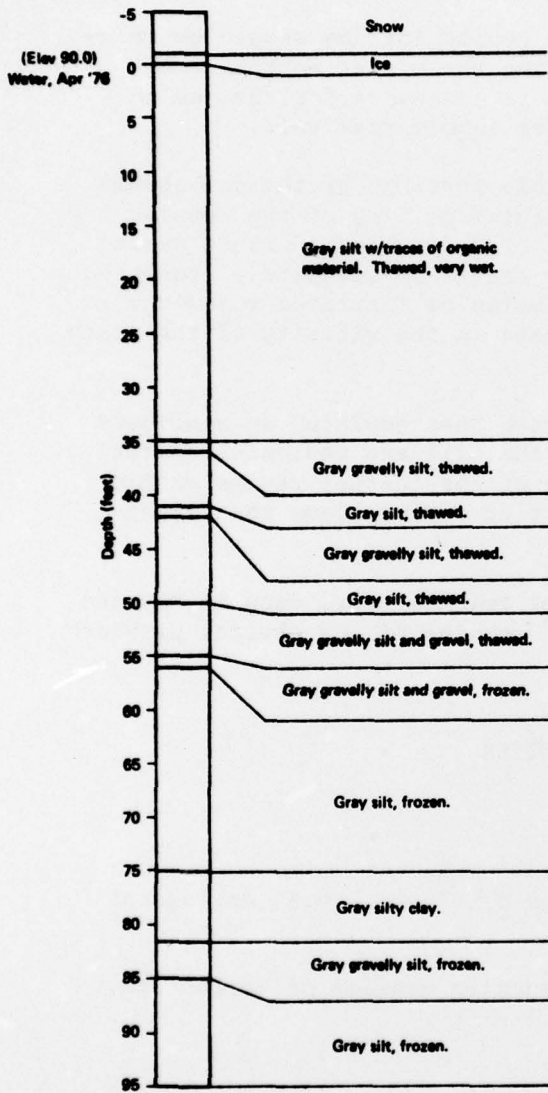
Figure A1. Drill log for hole no. 1.

In April 1976, Jim Thrasher and Associates, under contract with CRREL, drilled four holes through the ice on the upstream face of the dam and abutment face near the south end (Fig. 2, holes 1-4). The drill logs of these holes are shown in Figures A1-A4 (App. A). Thermocouple assemblies were installed in each hole with thermocouples at 47, 63, 79, 87 and 95 ft below the reservoir bottom. The purpose of the drilling was to determine the location of any thaw bulb that might exist under the lake and to determine if the thaw bulb extended below or into the dam. The enlargement of this thaw bulb due to reservoir filling could account for the slumping at the southern abutment.

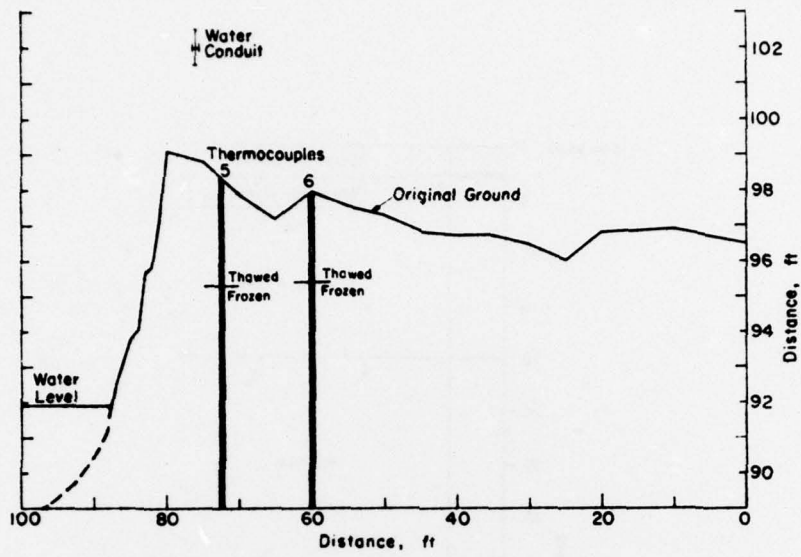
Figure B1. Cross section no. 1.

Five cross sections were made across the dam (see Fig. 2 for locations). Figures B1-B5 (App. B) show these cross sections. The cross section shown in Figure B2 gives the location of permafrost probings which were made in the near vertical upstream bank of the dam abutment and shows the zone of thawed material.
