# PULSED PLASMA PROPULSION TECHNOLOGY

FINAL REPORT FOR PERIOD 10 MARCH 1972 - 30 MAY 1977

AUTHORS: DOMINIC J. PALUMBO  
WILLIAM J. GUMAN

FAIRCHILD INDUSTRIES, INC.  
FAIRCHILD REPUBLIC COMPANY  
FARMINGDALE, N.Y. 11735

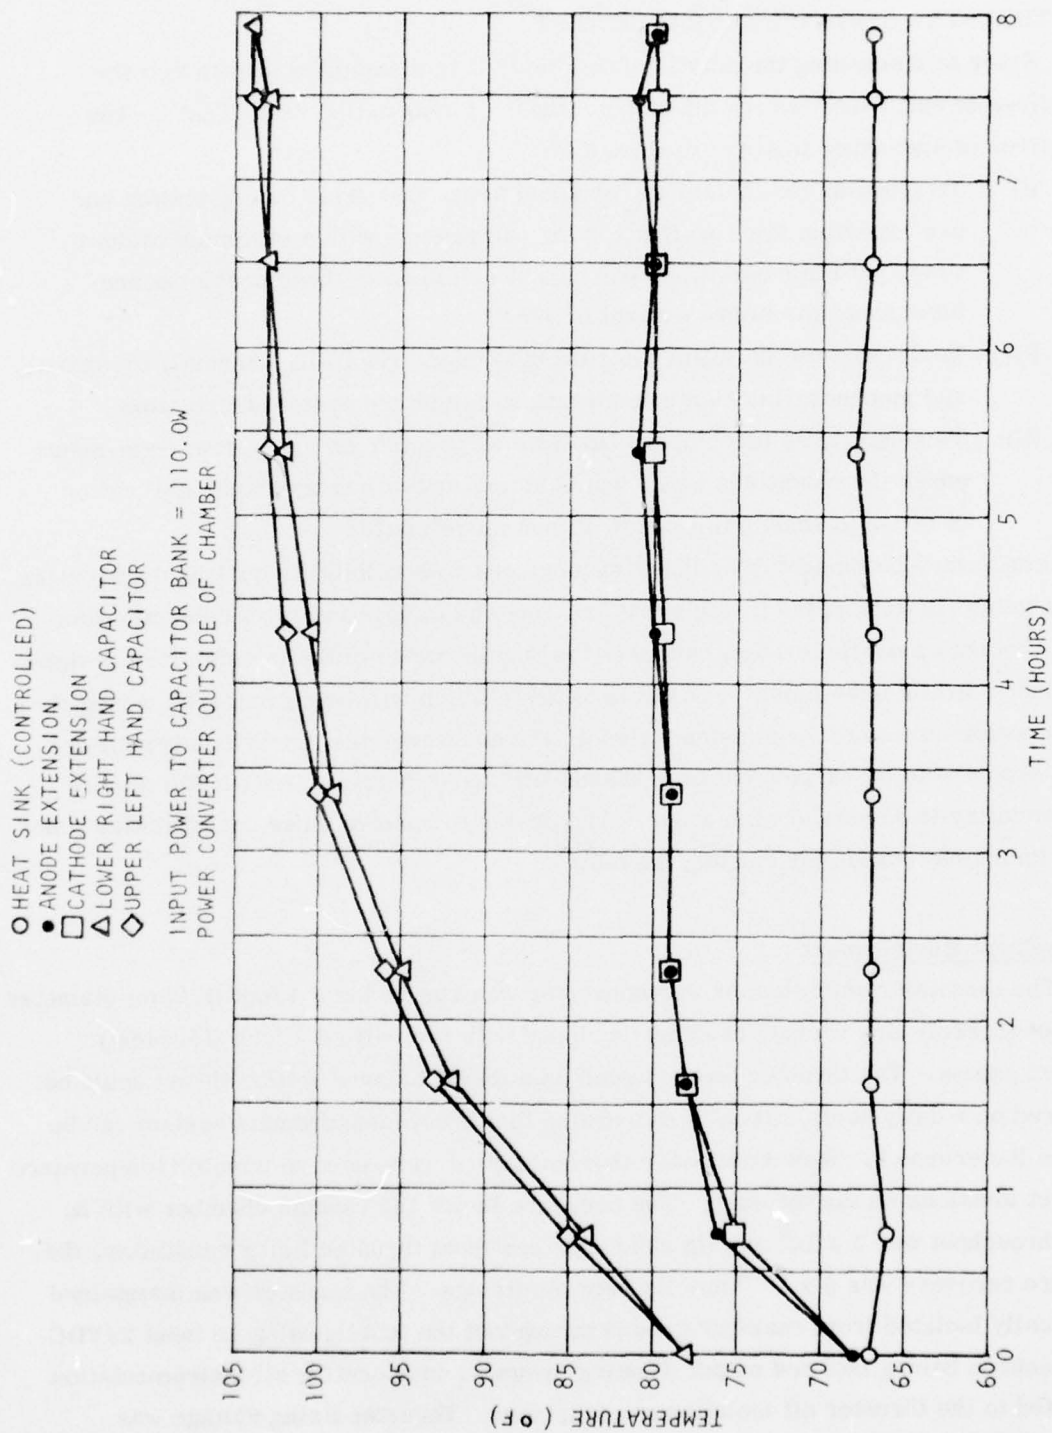
During one of the iterations to the thermal design performed prior to achieving the proper configuration, capacitor case temperature near the front end was allowed to rise close to the maximum 40°C recommended operating temperature. A capacitor failure occurred shortly thereafter with only 16,577 pulses on the failed unit. It is difficult to determine whether this failure occurred because of the temperature or it was simply the result of what is commonly referred to as "infant mortality". Normally, one of the screening tests performed on flight qualification capacitors is to run the units under most severe conditions with the thruster system for a minimum of 50,000 firings to circumvent the low probability of statistical early failures to which this term is applied.

The results of thermal vacuum testing are presented in Figure 3 where the temperature at various locations on the thruster is plotted as a function of time. The data of Figure 3 were obtained at a pulse rate of one firing every 6.8 seconds for a

Figure 3. Results of Thermal/Vacuum Testing on Endurance Test Thruster System
