**ACID ATTACK OF CONCRETE CAUSED BY
SULFUR BACTERIA ACTION, PIEDMONT AND
CLENDENING LAKES OUTLET TUNNELS
MUSKINGUM WATERSHED, OHIO**

Henry T. Thornton, Jr.

Concrete Laboratory

Final Report

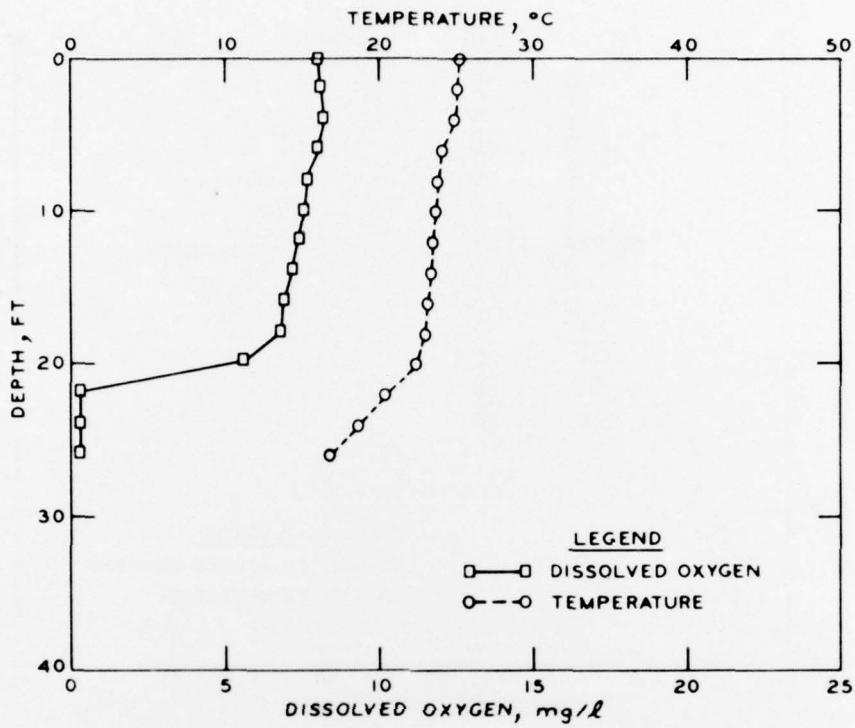
Figure 1. Piedmont Lake, 15 July 1976

22. Tables 3 and 4 give the temperature and dissolved oxygen profiles with water depth for Piedmont and Clendening lakes, respectively. July data for 1973 through 1976 are compared to show typical conditions during the summer months at Piedmont. November 1973 and September 1976 data are given to show how conditions begin to change in the fall. Data given for Clendening Lake include days in August of 1974, 1975, and 1976, and September 1976. The July 1976 and September 1976 data, Piedmont Lake, are plotted in Figures 1 and 3, respectively. August 1976 data (no tabulation available) are plotted in Figure 2. Clendening Lake data from June, July, August, and September 1976 are plotted in Figures 4-7. These data were obtained from collection points in the deep parts of the lakes near the dams, PES20002 at Piedmont, CLB20002 at Clendening, and show that dissolved oxygen depletion occurs in the summer months at depths of 20 to 22 ft and below at Piedmont, and at depths of around 15 ft and below at Clendening Lake. Plots of data (Figures 3 and 7) collected in the early fall illustrate the return of uniform distribution of temperature and dissolved oxygen with depth due to natural cold-weather mixing action. A study of all the data furnished by Huntington District indicates that dissolved oxygen depletion begins in Piedmont Lake in early June and lasts into September, when stratification starts to break down. There were insufficient data to determine when this cycle starts at Clendening, but mixing action starts in September.

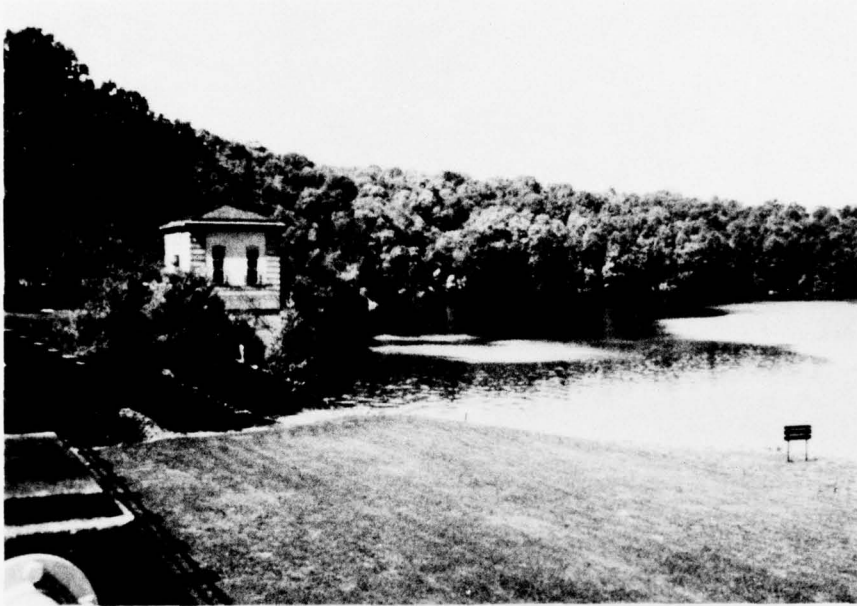
Photograph 1. Clendening Lake

1. Piedmont and Clendening Lakes are two of a system of projects designed to provide flood control, recreation, and water conservation in the Muskingum Watershed in southeastern Ohio (Photographs 1 and 2). Piedmont and Clendening Lakes were constructed in 1937 and 1936, respectively, and cover approximately 2300 and 1800 acres,* respectively. Periodic inspection reports on these two projects in May of 1970 and June of 1974, and interim inspections in December 1976, documented observations of inordinate deterioration of the concrete in the outlet tunnels. The observations made during the inspections pertaining to the condition of the tunnel concrete are summarized below:
