Special Report 77-29

# INFRARED THERMOGRAPHY OF BUILDINGS

## Qualitative Analysis of Window Infiltration Loss

Federal Office Building, Burlington, Vt.

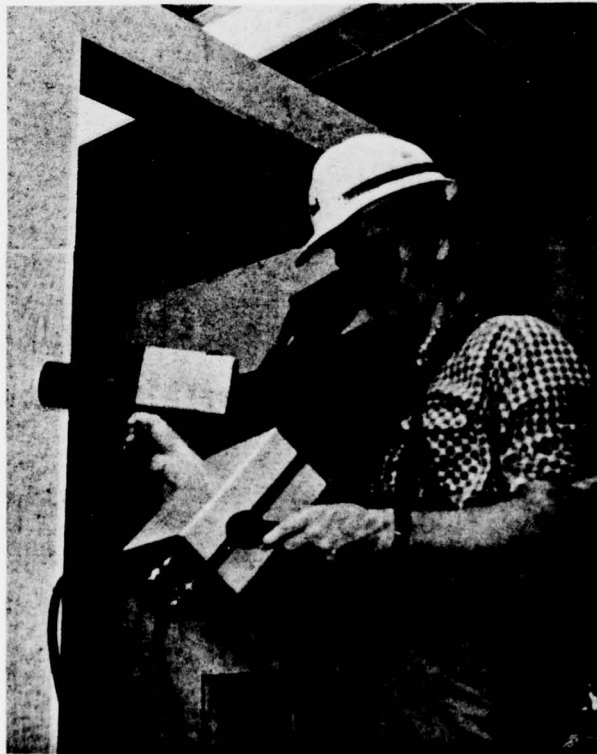
Figure 32.

On the evening of 31 March 1977, a heat loss survey of the Federal Office Building in Burlington, Vermont, was conducted to determine the extent of conduction and infiltration losses from windows throughout the building. The Federal Office Building is a six-story brick structure with single-pane glass in all the windows. All the windows in the building are projected except the non-opening windows in the lobby of the Post Office. An AGA Thermovision infrared camera system was used to conduct this survey (see Fig. 32).
