Report No. CG-D-40-77

RECREATIONAL BOAT SAFETY
COLLISION RESEARCH:
COLLISION ACCIDENT INVESTIGATIONS
JULY 1976 - DEC 1976

JANUARY 1977

FINAL REPORT

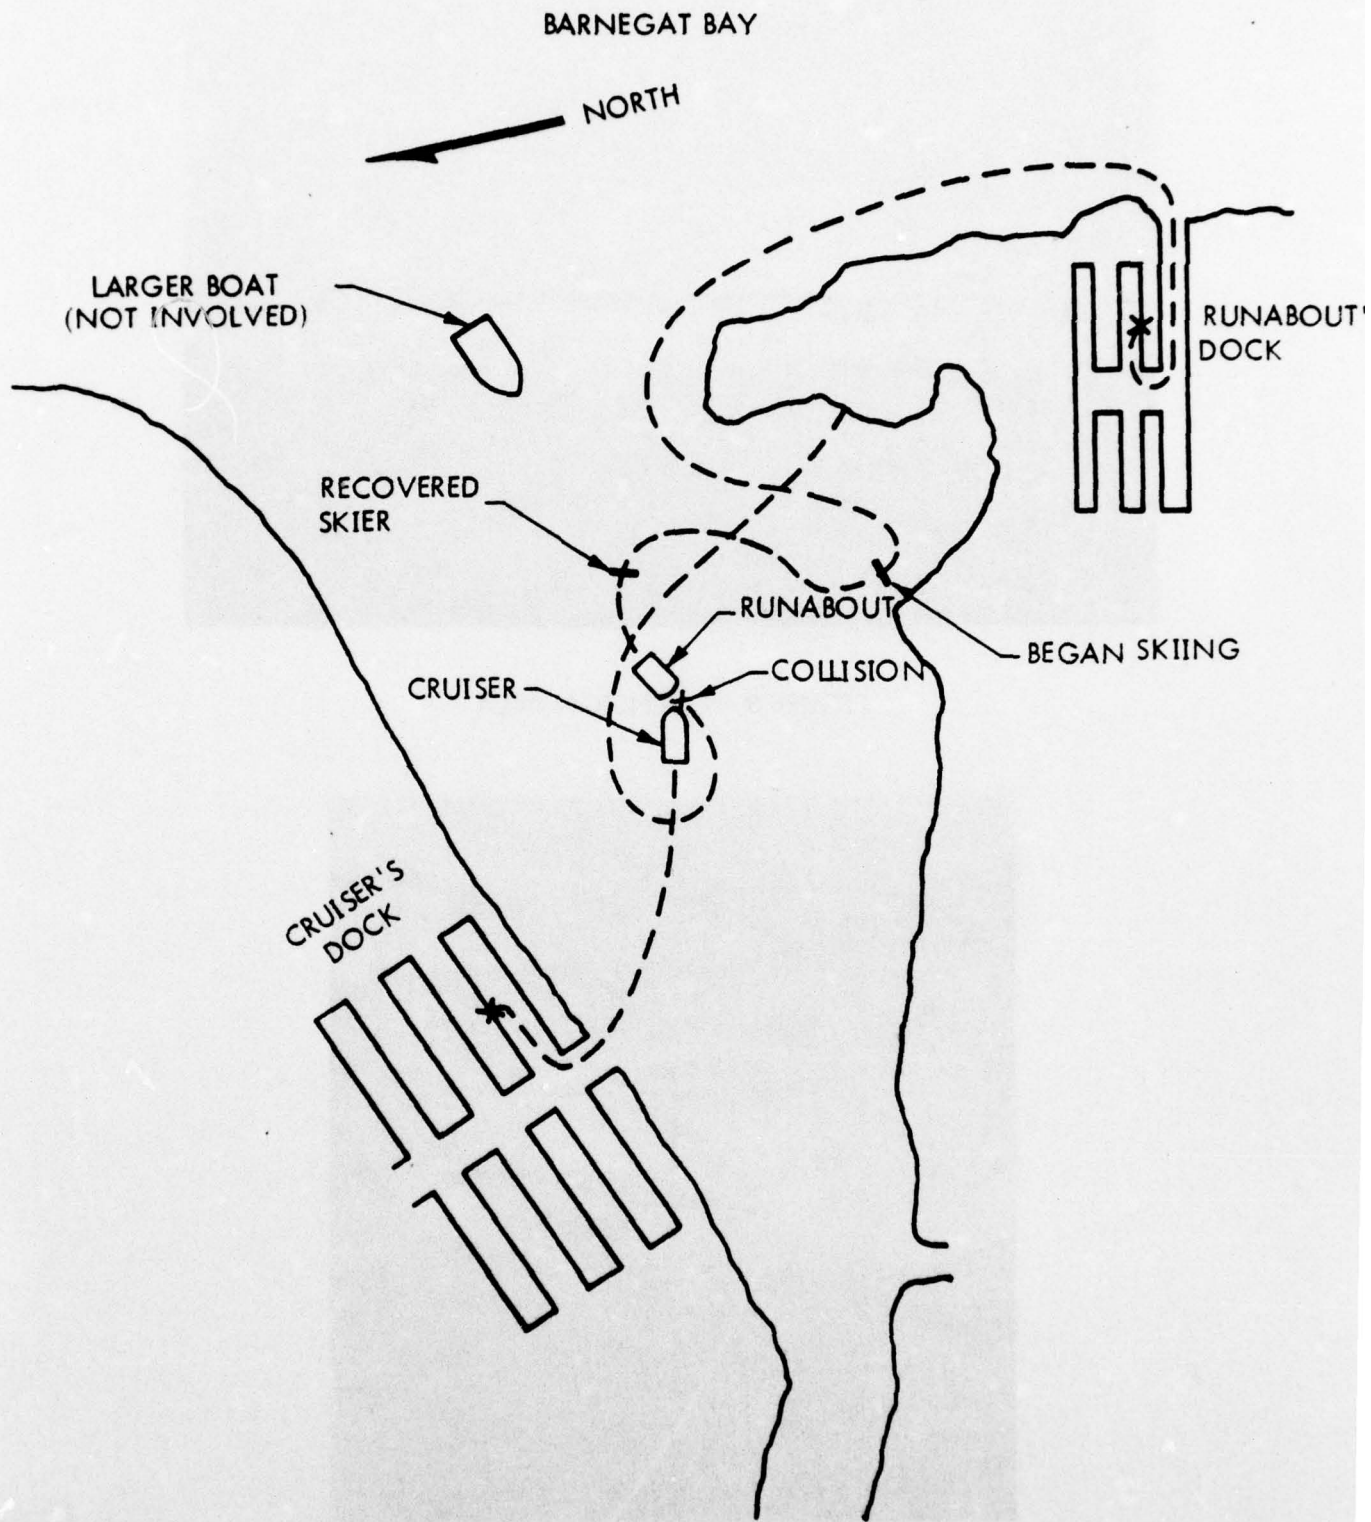
FIGURE 2. COLLISION AREA DIAGRAM

The runabout was on plane and bow high at impact. It appears that the initial contact was a glancing blow, which continued the starboard swing of the runabout's stern, which had been started by the operator's avoidance maneuver. The difference in the amounts of damage to the two boats was due to differences in their underwater surface areas, their weights, speeds, types of construction, and hull thicknesses.

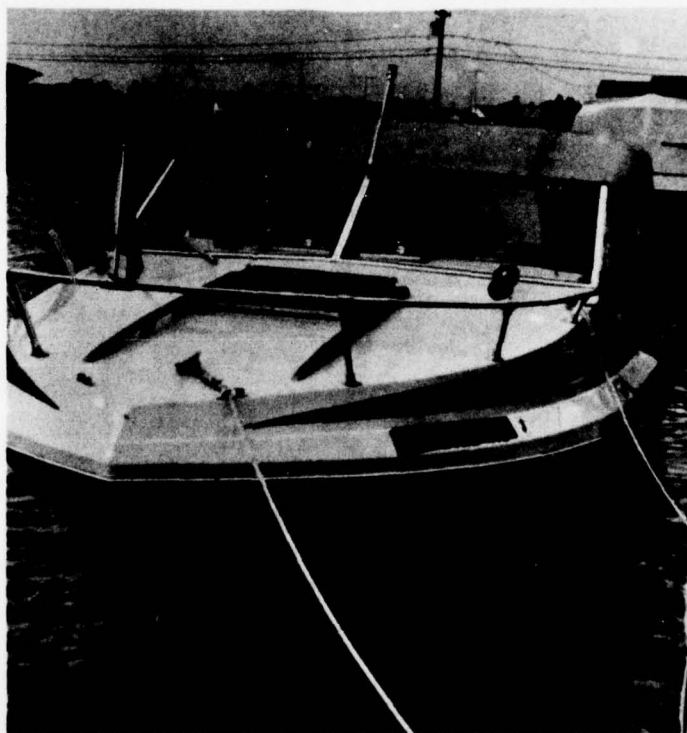
FIGURE 4. 21' (6.5 M) CRUISER. NOTE SCRATCH AND GOUGE AT STEM

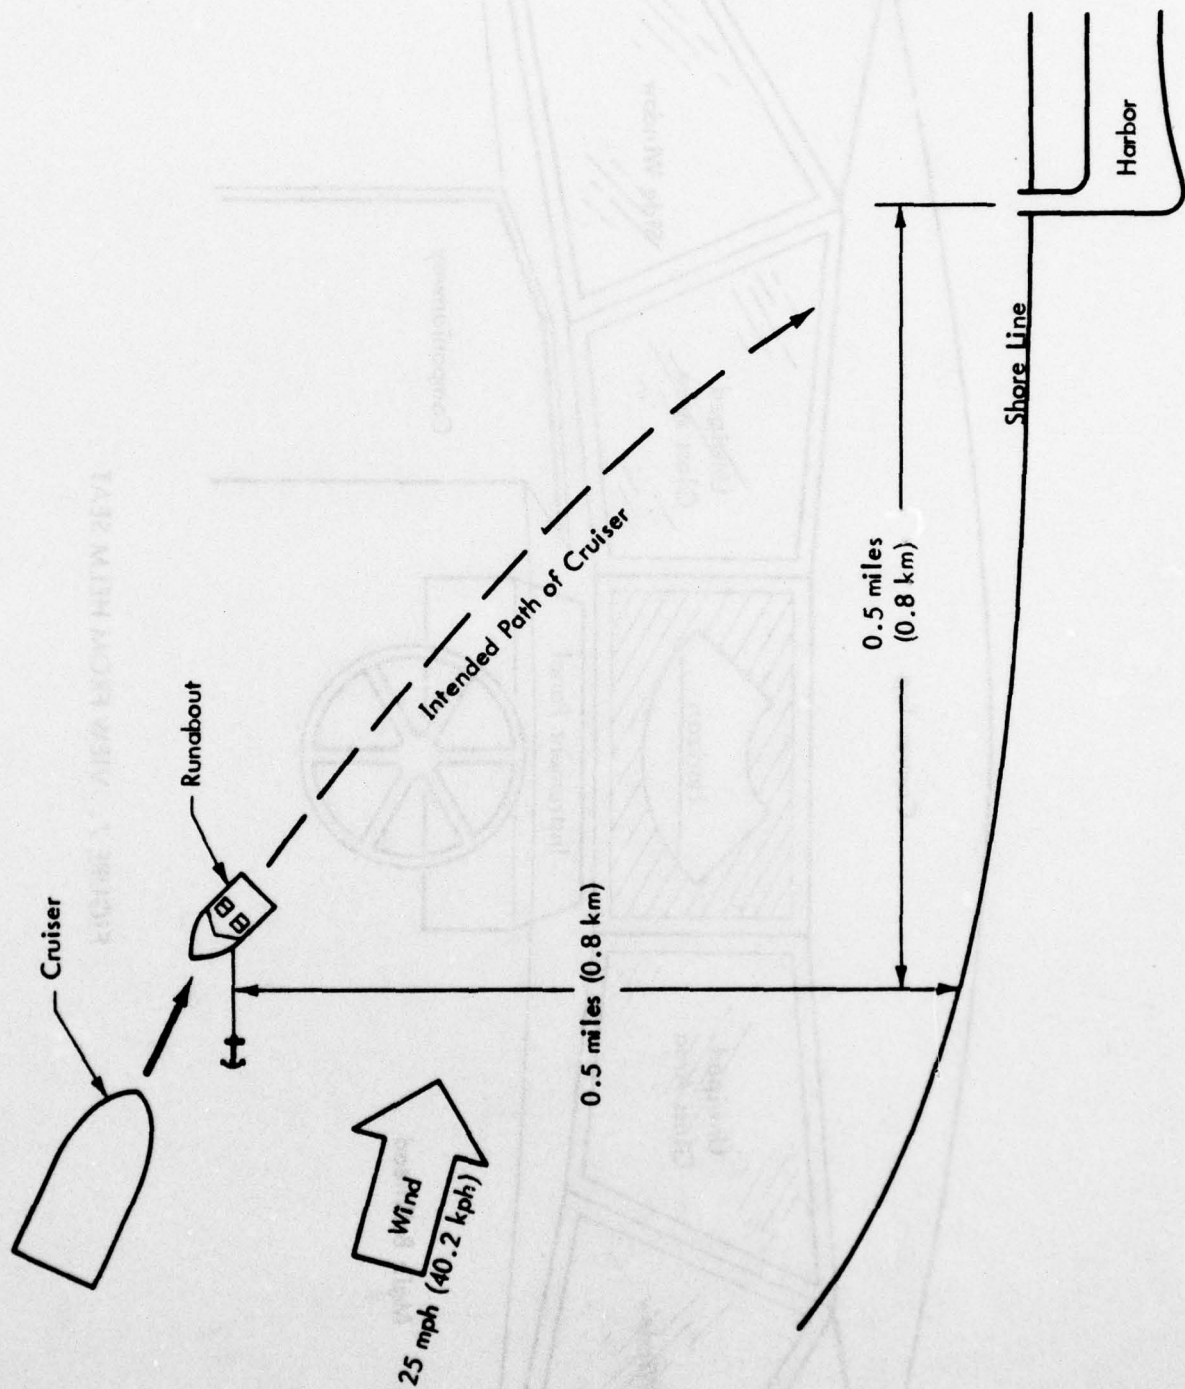
FIGURE 8. COLLISION AREA DIAGRAM

The cruiser hit the runabout about one foot (0.3 m) to port of the center of the bow from almost head on. The runabout was anchored from a point close to the port corner of the windshield. The impact caused the runabout's bow to sink and the stern to rise. The runabout was pushed sideways for some distance until the anchor line stretched to the point that it caused the runabout to rotate clockwise. The cruiser then continued through the bow of the runabout at approximately right angles to the centerline from left to right. (See collision area diagram, Figure 8.)

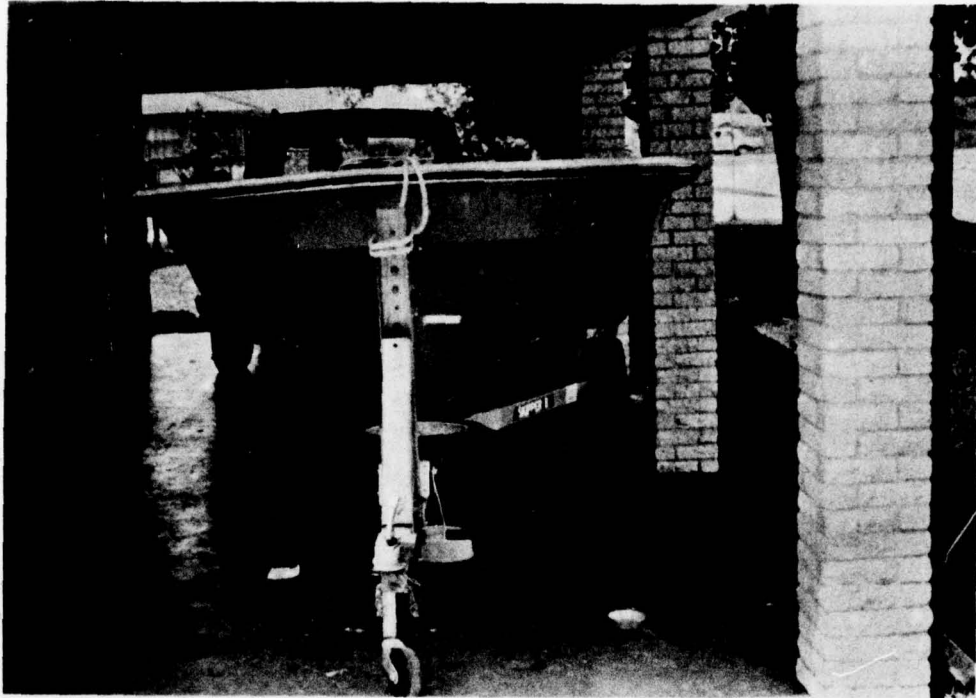
FIGURE 6. BOW OF BOAT #1

The boat was loaded with minimal equipment, a 12 gallon (45.4 l) gas tank and the battery. Visibility was judged by the owner to be good at the speed at which the operator was traveling. Damage was slight, scratches to the bow bump rail and gelcoat. Figure 2 shows a profile; Figures 3 and 4 are views of the damage. Figure 5 is the view looking forward from the operator's seat, and Figure 6 is a view of the bow. Additional data obtained during the investigation were as follows:

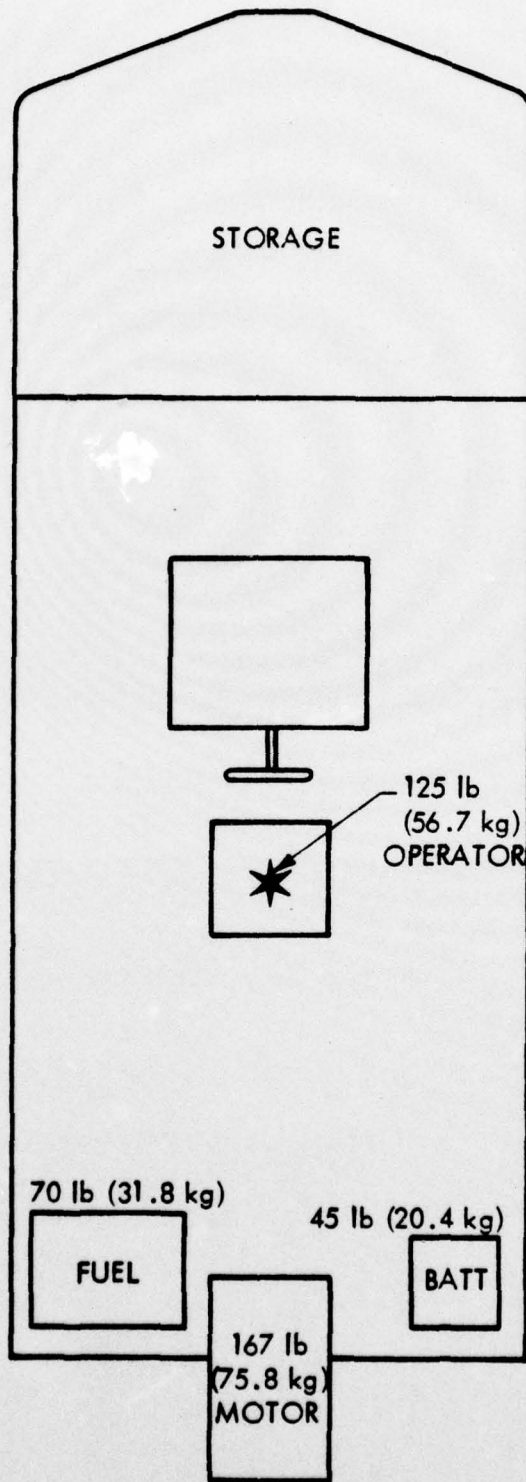
FIGURE 12. BOAT LOAD DISTRIBUTION AT TIME OF ACCIDENT (BOAT 1)

The boat was loaded with an 18 gallon (68.1 l) gas tank and the battery. It had a built-in ice chest on the port side and a built-in thwart at the bow. Damage was extensive; the steering wheel was torn completely out of the console. The console had a large hole and crack running from the top to the deck. The lever was broken off the control box. The starboard side sustained several cracks in the fiberglass, one of which was approximately 18 in. (45.7 cm) long. Figures 7 and 8 show the views of the starboard side. Figure 9 is a view from the stern, and Figure 10 is a view from the bow. Figure 11 shows the damage to the control box. Refer to Figures 12 and 13 for load distribution in the boats at the time of the accident.

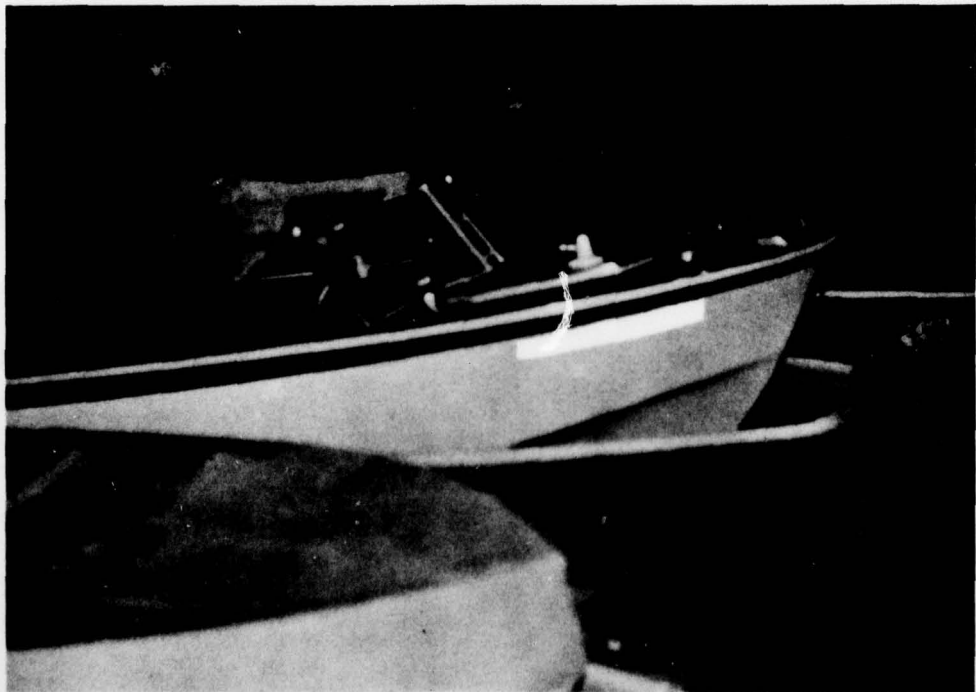
FIGURE 2. HITTOR'S BOAT

The hittor's boat was dropping off plane and was probably traveling at hump speed when it struck the skier. If it had been going slower, she probably would have been pushed aside and could have escaped unhurt.

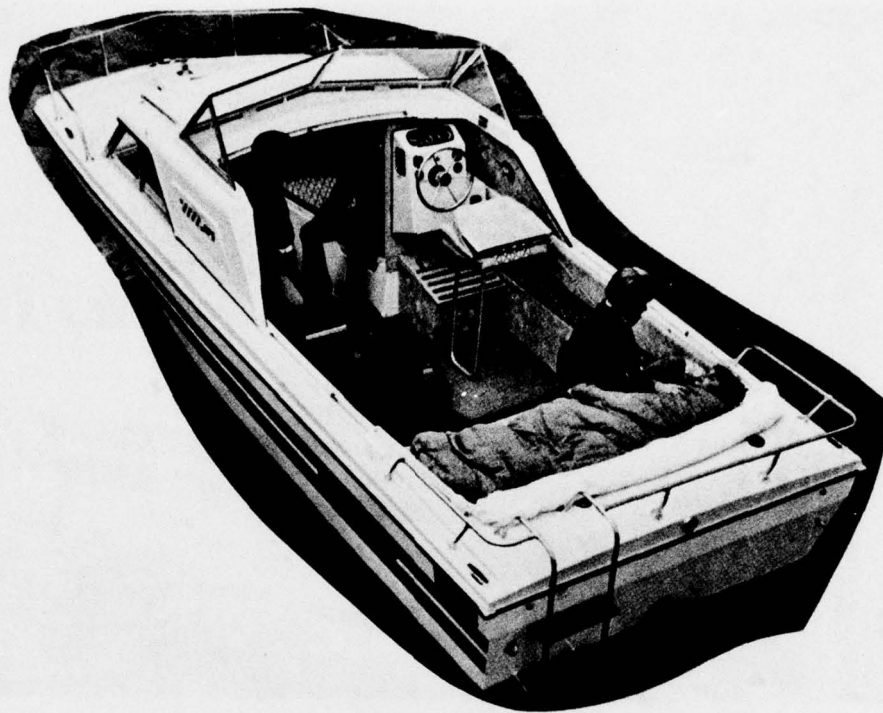
FIGURE 11. BROCHURE PICTURE OF MFG GYPSY 21 FOOTER

Damage to this boat was very extensive as shown in Figures 5 through 10. Figure 11 was taken from the brochure of the manufacturer (convertible top and passenger seat not shown). The boat was considered a total loss (about \$ 7,000 after salvage of engines and drives, etc.).

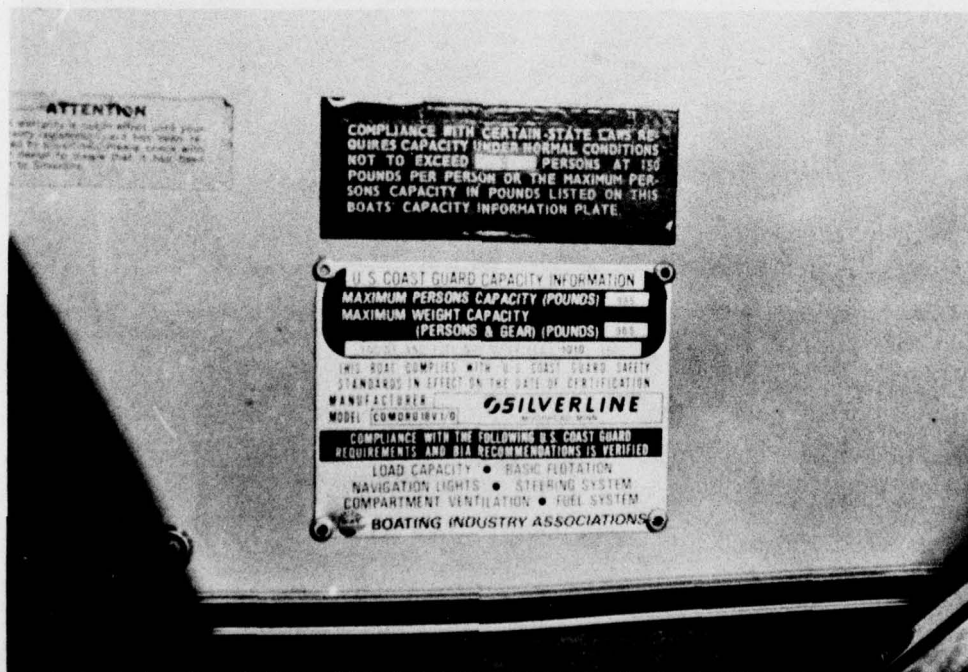
FIGURE 12. BOAT NO. 2 CAPACITY PLATE

This boat was a Silverline model Comoro 18 V. The LOA was 17 ft 7 in. (5.4 m) with a beam of 85 in. (2.2 m) at the transom and weighing approximately 2000 lb (907 kg). Maximum persons capacity was 985 lb (446.8 kg); maximum weight capacity was 985 lb (446.8 kg) (capacity label, Figure 12). The boat was powered by a 165 hp Mercruiser I/O. Photographs of the boat are shown in Figures 13 through 18. According to the HIN, the boat was built in Model Year 1974 (probably September or November — the letter designation for the month was not readable).

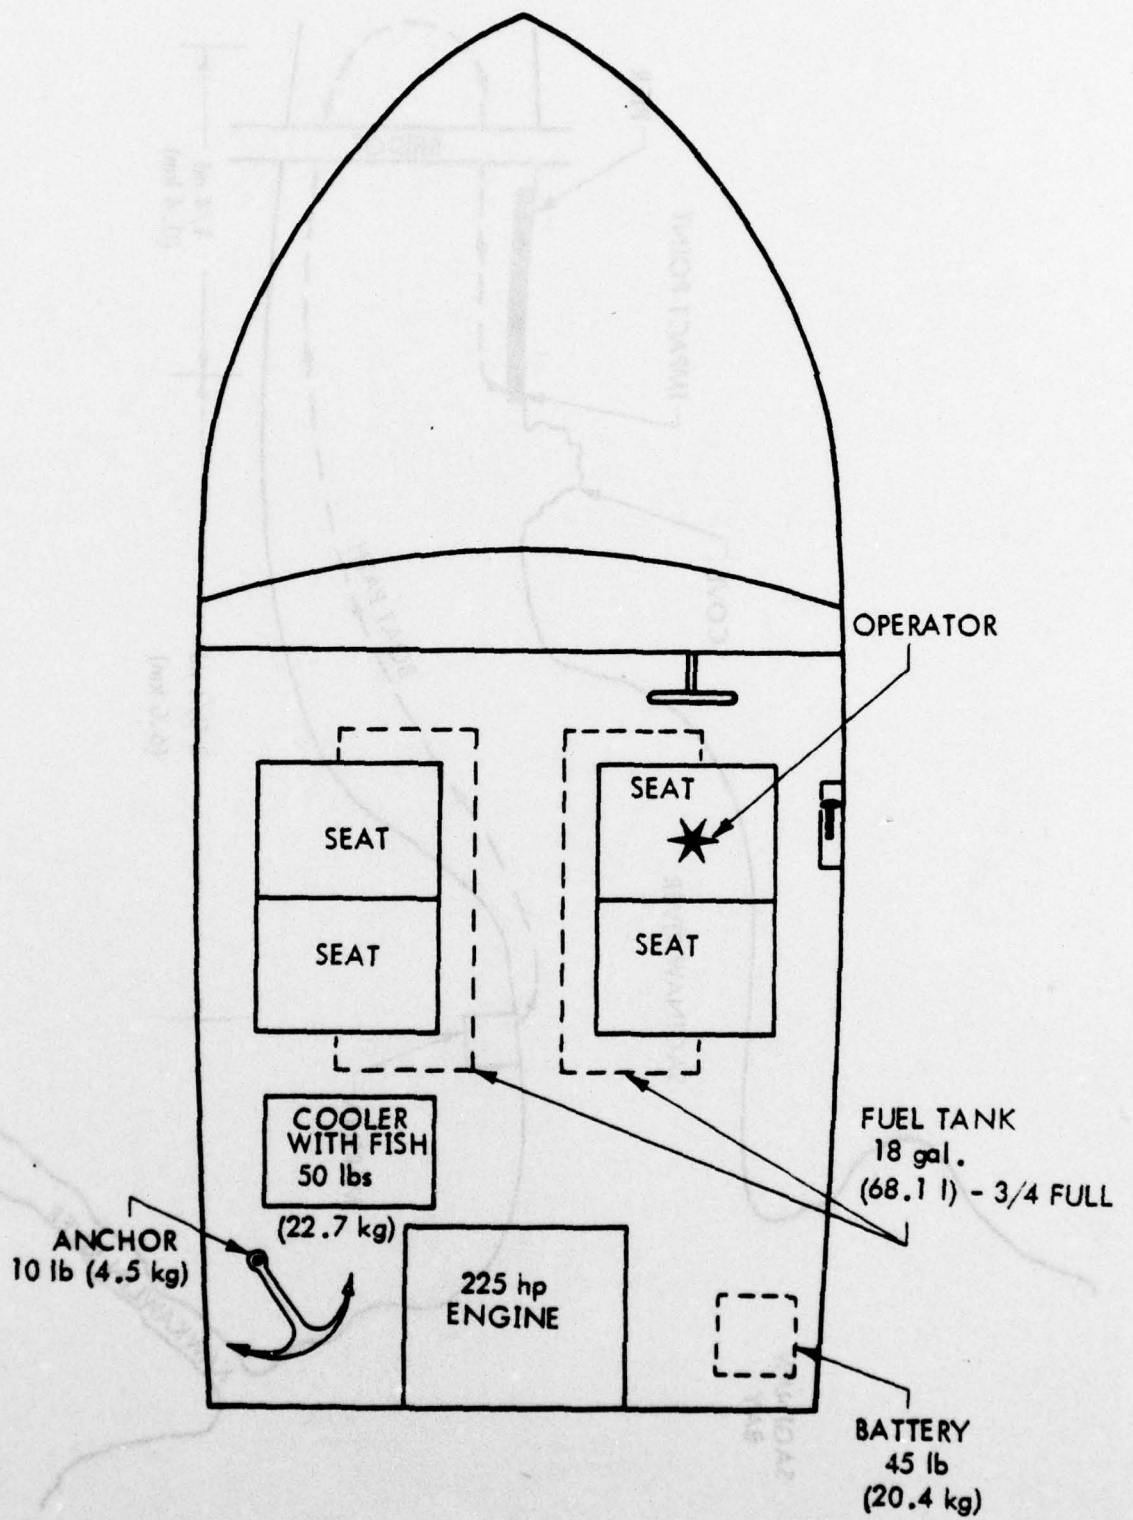
FIGURE 1. BOAT LOAD DISTRIBUTION AT TIME OF ACCIDENT

Gear aboard was as shown in Figure 1 and the weather as noted in Section 2.0.

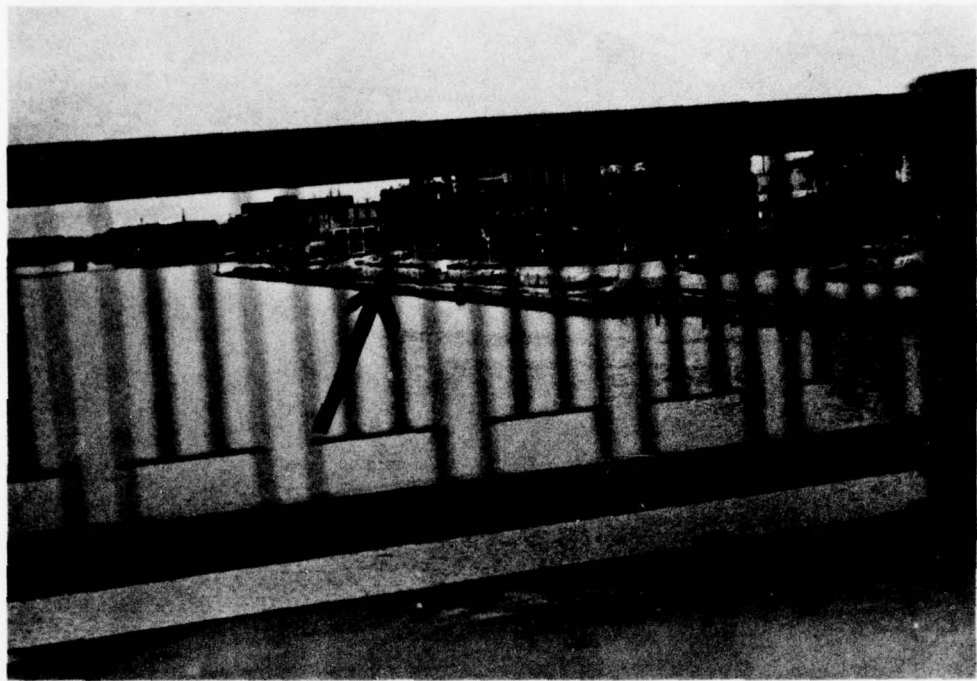
FIGURE 3. BOAT IMPACT AREA

The operator was steering with his right hand when the boat suddenly turned to starboard. He did not have time to grab the wheel with his left hand and retard the throttle with his right hand before impact with the pier. The boat impacted the pier bow on. There was visual evidence that the operator was thrown forward into the approximate center of the instrument panel.

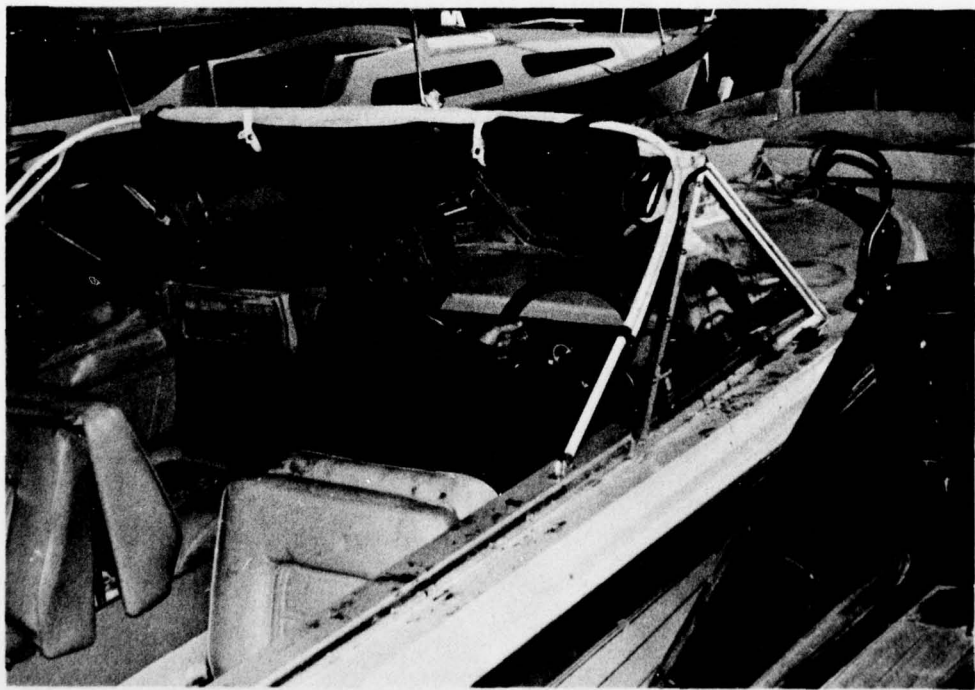
FIGURE 10. OVERALL BOAT VIEW

The boat was an 18 ft (5.5 m) 1972 model IMP inboard/outdrive powered by a 1972 225 hp Chevrolet engine. It was a V-hull bowrider of fiberglass construction. The capacity plate attached to the boat specified a maximum persons capacity of eight people at 150 lb (68 kg) each, a maximum weight capacity of 1600 lb (725.7 kg), and a maximum horsepower of 245. The impact resulted in major structural damage to the bow as shown in Figures 4, 5, and 6. The secondary impact of the operator's head with the instrument panel tore out the rear view mirror and broke the key off in the ignition as shown in Figure 7. The back-to-back port seats were separated at the top as shown in Figure 8. The skeg on the lower unit was broken off as shown in Figure 9. Overall boat views are shown in Figures 10-13.

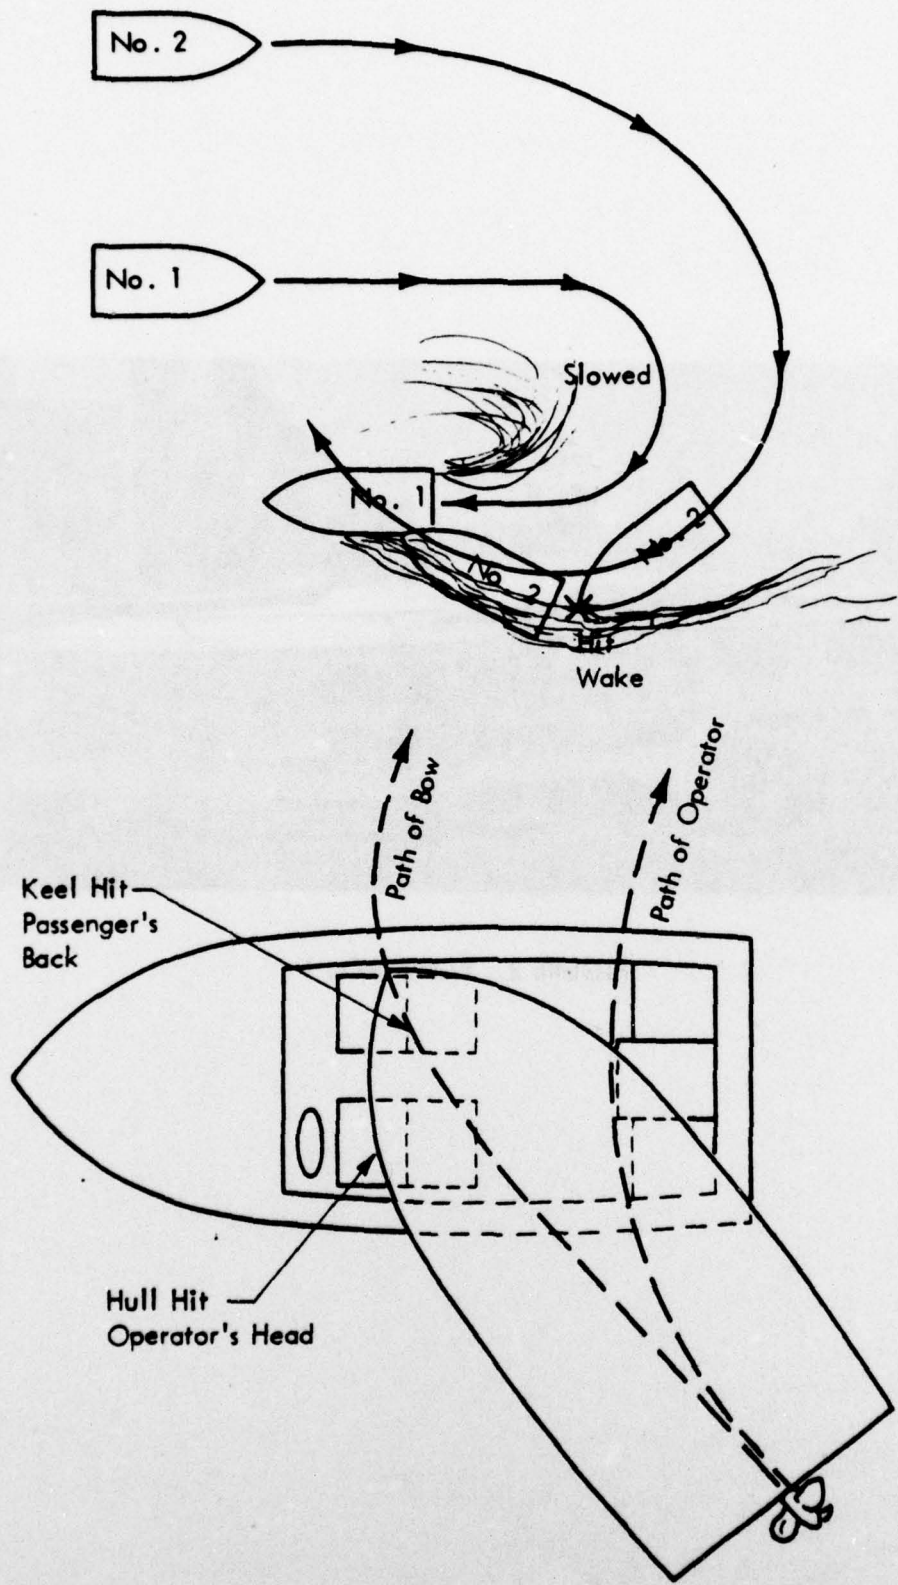
FIGURE 1. COLLISION AREA DIAGRAM

At the bow high attitude, the bow was cantilevered out of the water. Because the length of the waterline was decreased, the resistance to turning when a transverse force was applied to the bow was greatly reduced. Because the boat was decelerating, there was no forward thrust from the propeller that would have helped to propel it through the wake. Instead, the three to four ft (0.9 to 1.2 m) wake contacted the side of the hullside at the bow and forced it to the right. The operator was located approximately six ft (1.8 m) forward of the center of rotation; therefore, he was thrown to his left into the aisle.

The boat continued at a bow high attitude and mounted the cockpit area of Boat No. 1. The momentum carried it completely over the other boat.

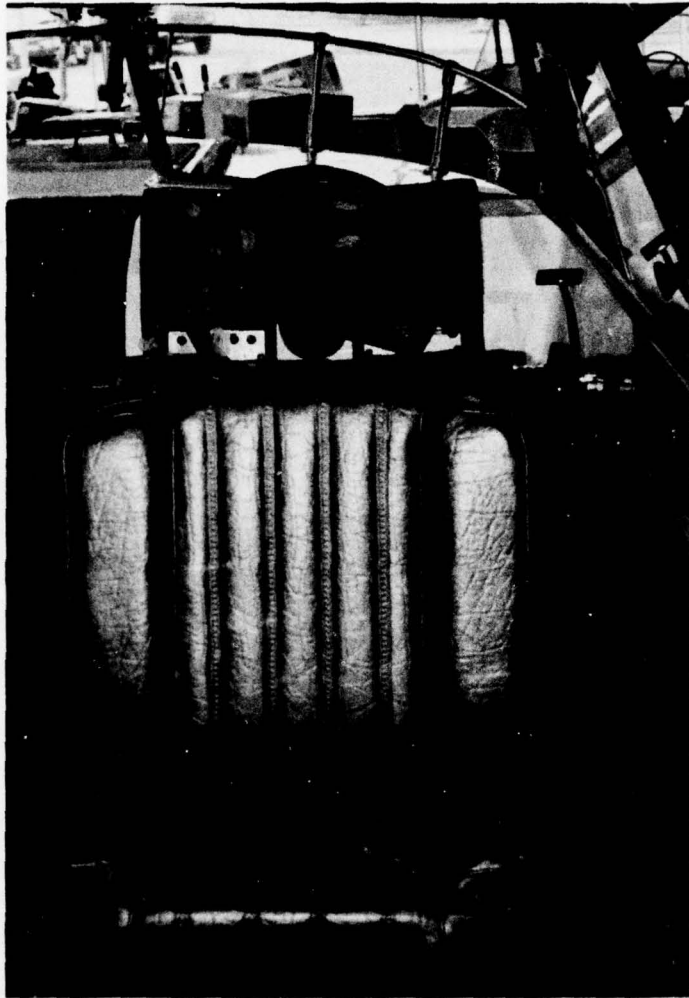
FIGURE 6. CONTROL STATION - BOAT NO. 2

Poor forward visibility from the helm contributed to the cause. The operator couldn't see the wake forward.

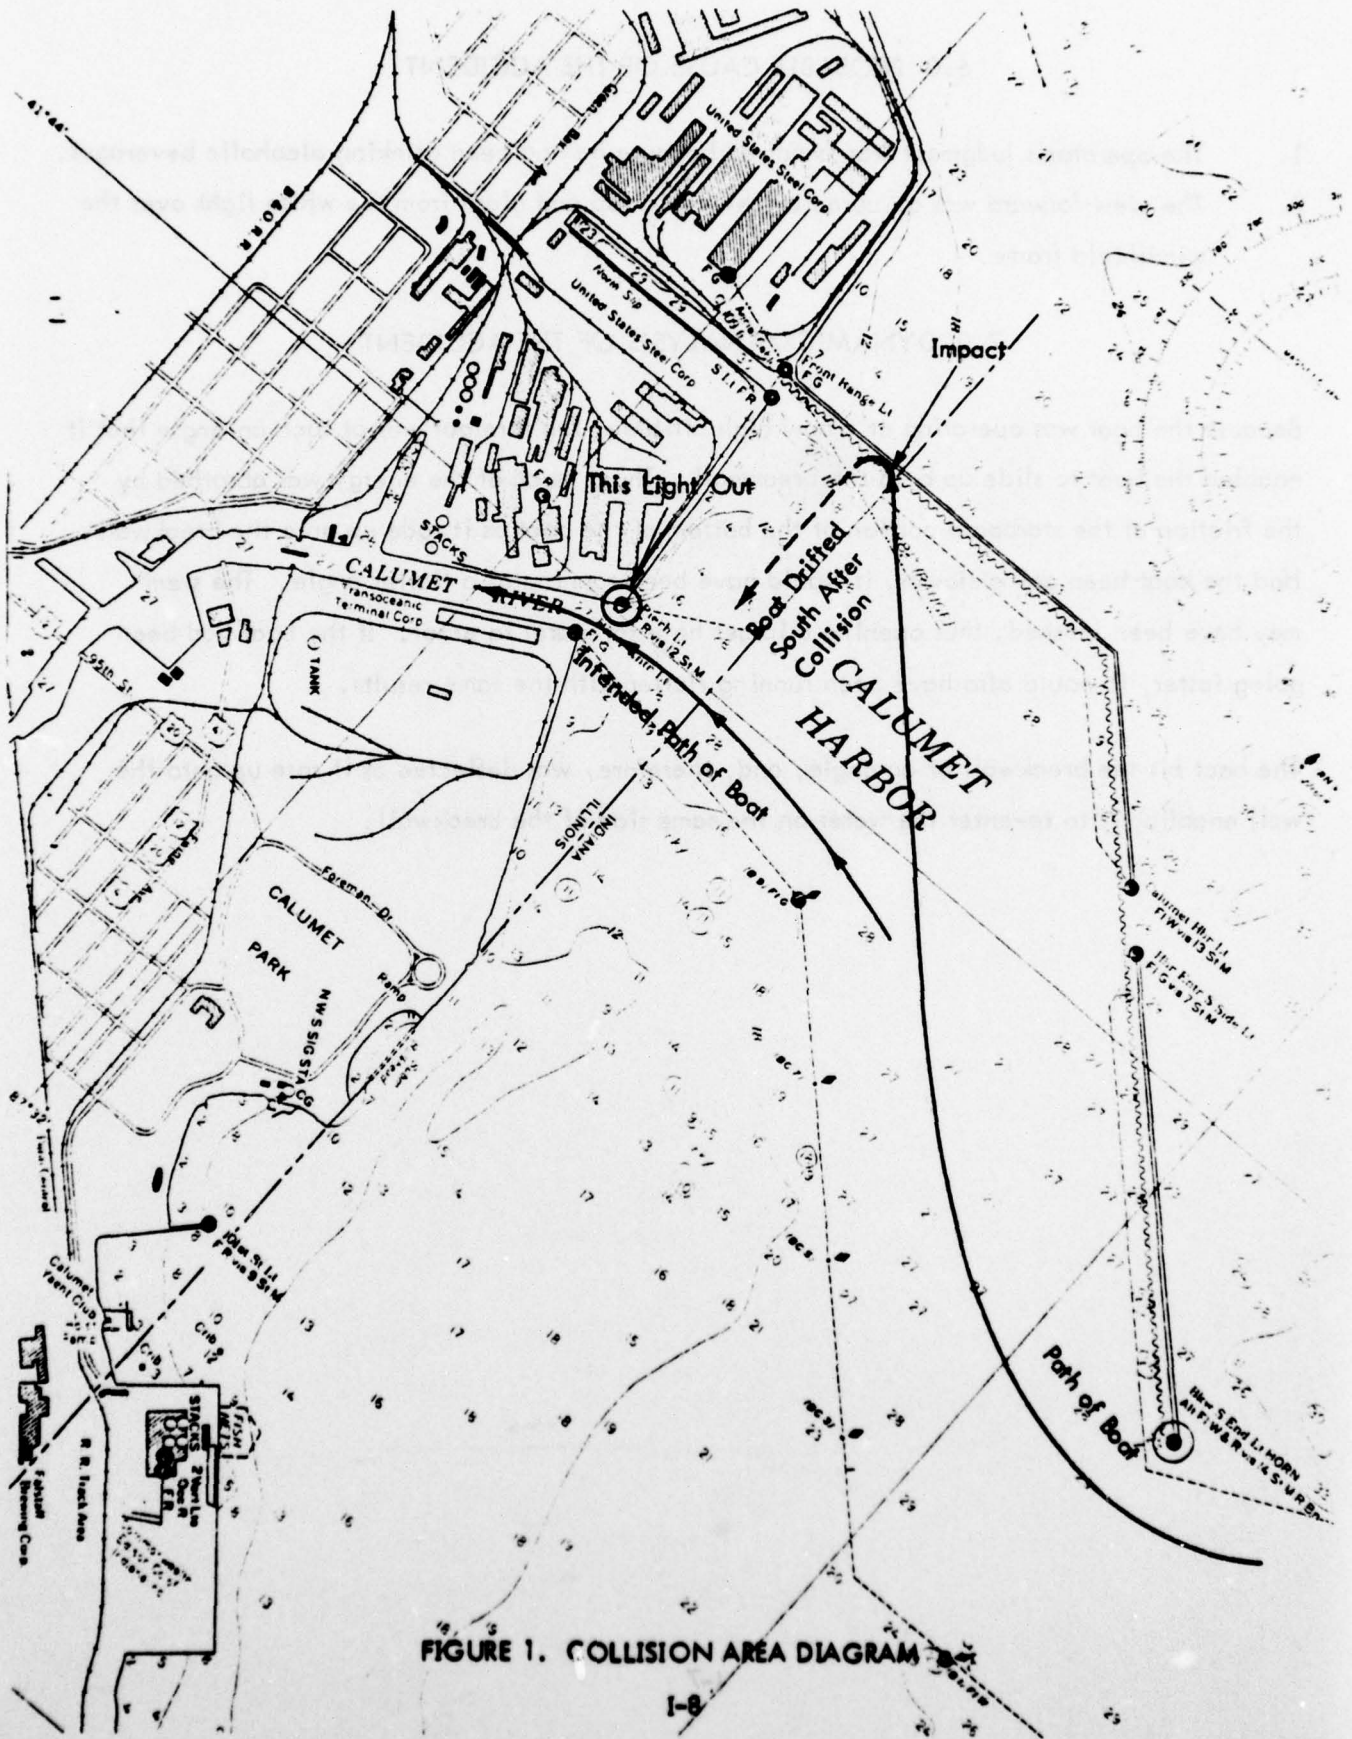
FIGURE 1. COLLISION AREA DIAGRAM

Because the boat was operating at a bow high attitude, the forefoot was at such an angle that it enabled the boat to slide up onto the breakwall. Thus, much of the energy was absorbed by the friction of the starboard portion of the bottom of the boat as it rode up onto the breakwall. Had the boat been going slower, it would have been running at a flatter angle. The stem may have been crushed, thus opening a larger hole for water to enter. If the boat had been going faster, it would also have been running flatter with the same results.

The boat hit the breakwall at an angle, and, therefore, was deflected as it rose up onto the wall enabling it to re-enter the water on the same side of the breakwall.

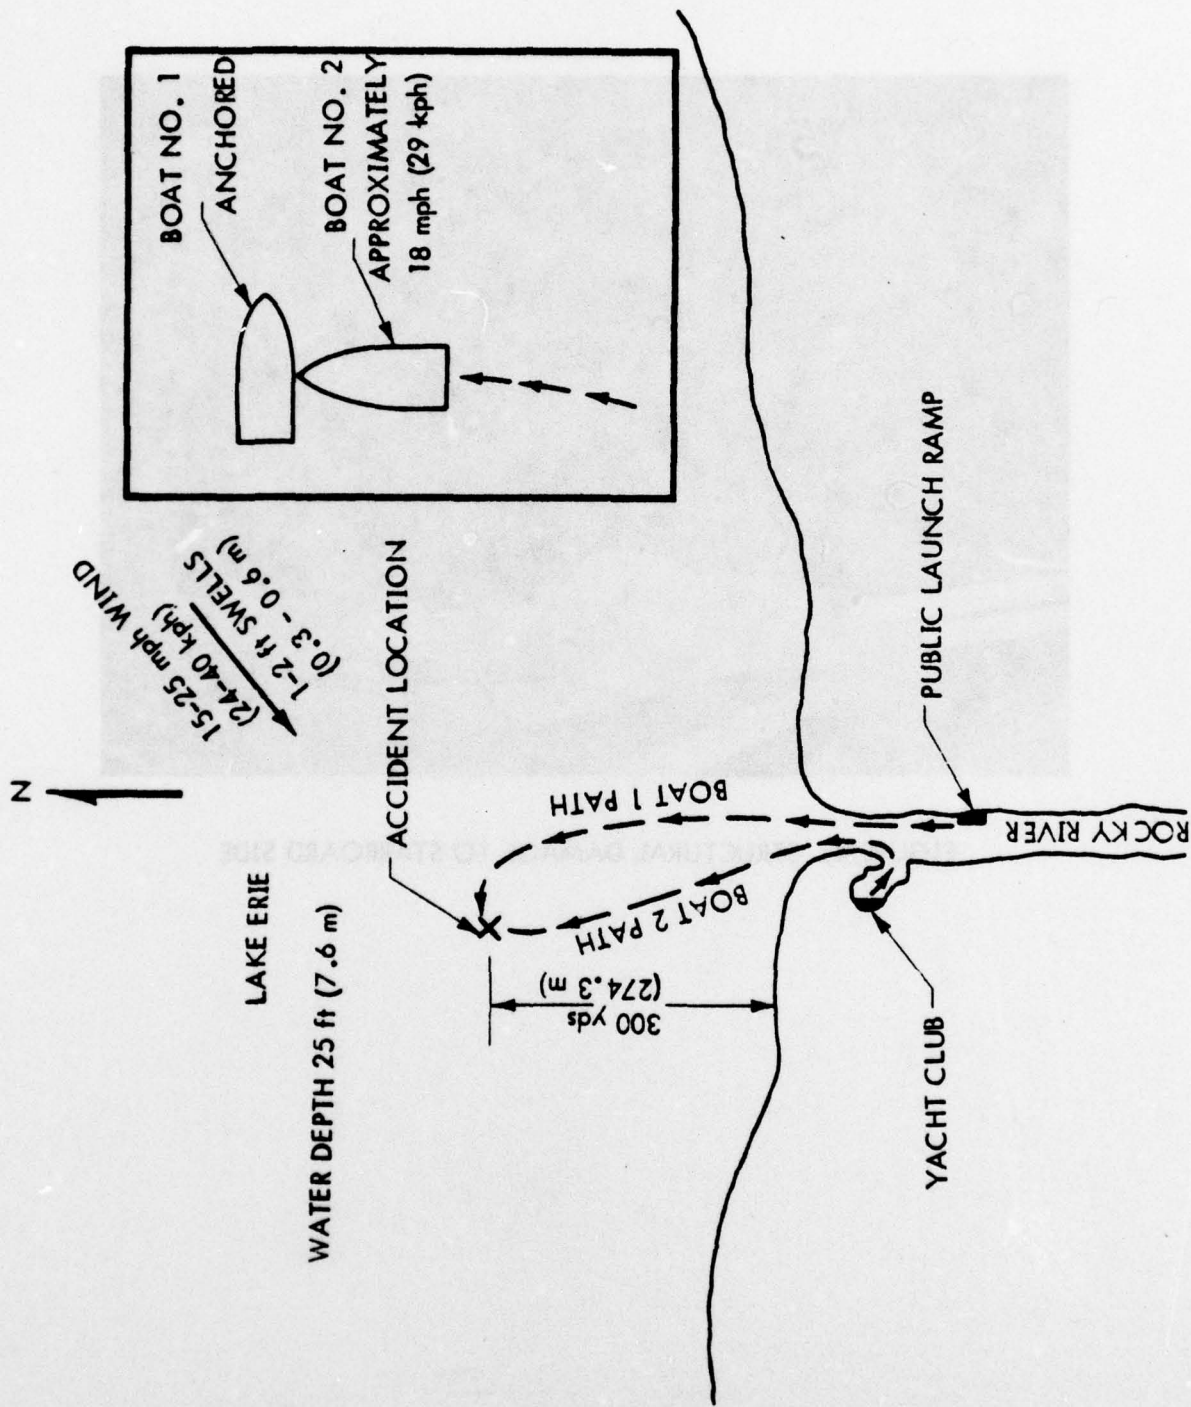
FIGURE 3. SKETCH OF ACCIDENT AREA

The bow of Boat No. 2 impacted the starboard side of Boat No. 1 near amidships and essentially perpendicular to the longitudinal axis. The impact ripped a large section out of the starboard side of Boat No. 1. The forward momentum of Boat No. 2 carried it across Boat No. 1 and into the water on the port side. As Boat No. 2 traversed across Boat No. 1, its weight pushed No. 1 down, causing it to begin flooding immediately. The bow of Boat No. 2 raised after impact, causing it to jump over Boat No. 1 as was evident from the minimal damage to the port side of Boat No. 1. Apparently, Boat No. 1 was pushed under water or sank immediately because the occupants of Boat No. 2 did not see it within seconds after the collision. Within a short time after sinking, Boat No. 1 rolled upside down and the bow section resurfaced.

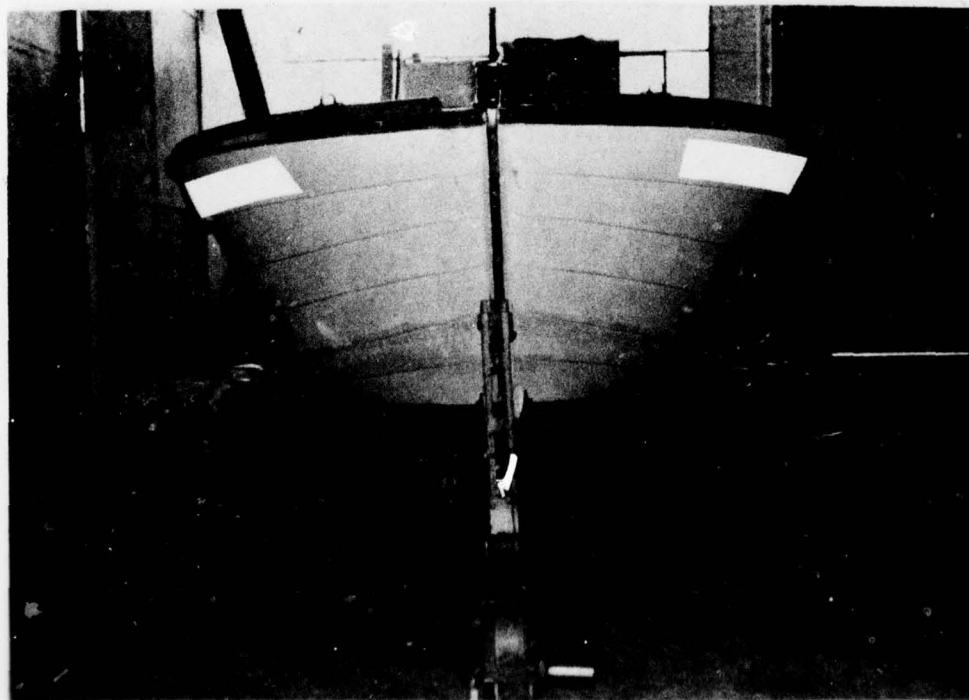
FIGURE 8. BOW VIEW

The boat was a 15-1/2 ft (4.7 m) 1962 Model Pen Yan runabout powered by a 1962 40 horsepower West Bend outboard motor. It was a semi-V closed bow of 3/4 in. (1.9 cm) wood lapstrake construction. The OBC plate attached to the boat specified a maximum weight capacity of 1305 lb (592 kg) and a maximum horsepower capacity of 60. The collision resulted in major structural damage to the starboard side as shown in Figures 4 and 5. Moderate damage to the port gunwale is shown in Figure 6. The aft facing seat was torn loose from the deck on impact. Prop marks on the forward facing seat are shown in Figure 7. Bow view is shown in Figure 8.

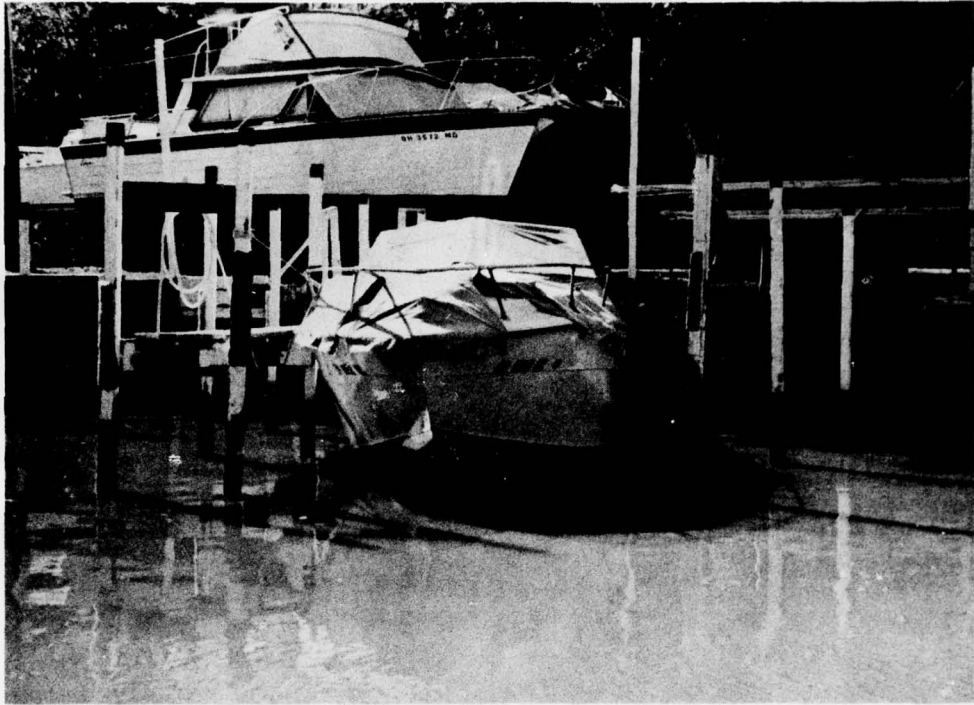
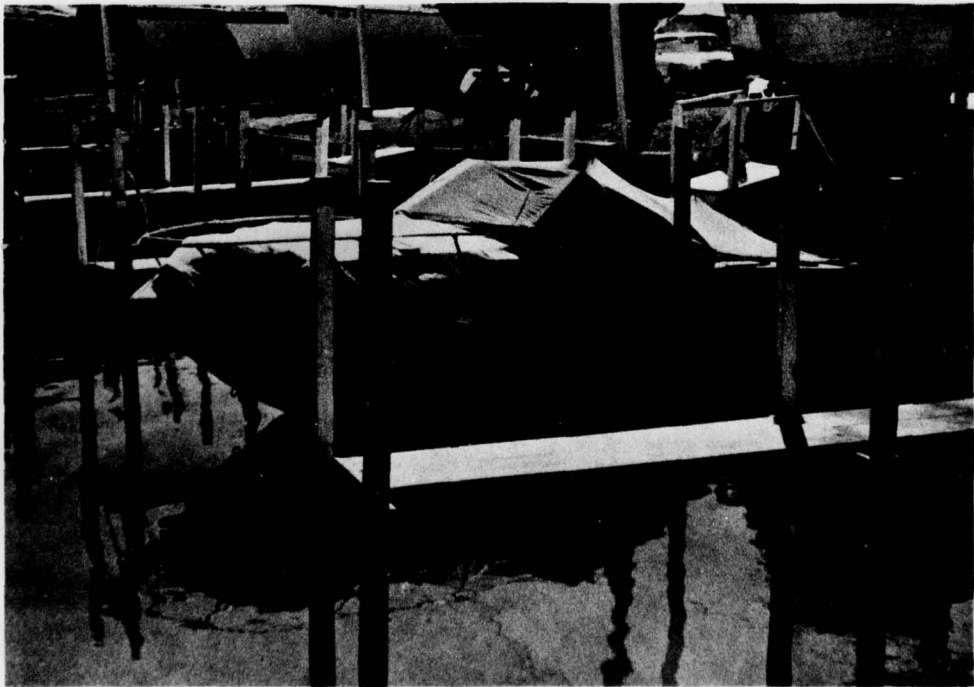
The boat was a 24 ft (7.3 m) 1972 Model Searay I/O cabin cruiser powered by two 1972 model 165 horsepower Mercury engines. The outdrives were Mercruisers incorporating power trim. Trim tabs were also installed on the transom. The hull was a deep-V of fiberglass construction. There was no capacity plate attached to the boat. The collision resulted in no damage to the boat above the static water line. The hull below the static water line could not be inspected, but it is assumed that only minor gelcoat damage existed. Refer to Figures 9 and 10 for overall boat views.

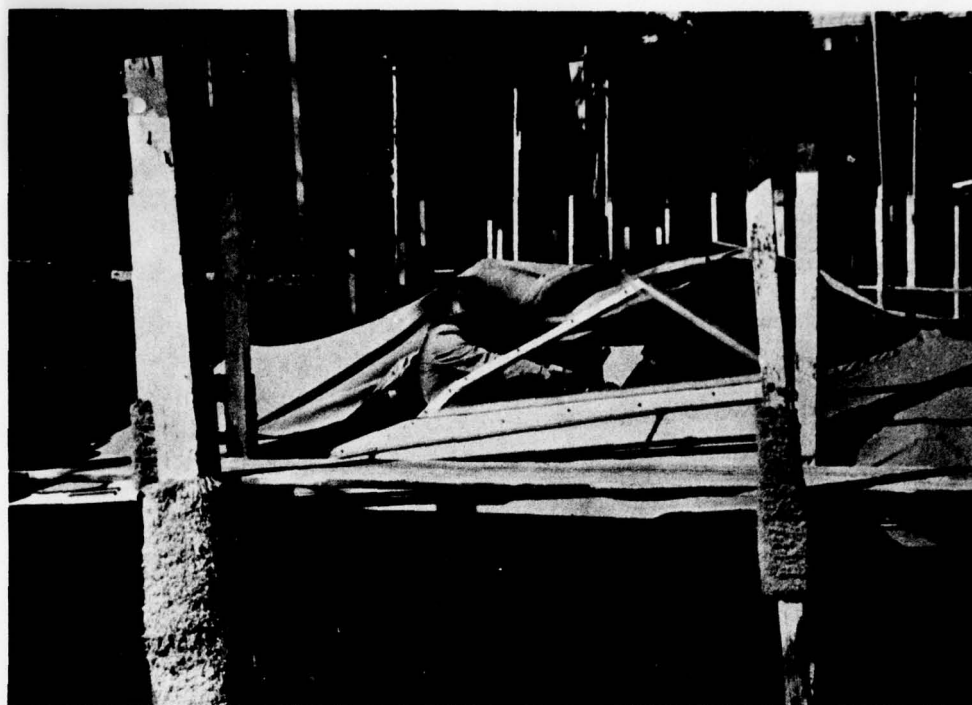
FIGURE 11. STATIC TRIM ANGLE (OPERATOR AT NORMAL SEATED HELM POSITION)

The helm station of Boat No. 2 was at least above average in design. The static trim angle is shown in Figure 11; also, note operator's forward view in Figure 12.

- Restricted forward visibility of Boat No. 2's operator is considered the major factor. He stated that he could not see over the bow when seated and traveling at the speed at the time of the collision with Boat No. 1 (2000 rpm and less than 20 mph (32 kph)). Refer to Figures 11 and 12 for static trim angle and seated operator eye level visibility at the helm.
