Report No. CG-D-40-77

RECREATIONAL BOAT SAFETY
COLLISION RESEARCH:
COLLISION ACCIDENT INVESTIGATIONS
JULY 1976 - DEC 1976

JANUARY 1977

FINAL REPORT

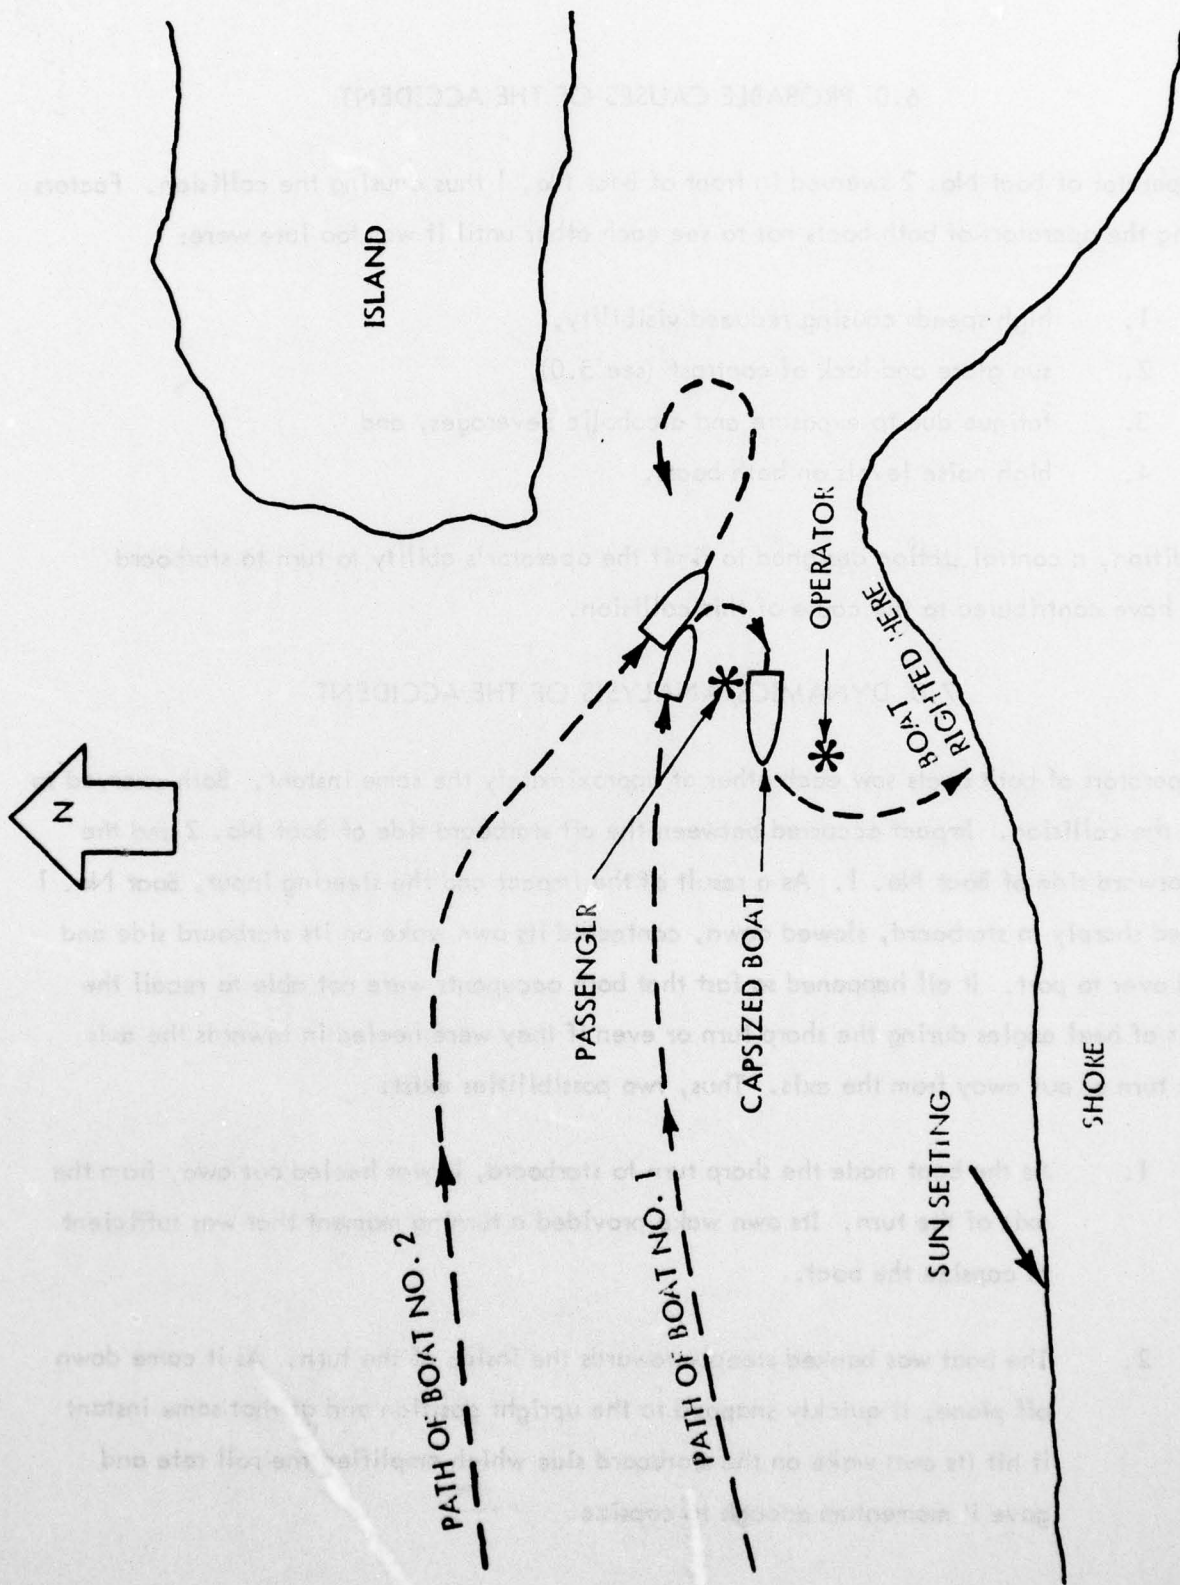
FIGURE 1. COLLISION AREA DIAGRAM

The operators of both boats saw each other at approximately the same instant. Both swerved to avoid the collision. Impact occurred between the aft starboard side of Boat No. 2 and the port forward side of Boat No. 1. As a result of the impact and the steering input, Boat No. 1 swerved sharply to starboard, slowed down, contacted its own wake on its starboard side and rolled over to port. It all happened so fast that both occupants were not able to recall the details of heel angles during the sharp turn or even if they were heeled in towards the axis of the turn or out away from the axis. Thus, two possibilities exist:

1. As the boat made the sharp turn to starboard, it was heeled out away from the axis of the turn. Its own wake provided a turning moment that was sufficient to capsize the boat.
2. The boat was banked steeply towards the inside of the turn. As it came down off plane, it quickly snapped to the upright position and at that same instant it hit its own wake on the starboard side which amplified the roll rate and gave it momentum enough to capsize.

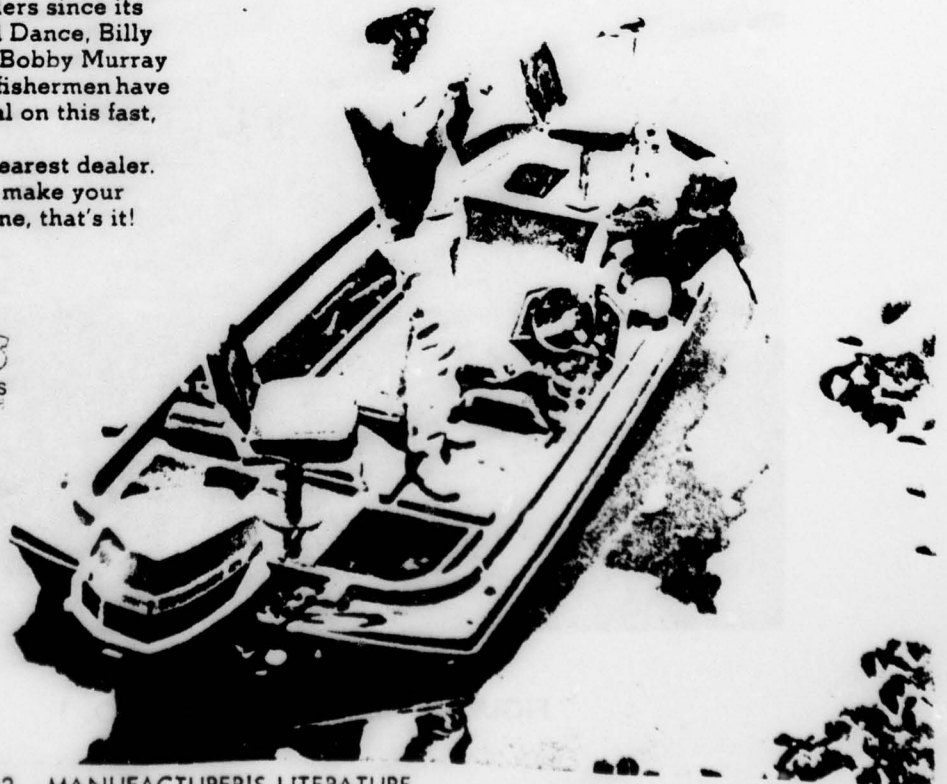
FIGURE 2. MANUFACTURER'S LITERATURE
(Boat at top is Boat No. 2; boat at bottom is Boat No. 1)
