**DEVELOPMENT TESTS AND FLIGHT TEST OF GRAPHITE
COMPOSITE LANDING GEAR SIDE BRACE ASSEMBLY
FOR A-37B AIRCRAFT**

TECHNICAL REPORT AFFDL-TR-77-56
Final Report for the Period 15 May 1973 to 15 March 1977

20. ABSTRACT (Continue on reverse side if necessary and identify by block number) This report describes the successful development, in-house testing, and flight testing of a graphite/epoxy side brace for the A-37B aircraft landing gear.

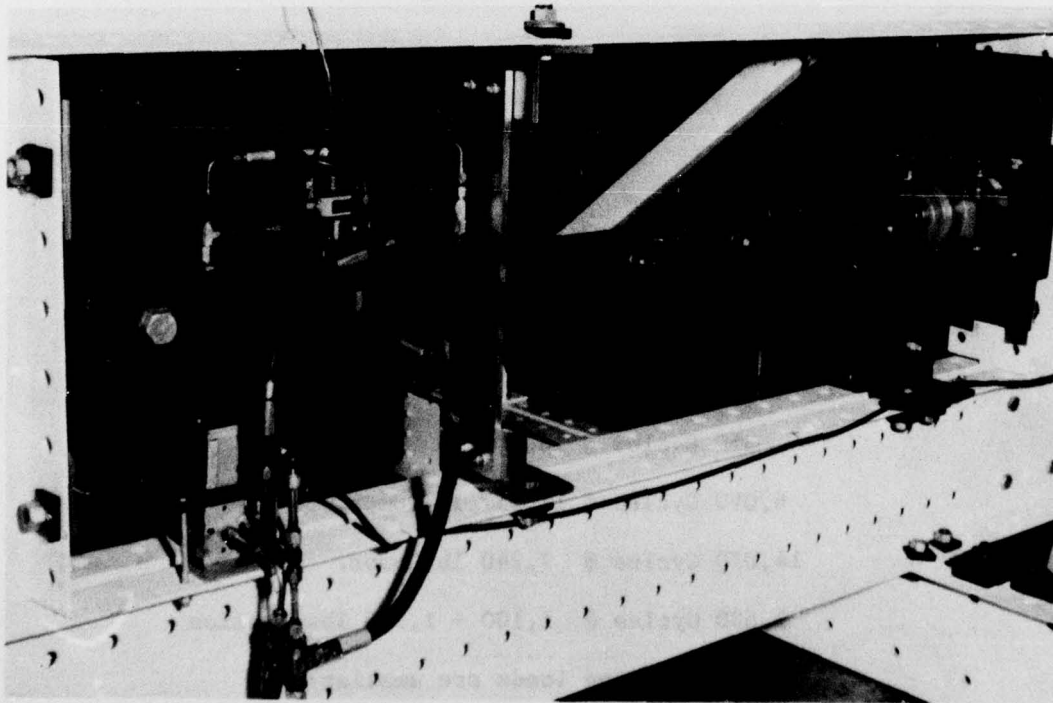
Figure 5 illustrates the test rig that was set up to conduct the fatigue test on a complete graphite epoxy side brace assembly. A rigid link was attached to the upper cross bolt of the assembly at a 45° angle to simulate the retraction linkage of the aircraft. At the time of the fatigue test, the amount of preload introduced into the assembly by this retraction link could not be determined. Thus, the linkage was adjusted so that the assembly was just "snug," in the unloaded position, with a nominal .06 inch overcenter dimension. The loads introduced into the

Figure 5. Fatigue Test of Complete Side Brace Assembly

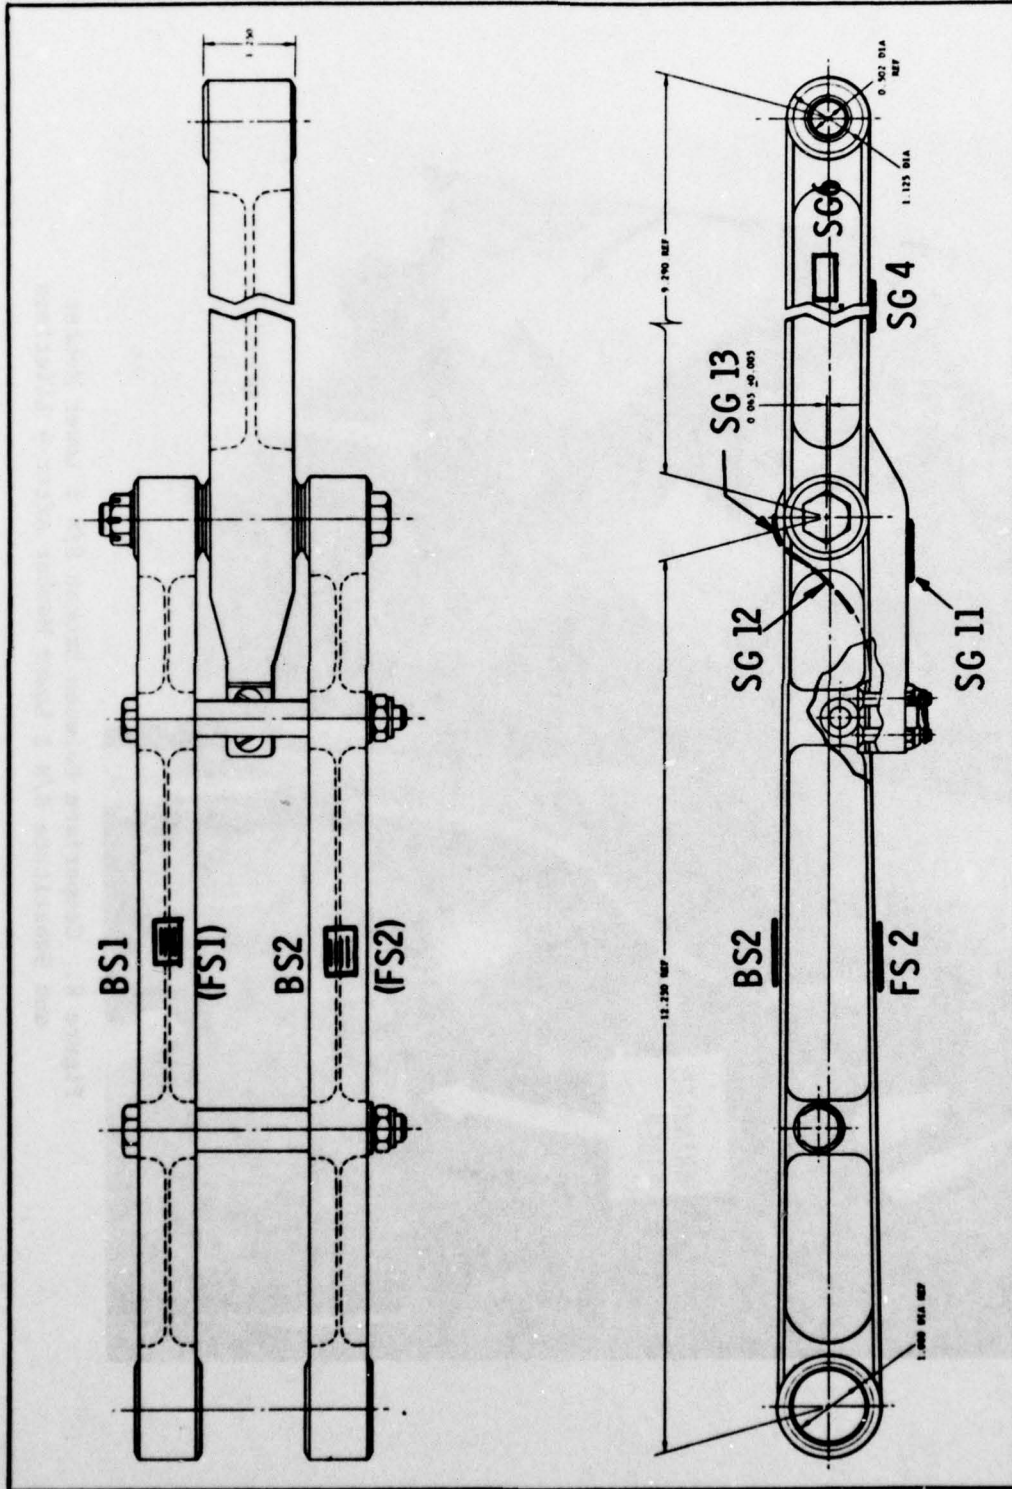
The S/N 1 lower member failed at 1.9 lifetimes into the fatigue test. Figures 6 and 7 illustrate the fatigue failure in the over-center "tang" area of the S/N 1 lower member. The S/N 1 upper members were not damaged, as shown in Figure 6, when the lower member failed, and thus the fatigue test was carried on with a substitute lower member (S/N 2). Figure 8 illustrates the fiber wrinkling which contributed to the fracture of the S/N 1 lower member (shown on the right). After the failure of the S/N 1 lower member, two additional strain gages (SG12 and SG13) were added to the overcenter "tang" area. Figure 9 illustrates the locations of all the strain gages on the side brace assembly. Strain gages SG12 and SG13 were located in the failure area of the S/N 1 lower member.

Figure 9. Strain Gage Number and Location

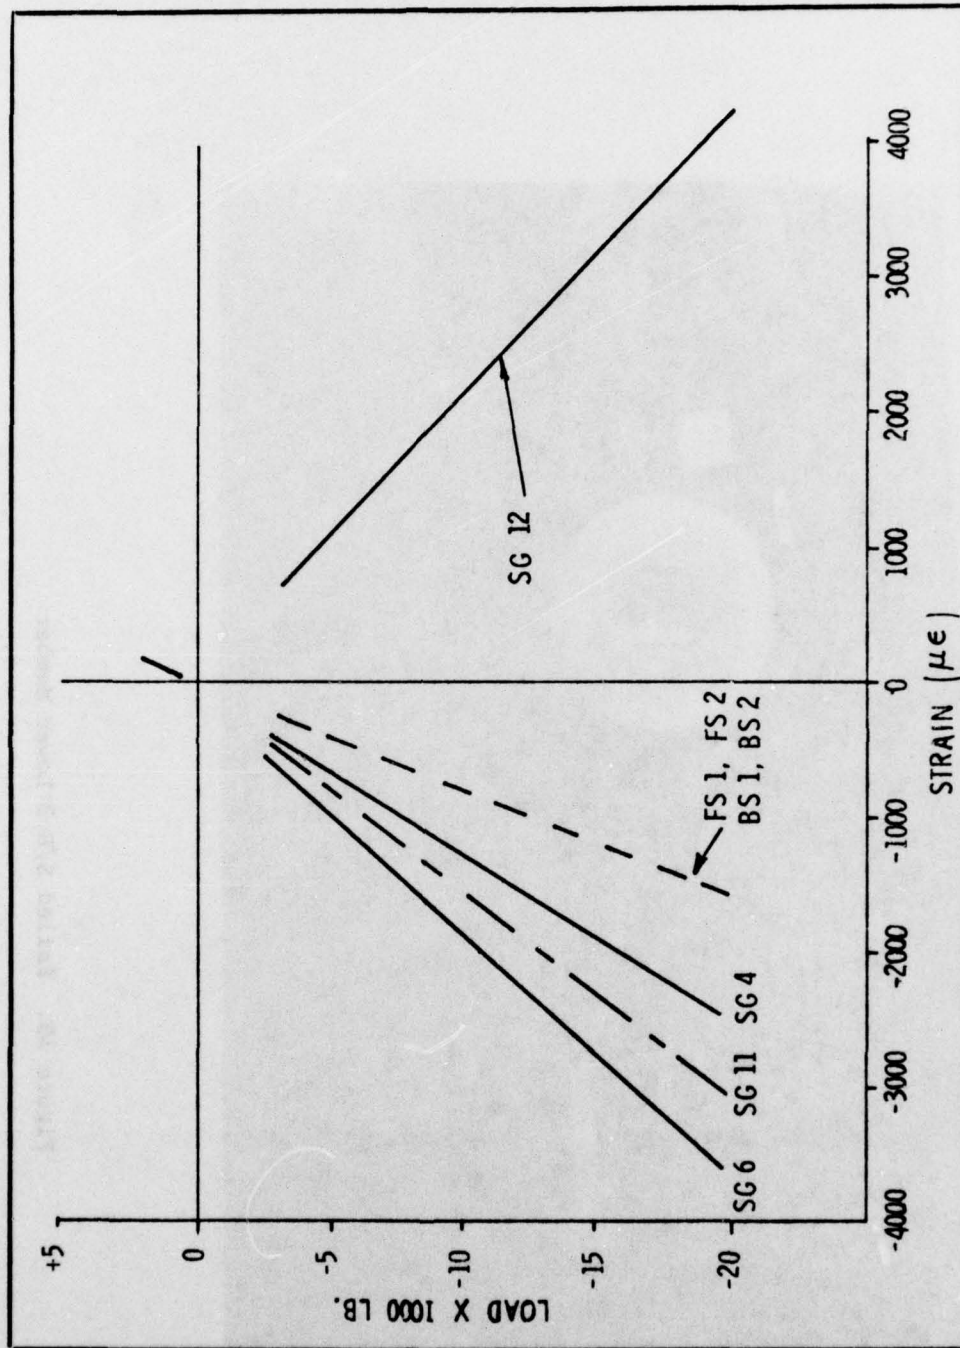
Figure 18. Typical Strain Data for the S/N 3 Assembly Subjected to a 25% Increase in Fatigue Loads

eventual failure would first occur in the overcenter area of the lower member. However, the question that obviously was not answered by these tests was how much longer the part would have lasted at the normal fatigue loads.

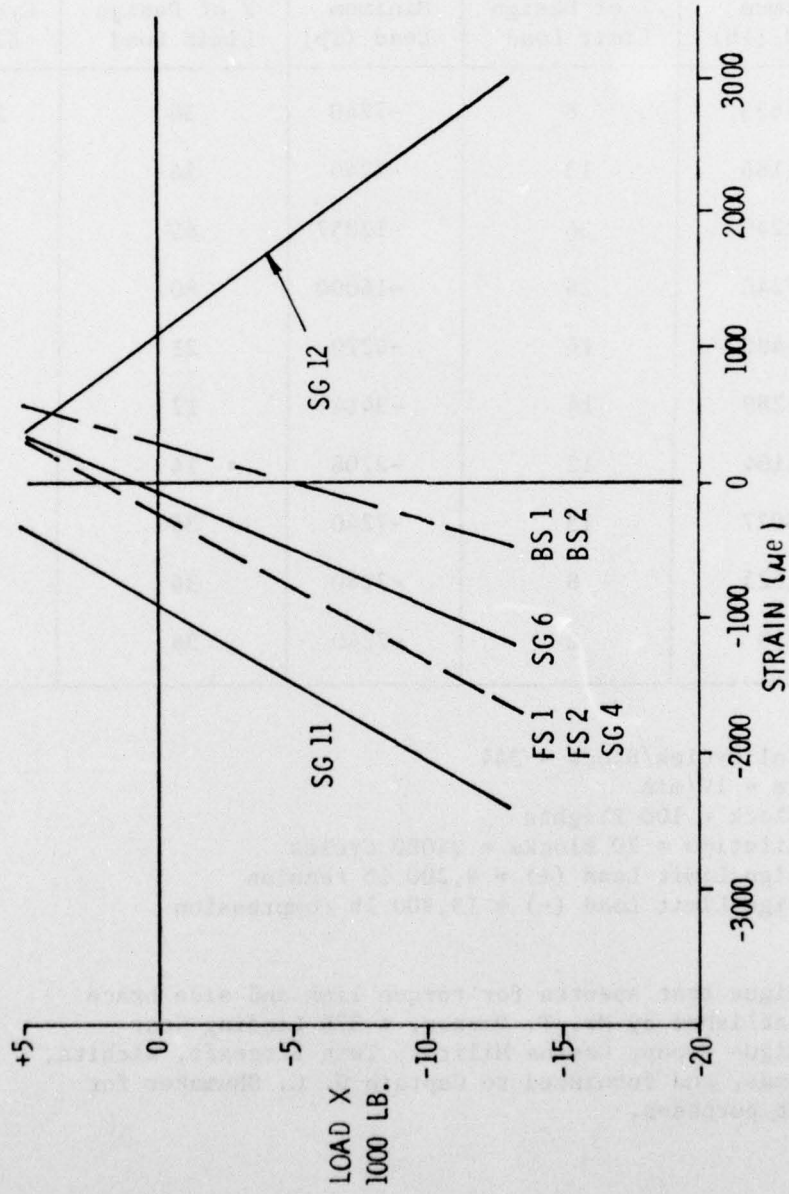
PROOF TEST STRAIN VS. LOAD

locking mechanism. This load is introduced through the upper cross bolt and positively locks the side brace in its overcenter position, once the gear is down and locked. It was a fairly simple matter to modify the proof test fixture to introduce this preload. An initial side load that gave a 1000 $\mu\epsilon$ reading at SG12 was applied to the side brace for subsequent proof tests. During the proof test of the flight test side brace, the load tester became uncontrolled and caused the assembly to be overloaded in compression. The lower side brace failed in the tang area at a compressive load estimated to be in excess of 30,000 lb. Unfortunately the strain recorder was not operating at the time, so there was no record of maximum strains achieved before failure. This unintentional destructive test did, however, corroborate the area likely to fail first and the mode of failure (Figure 26). Following this setback, the second fully instrumented graphite side brace was successfully proof tested, generating more realistic strain values with the initial side load. A plot of strain versus load is presented in Appendix B.

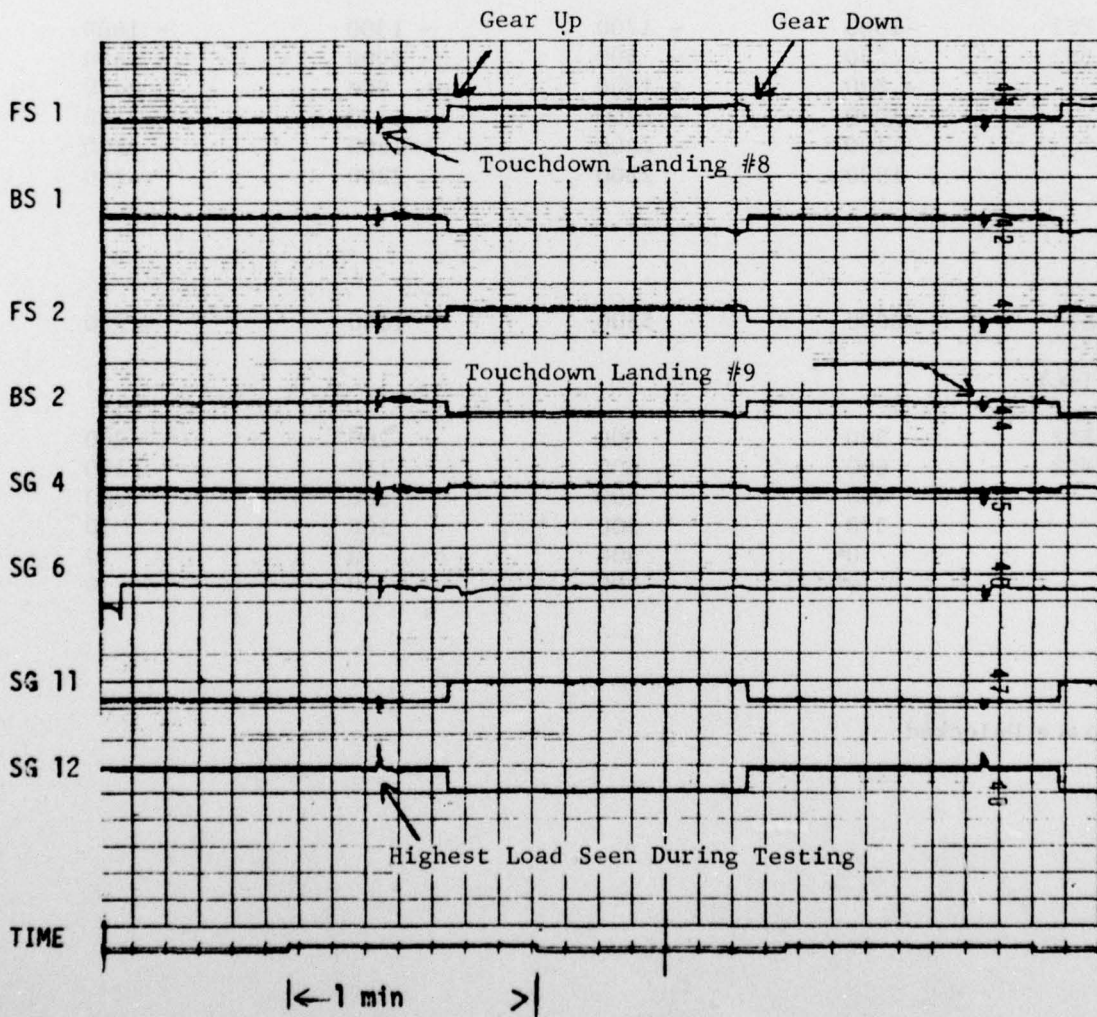
SAMPLE STRAIN DATA

This section of strip chart shows the strain data from landings 8 & 9 of the second flight. The bending load imposed on the side brace by the overcenter downlock spring is clearly seen on all channels except SG6, which is located on the neutral axis of the lower arm. On this particular flight there is some noise on SG6. The data shows that even severe landings such as this produce relatively low strains. On landing 8 SG 12 records the highest load seen on the test. This impulse load corresponds to a load of ≈ 5000 lbs, or $\approx 30\%$ of T37 design limit load.
