Report SAM-TR-77-19

**OPTICAL EVALUATION OF F/FB-111
FIELD-SERVICE-TEST WINDSHIELDS**

September 1977

Progress Report for Period 17 April 1975-16 November 1976

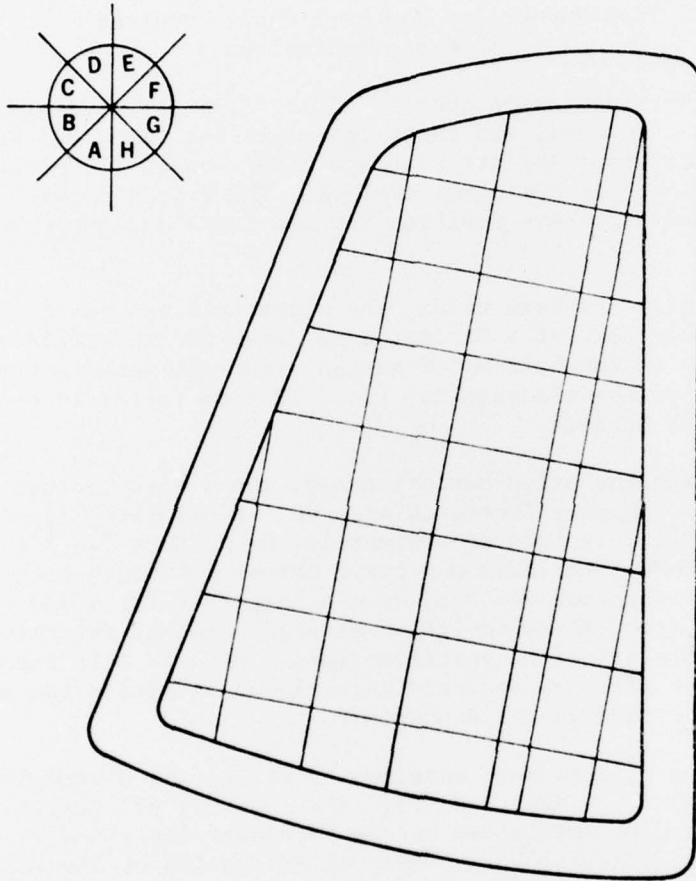
Figure 2. Prism-deviation overlay pattern.

To generate the prism-deviation map, the windshield was vertically suspended from a hoist, fore-arch area up. A template placed over the windshield divided it into approximately 10- X 10-cm (4- X 4-in) squares (Fig. 2). A HeNe laser beam was posed normally through each square, and the beam divergence was read from a target vectored and calibrated in minutes of arc. These deviation maps are used to determine if the windshield meets boresight specifications. With technic refinement, these data have afforded accurate information in predicting multiple-image locations through the windshield.
