**MEMBRANE ENCAPSULATED SOIL LAYER  
(MESL) FOR CONTINGENCY AIRFIELDS**

**U. S. ARMY ENGINEER WATERWAYS EXPERIMENT STATION  
SOILS AND PAVEMENTS LABORATORY  
P. O. BOX 631 VICKSBURG, MISSISSIPPI 39180**

APRIL 1977

**FINAL REPORT FOR PERIOD  
MAY 1976-FEBRUARY 1977**

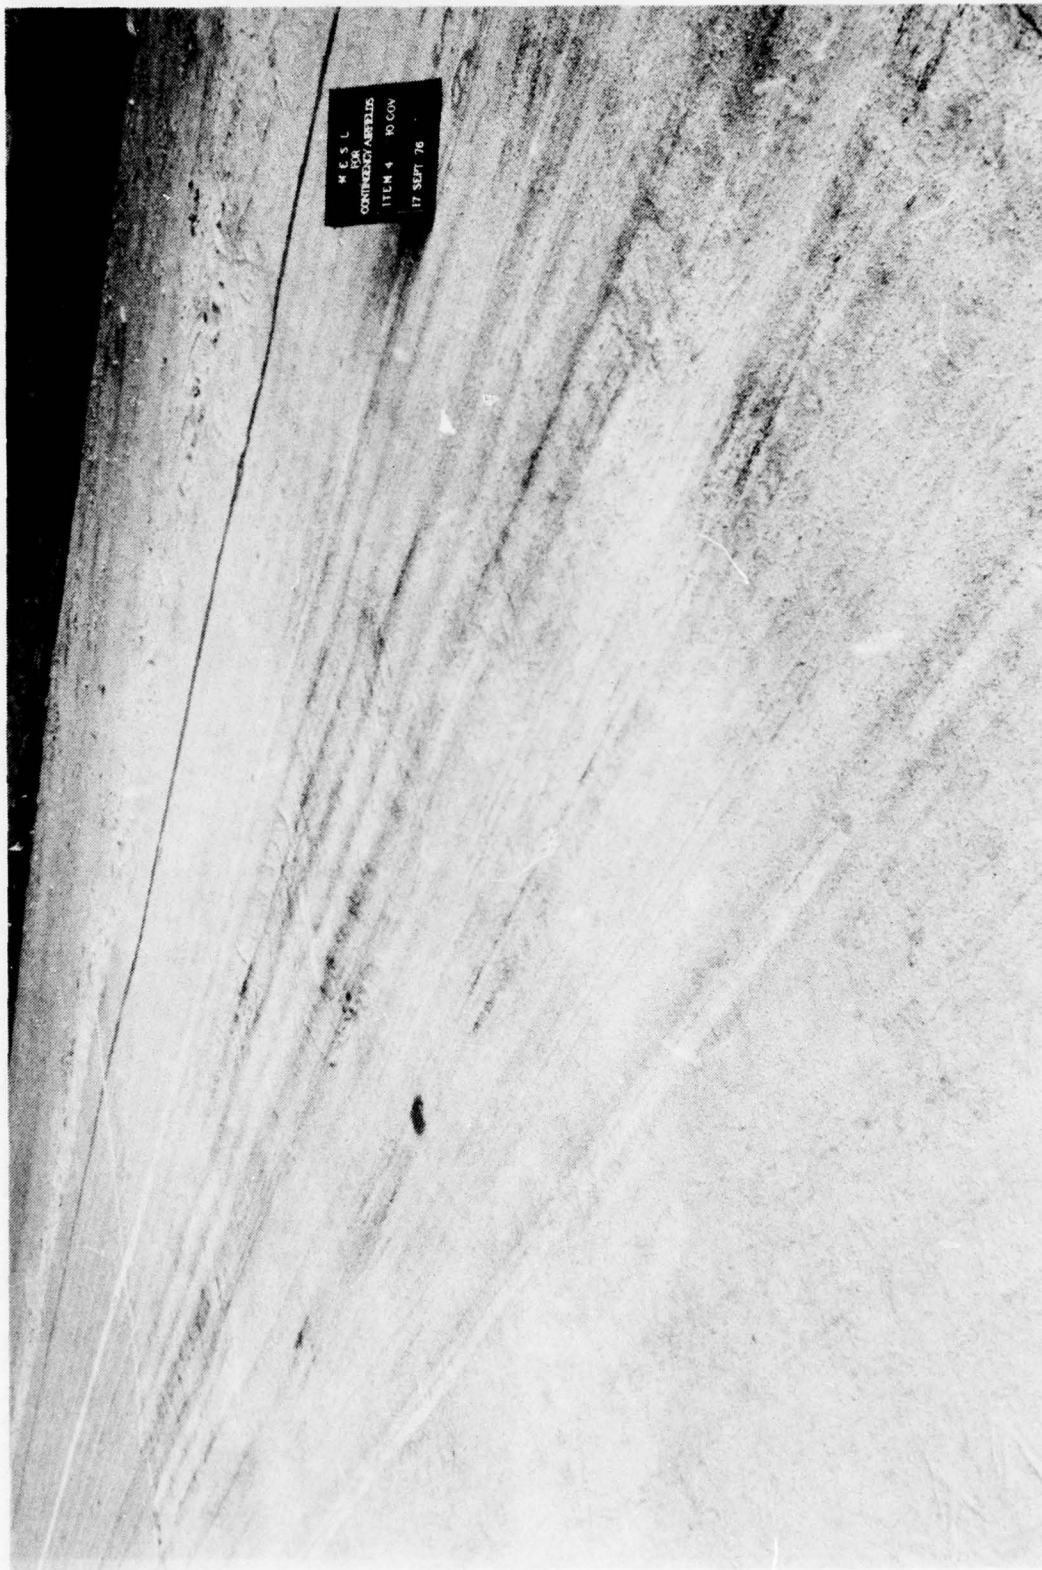
Figure 40 shows item 4 prior to traffic. Typical cross sections taken at 0, 10, and 14 coverages are shown in Figure 27. Slight wrinkling of the surface membrane and consolidation of approximately 1.5 inches, as shown in Figure 41, were noted on one-third of the item nearest to item 3 at two coverages. At six coverages wrinkling progressed to the point that it appeared to be no longer waterproof. Traffic was continued, and at 10 coverages deformation of about 3.5 inches was measured as shown in Figure 42. Wrinkling of the surfacing material was more pronounced, and the item was considered failed. Figure 43 shows the overall condition of the surface at 10 coverages. To verify that the surface was no longer waterproof, water was applied to part of the surface, and four more coverages of traffic were applied. During these coverages, it was evident from rutting that the lean clay had become wet and lost strength so traffic was terminated at 14 coverages.

Figure 43. Item 4 After 10 Coverages

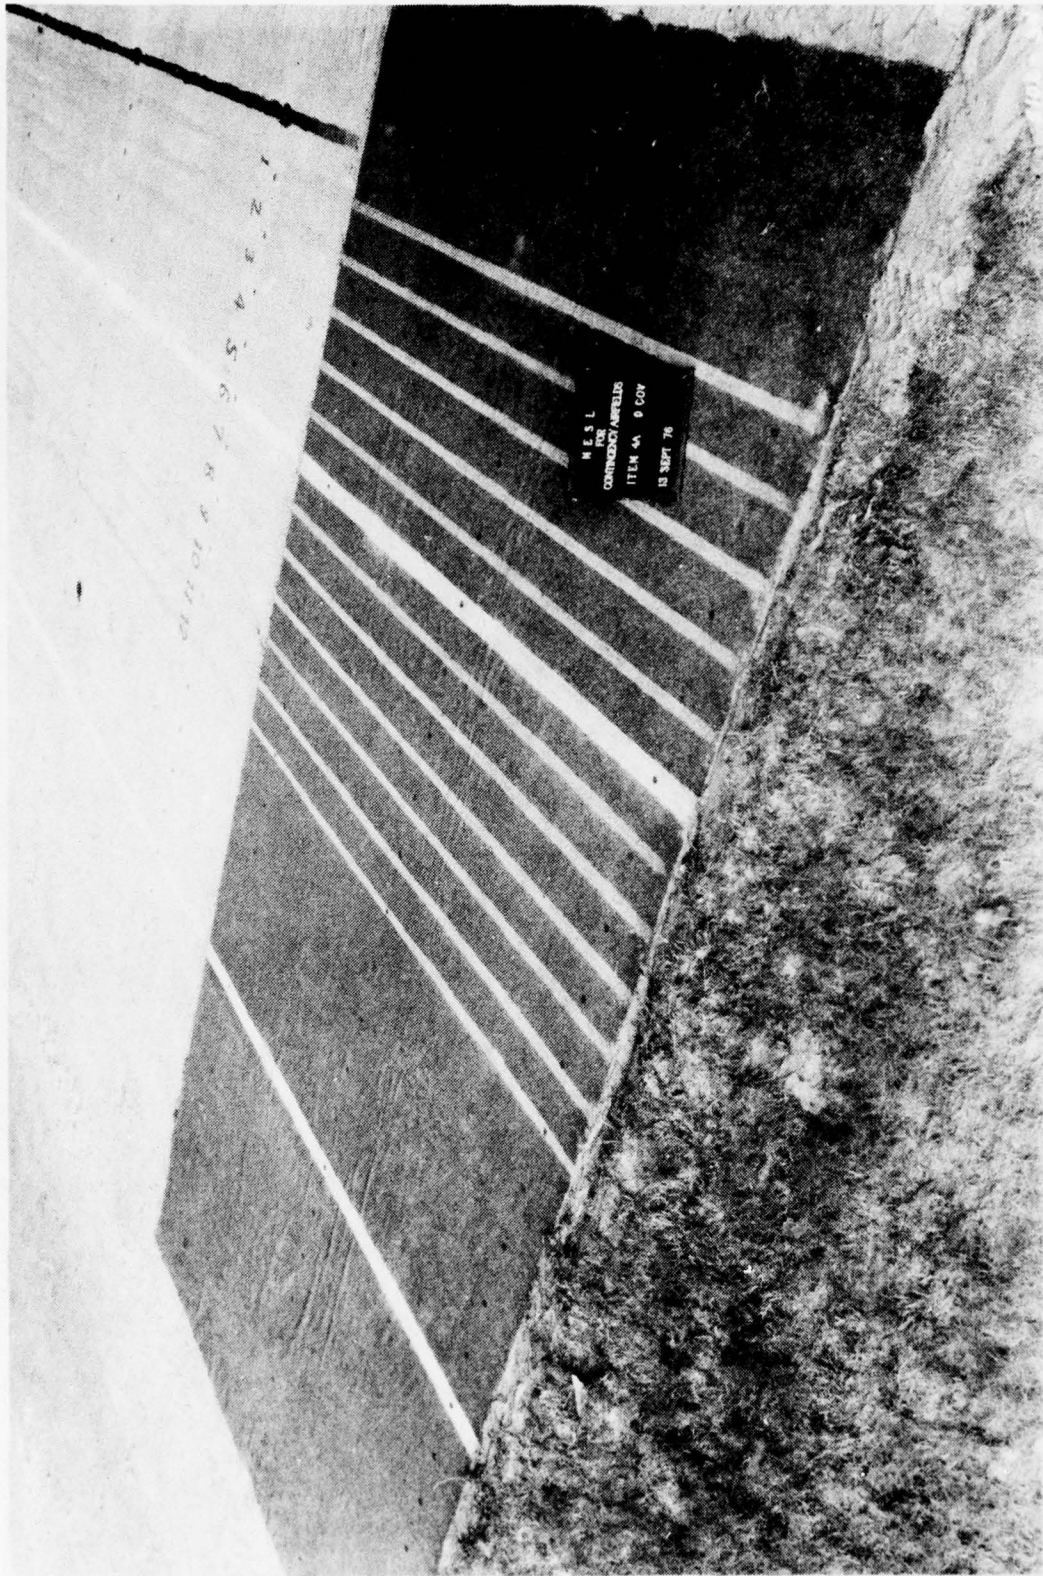
Figure 44 shows item 4A prior to traffic. Typical cross sections are shown in Figure 27. The half of the item located adjacent to the sod section, item 5, was affected by water migrating into the MESL from item 5. Wrinkling of the surface of the artificial turf occurred under traffic, and the material pulled loose from the surface of the MESL causing it not to conform to permanent deformation in ruts. No tears or other damage were noted in the material under traffic. After 10 coverages of traffic, permanent deformation of 2.5 inches, as shown in Figure 45, was measured. Traffic was terminated after 10 coverages, and the item considered failed due to the material tearing loose from the MESL surface and rut depth approaching depth required for failure. Figure 46 shows the surface after 10 coverages.

Figure 44. Item 4A Prior to Traffic

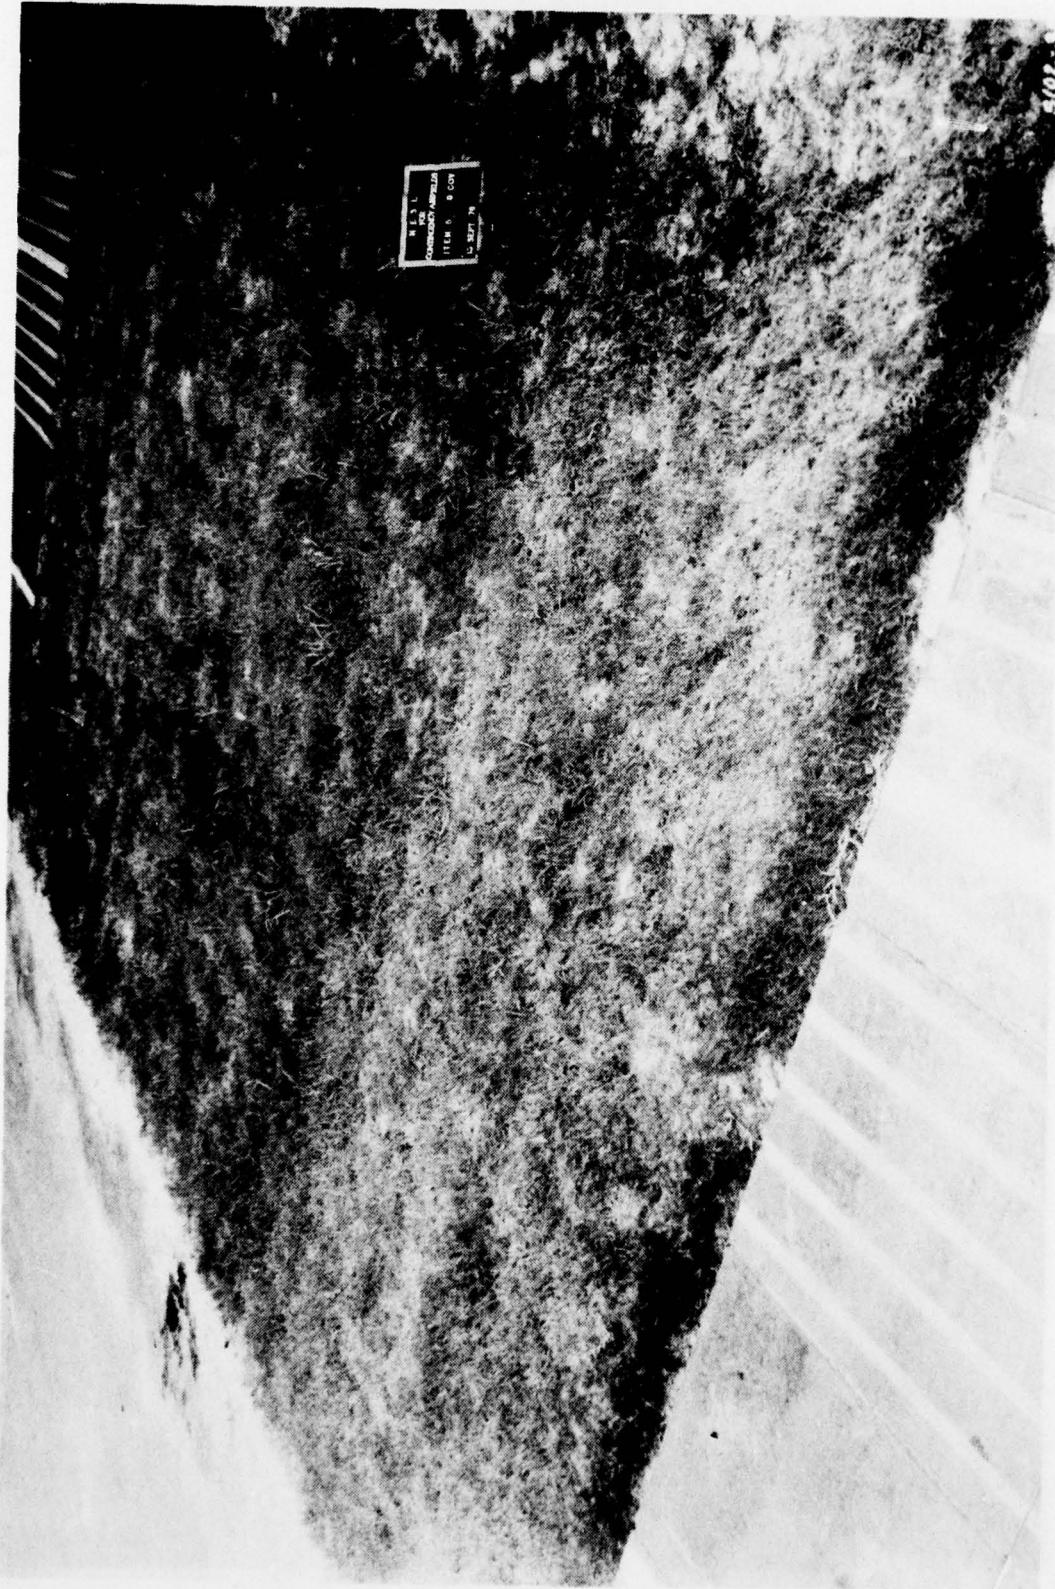
Figure 47 shows item 5 prior to traffic. The item failed on the first pass of the load cart during the rolling-wheel drawbar pull test. A rut depth of about 4 inches, as shown in Figure 48, developed as the load cart was towed onto the item. Moisture had penetrated through the surface of the MESL into the lean clay, causing a loss in strength of the MESL.

Figure 47. Item 5 Prior to Traffic

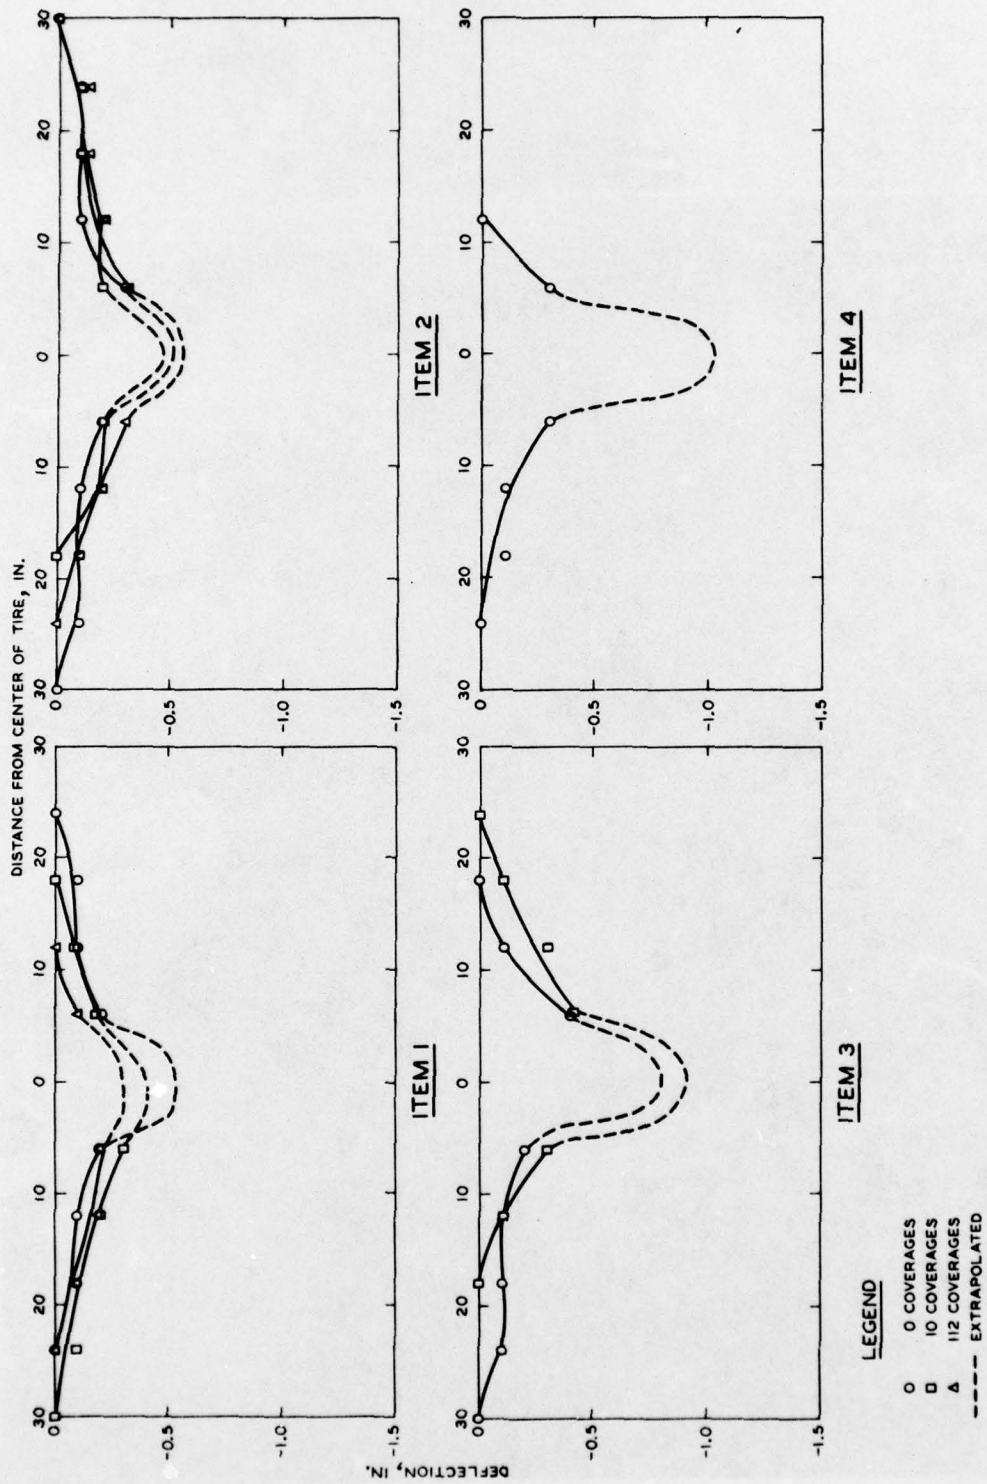
Deflection measurements were taken in items 1 and 2 at 0, 10, and 112 coverages; in item 3 at 0 and 10 coverages, and in item 4 at 0 coverages. Plots of deflection measurements are shown in Figure 49. These plots show that the deflection in item 1 decreased with the application of traffic. In item 2 the deflection decreased from 0 to 10 coverages, but at 112 coverages the deflection was greater than at 0 coverages. In item 3 the deflection increased from 0 to 10 coverages. Deflections were taken only at 0 coverages in item 4 because at 10 coverages the load wheel continued to sink when it was stopped on the item. Permanent deformation measured at the center of the load wheel, after the load wheel had been removed for 5 minutes, at 0 coverages was 0.4, 0.4, 0.7, and 0.9 inches for items 1, 2, 3, and 4, respectively. At 10 coverages permanent deformation was 0.2, 0.4, and 0.6 inches for items 1, 2, and 3, respectively. At 112 coverages permanent deformation was 0.1 and 0.2 inches for items 1 and 2, respectively.

Figure 49. Comparative Deflections

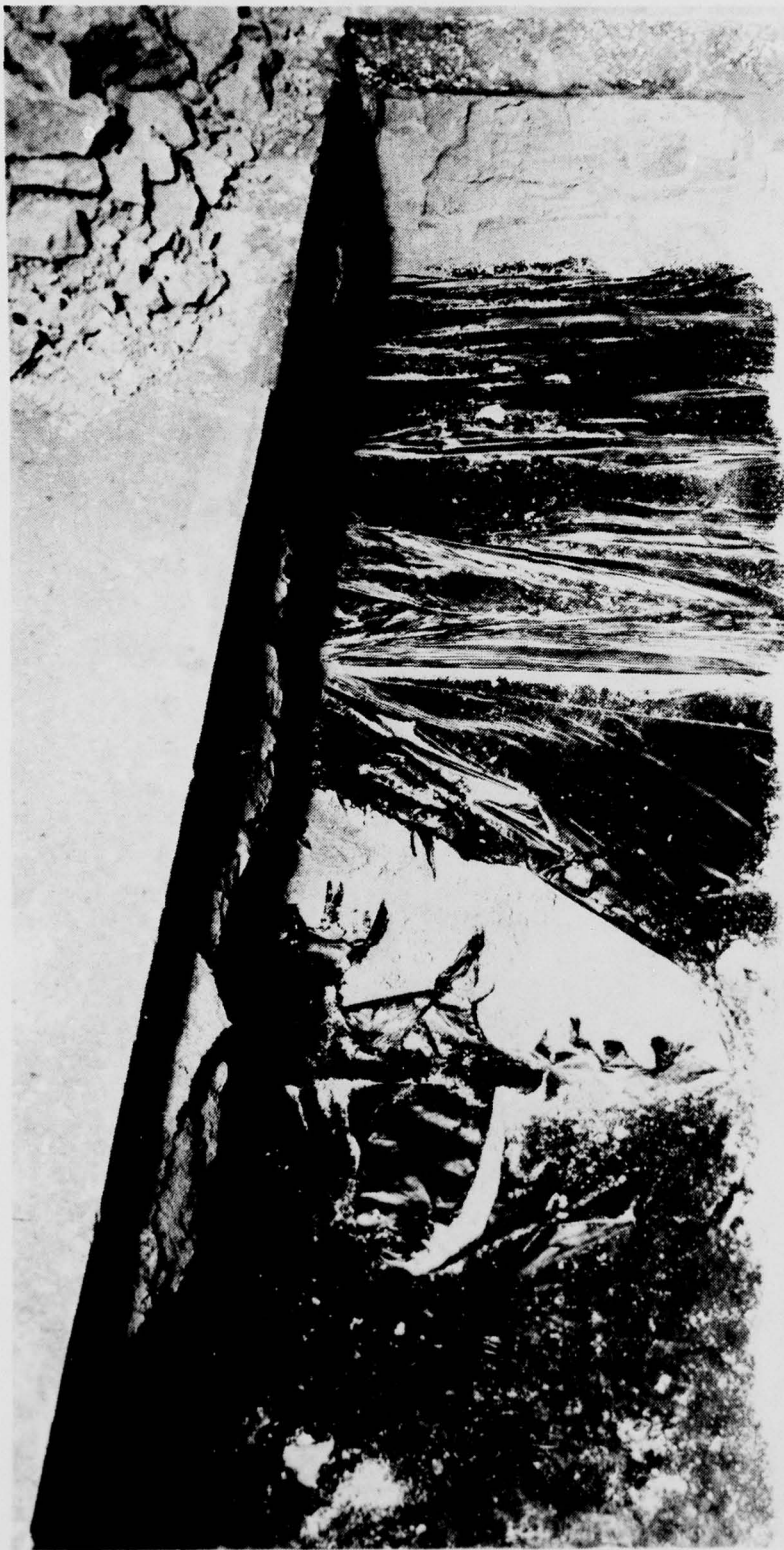
Figure 50. Polyethylene Membrane on Bottom of MESL  
After Traffic, Item 1

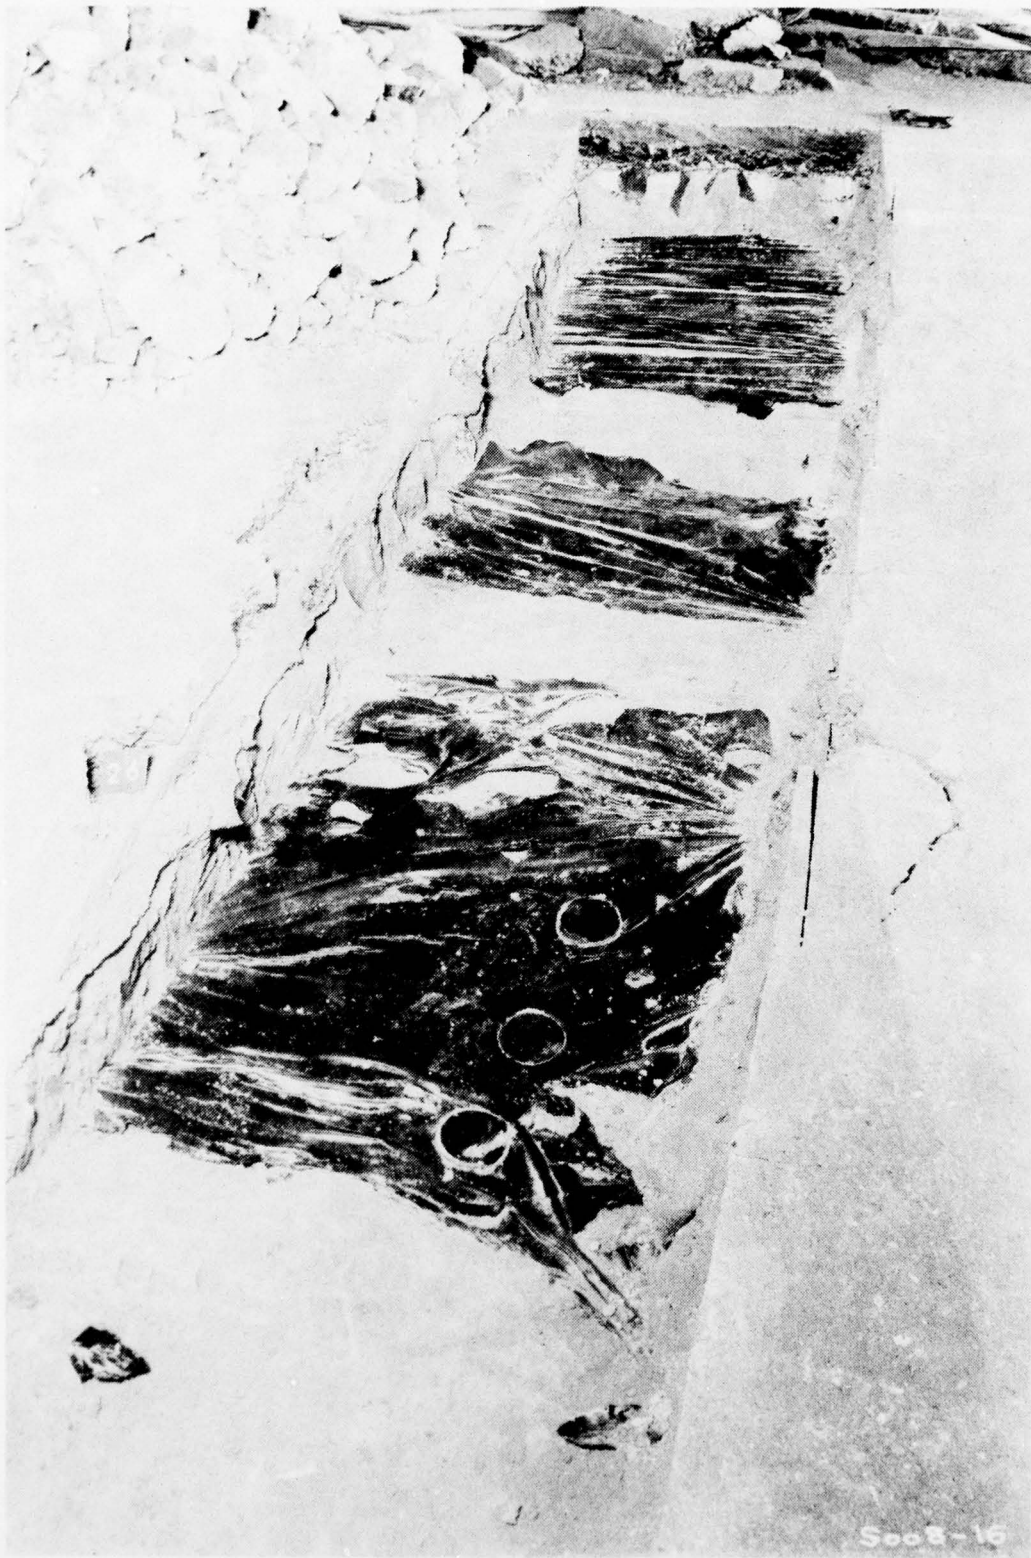
Figure 51 shows the test trench after the lean clay material in the MESL was removed. As shown, the polyethylene membrane used at the bottom of the MESL had worked to the edges, as in item 1, but in this item the membrane had torn; therefore, the MESL was no longer waterproof at the bottom.

Figure 51. Polyethylene Membrane on Bottom of MESL  
After Traffic, Item 2

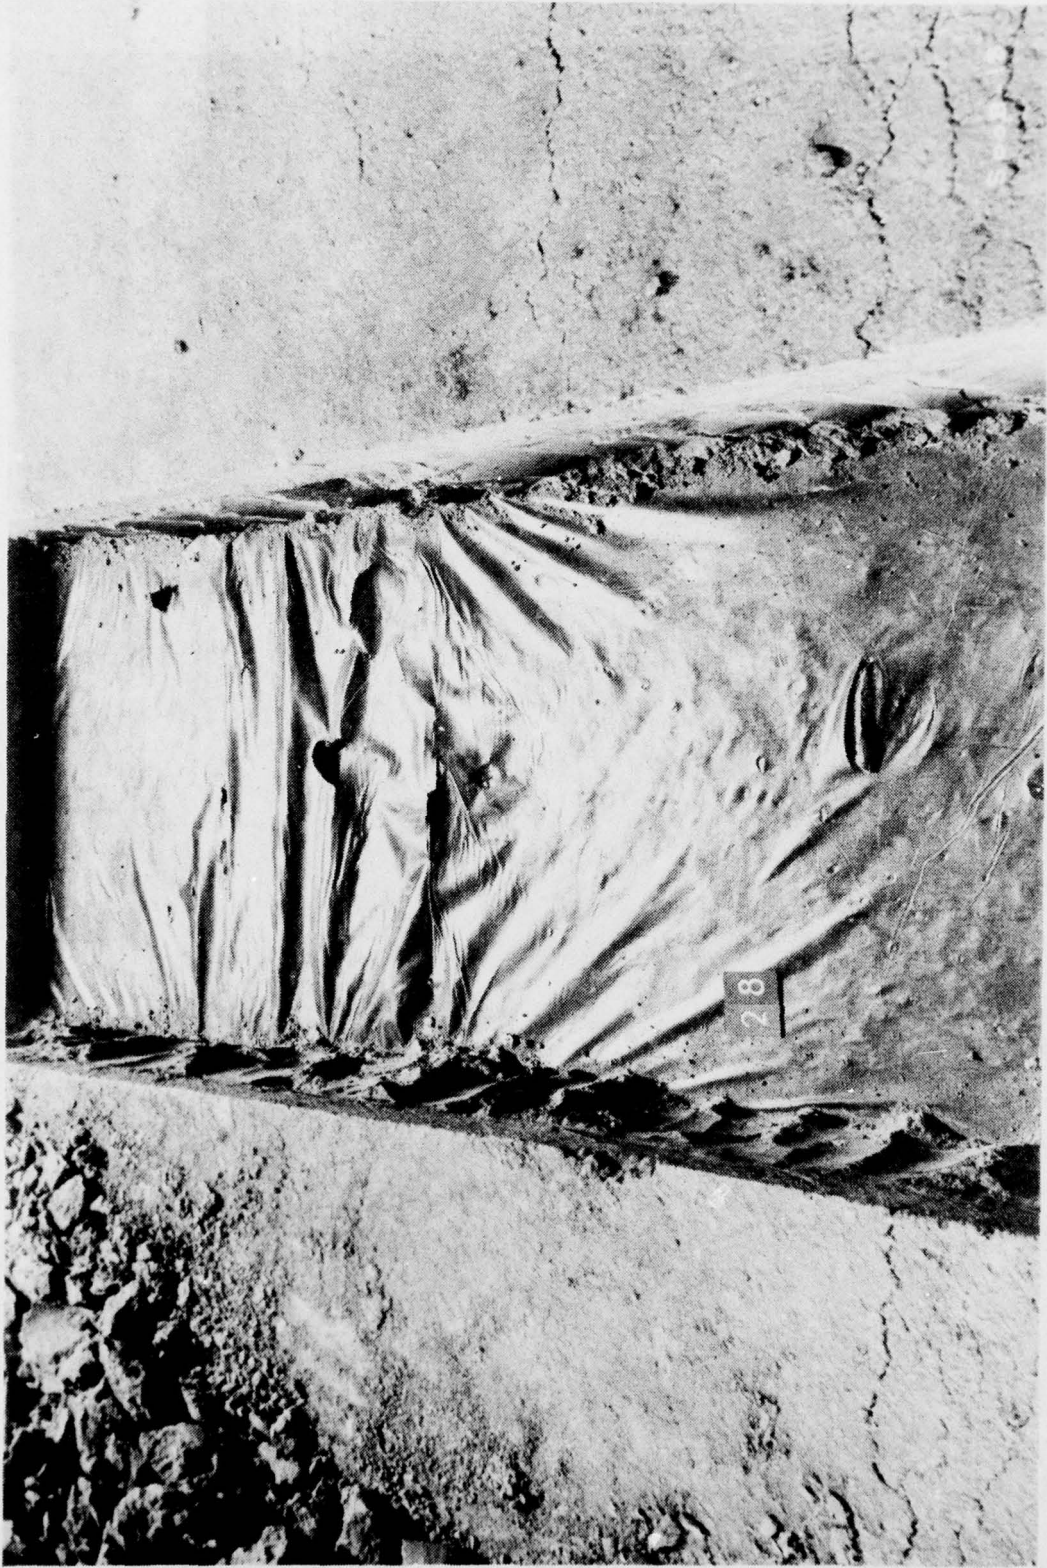
In-place tests on the subgrade show that the water content and density were about the same after traffic as during construction, but the CBR had increased from 7 to 9. Figure 52 shows the slab of asphaltic concrete removed from the test trench, cracks that developed the full depth of the pavement, and wet lean clay that adhered to the top membrane when asphaltic concrete was removed. Figure 53 shows that the polyethylene membrane at the bottom of the MESL was intact but began to fold at the edge of the traffic lane.

Figure 53. Polyethylene Membrane on Bottom of MBSL After Traffic, Item 3
