HEADQUARTERS STRATEGIC AIR COMMAND
DIRECTORATE OF AIRCRAFT MAINTENANCE
AIRCRAFT ENGINEERING DIVISION
(Hq SAC/LGME)
OFFUTT AIR FORCE BASE, NEBRASKA 68113

ENGINEERING REPORT NO. P-206
TF30-P-7 INSTALLED TRIM CORRECTION

14 January 1977

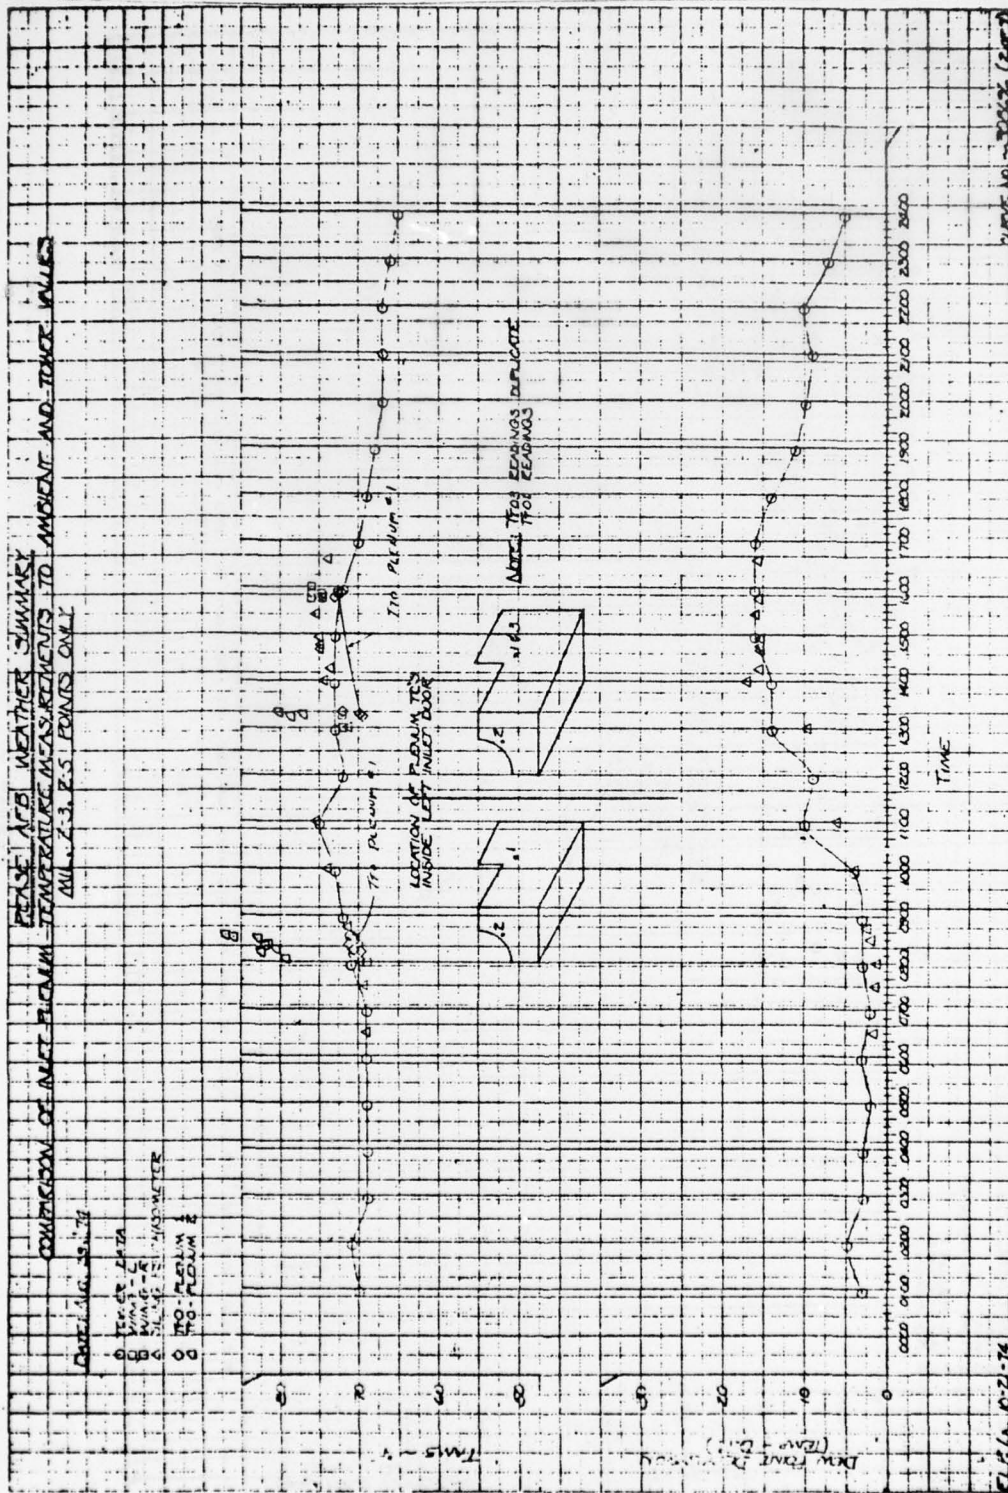
Figure 4

(3) Significant differences were noted between temperature and dew point readings recorded at the base weather observation point and those recorded at the power check pad. See Figures 2, 3, 4, and 5 for examples. The desired engine performance is calculated based on ambient conditions existing at the time of the engine trim run. A deviation of 5°F temperature between what is measured and what goes into the engine

will cause an apparent performance change of a military trim band magnitude. A 5°F dew point deviation will cause a change of 1/2 military trim band magnitude.

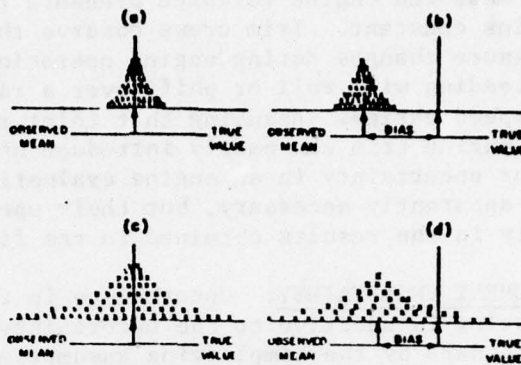
Fig. 1 Accuracy, precision, and bias

5. ACCURACY, PRECISION, AND BIAS: A quick appreciation for the meaning of the words accuracy, precision, and bias (or systematic error) can be obtained by viewing Figure 1. The observations plotted in Figure 1(a) are precise and unbiased. In Figure 1(b) the observations are precise and biased. In Figure 1(c) the observations are imprecise but unbiased, and in Figure 1(d) the observations are both imprecise and biased. Precision has to do with the scatter of the observations about a point of central tendency. Bias is the difference, if any, between the true value (TV) and the mean of the observations. Accuracy is a more general term, encompassing both the concepts of precision and bias. The least accurate observations are those found in Figure 1(d), the most accurate in Figure (a).

6. INSTRUMENT VARIATION: The illustrations on Figure 1 show that an instrument usually does not repeat exactly on repeated observations.

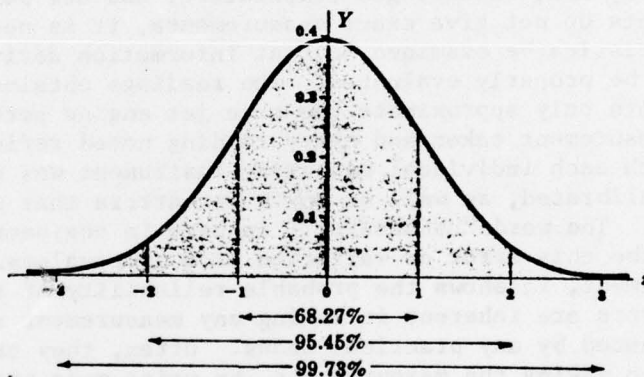
Fig. 2 THE NORMAL DISTRIBUTION

7. RANDOM ERROR DISTRIBUTION: The Gaussian (or normal) distribution is the familiar bell shape curve of statistics which represents the frequency distribution function derived from study of a large number of random unrelated events (see Figure 2). It is used in statistics as the description of random events and, therefore, as the basis for establishing confidence intervals in sampling. (An engine trim represents a single sample of engine performance from the performance distribution for the engine and test instrumentation.) A statistical term, standard deviation (SD), associated with any distribution is the measure of the width of the bell curve about the mean for a given set of data. A measure of scatter or imprecision of repeated measurements is provided by the square of the standard deviation. This is the variance in a series of observations and defined as the mean of the sum of the squares of the deviations of observations from their average. The percent of total observations in the distribution that fall within a given amount or interval of the mean can be predicted if the standard deviation is known. For example, 68.3% of all readings in a normal distribution will fall between plus and minus one SD, 95.4% will fall between plus and minus two SDs, and 99.7% will fall between plus and minus three SDs. Likewise, knowing the standard deviation, we can also define the percentage of total observations that fall within any specified error interval. For example, for a commonly used "confidence interval" of 90%, a normal distribution would have 90% of all errors equal to or less than 1.645 standard deviations. Another

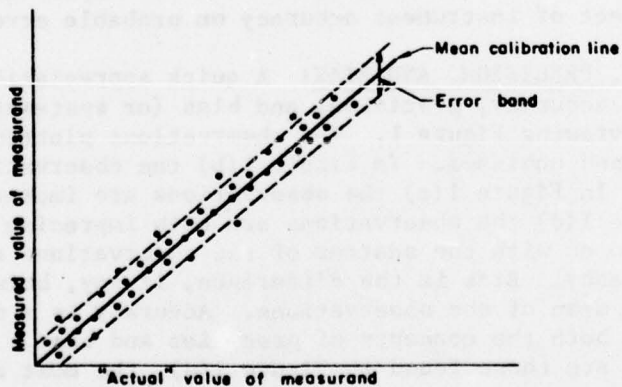
Fig. 3 System accuracy defined as the relationship between the measured value of a parameter and its "actual" value (see text).
