Technical Report 260

**FIELD TEST OF A MESL
(Membrane-Enveloped Soil Layer)
ROAD SECTION IN CENTRAL ALASKA**

July 1975

CORPS OF ENGINEERS, U.S. ARMY

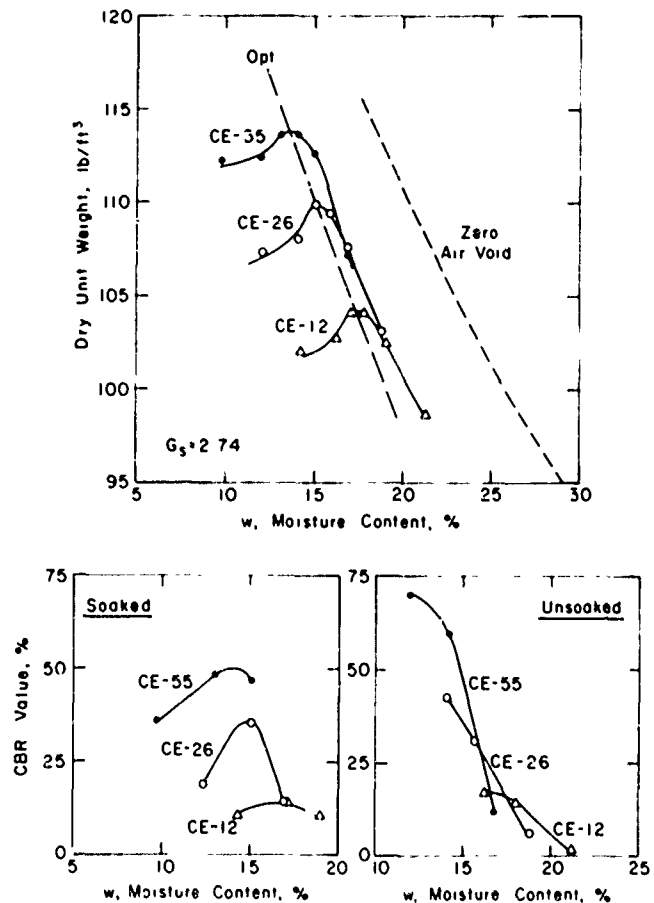
Figure 3. Silt compaction and CBR versus moisture content.

The compaction curve for the embankment silt (Fig. 3) indicates the CE-12 optimum to be 104.0 lb/ft³ at 17.5% moisture content (all values presented here are recorded in Table 1). The field compaction test on the first lift of silt gave values of 99.5 lb/ft³ and 16.9% moisture, and soil cores taken after construction showed that the silt moisture content averaged approximately 13.1%. Consequently the field compactive effort approximated densities in the order of 96% of the CE-12 compaction test. The lower than optimum in-place moisture content of the MESL is believed to be an even more important requirement than achieving optimum density for maintaining the soil strength in frost areas to minimize or prevent moisture migration during freezing.

As a matter of necessity, the use of fine-grained materials as structural layers requires the prevention of moisture absorption to maintain strength. Evidence of this is shown in Figure 3 with the plotted results of the soaked and unsoaked C_R values and molded moisture contents. The soaked samples show a large decrease in the CBR values for molding moisture contents above and below the optimums. Figure 12 shows the general increase in moisture content within the MESL between August 1970 and April 1972 at stations 1+00 and 2+40. Moisture contents at station 2+40 tended to average slightly above the 17.5% CE-12 optimum level with a maximum value of 23.2% at a depth between 8 and 12 in. The moisture content in the vicinity of station 1+00 also showed an increase in this

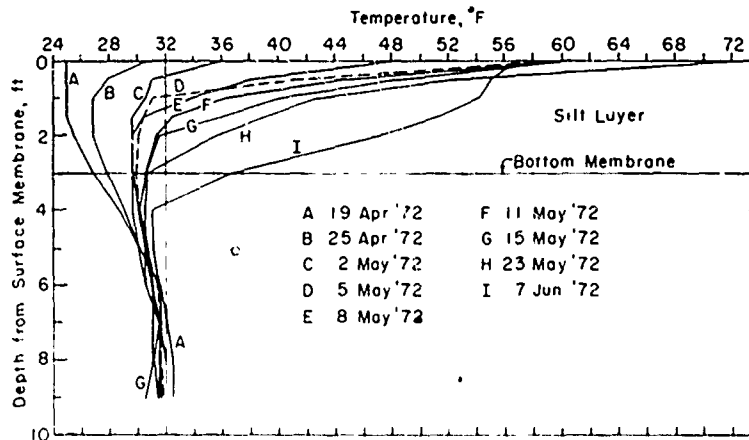
Figure 9. Temperature gradients in MESL during thaw-trafficking at station 2+41.

The temperature gradients in Figure 9 show the thaw progression more closely during the May 1972 traffic tests. From interpolation of the thermocouple readings, thaw of the silt embankment began on 27 April 1972, and reached the 3-ft depth approximately one month later. Therefore, when the May 1972 traffic passes were started, the thaw had progressed about 1 ft into the top of the MESL.

Benkleman beam tests were performed on the MESL upon completion of the May 1972 tests. At that time, thaw had progressed about 2 ft down into the MESL (Fig. 9). The traffic test vehicle deflections on the left track varied between 0.021 and 0.286 in. The right track deflections were considerably greater, ranging from 0.045 to 0.429 in. As might be expected, the highest deflection in each wheel track occurred in the area of greatest rutting—specifically, the 0.429-in. deflection occurred in the right wheel track near station 0+60, and the 0.286-in. deflection occurred in the left wheel track near station 1+15. The results of these tests are given in Table II. The standard axle loading for Benkleman beam testing on permanent roads is 18,000 lb. Trucks presently in the military inventory were used for these tests to obtain data for seasonal comparisons only.

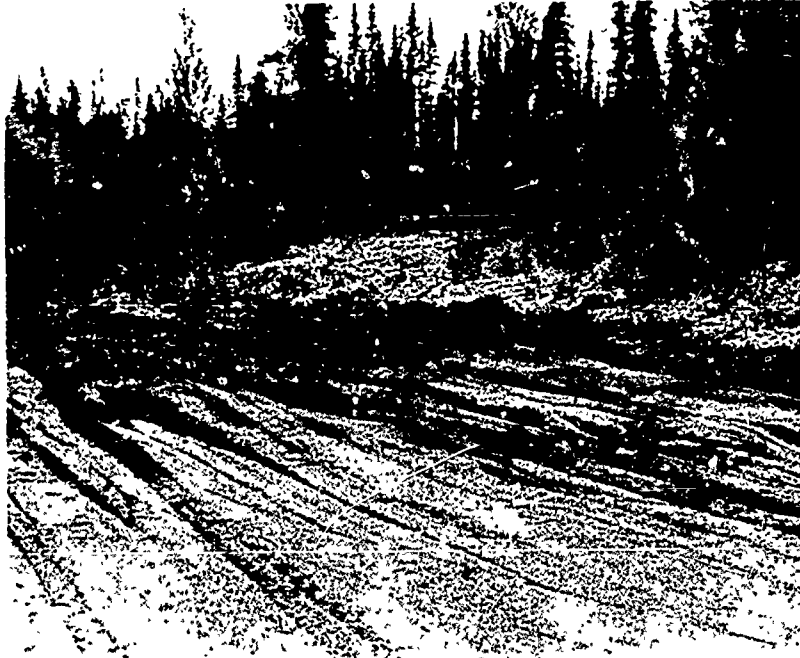
Figure A3. Compacted subgrade at north end of road.

After compaction of the subgrade, CBR tests were made with the lower membrane in place. At station 2+30, where the high moisture content silt subgrade was present (Fig. A3), a CBR of 1.0 was obtained (all figures given here are for a 0.2-in. penetration of the piston). At station 1+40, where the silty gravel was placed and compacted, the CBR was 23.0. Upon completion of the MESL, CBR values obtained on top of the top membrane were 6.0 and 12.0 for stations 2+40 and 1+40, respectively.

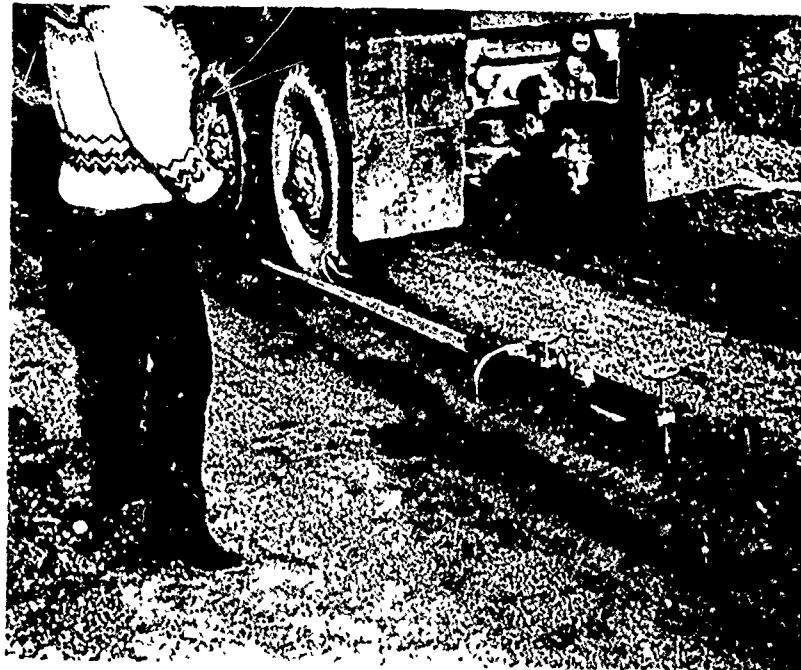
Figure A20. Benkleman beam test on MESL during October 1970.

Before significant traffic had occurred on the MESL section, Benkleman beam tests were run on it in early October 1970 (Fig. A20). With a 10-kip per axle, tandem-axled, single-wheeled dump truck moving along the section, wheel track deflections of 0.022 to 0.042 in. were observed. The tests were conducted again with a 9.4-kip axle load on the same truck in May 1971 (Fig. A21) and the deflections ranged from 0.012 to 0.024 in. Even though some frost had entered the ground before the October test, and the surface of the MESL had thawed slightly before the May 1971 deflection tests, the data show that the section behaved more like an unfrozen section in October, and more like a frozen section in May. These small deflections show that the section had not noticeably deteriorated with freezing and thawing during the first season. Benkleman beam data, and all other traffic data discussed in this section, are presented in Table II.

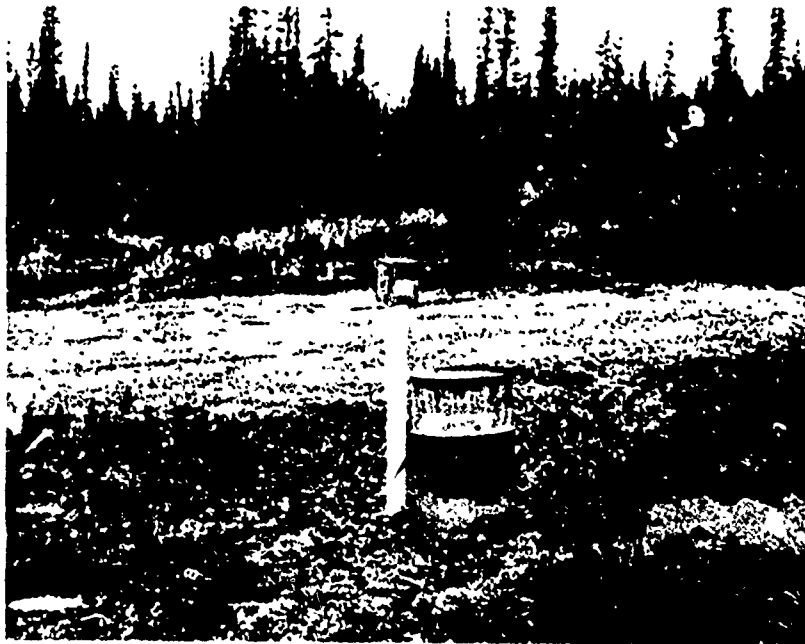
Figure A33. Thermocouple switch location at north end of MESL.

In September 1971 a thermocouple assembly of 12 points was installed at centerline (Fig. A33) to a depth of 9 ft below the MESL surface (Fig. 5). The opening in the bottom membrane was not sealed after the thermocouple assembly was installed. Readings were taken during trafficking to observe the progression of the thaw line within the MESL. Figures 6 and 7 reflect the severity of freezing and thawing which occurred in the Fair-
