**HYDROFLUIDIC STABILITY AUGMENTATION SYSTEM (HYSAS)
OPERATIONAL SUITABILITY DEMONSTRATION**

Honeywell Inc.
1625 Zarthan Avenue
St. Louis Park, Minnesota 55416

October 1977

Final Report for Period March 1973 - March 1977

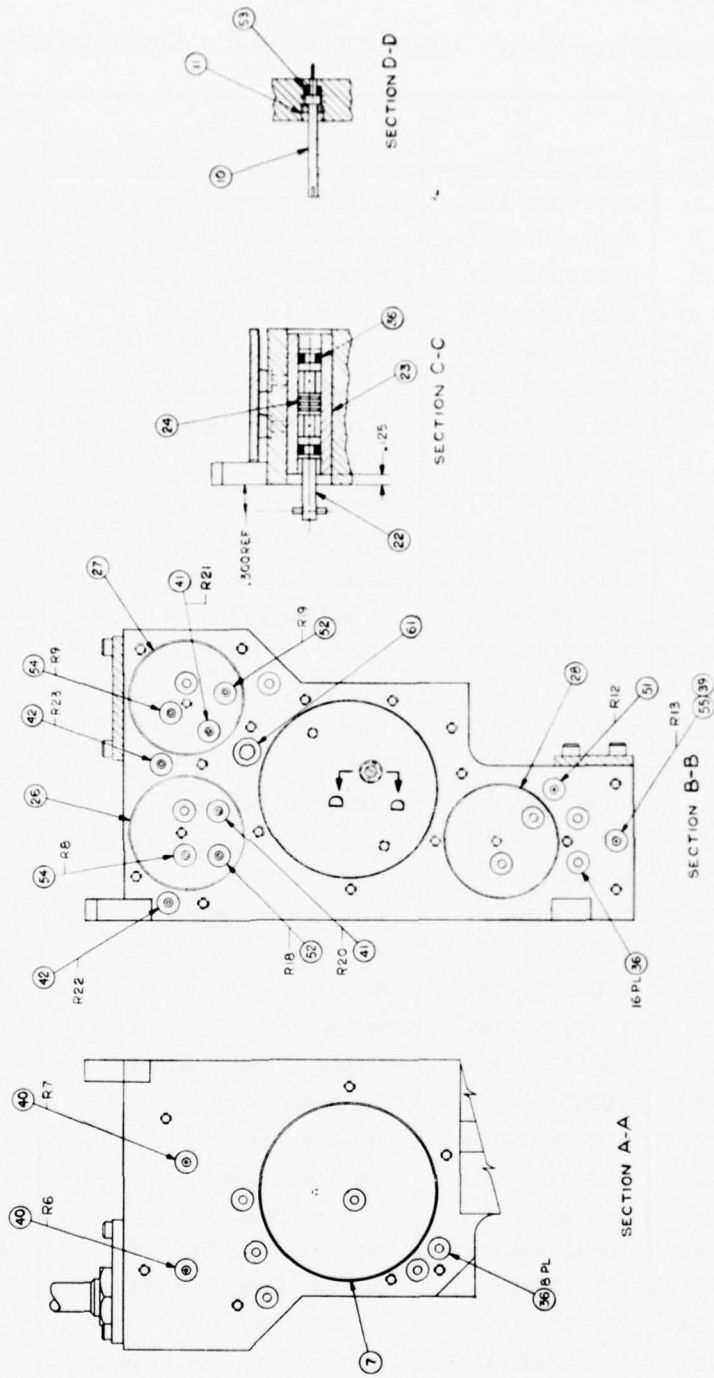
Figure 2. YG1143 Yaw Axis Controller Assembly Drawing (Concluded).

PID leakage was the demonstrated or suspected cause of leakage in seven malfunctions: B02012, B02022, B02023, B02031, B02044, B02049, and B02052. A drawing of the PID spool and sleeve is designated as Section C-C in Figure 2, and the spool can also be seen in Figure 3. The spool seal design is identical to that designed on Contract DAAJ02-72-C-0051 (Reference 1). It proved to be satisfactory in laboratory tests and in flight tests. This design uses substantially less "O" ring compression than that of similar standard applications to reduce friction and to prevent damage to the "O" ring during assembly. If the compression were large, the "O" ring would extrude into the metering slot during assembly and this material would be sheared off as the "O" ring moved past the end of the slot. This would not only damage the "O" ring but it would also introduce contamination. A complete redesign will be required in future applications, and it must have the following features if a spool and sleeve configuration is selected.

The PID design was marginal; however, many of the installations worked satisfactorily throughout the 1-1/2-year program. Those that leaked did so only when the aircraft was parked. Internal pressure under this condition was equal to a head of several feet of oil, which is insufficient to seat the "O" ring. During laboratory testing, the level of the reservoir was below that of the PID valve, thus preventing external leakage; during operation or flight, the pressure was very high, thereby seating the "O" ring. It appears that the "O" ring became unseated when the aircraft was parked and the pedals were moved with the hydraulic system off.

BIT leakage was found during installation but was never experienced after the aircraft had completed its initial ground check. The BIT assembly is defined as Section D-D in Figure 2. The null adjust pin (No. 10 in Figure 2) and the "O" ring are retained by the locking sleeve (No. 11). This sleeve tends to work loose when BIT is depressed and released repeatedly (i. e., when the null adjust pin is rotated repeatedly). To correct the problem, this sleeve was permanently "staked" using a center punch on all units. This "staking" can be seen in Figure 34. All of the OH-58 units and some of the TH-57 units received this modification before they were shipped. The remaining TH-57 units were modified on site in Pensacola.

An interim corrective action consisted of using a larger 006 "O" ring in place of a standard 005 "O" ring to slightly increase compression. This corrective action was incorporated in all Pensacola units in October 1975. OH-58 yaw axis controllers received this modification whenever a problem occurred or whenever they were returned to Minneapolis for another problem. The larger "O" ring reduced the problem but some seepage was observed on units incorporating the modification.

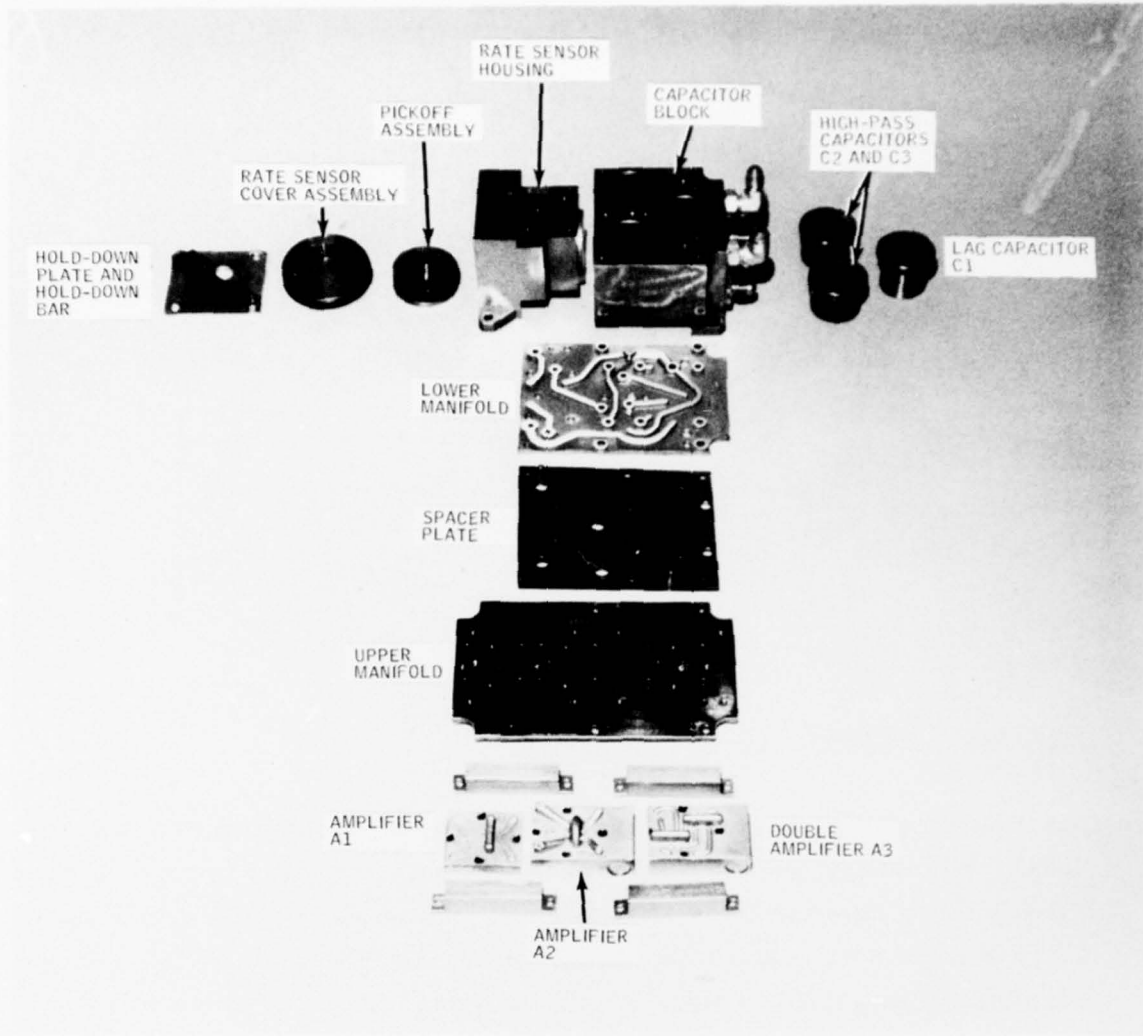
Figure 8. YG1136A - Roll Axis Controller Exploded View.

Proof pressure testing also showed that the hold-down clamps were not strong enough to contain the rate sensor covers; therefore, a stronger hold-down plate was designed (Figure 8). Stainless steel bolts used for holding down the manifolds were replaced with high-strength bolts to obtain the 900-psi proof pressure capability.

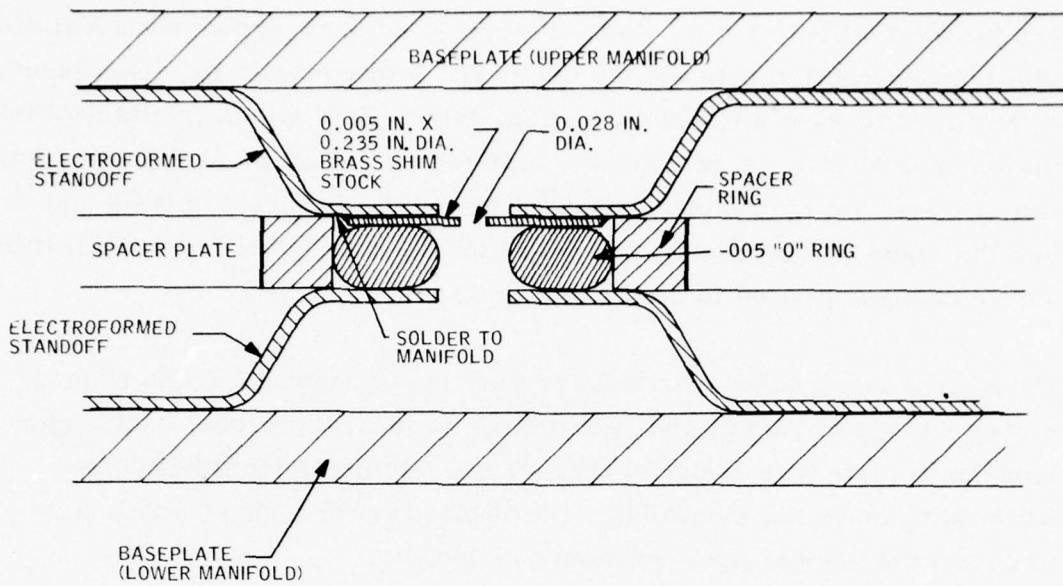
Figure 12. Cross Section of a Typical Junction Between Upper and Lower Manifolds.

The major design change incorporated into the roll axis controller for operational suitability was that the size of the standoffs on both the upper and lower manifolds was reduced. These smaller standoffs, which use a 005 "O" ring rather than a 007 "O" ring as on the original roll axis controller, are used on both yaw and roll axes controllers because they are more consistent and improve performance. However, during proof pressure testing it was discovered that the spacer plate (Figure 8) had not been redesigned and the holes were sized for 007 "O" rings. Small spacer rings were then fabricated and placed in the oversize holes to

reduce their effective diameter. Figure 12 shows a cross-sectional view of a typical junction between the upper and lower manifolds. One junction is required to have a 0.028-inch-diameter orifice, which is attached in the manner shown. A replaceable orifice cup cannot be used in this location because the height is insufficient to use the Figure 11 configuration and the standoff diameter is too small to use the Figure 13 configuration. These changes proved to be satisfactory.

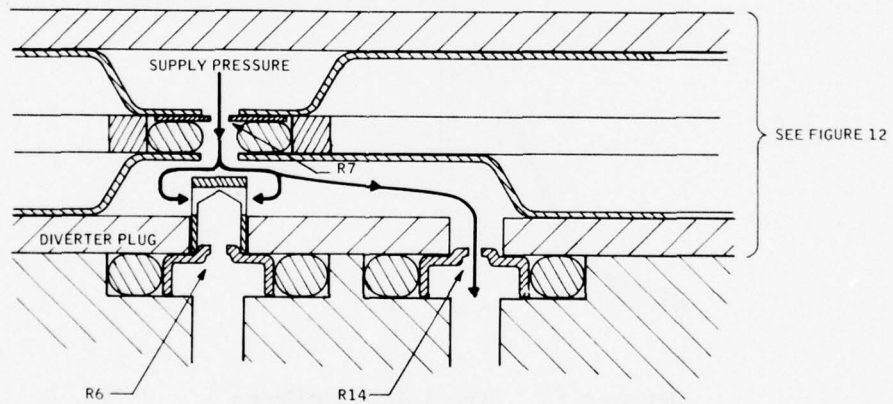
Figure 15. Bias Resistor Configuration with Diverter Plug.

The cause of a large, unexplained offset at the output of the high pass was determined to be the physical orientation of the bias resistors as shown in Figure 14. Because the flow through R7 impinged directly on R6, the recovered pressure at P1 is greater than at P2 even though R6 and R14 are equal. Figure 6 shows the location of these resistors in the circuit. This problem was solved by pressing a diverter plug into the lower manifold baseplate as shown in Figure 15 to prevent impingement of the stream from resistor R7 onto resistor R6.

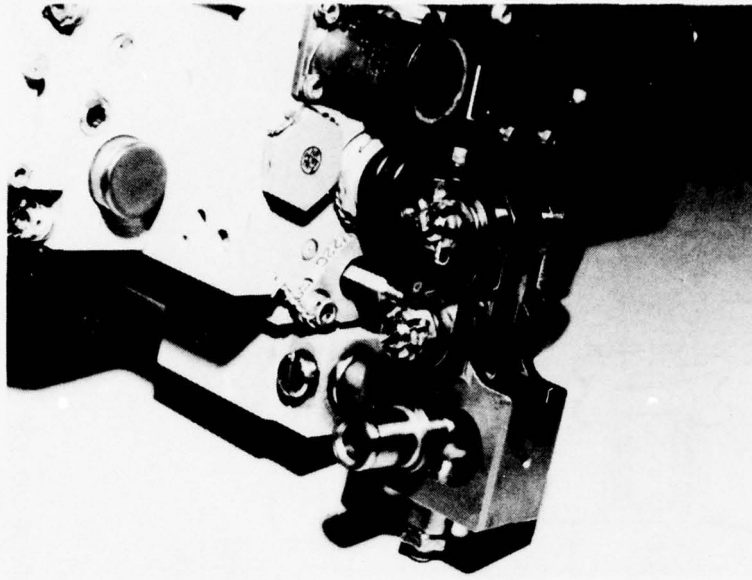
Figure 31. Servoactuator Summing Linkage - Photograph.

During installation at Lowe Field in Fort Rucker, the problem of force feedback into the pedals occurred again and could not be corrected by shimming or adjustment (see HMR B02014). Yaw axis controller S/N 16 was removed from the aircraft and sent to Honeywell to determine if the problem could be duplicated in the laboratory.

The laboratory acceptance test fixture was modified to include the aircraft antitorque control lever (Item 9 in Figure 30) so that the magnitude of the effective pedal forces could be measured. Figure 31 is a photograph of the force-inducing summing linkage and Figure 32 is a detailed sketch. Tests demonstrated that excessive friction on the

upper bolt caused the control servoactuator output to "kick" back into the pedals rather than move the servoactuator pilot valve. Experiments showed that proper shimming in the area of the upper bolt could prevent friction-producing misalignments. Inspection of the unit also showed that there was some wear between the lower spacer and its slot in the rod end assembly.

Review of the linkage design included a review of the results of the described tests, results of previous flight tests on a very similar design, and data on the original design. It was concluded that the force feedback problem could be eliminated by incorporating the changes outlined in Figure 33. The upper bolt was modified to accept an aluminum bronze bushing, thereby providing a good bearing surface for the center link. The 15-5PH sleeve was used to hold the bushing in place and to provide proper spacing for the upper bolt linkages. Shims were to be used to maintain proper alignment of the upper bolt linkage. The lower spacer was
