AFML-TR-77-112

**INFLUENCE OF SUBSURFACE DEFECTS ON FATIGUE  
PROPERTIES OF TITANIUM ALLOYS**

UNITED TECHNOLOGIES CORPORATION  
Pratt & Whitney Aircraft Group  
Government Products Division  
West Palm Beach, Florida 33402

Technical Report AFML-TR-77-112  
Final Technical Report for the Period 1 March 1975  
Through 1 March 1977

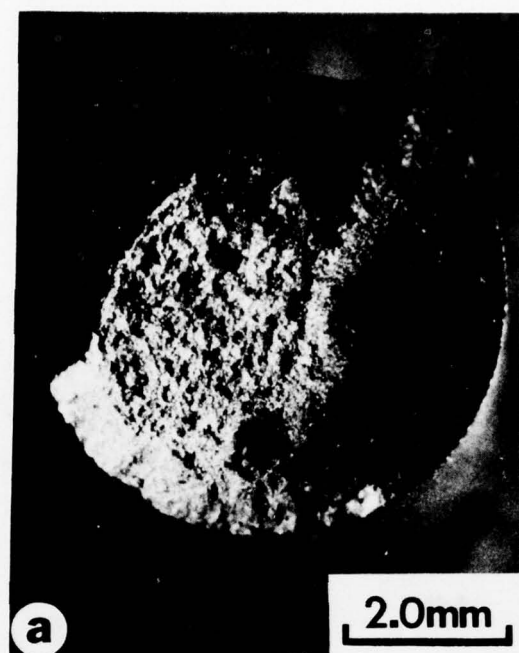
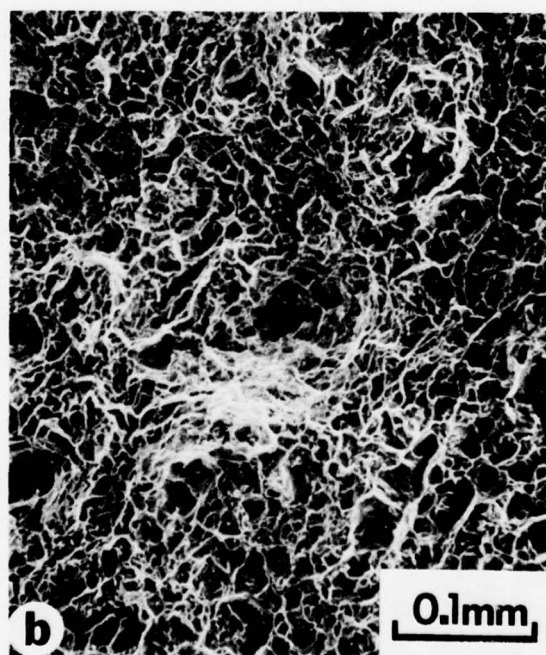
**Figure 3** (a) General Appearance of the Fracture Surface of a Hydride-Seeded Specimen (No. 16). Note the circumferential shear lip. The subsurface nucleation site could not be located.

(b) Typical Topography of the Fracture Surface

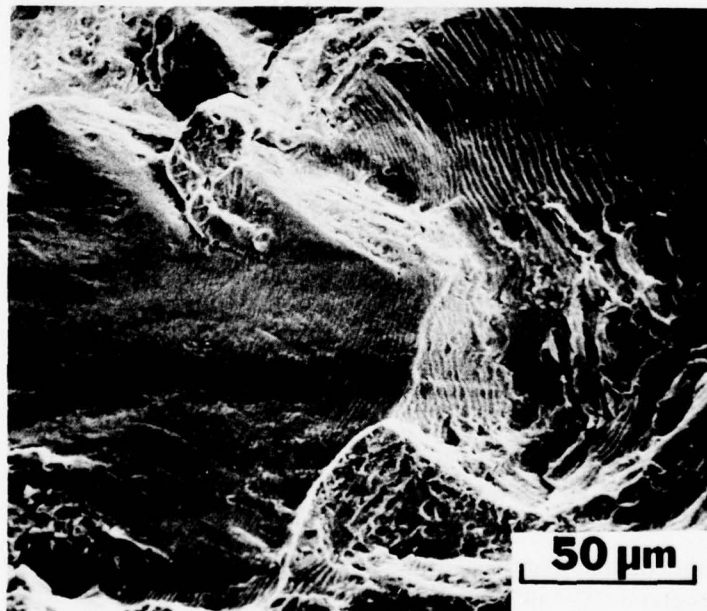
**Figure 6** (a) Striations Observed on Facet A of the Fracture Surface Shown in Figure 5(a).  
(b) Striations observed on Facet B of the Fracture Surface Shown in Figure 5(b).

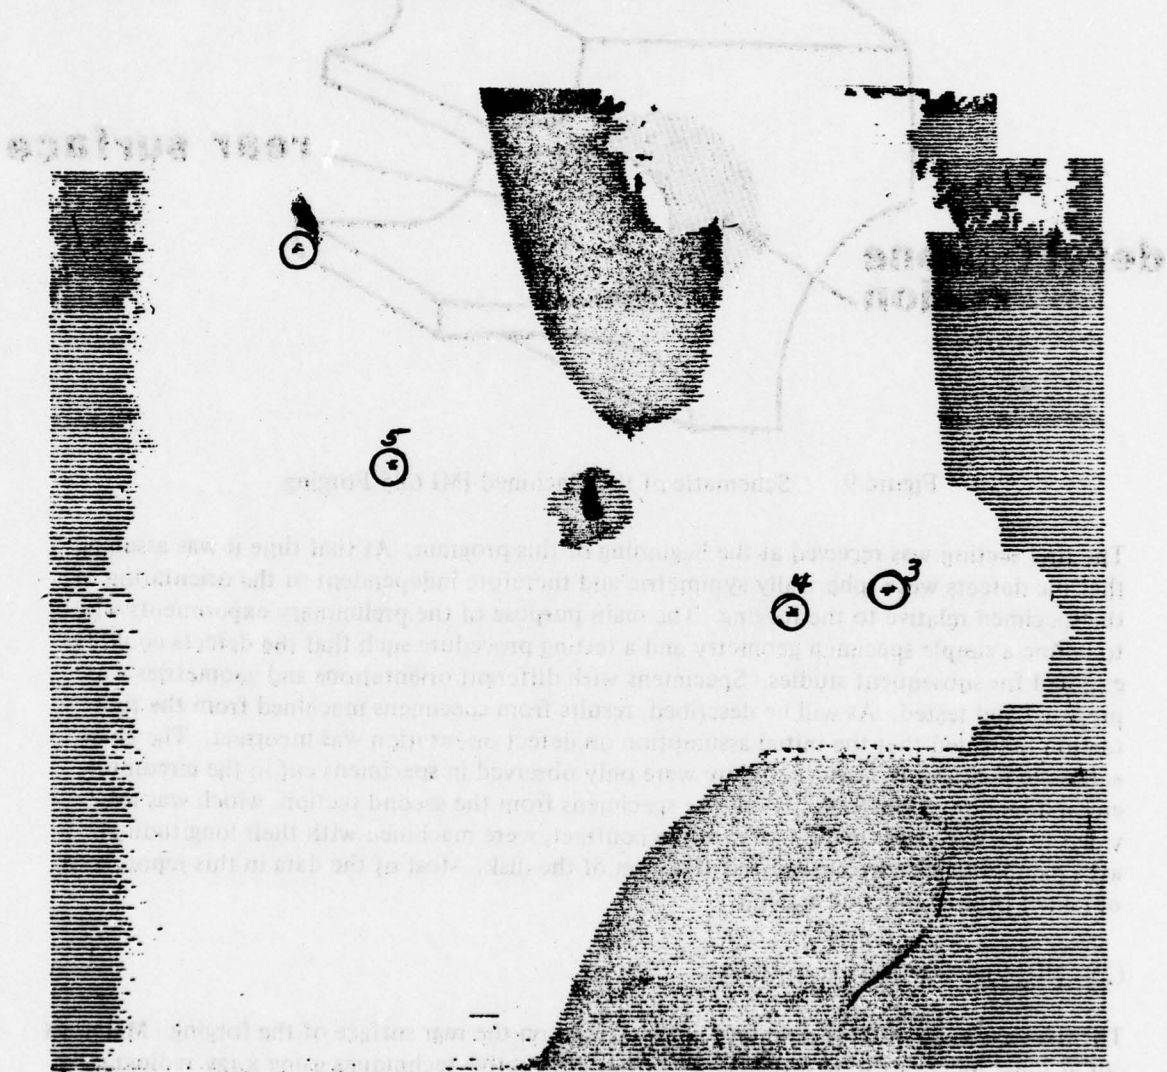
equipment was such that the sonic indications corresponds to structural heterogeneities in the size range 0.01 to 0.10 inch. The second forging section was examined by ultrasonic C-scan technique along the circumferential direction only and several sonic indications were detected. The locations of these indications and their relative signal intensities (in decibel) are illustrated in Figure 10 and Table 4. For reference, the specimens which include these possible defects are also given in Table 4. Two other sonic indications were located at 1.13" and 1.38" below the second surface of this forging. The specimens which contain these possible defects, designated as #48 and #49, were used in the 400°F LCF tests.

**Figure 10** Ultrasonic C-Scan Recording from an IMI 685 Forging Section. The probe was oriented parallel to the circumferential direction of the forging.

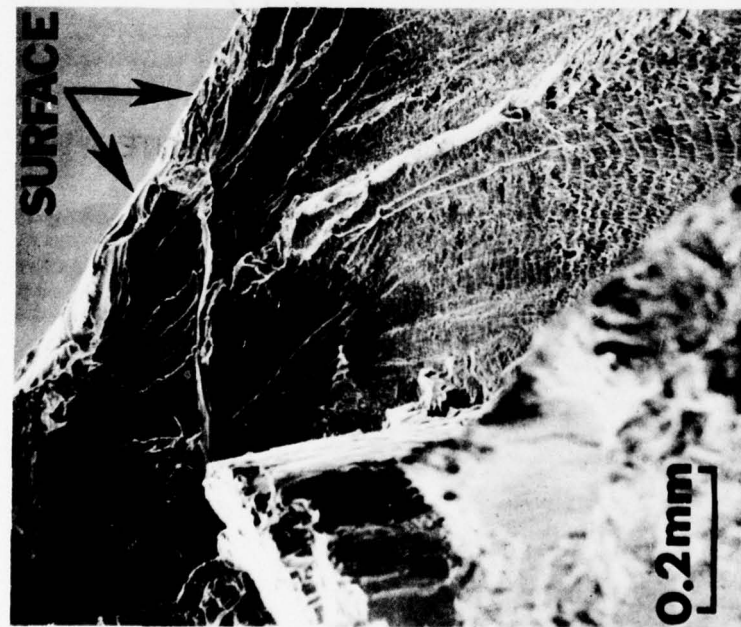
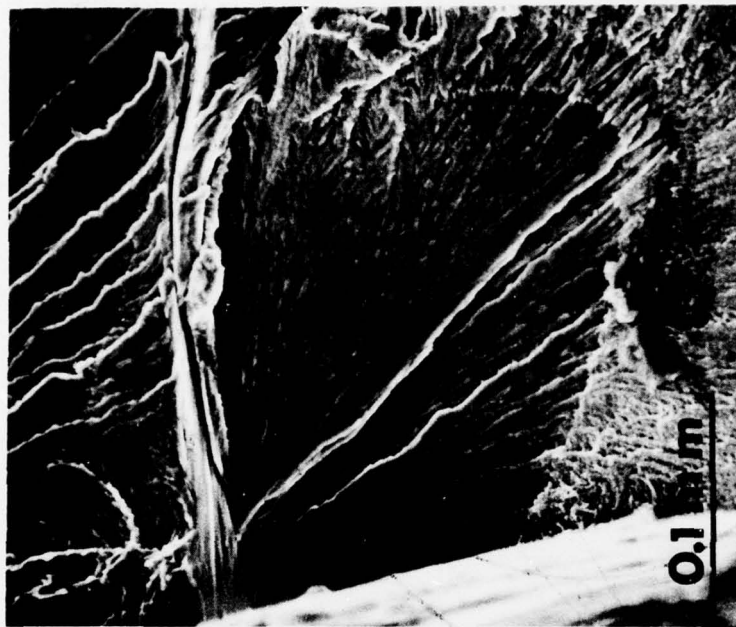
Figure 15 Scanning Electron Micrographs Showing the Appearance of the Subsurface Crack Nucleation Site Indicated in Figure 14b.

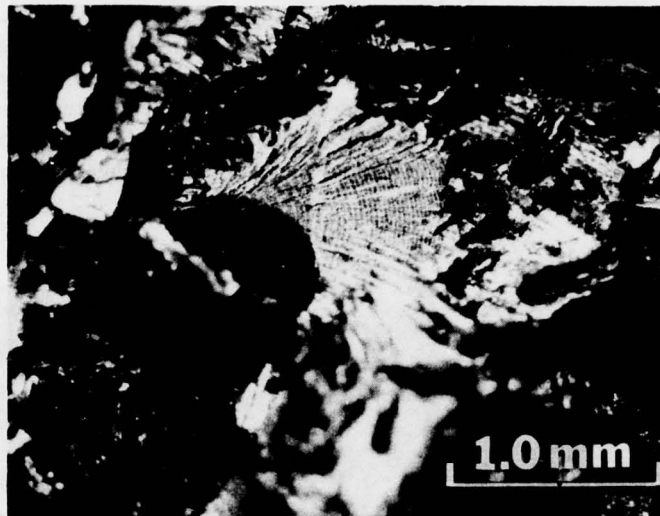
An interesting observation of the striations on facet E is shown in Figure 17 from which it can be seen that the striation spacings decrease from left to right indicating that the crack slowed down during propagation across this facet. The implication of this observation will be discussed later.

Figure 17 Fatigue Striations Observed on Facet E of the Fracture Surface Shown in Figure 16. Note the gradual decrease in striation spacing as the crack propagated across this facet from left to right.

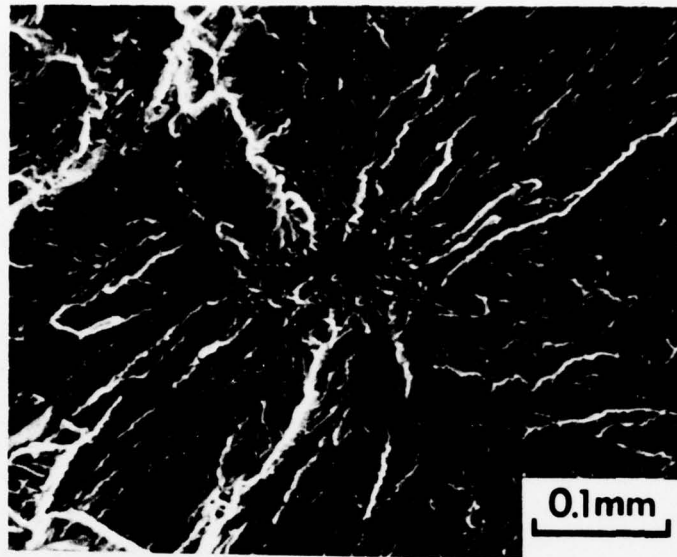
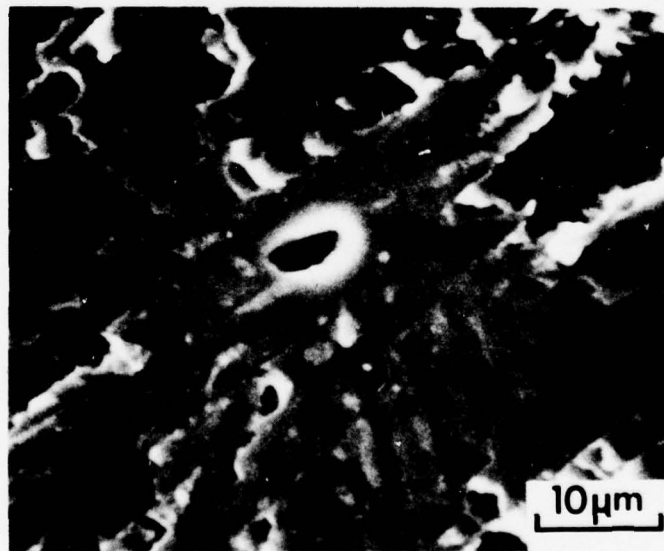
The general appearance of a dwell-tested fracture, as exemplified by Specimen #4, is shown in Figure 19. The fracture origin is located near the center of this Figure and is shown in greater detail in Figure 20. The fatigue crack initiated at a macroscopically flat facet about 0.033" diameter which is inclined at a small angle to the stress axis. Near the center of this facet is a pore about 0.0002" long. A "river" pattern is observed to originate from this pore, and markings, termed "brittle-type" striations in earlier reports, were observed on this facet. Figure 21 shows the microstructure at the fracture origin before (a) and after (b) chemical etching. As illustrated in these scanning electron micrographs the "brittle-type" striations mark the positions of interfaces between the alpha platelets which contain a thin lamellar of the beta phase. The microstructure of a longitudinal section through the fracture origin is shown in Figure 22. The location of the pore is indicated by an arrow. No microstructural anomaly at the fatigue origin is apparent.

Figure 20 (a) The Topography of the 'fish eye' Crack Nucleation Site  
 (b) Detailed Appearance of the Central Pore and its Surrounding. Note the presence of the "brittle-type" striations on the 'fish eye'.

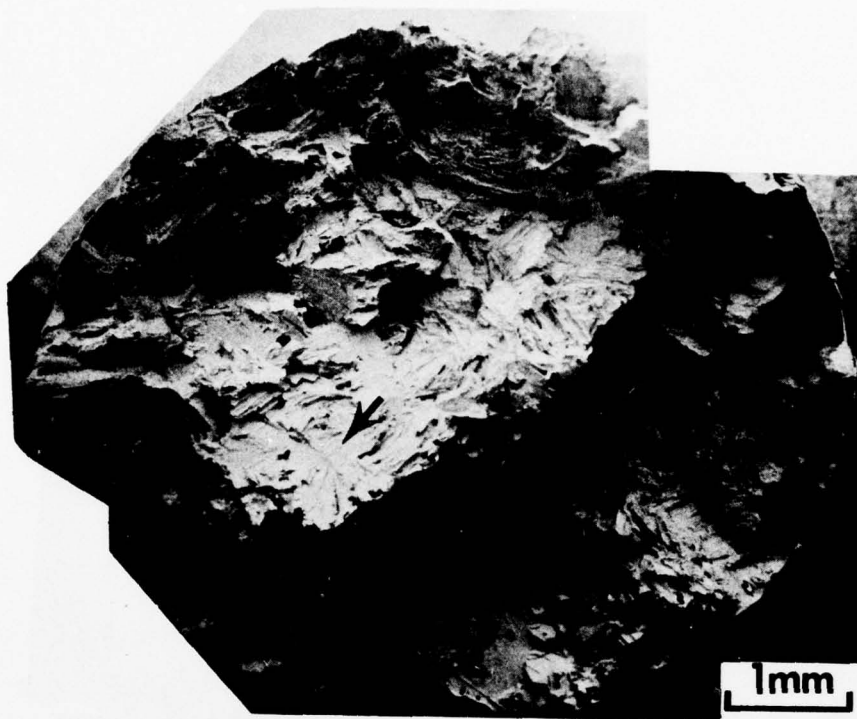
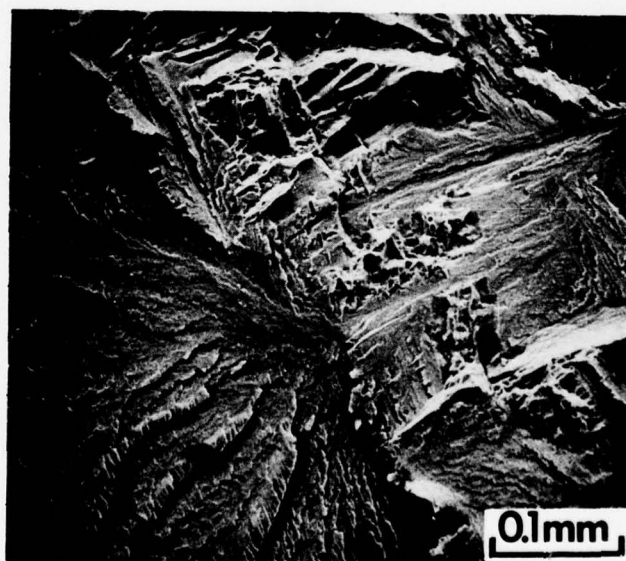
The general appearance of a dwell-tested fracture which does not involve a rosette defect is shown in Figure 25a for specimen #47. The fracture surface contains a macroscopic step, the fracture origin is located by an arrow near the edge of the upper step. It consists of a small facet and is marked by a "river" pattern as shown in Figure 25b. The appearance is similar to that of a rosette failure except that the small central pore is absent. No fatigue striations were observed on this fracture surface.

Figure 25 (a) General Appearance of the Fracture of Specimen No. 47. The fatigue origin consists of a facet located at the edge of a step on the fracture surface.  
 (b) Details of the Fatigue Origin. Small central pores characteristic of the rosette-type fracture were not observed.

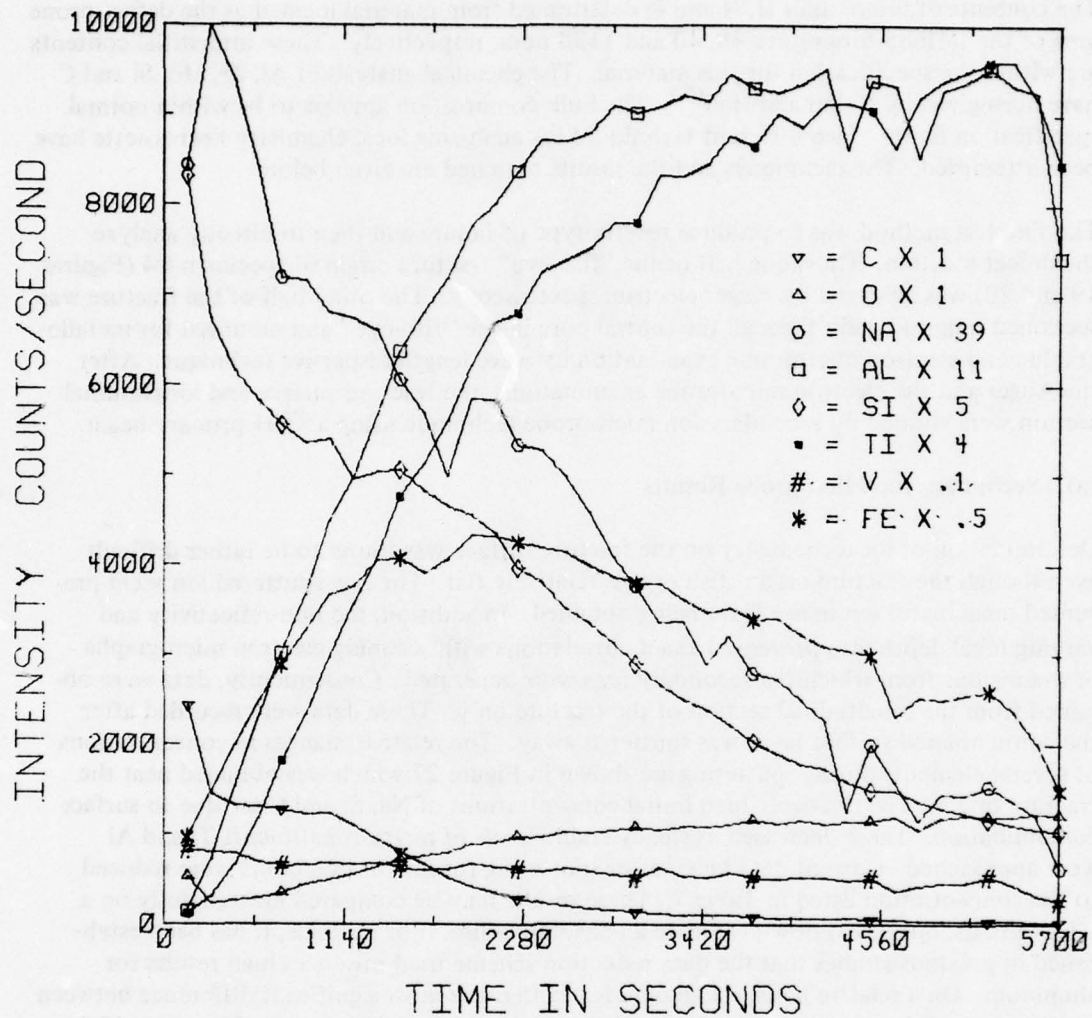
Determination of local chemistry on the fracture surface was found to be rather difficult even though the fracture origin (fish eye) is relatively flat. The low sputtered ion yield prevented meaningful ion image from being obtained. In addition, the non-reflectivity and varying focal depth also prevented exact correlations with scanning electron micrographs of the regions from which the secondary ions were generated. Consequently, data were obtained from the longitudinal section of the fracture only. These data were recorded after the contaminated surface layer was sputtered away. The relative changes in concentrations of several elements during sputtering are shown in Figure 27 which was obtained near the fracture origin. The relatively high initial concentrations of Na, Si and C are due to surface contamination. These decreased as steady stable levels of major constituents Ti and Al were approached. Current data taken after sputtering for one to two hours were reduced to the concentration listed in Table 7. These results may be compared meaningfully on a relative basis, but have known errors in an absolute sense. For instance, it has been established in previous studies that the data reduction scheme used produces high results for aluminum. On a relative basis, Table 6 indicates that the most significant difference between the fracture origin and the bulk is in the N contents, which is slightly over four times higher at the origin. Contrary to popular speculation, the H content at the origin was found to be lower than that in the bulk by a factor of two. Other differences are small but tend to indicate that the fracture origin is lower in alpha-stabilizing elements Al and C and higher beta stabilizing elements Fe and B.

Figure 27 Change in Intensities of Several Elements as a Function of Sputtering Time. Determination of compositions at the 'fish eye' fracture origin and the bulk commenced after steady levels of major elements were observed.

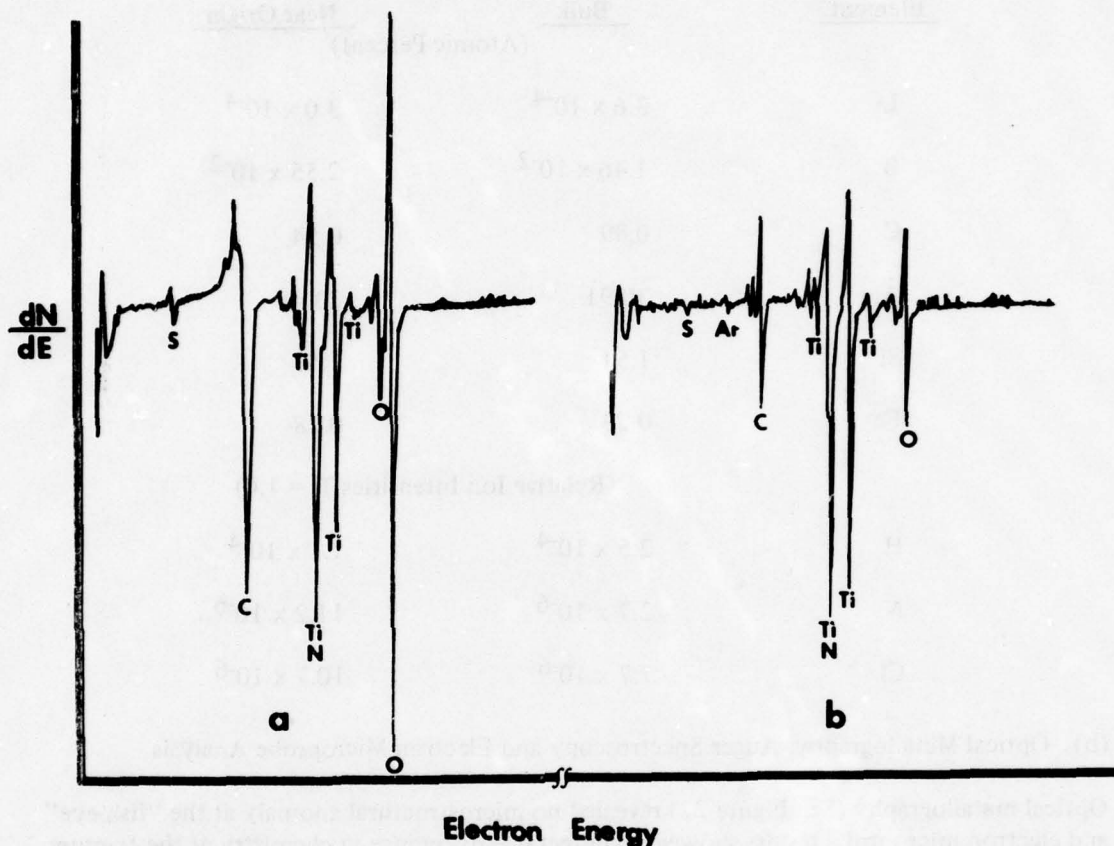
Optical metallography (See Figure 22) revealed no microstructural anomaly at the "fish-eye" and electron microprobe results showed no detectable difference in chemistry at the fracture origin. However, the sensitivity of the electron microprobe technique for detecting interstitials is known to be poor, especially at low concentrations. Some of the results of the Auger electron spectroscopy (AES) are shown in Figure 28 which were obtained at the fracture origin before (Figure 28a) and after sputtering (Figure 28b). It can be seen that the sputtering reduced the concentrations of S, C and O which are common surface contaminants. The nitrogen peak coincides with one of the Ti peaks and therefore its concentration cannot be readily determined. No significant difference was observed between the AES results at the fracture origin and bulk material.

Figure 28 Auger Electron Spectrographs at the 'fish eye' Fatigue Origin  
 (a) Before sputtering  
 (b) After sputtering, note the decrease in C, O and S which are common surface contaminants.

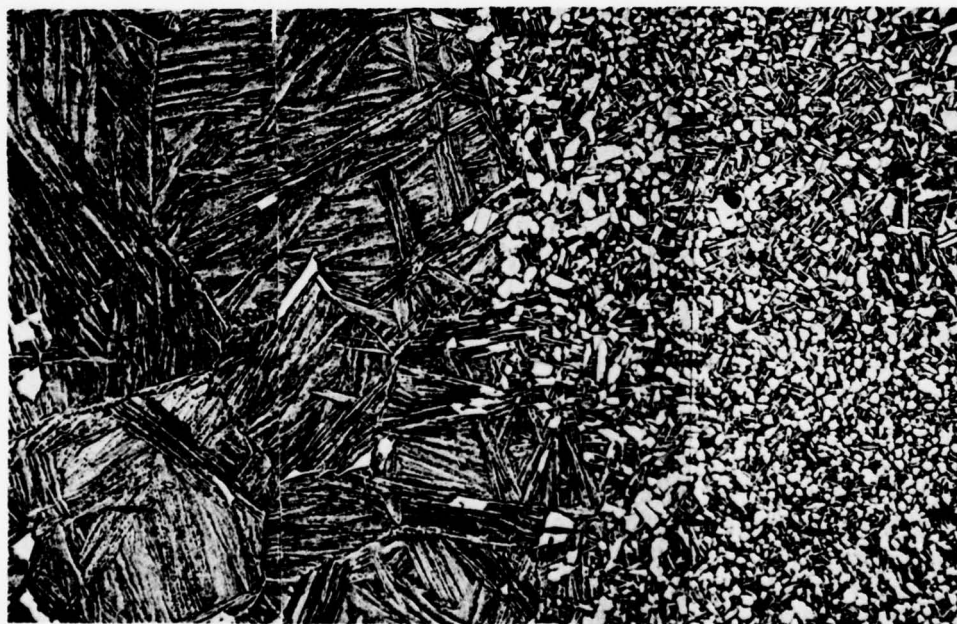
Figure 30 The Microstructure Shown in Figure 29 After Additional Recrystallization Treatment at 1830°F for 1 Hour.

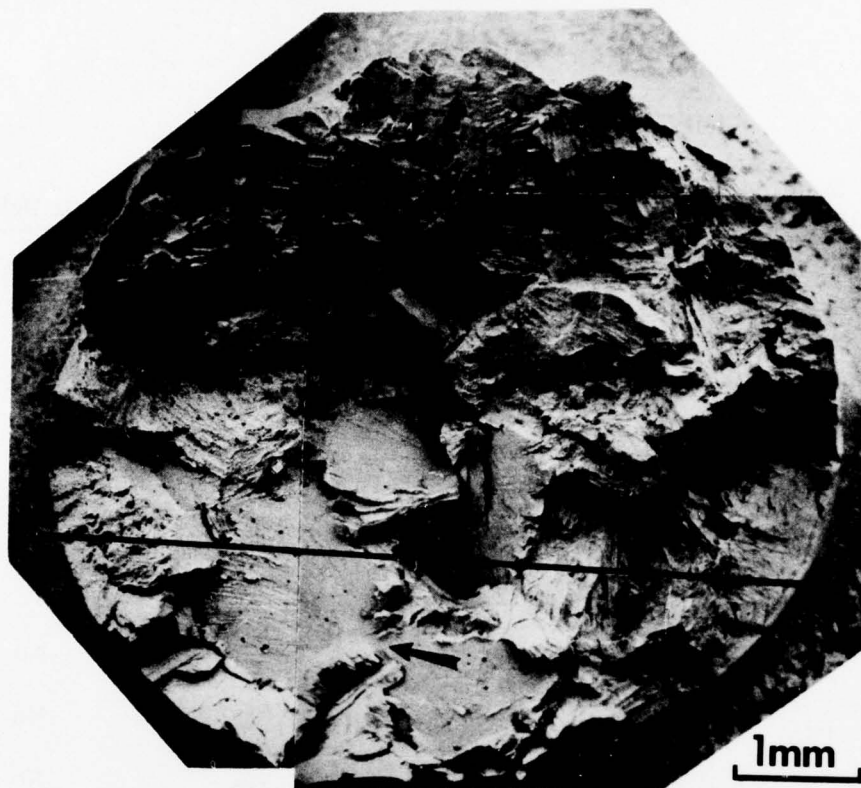
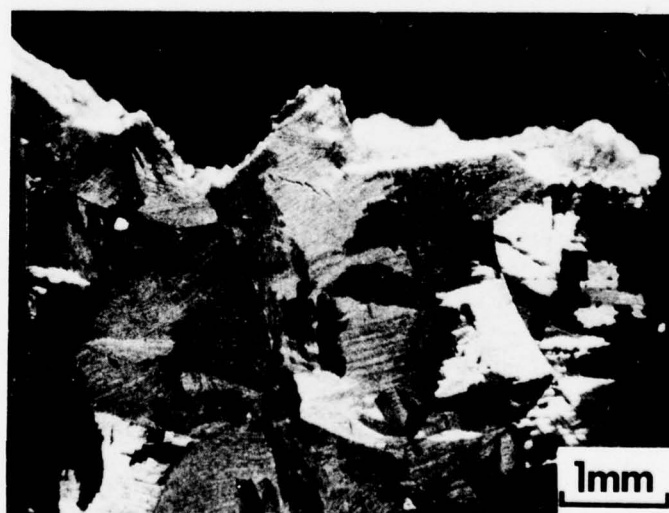
All short life specimens failed from subsurface origins which did not appear to show the characteristic features of a rosette-type failures observed in room temperature tests. A typical fracture for a defect-containing specimen is shown in Figure 31a in which the apparent fatigue origin is indicated by an arrow. It can be seen that the scale of the cleavage facets are much larger than those observed in tests at 70°F. A longitudinal section of the fracture surface, shown in Figure 31b, shows that the cracks cut across several colonies within a prior beta grain. In fact the facet size appears to be set by the latter microstructural dimension.

Figure 31 (a) General Appearance of the Fracture of Specimen No. 49 Tested at 400°F. The apparent fracture origin is indicated by an arrow.  
 (b) A Longitudinal Section Along the Line Indicated in (a), Showing the prior  $\beta$  grain size adjacent to the fracture surface.

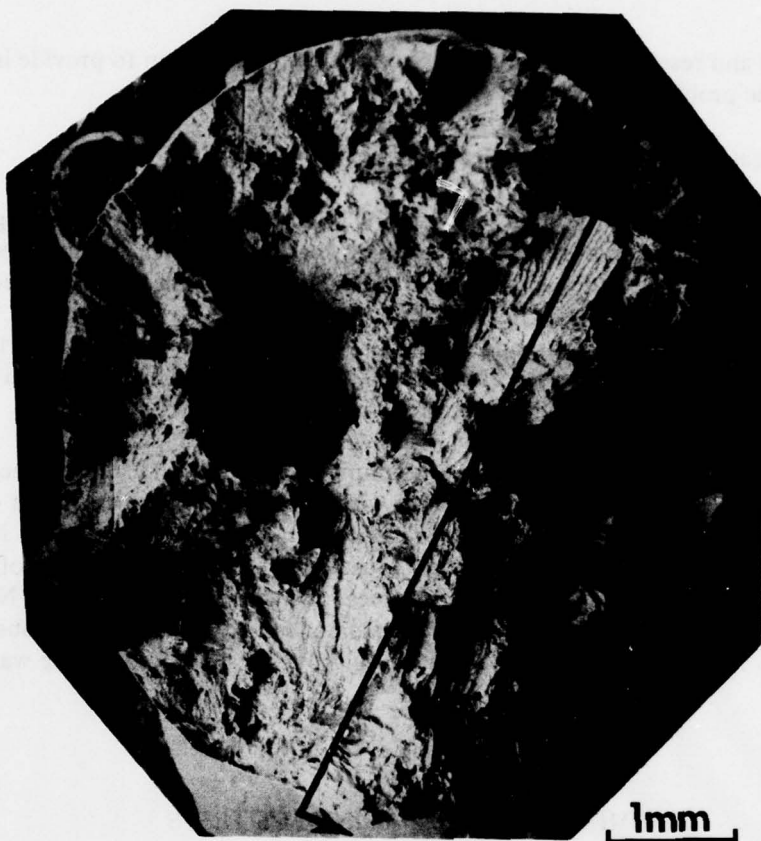
In contrast, cracks in specimens that failed with long lives were surface nucleated. Figure 32a shows the general fracture appearance. It can be seen that the facets are smaller than that of the defect-containing specimen. The smaller facet size appears to correlate with the dimensions of alpha colonies and prior beta grain shown in Figure 32b.

**Figure 32** (a) General Appearance of the Fracture of Specimen No. 44 Tested at 400°F.  
(b) A Longitudinal Section Along the Line Indicated in (a), Showing the Prior  $\beta$  Grain Size Adjacent to the Fracture Surface.

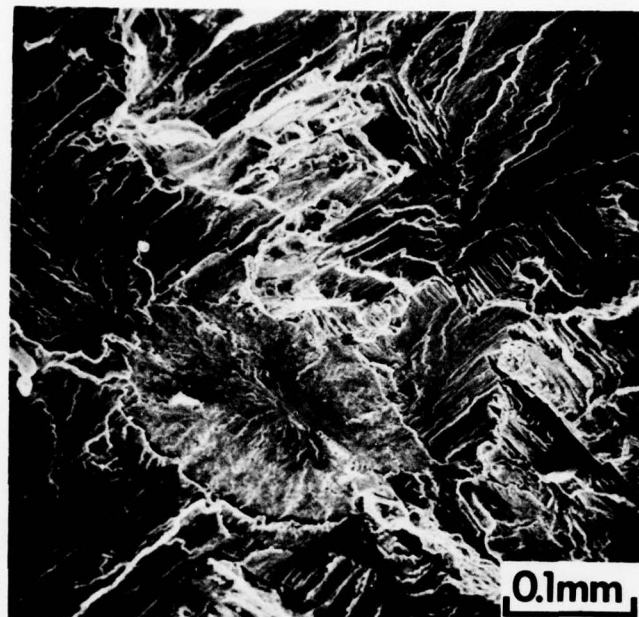
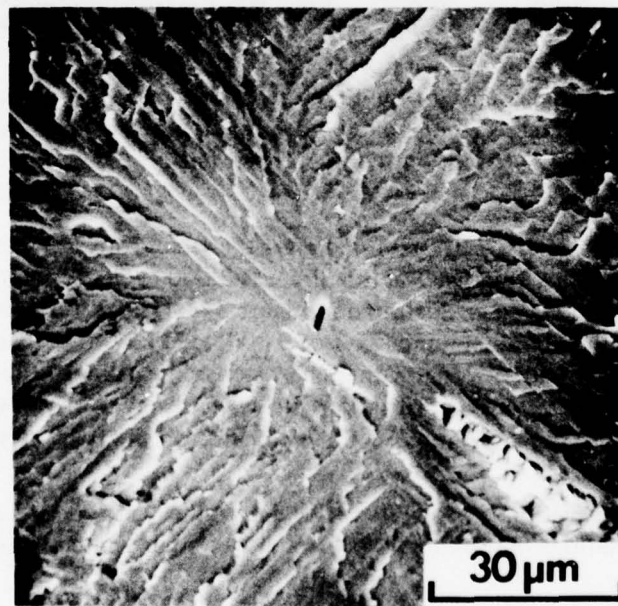
The defect containing specimen (#20) fractured after the second stress increment at a maximum stress of 97 ksi. The cumulative fracture life was 2,600 cycles. Fracture initiated at a subsurface rosette defect which is illustrated in Figure 34. The fracture origin consists of an elliptical facet with major and minor axes of 0.009" and 0.006". Near the center of this facet is a small pore 0.00016" long. Other characteristic features of the rosette fracture, "river pattern" and "brittle-type" striations are again observed. However, neither crack-front markings nor fatigue striations could be located on the fracture surfaces.

Figure 34 (a) General Appearance of the Fracture Near the Rosette Crack Origin Observed in Specimen No. 20.  
(b) Details of the Rosette Crack Origin Showing the Characteristic Central Pore and the Brittle-Type Striations.

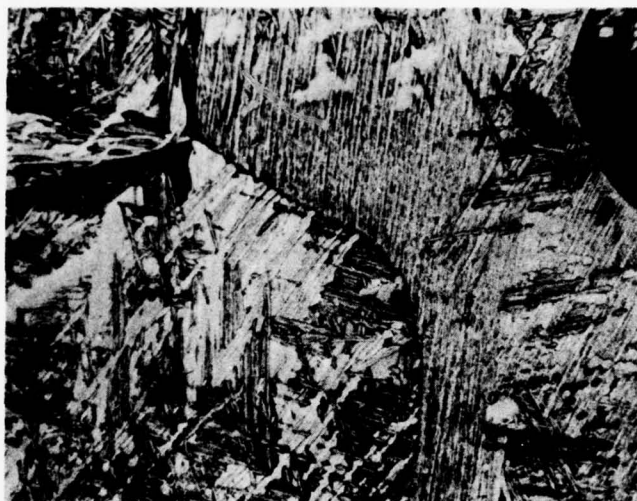
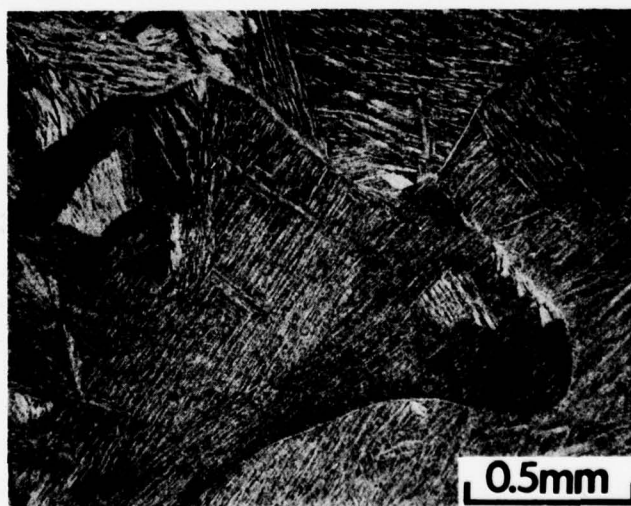
Figure 37 (a) Microstructure of the Second and Third Sets of Specimens  
 (b) Microstructure of the Third Set of Specimens After a Slower Cool From the Solution Temperature

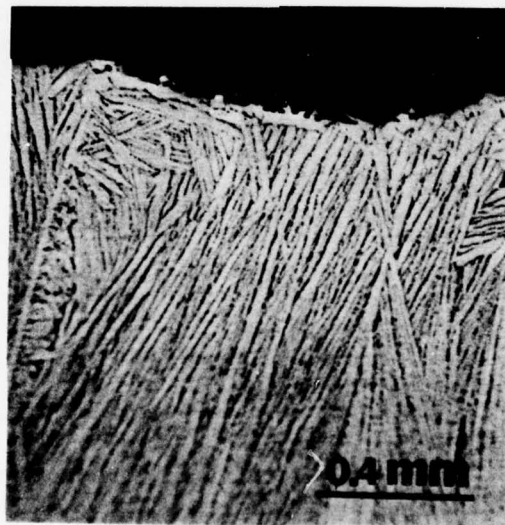
Figure 40 (a) Microstructure of a Longitudinal Section Through the Nitride-Seeded Pore (Indicated By an Arrow) in Specimen No. 38.  
 (b) Microstructure of the nitride-seeded Pore Shown in Higher Magnification.

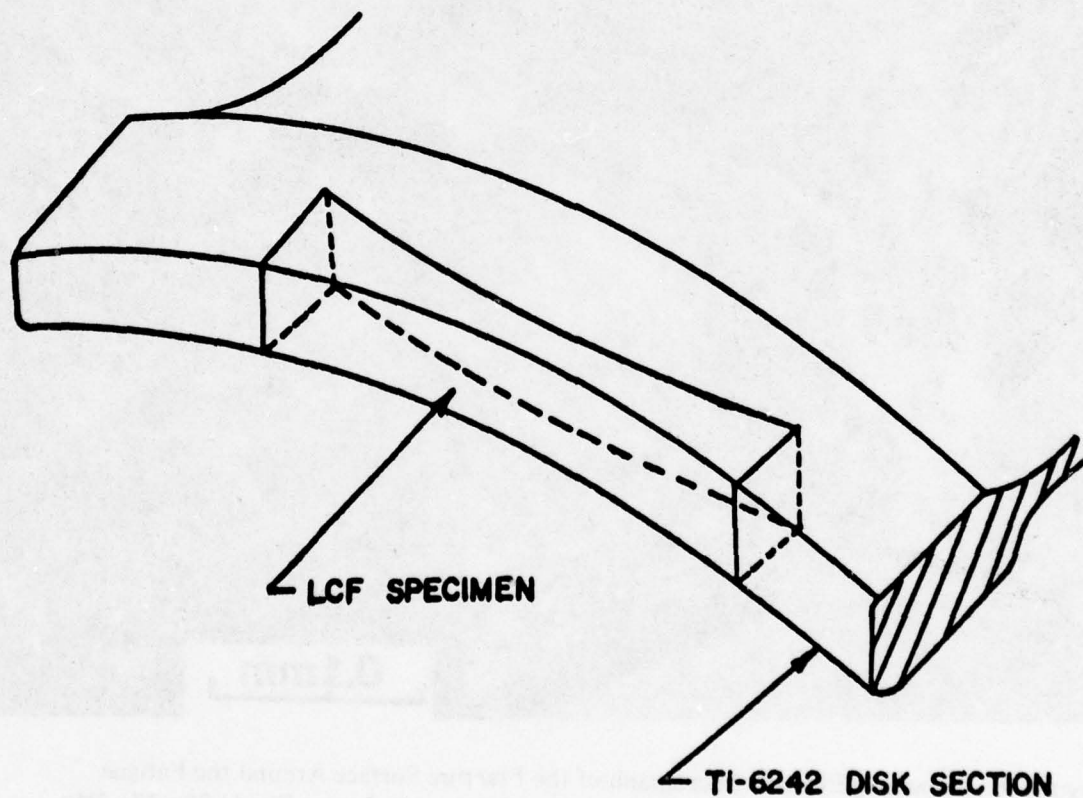
In an attempt to reproduce rosette-type of failure observed previously by P&WA in a flat disk manufactured from Ti-6Al-2Sn-4Zr-2Mo alloy (See Section II.1) a disk section was inspected by ultrasonic C-scan technique to locate defective regions. A fatigue specimen was then fabricated containing one such region in the gage section, the shape and orientation of this specimen is shown in Figure 44. The microstructure of this material is shown in Figure 45 and is typical of an alpha:beta forged and heat treated component. The specimen was tested at a cyclic stress level of 10-110 ksi with a dwell of 1.5 minutes at maximum load. Fracture of the specimen occurred after  $1.2 \times 10^4$  cycles. The fracture surface around the nucleation site is shown in Figure 46, and the nucleation site is shown at higher magnification in Figure 47a. The fatigue origin consisted of a row of interconnected pores extending to the surface of the disk. This row of pores is inclined at about  $45^\circ$  to the plane of the disk and has dimensions of  $0.001'' \times 0.00013''$ . The fracture origin bears some similarity to cleavage rosette-type of failure in that it consists of small holes surrounded by a cleavage facet on which no fatigue striations were observed. Figures 47b and c illustrate the fracture appearance at positions removed from the fracture origin in which striations can be observed.

Figure 44 The Shape and Relative Orientation of the Fatigue Specimen Machined from the Ti-6Al-2Sn-4Zr-2Mo Flat Disk. A defect had been located at the gage section of the specimen by the ultrasonic C-scan technique.

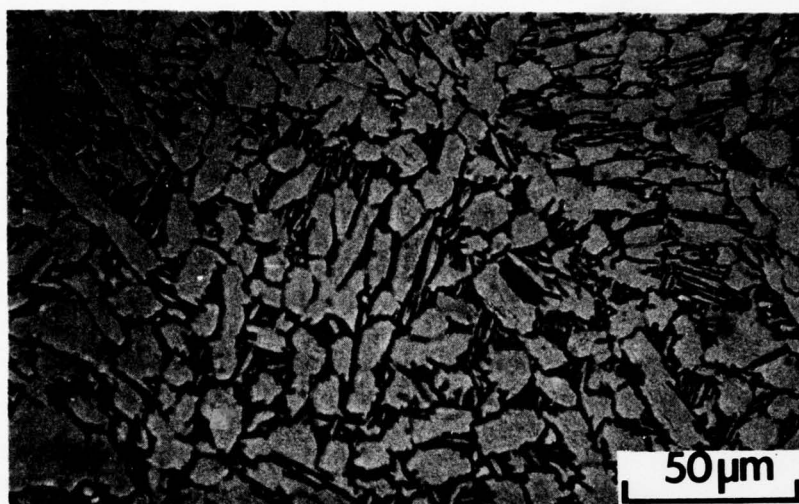
Figure 45 Microstructure of the Ti-6Al-2Sn-4Sn-2Mo Disk

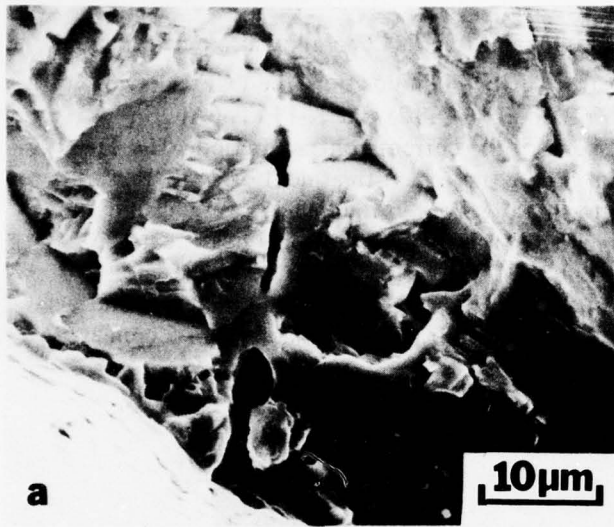
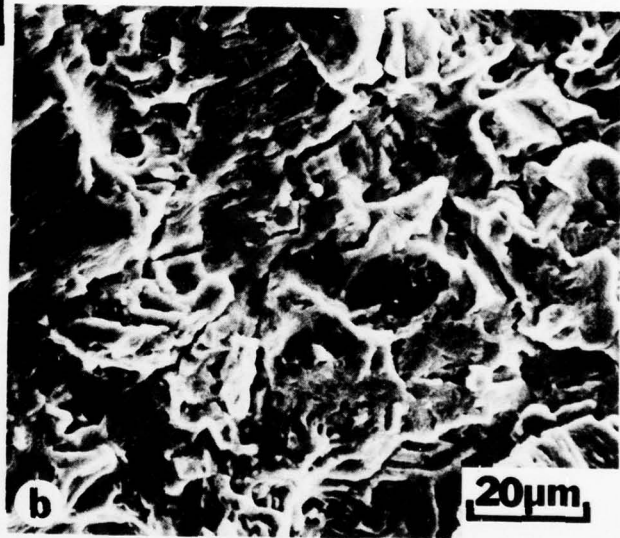
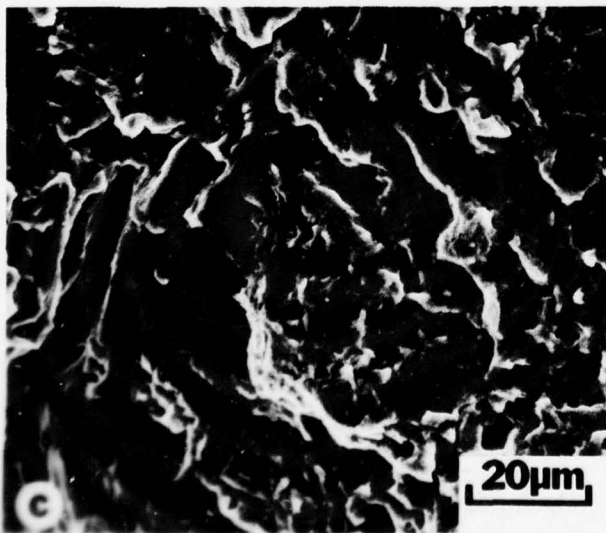
Figure 47 (a) Details of the Crack Nucleation Site Shown in Figure 46. Typical appearance of fatigue striations on fracture surfaces are shown in (b) and (c).

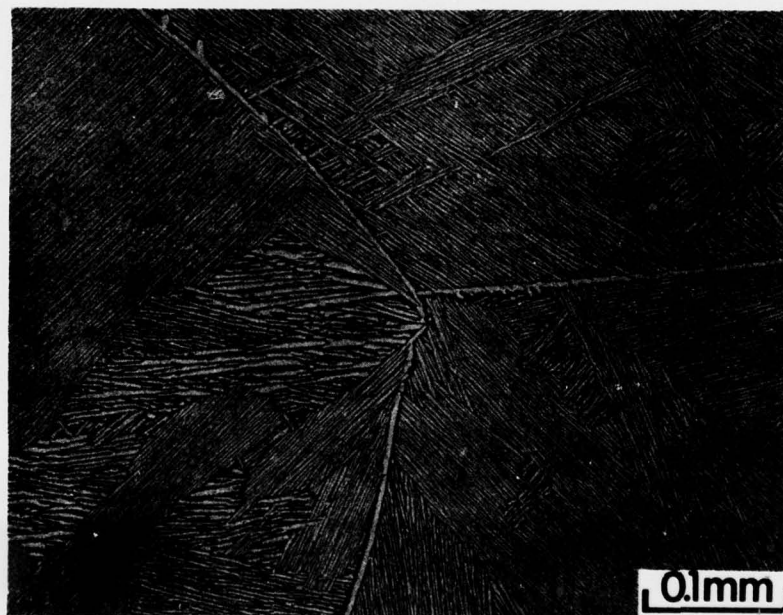
Figure 48 Microstructure of the Beta-Heat Treated Ti-6Al-2Sn-4Zr-2Mo.

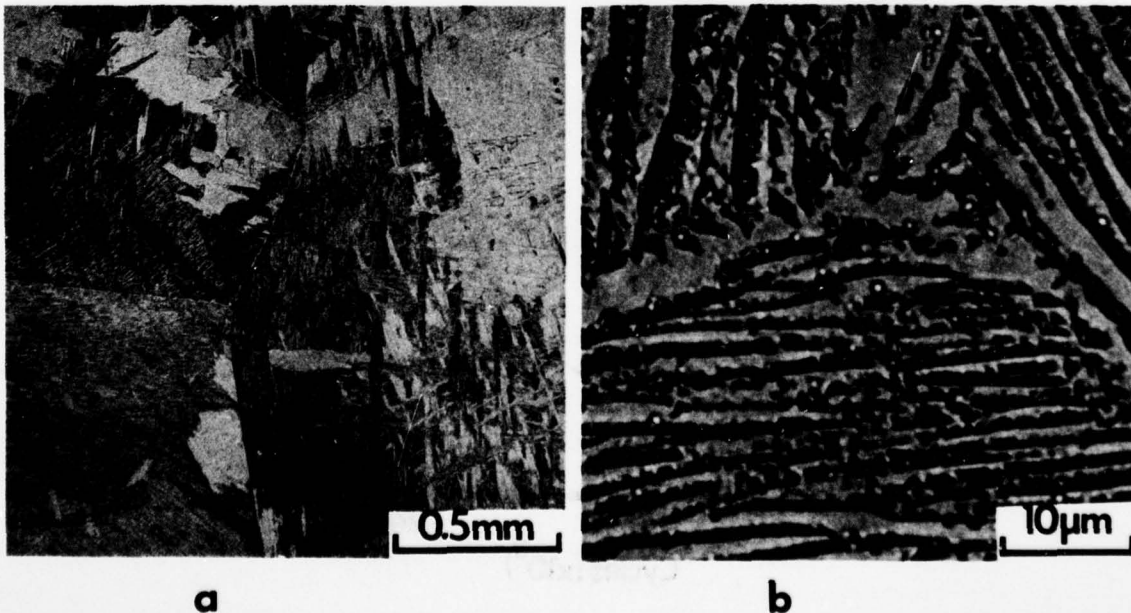
The Ti-11 alloy was beta forged and had a heat treatment consisting of 1600°F/24 hr./AC + 1300°F/2 hr./AC + 1100°F/8 hr./AC. This heat treatment resulted in some spheroidization of the beta phase as shown in Figure 49. Two specimens were LCF dwell-tested under a stress range of 36-120 ksi at room temperature. Failure had not occurred after 6200 cycles. The corresponding fracture life of this material at 10 cpm is ~ 20,000 cycles. Therefore the fatigue debit in Ti-11, if present, is again smaller than for IMI 685.

Figure 49 Microstructure of Ti-11 (a) shows the Large Prior Beta Grains and (b) Shows the Spheroidized Beta Phase
