LACV-30 AUXILIARY POWER UNIT INVESTIGATION

Robert P. Kaiser  
Bell Aerospace Textron  
P.O. Box 1  
Buffalo, New York 14240

June 1977

Final Technical Report for Period September 1976-January 1977

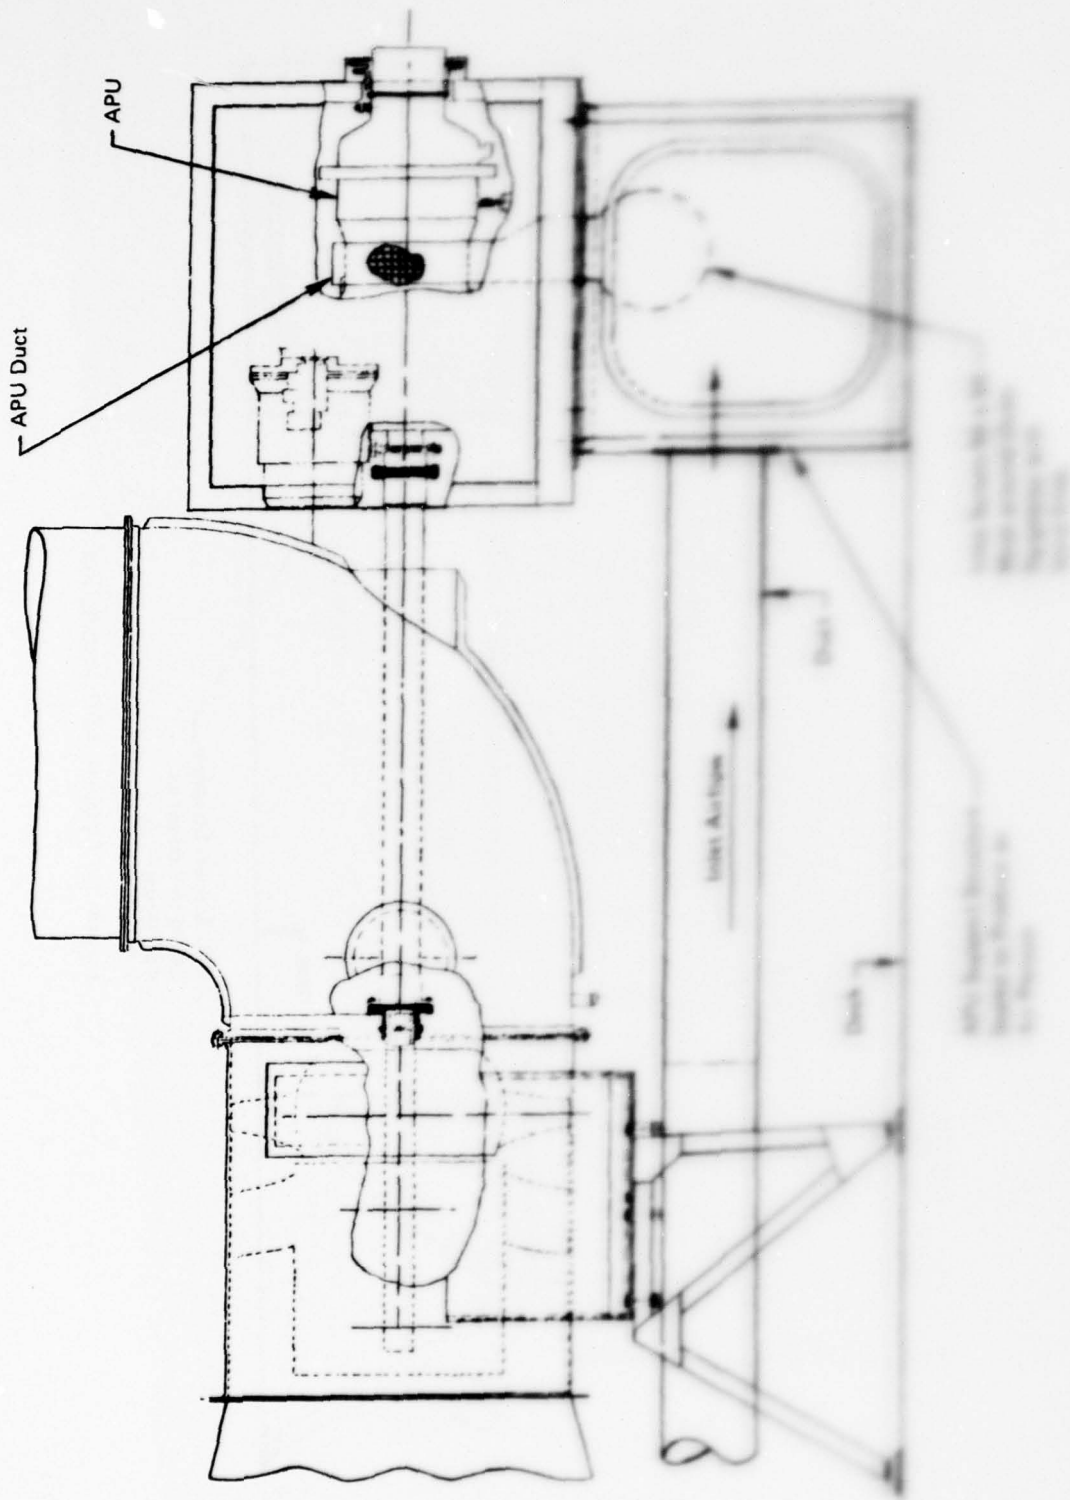
Figure 2. Original APU Installation

The LACV-30 Air Cushion Lighter employs an Auxiliary Power Unit (APU) to supply 30 kilowatts of electrical power and to drive a 90 horsepower fan used in the inlet Air Management System (AMS). A Solar T-62T-32-3 gas turbine engine is used as the prime mover. The engine is packaged in an enclosure with a starter, alternator and secondary reduction gearbox, by Alturdyne. The enclosure and its internal arrangement is shown in Figure 1. The system is installed on the two lead vehicles: LACV-30-1 and -2. The original installation configuration is shown in Figure 2.

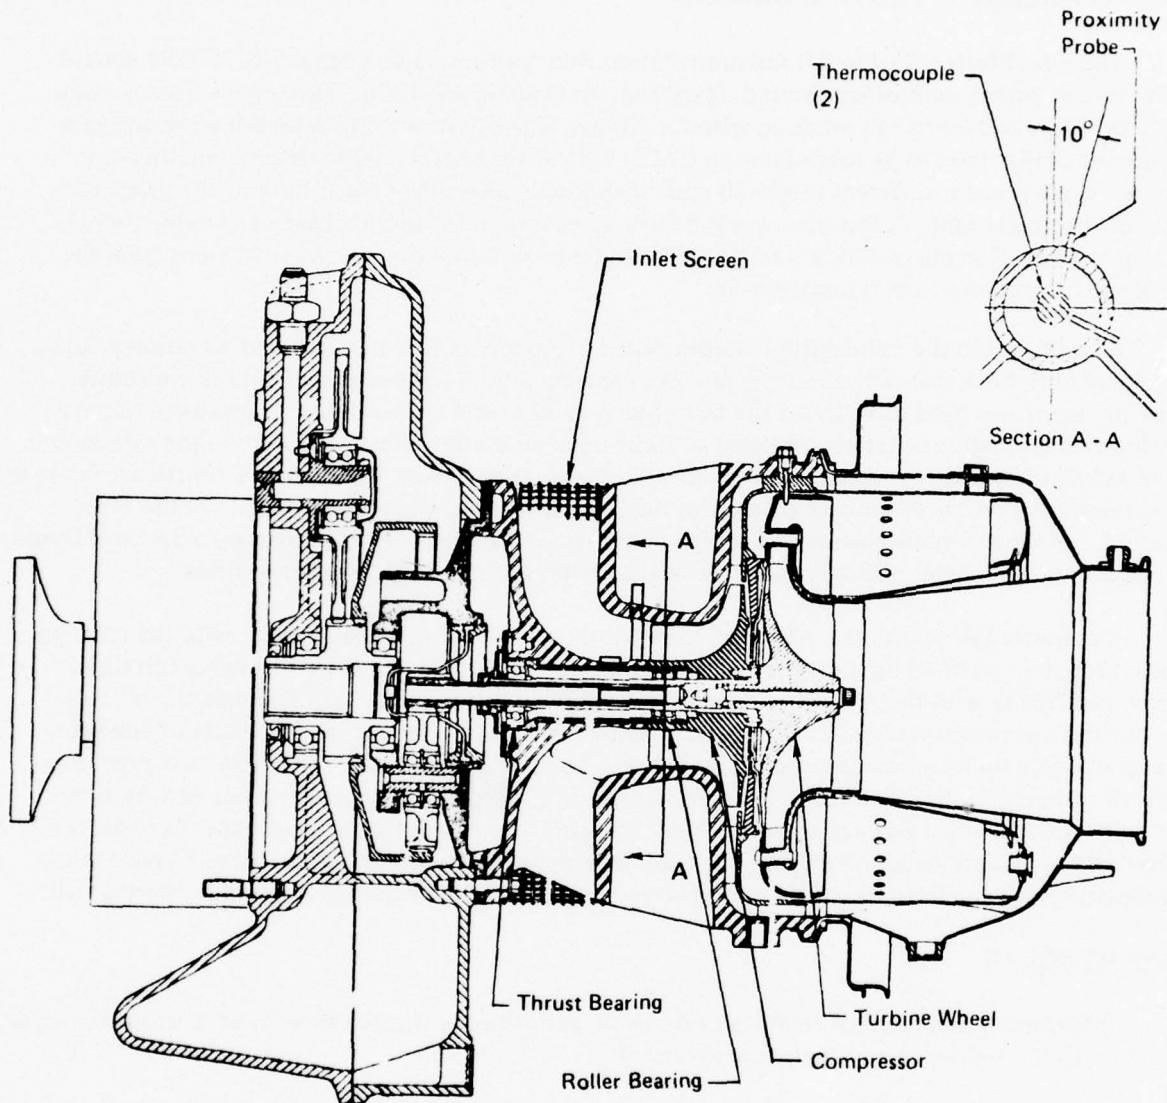
Figure 4. Internal Engine Instrumentation for Tests

Instrumentation selected to monitor dynamic performance was the same as at Aberdeen Proving Ground with the following additions (see Figure 4):

1. **Roller Bearing Temperature Thermocouples.** These were installed in duplicate through the bearing support shoulder with the bead preloaded against the bearing race. The thermocouples were J-type (iron-constantan) 0.06-inch diameter magnesium-oxide-packed, metal-sheathed leads secured with tack-welded stainless foil.
2. **Shaft Orbit Proximity Probes.** Two probes were installed through the outer wall of the air inlet housing to sense movement at the end of the aluminum structure of the bearing support column just ahead of the impeller.
