E.E.S. REPORT C-3599-A(2)  
30 MARCH 1950

UNITED STATES NAVAL  
ENGINEERING EXPERIMENT STATION

ENDURANCE TEST OF  
PHILIPS MODEL 1/4D EXTERNAL COMBUSTION ENGINE

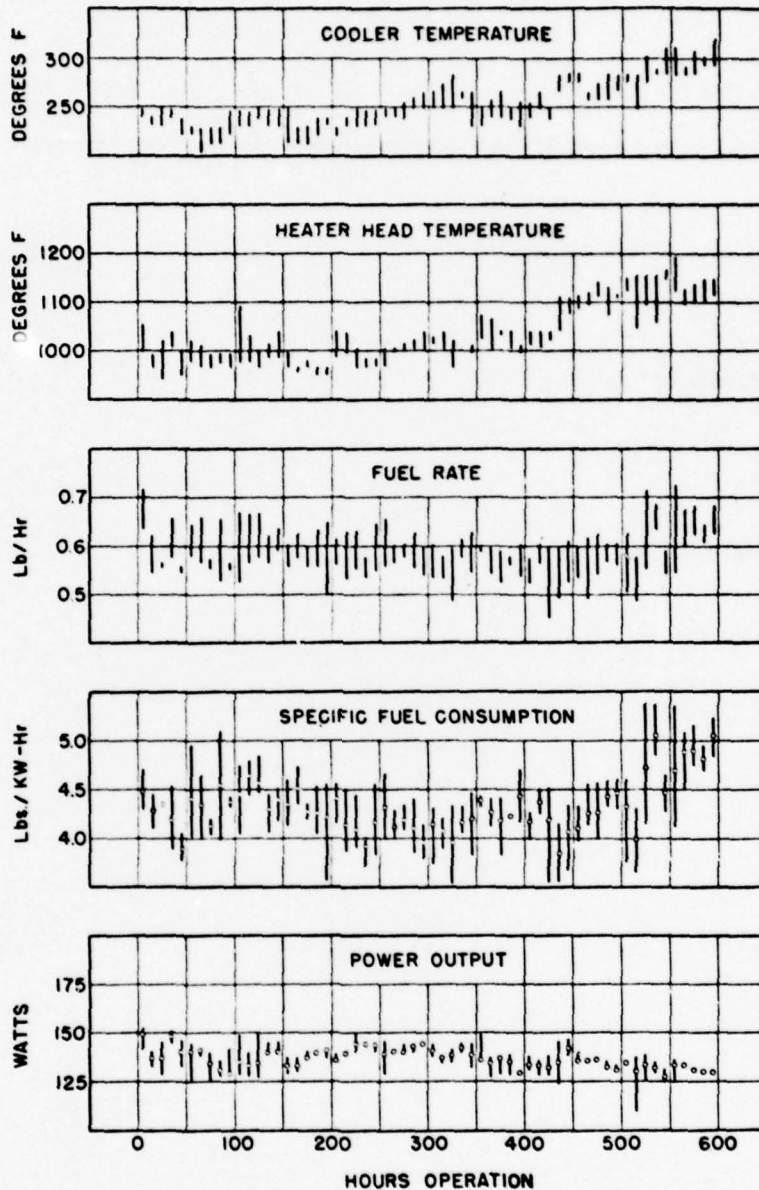
ENDURANCE TEST PERFORMANCE  
PHILIPS MODEL 1/4D EXTERNAL COMBUSTION ENGINE

- Note:
1. Data points indicate average observed readings for each 10-hour period. Each graph bar indicates the maximum and minimum values for each 10-hour period.
  2. All engine operation was with water-white lead-free gasoline except 500 to 530-hour periods during which 80 octane motor gasoline was used.
  3. Heater head thermocouple failed by breakage at 329 engine hours. Thermocouple in different location used during balance of test.
