**PRECIPITATION STATIC ELECTRICITY AND  
SWEPT-STROKE LIGHTNING EFFECTS ON  
AIRCRAFT TRANSPARENCY COATINGS**

R.C.Twomey  
Douglas Aircraft Company  
McDonnell Douglas Corporation  
3855 Lakewood Boulevard  
Long Beach, California 90846

DECEMBER 1977

TECHNICAL REPORT AFFDL-TR-77-141

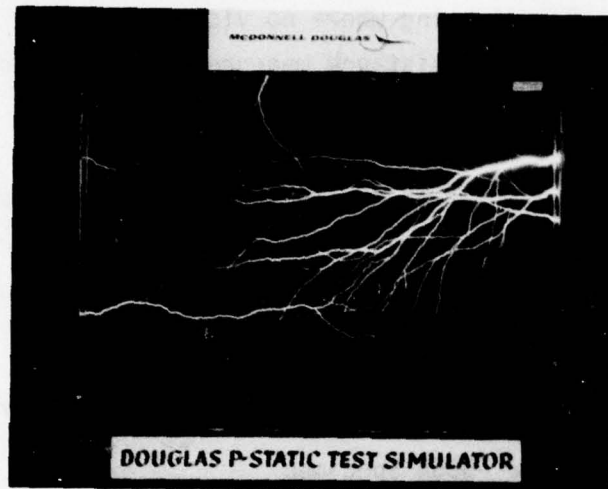
Figure 13. Multiple Exposure Discharges on -505A Specimen.

Figure 13 is a photograph made during the second exposure run. This photo is significant because it shows six separate discharge patterns that took place individually at different times during the period the camera shutter was open. Varying intensity flashes from different parts of the surface are clearly visible. The pencil electrodes are visible in the reflected light from the discharge flashes. The corona glow at each pencil tip produces a background dot matrix. At no time during all of this testing was there any evidence of dielectric puncture of the acrylic outer ply. No internal sparking was noticed along the deletion line.

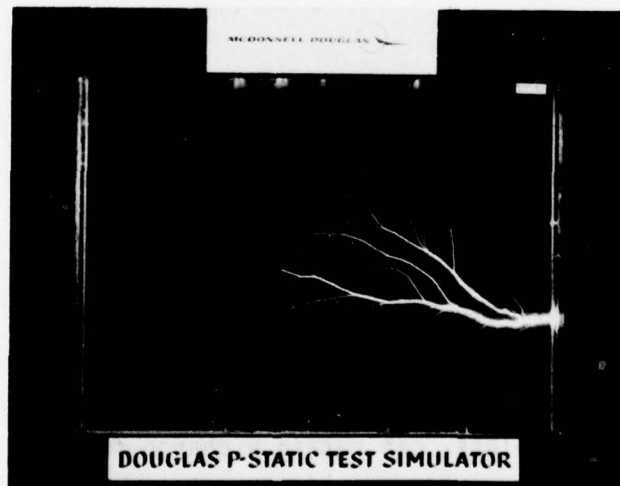
Figure 17. Surface Discharges During Second Exposure Run on -1A Specimen.

Sixty-five additional surface flashes were allowed during the second run for a grand total of 124 flashes. This compares with a total of 163 flashes on the -505A specimen. A photograph of one of the second run surface flashes is shown in Figure 17.

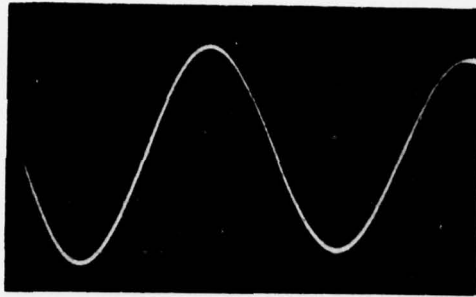
Figure 19 is a series of drive and response waveforms run at 25 KV charge on a 0.54-microfarad capacitor bank (four 2 microfarad capacitors in series). Figure 19a is the drive current as measured across a resistive shunt. The initial peak of this damped wave represents 8 kiloamperes. Figure 19b is a detailed study of the early time characteristics of the waveform of Figure 19a. Figure 19a is at 2 microseconds per division, while Figure 19b is at 0.05-microsecond per division. The vertical response of Figure 19b is 2.5 times as sensitive as for Figure 19a, and indicates a clean front end structure. Figure 19c is a trace of the response signal in the bus-to-bus current flowing in the -1B specimen. It was measured using the Stoddart 91550-1 current probe around the wire which interconnected the buses. Figure 19c is to the same time scale as Figure 19a (2  $\mu$  sec./div) and shows that for time beyond the initial induced transient, the waveform has the same frequency as the drive current. Note that with the exception of Figure 19a, all the other Figure 19 traces used the reduced scan feature of the 466 oscilloscope wherein the small graticule squares apply.

(a) Lightning drive  
 2  $\mu$  sec/div  
 8K amp first peak  
 (3.56K A/Div)  
 (Large graticule squares)

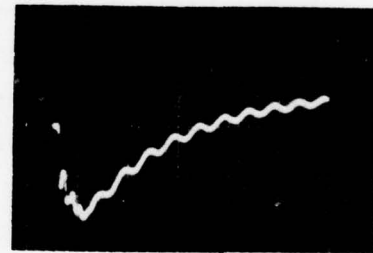
Figure 19d is a detailed study of the fast time characteristics of the waveform of Figure 19c. Figure 19d was taken at the same vertical sensitivity as Figure 19c, but at 0.2-microsecond per division. The transfer impedance of the Stoddart current probe is higher for high frequencies than for low frequencies. Therefore, the amplitude of the initial, fast rising (negative going) transient in Figure 19b represents 41 amperes, while the first positive peak of the lower frequency portion of the wave represents 36 amperes.

(d) Early time characteristics  
 of (c) 0.2  $\mu$  sec/div  
 same vertical sensitivity  
 as (b)
